# The Madagascar Water Project

MWP-1  
ANDOVORANTO

## MWP – 1

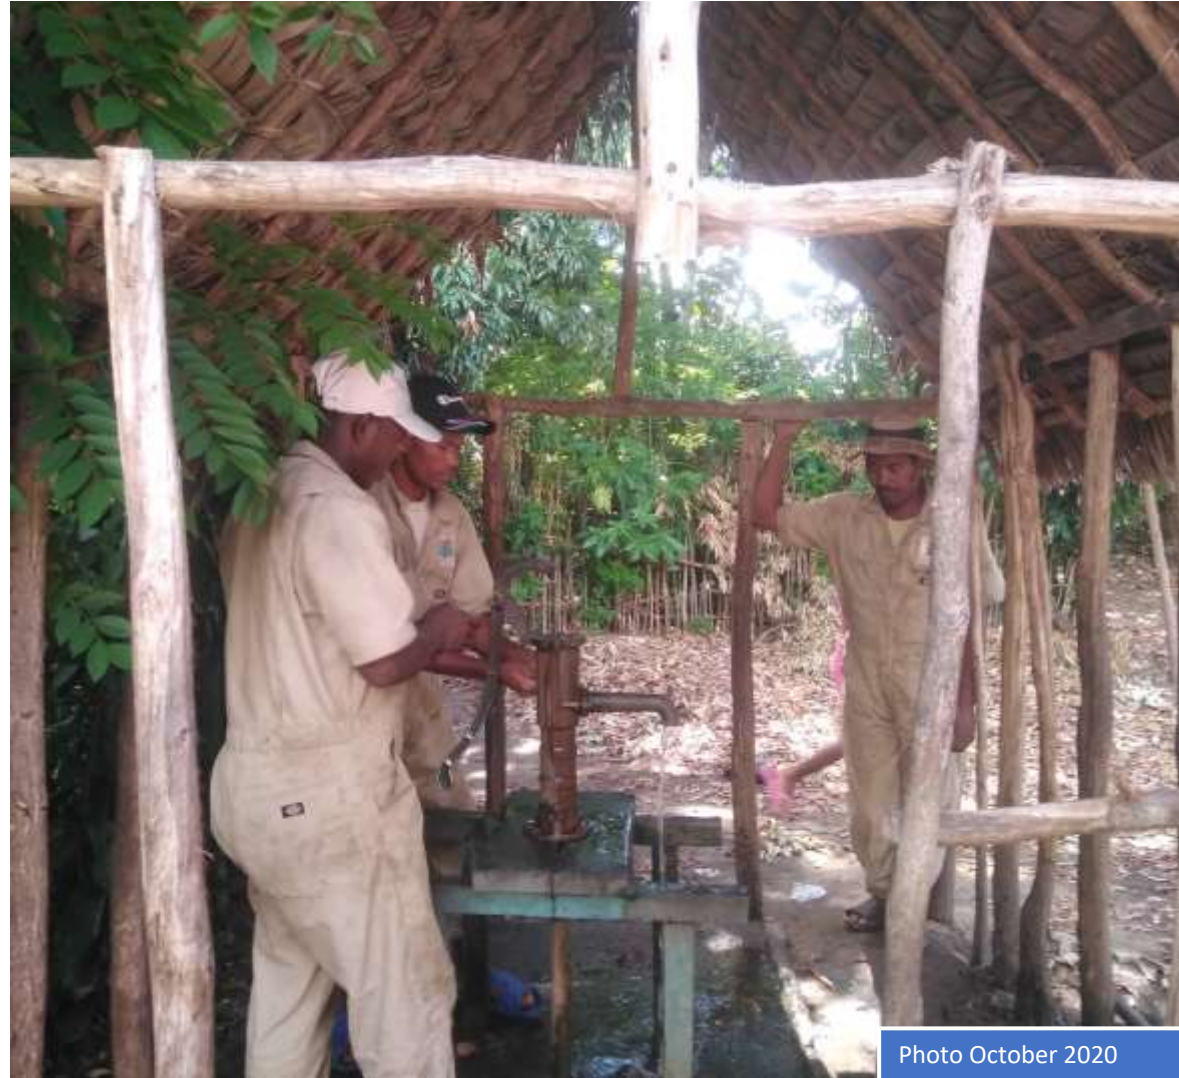
Status on Arrival: Not Working – Pump Broken

Action Taken: Rebuild table, replacement pump not available

- 1) New pump, slab
- 2) Build enclosure / shelter
- 3) Continue work with Well Committee

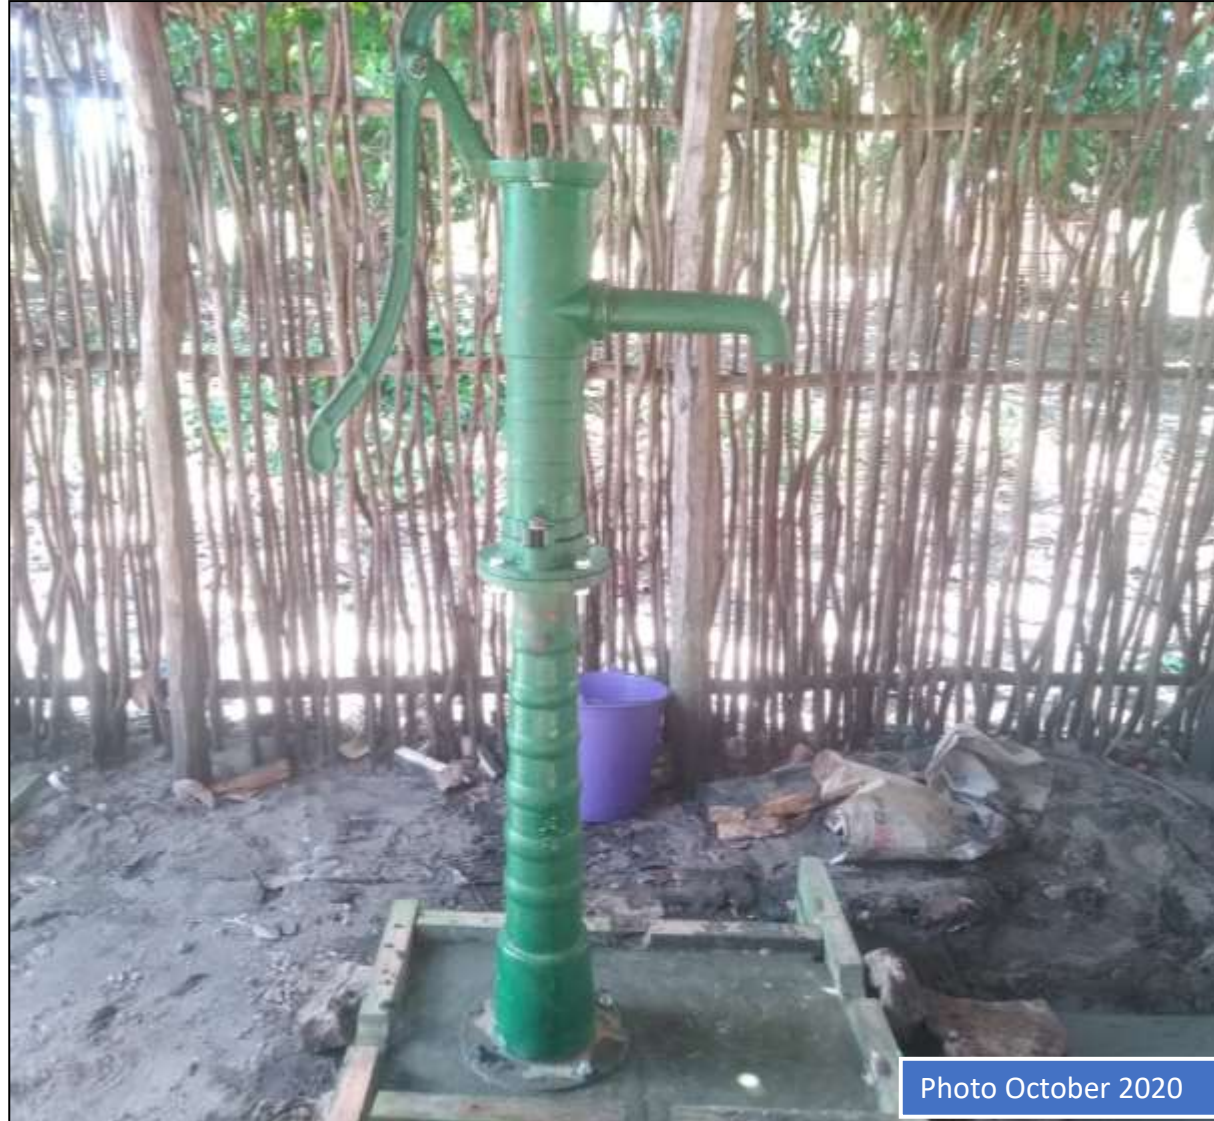
Photo October 2020

- Status on Arrival: Working
- Action Taken: Routine maintenance
- Current Status: Working
- Recommendation:
  - Pump or inside spares need to be replaced Asap
  - Strengthen social, Shelter

- 1) Build enclosure / shelter
- 2) Continue work with Well Committee

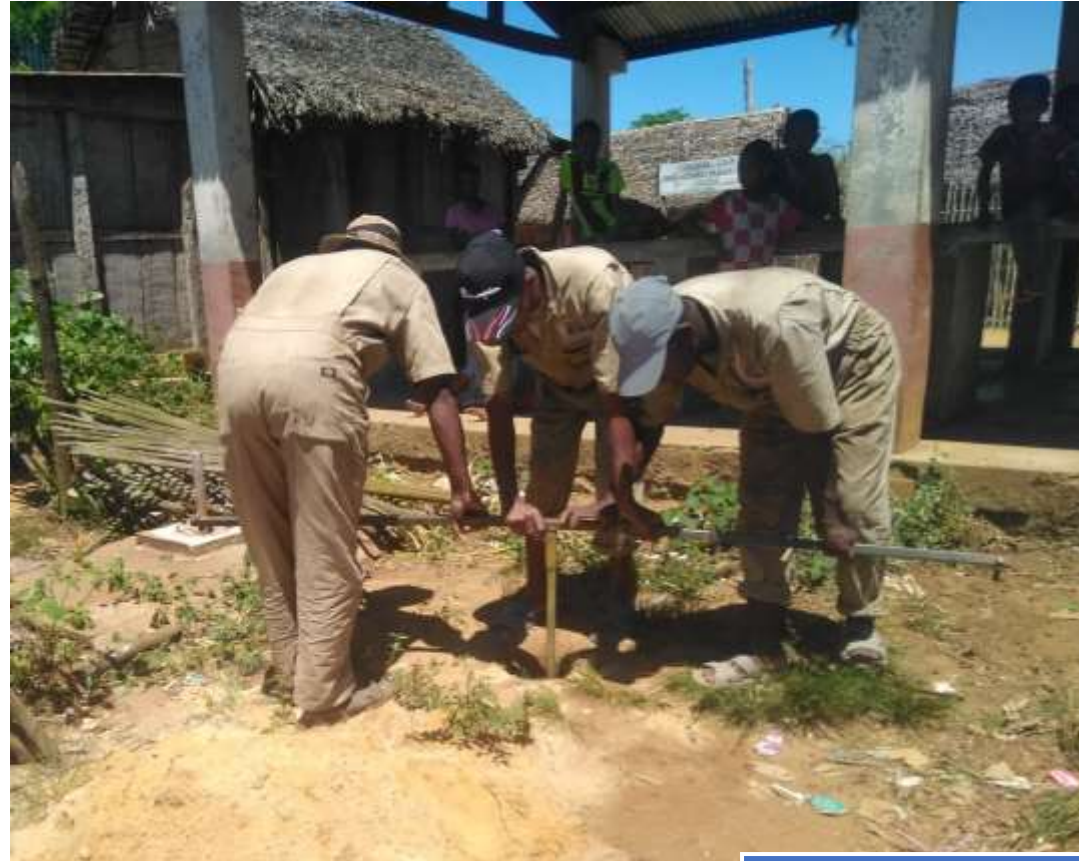
Photo September 2020

- Previous status: produce well
- Action taken: routine maintenance
- Current status: produce, good flow
- Recommendation: strengthen Social
- Note: XL Pump, wall, no shelter
- Note: Infrastructure will still last 2year

- 1) Complete Rebuild: new slab, table, pump
- 2) Build enclosure / shelter
- 3) Continue work with Well Committee

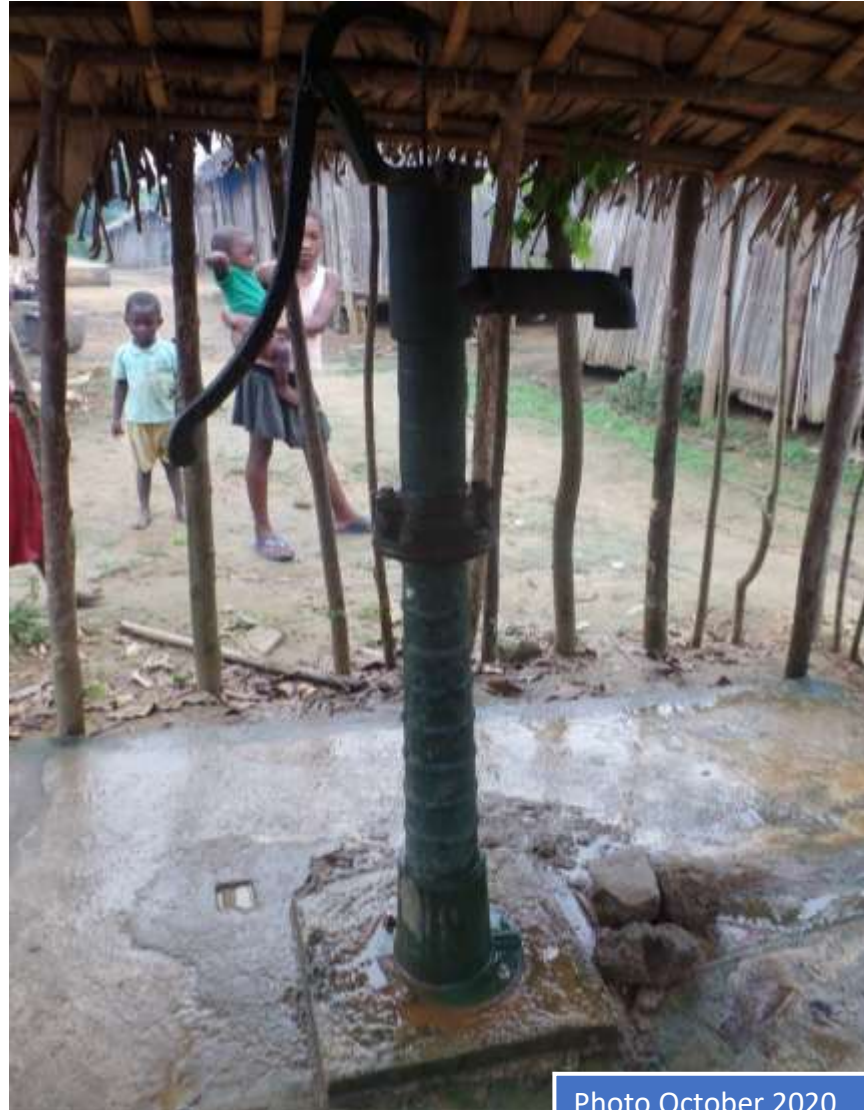
Photo October 2020

Status on Arrival: Not Working – pump cracked

Action Taken: Replace Pump: Rebuilt Batimax

- 1) Replace pump
- 2) Build enclosure / shelter
- 3) Continue work with Well Committee

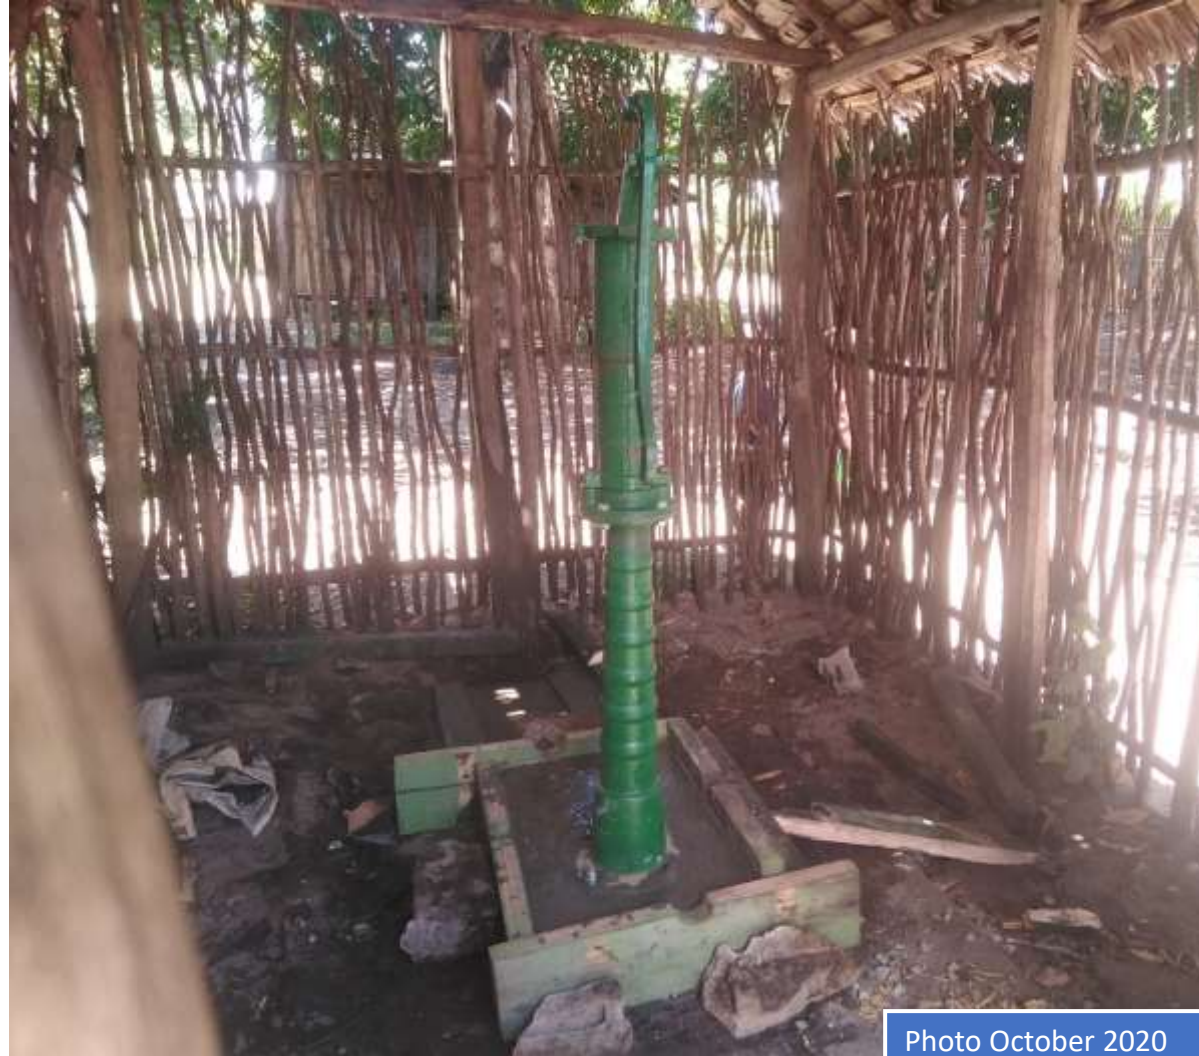
Photo October 2020

- Status on Arrival: Working
- Action Taken: Routine maintenance
- Current Status: Working
- Recommendation:  
-Strengthen social

- Previous status: produce well
- Action taken: routine maintenance
- Current status: produce, good flow
- Recommendation: strengthen Social, table need to be changed on next trip
- Note: good shelter, good wall

- 1) Replace pump
- 2) Continue work with Well Committee

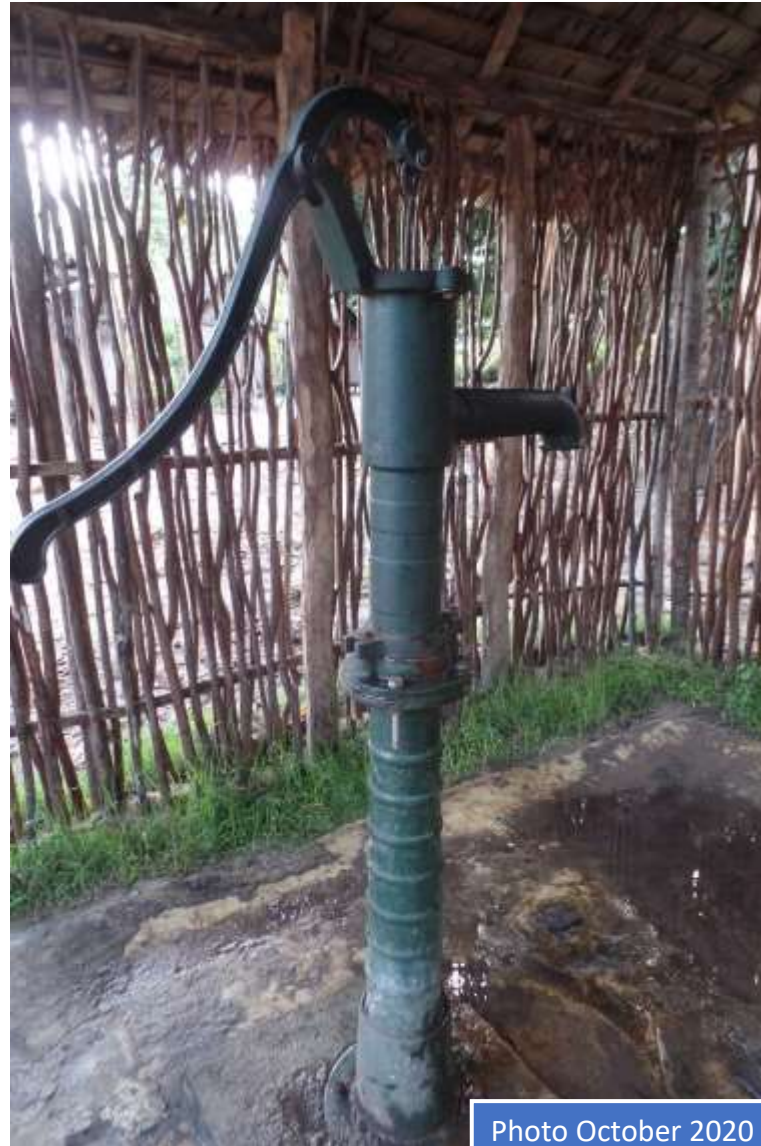
Photo October 2020

- Status on Arrival: Not Working, problem of pump
  - Action Taken: Complete rebuilt with New XL PUMP
- Setting up of XL pump stand by securing maximum the hose. The test of flow is very good and the well is stable and secured).
- Current Status: Working
  - Recommendation:  
-Strengthen social

- 1) Complete Rebuild: new slab, table, pump
- 2) Improve enclosure / shelter
- 3) Continue work with Well Committee

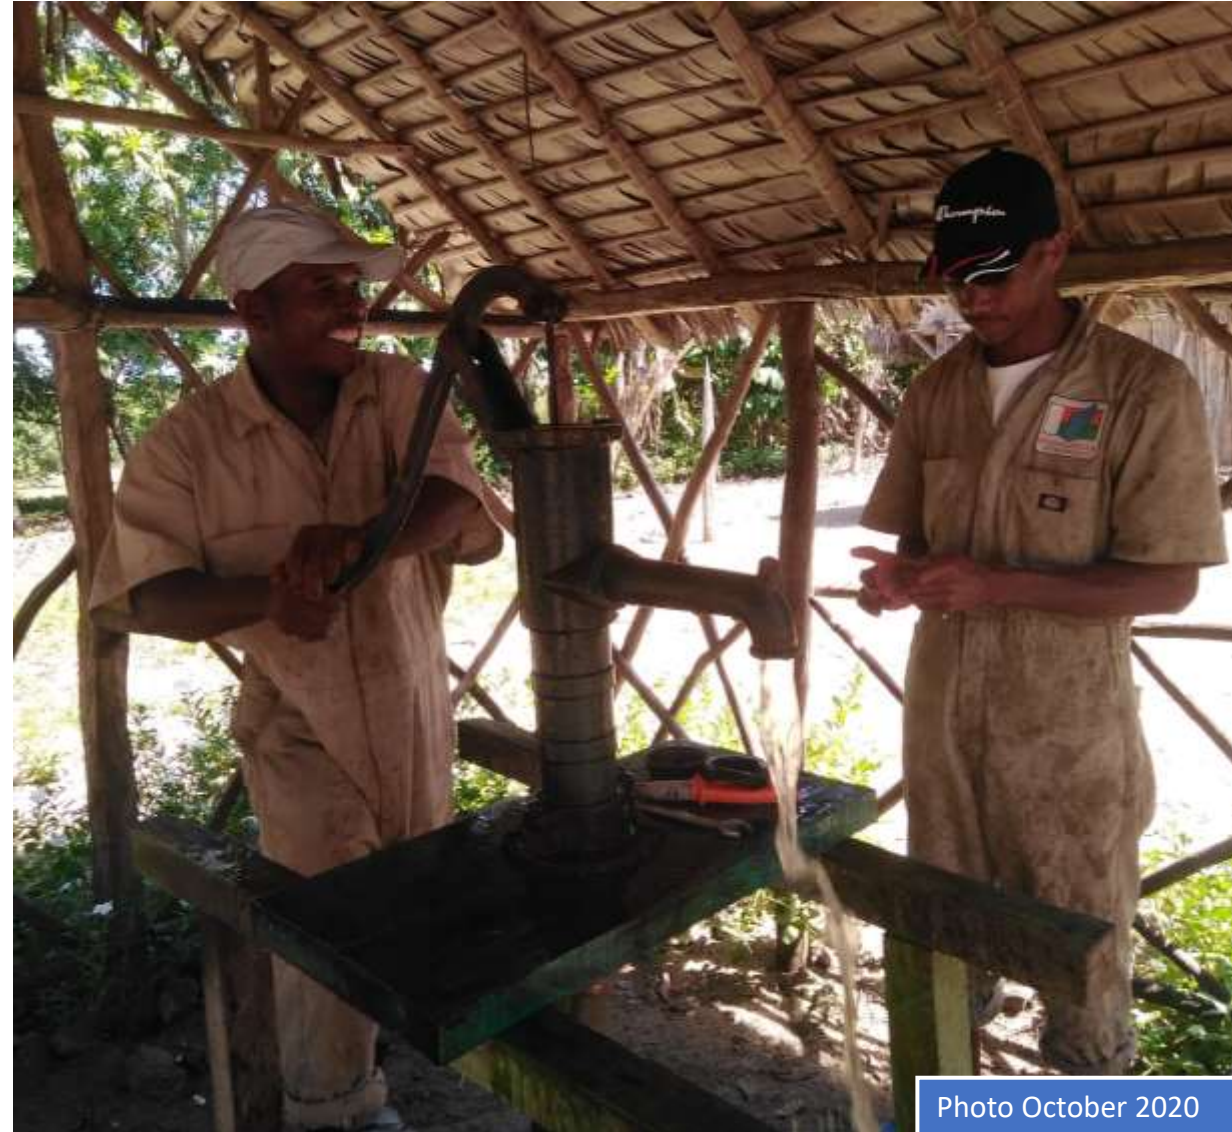
Photo October 2020

- Note: Leather cup broken in 1day, well lack of care, after strong sensitization, people promised to build a shelter...

- 1) New pump
- 2) Build enclosure / shelter
- 3) Continue work with Well Committee

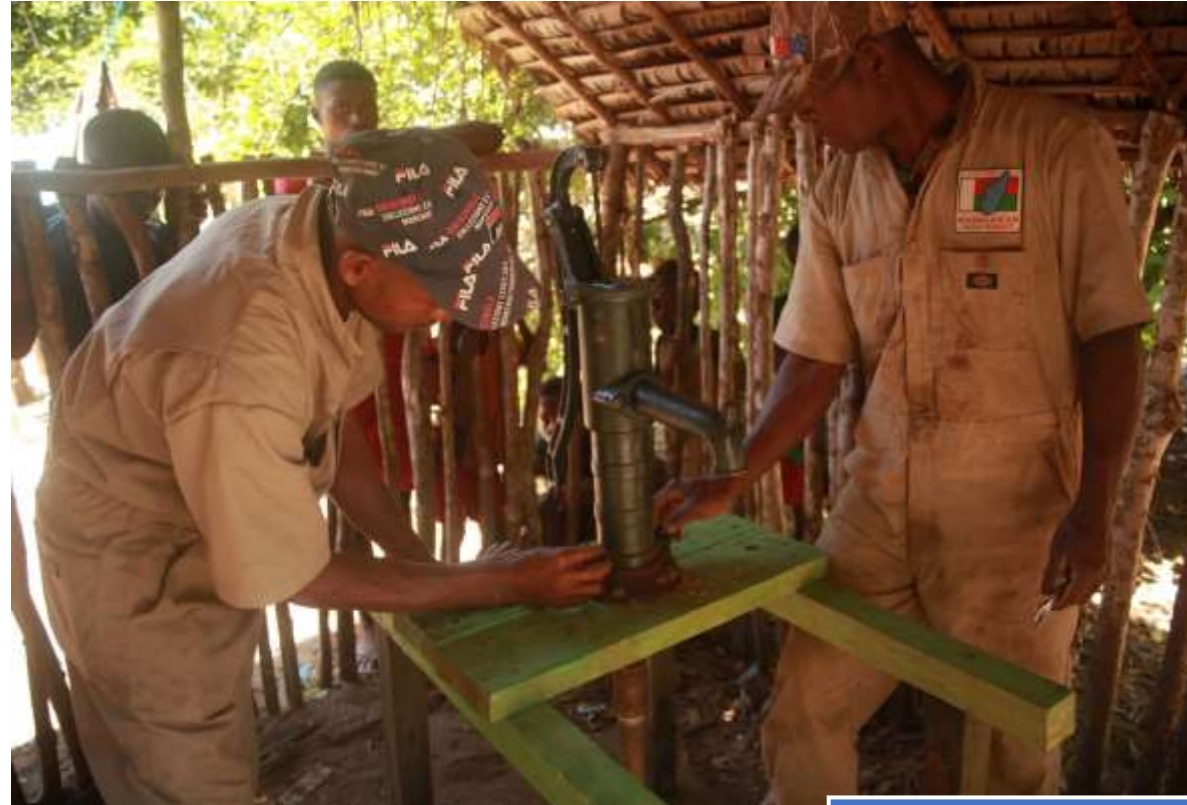
Photo September 2020

- Previous Status: 9m pump broken, wood broken
- Action taken: complete rebuilt, 9m pump changed to New Batimax pump
- Final status: working well

- 1) Repair table, change pump
- 2) Organize Well Management Committee

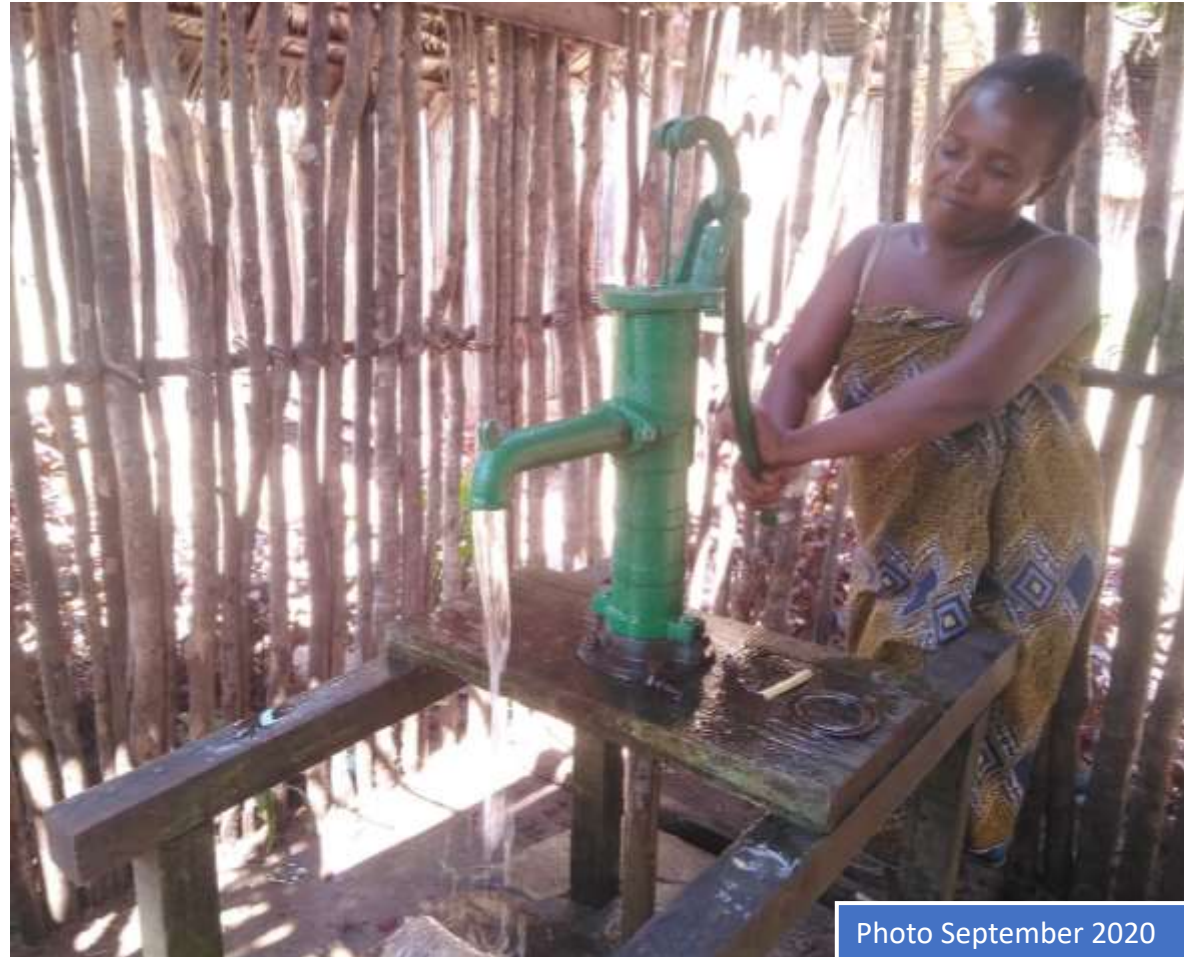
Photo September 2020

- Previous status: Tired 9m pump still producing, table broken, no shelter
- Action taken: complete rebuilt with new Batimax pump
- Current status: produce, good flow
- Recommendation: strengthen Social
- Note: many people use the well

- 1) Build enclosure, shelter
- 2) Change pump
- 3) Continue work with Well Committee

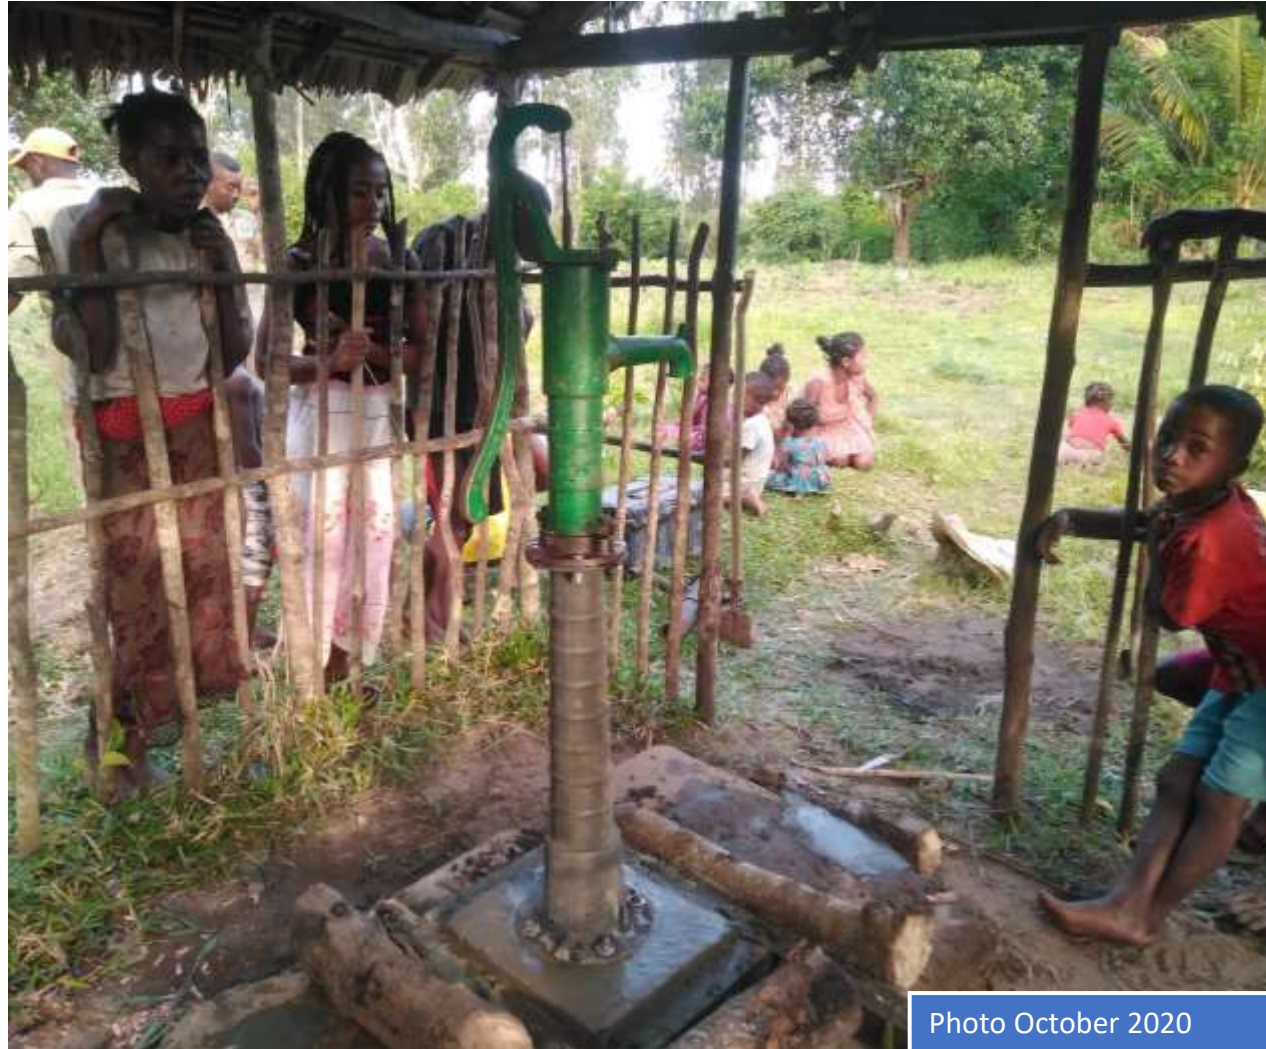
Photo October 2020

- Previous status: produce, no shelter no wall, pump weak
- Action taken: Complete rebuilt of table, setting new pump
- Current status: producing, good flow
- Recommendation: strengthen social
- Note: leather cup working, one spare left

- 1) Improve enclosure, shelter
- 2) Continue work with Well Committee

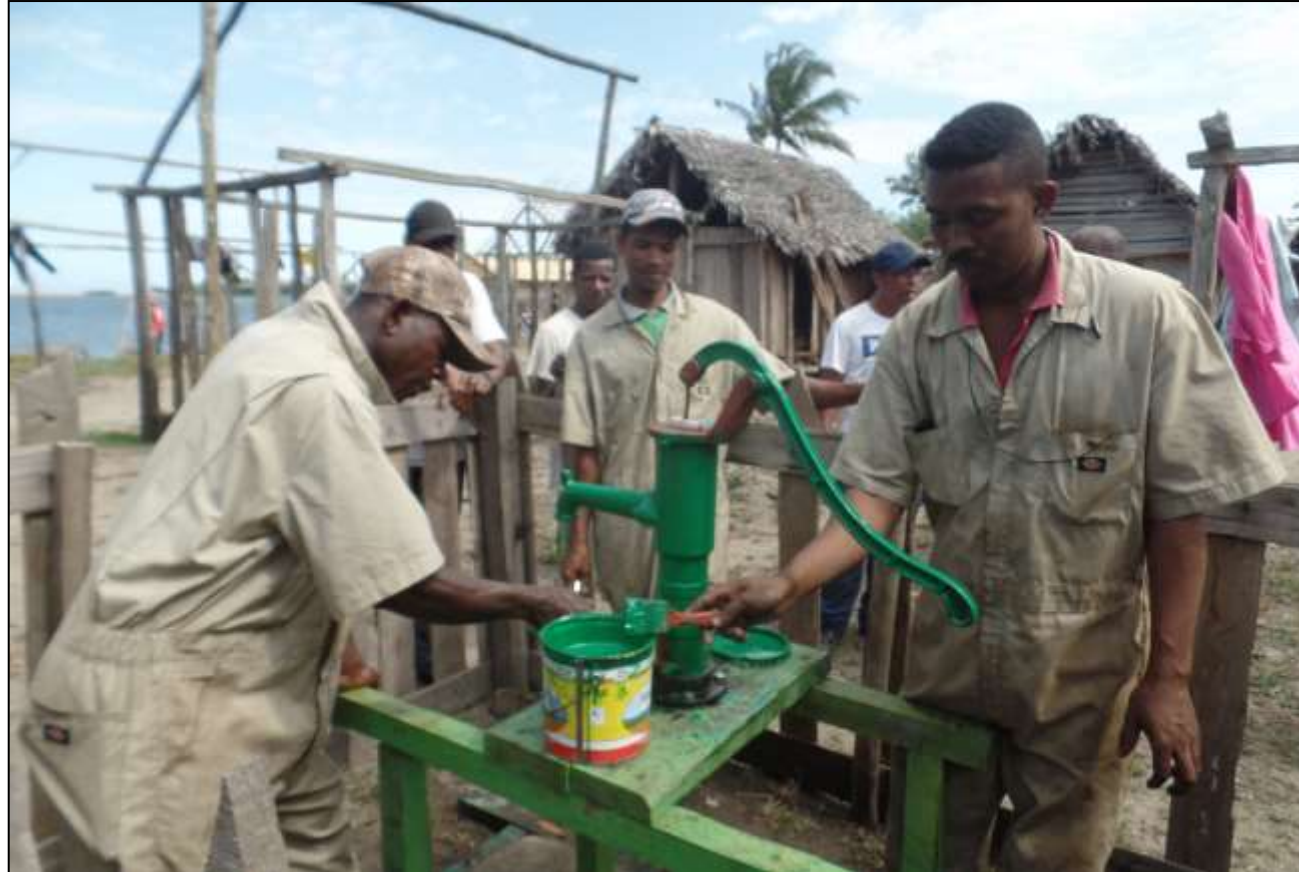
Photo October 2020

Status on Arrival: Not Working – pump broken

•Previous status: did not produce due to problem of pump, the top is broken and pump is very tired. Wood rotten. Well walled.

- 1) Build enclosure, shelter
- 2) Change pump
- 3) Continue work with Well Committee

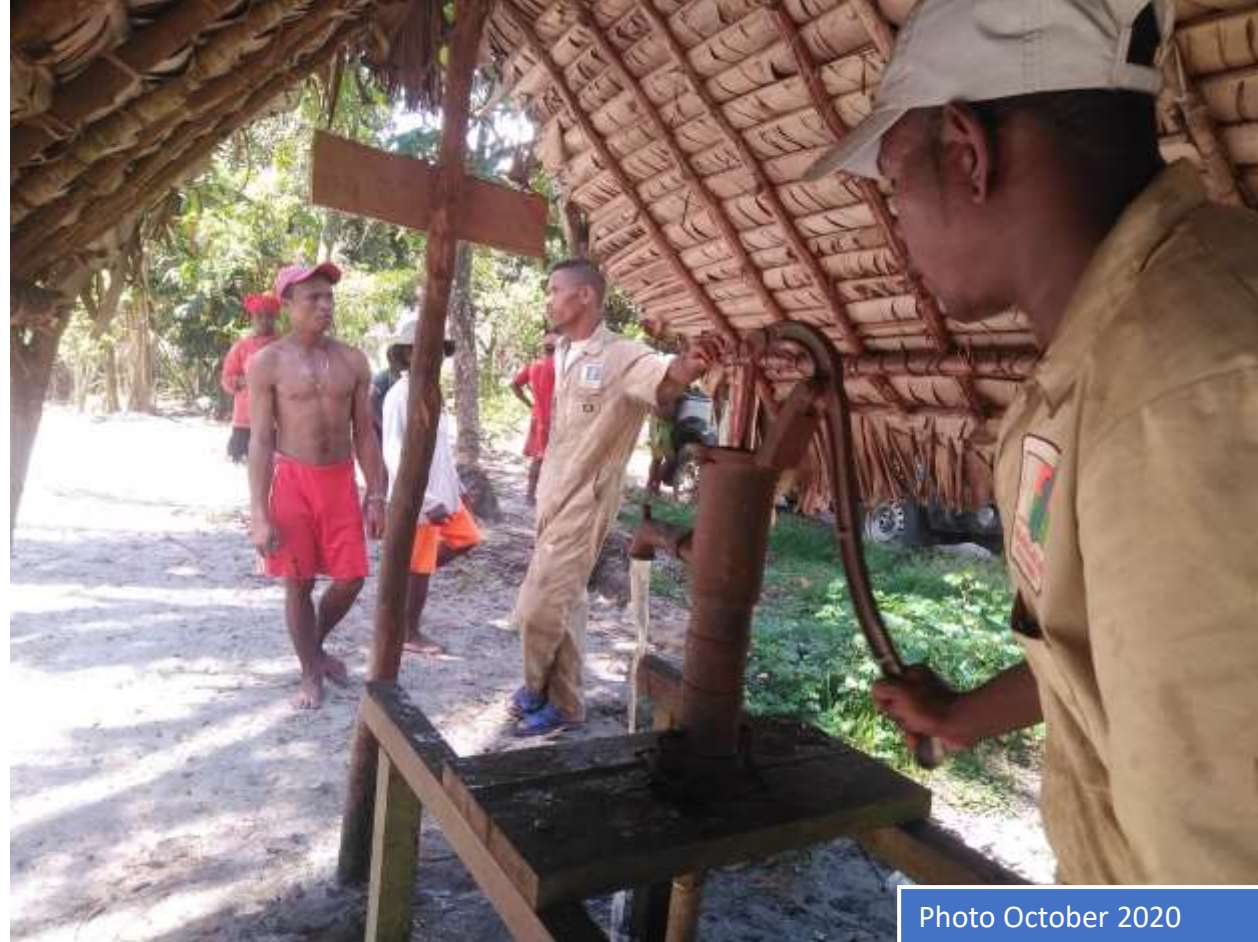
•Previous status: produce with slight odor and little black, Pump in good condition. No roof no wall.

- 1) Build enclosure, shelter, improve well security
- 2) Continue work with Well Committee

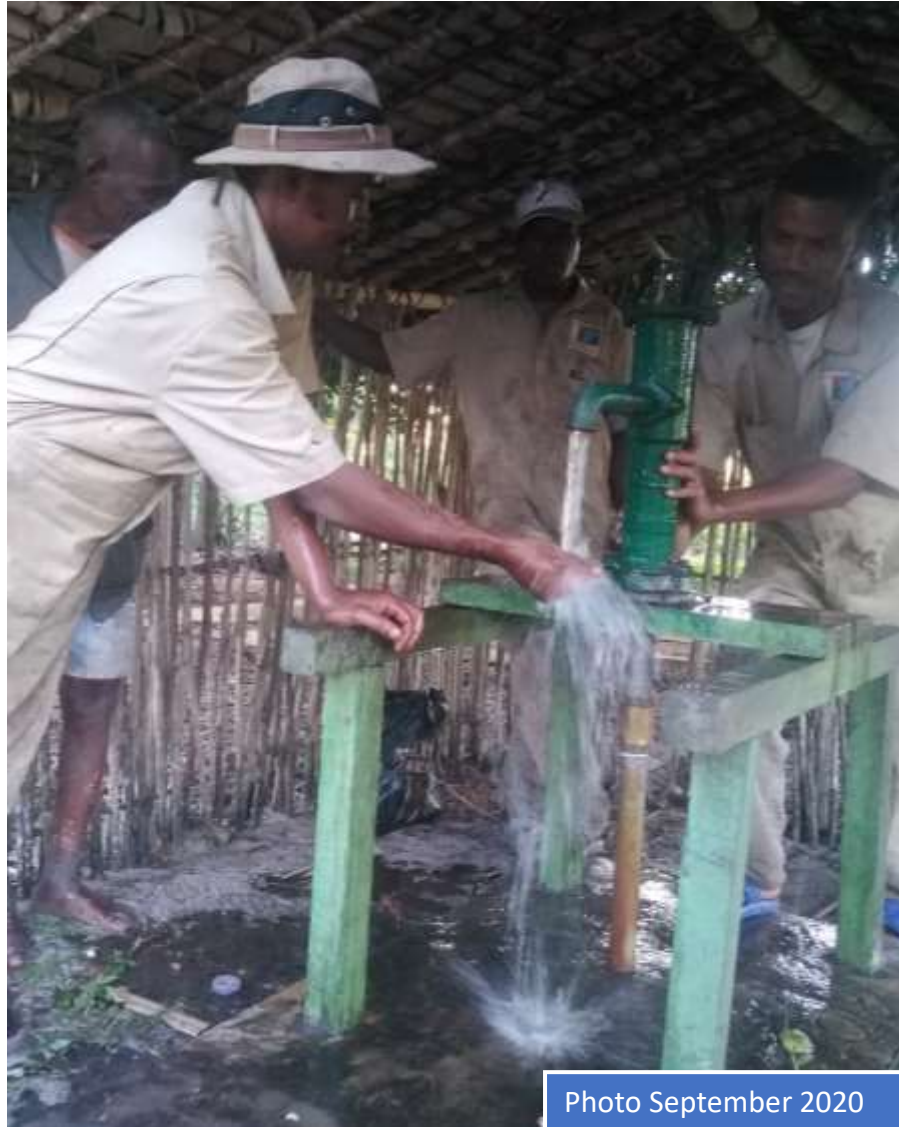
Photo September 2020

- Previous status: produce, wood rotten,
- Action taken: partially rebuilt table,
- Current status: producing, good flow.
- Recommendation: assist well committee

- 1) New table, pump
- 2) Improve enclosure, shelter
- 3) Continue work with Well Committee

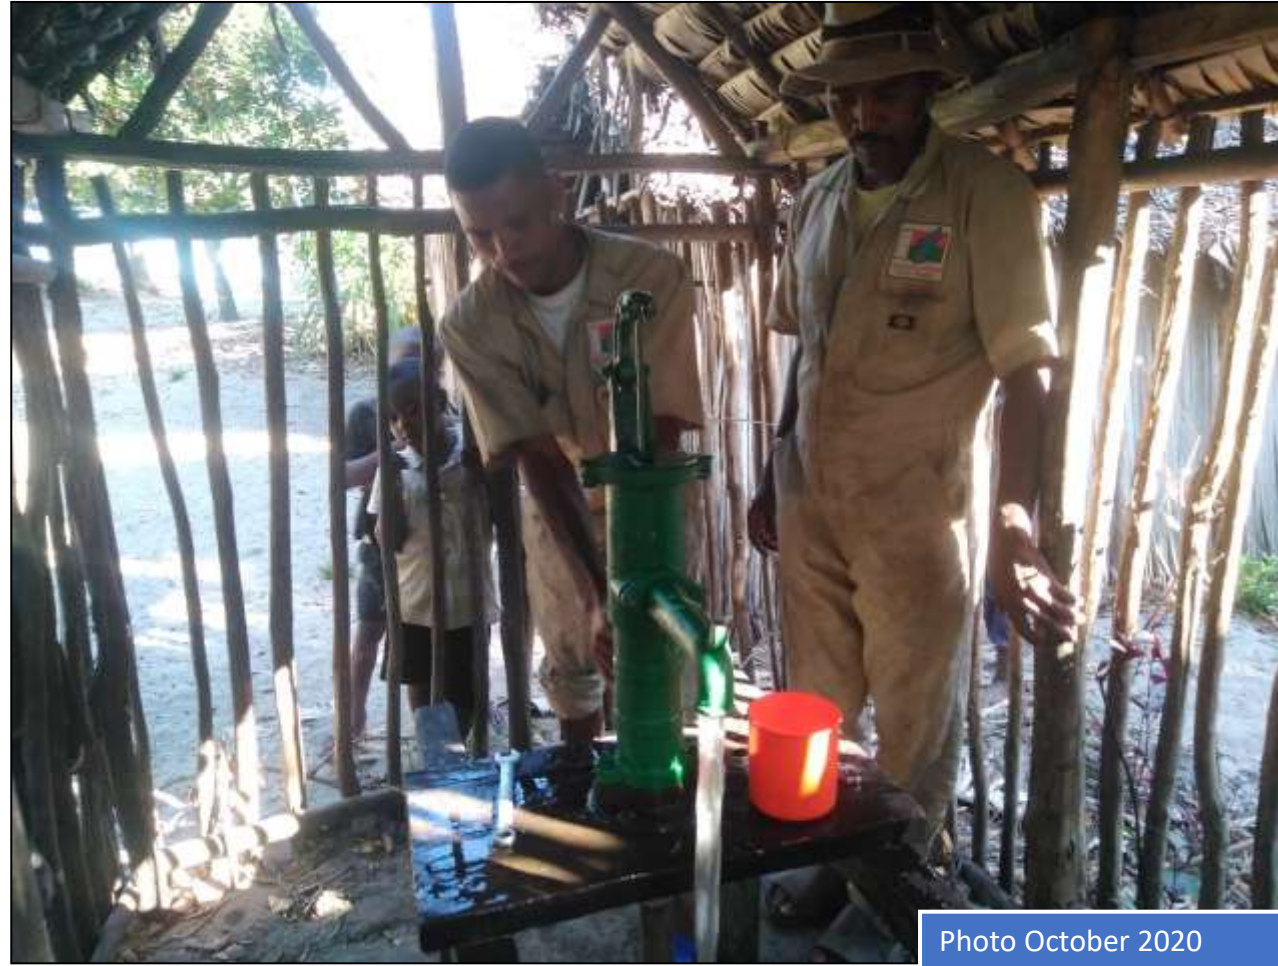
- Status on Arrival: Not working due to stopper plug problem
- Action Taken: change stopper plug, routine maintenance
- Current Status: Working

Recommendations:

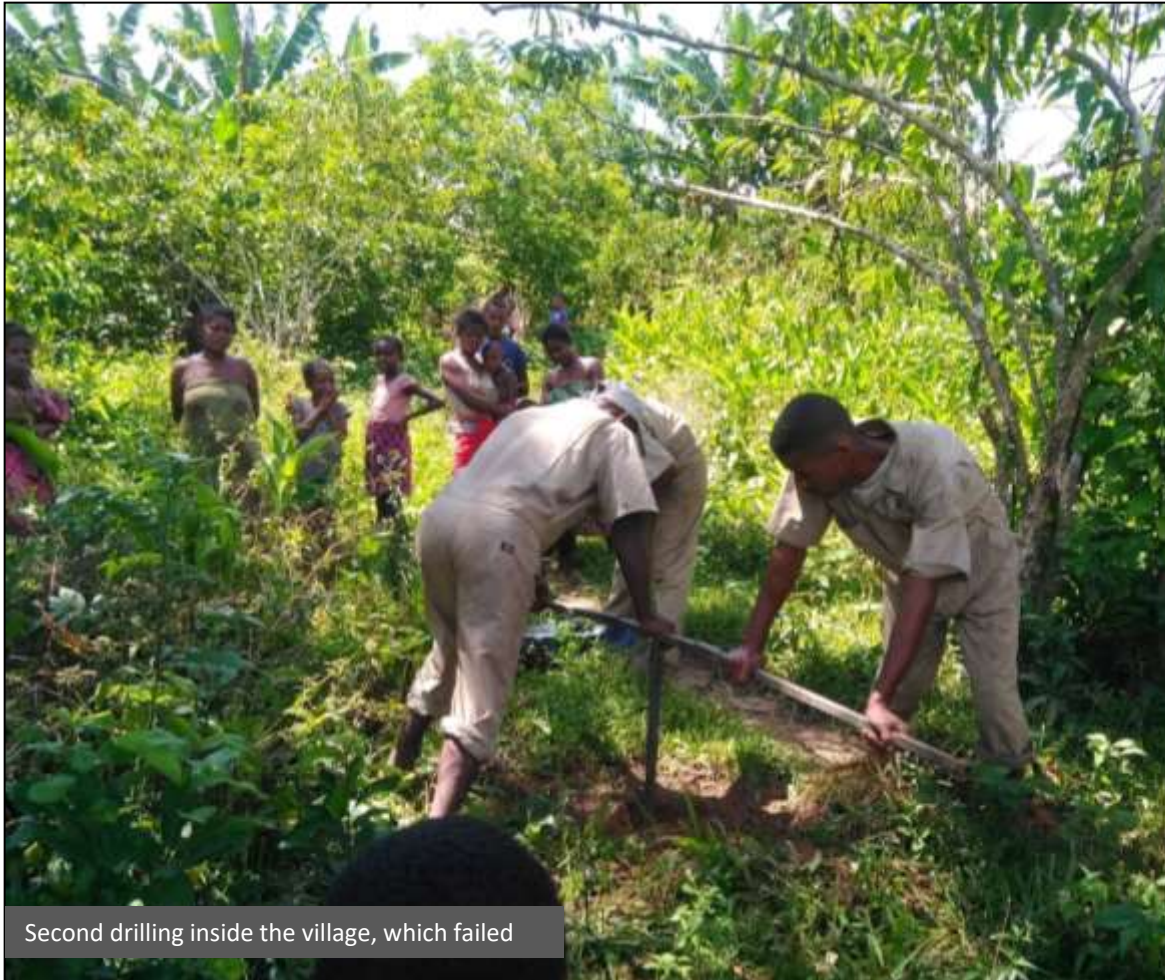
Second drilling inside the village, which failed
