Safety Alert	
Service Bulletin #	AASA-1-1-2013
Superseded Bulletin #	N/A
Issue Date	January 8 th 2013
Effective Date	January 8 th 2013
Limitations for Completion	Before Next Flight
Make & Model Affected	Lightning LS1 SLSA & ELSA
	SN78 thru SN154
Page 1 of 5

All Lightning LS1 aircraft both SLSA and ELSA SN78-SN154

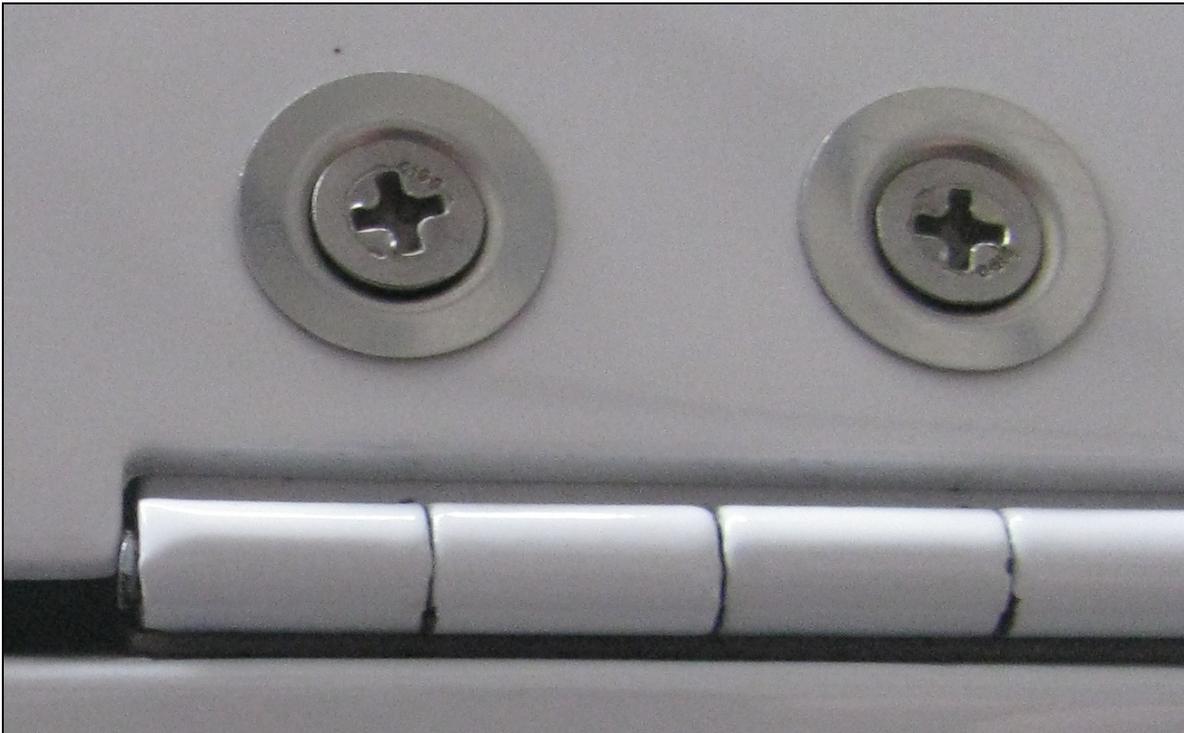
On January the 7th 2013 it was reported to an Airworthiness Inspector from the Birmingham FSDO by an Owner/operator that an LS1 had an elevator hinge pin work loose. The hinge pin did not come out of the hinge fully, it had worked out no more than 1/8" passed the last hinge roll.

The hinge pin may protrude out of the hinge roll and is captured by the horizontal tail skin. This is acceptable and no further action is required. **See Figure 1.**

Figure 1. Hinge pin captured by tail skin. Acceptable.

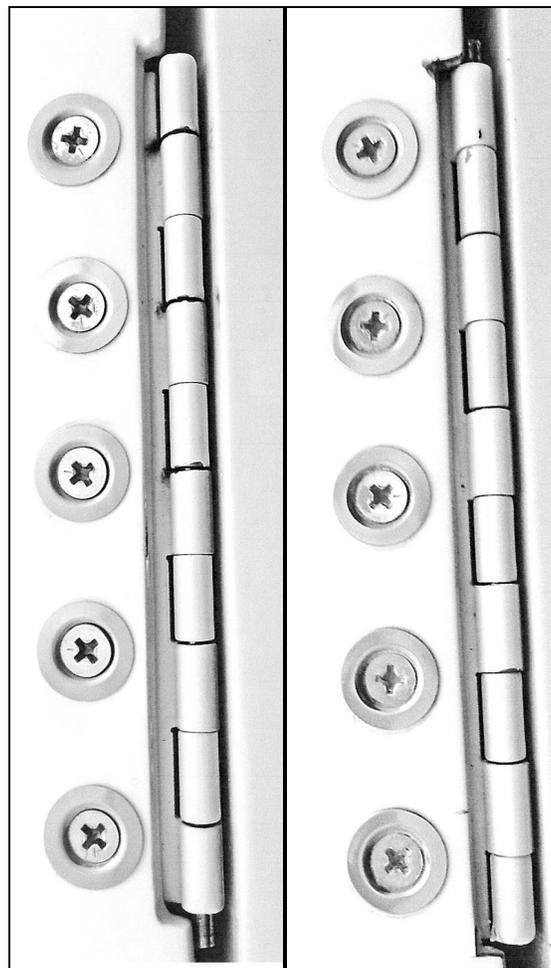
If the hinge pins are noted to be protruding, but no more than 1/8", the aircraft may be flown to a place qualified to comply with this safety alert. The aircraft may not be flown more than 3hrs to do so and only for the purpose of ferry to the Service Facility. **See figure 2.**

IF the hinges are protruding more than 1/8", than the aircraft must be grounded and this Safety alert complied with before the next flight.

Figure 2. Note: Hinge pin protrudes past hinge leaf.

In any event if the hinge pins are protruding and are not firmly captured by the tail skin the following procedure must be accomplished to safely resolve the issue.

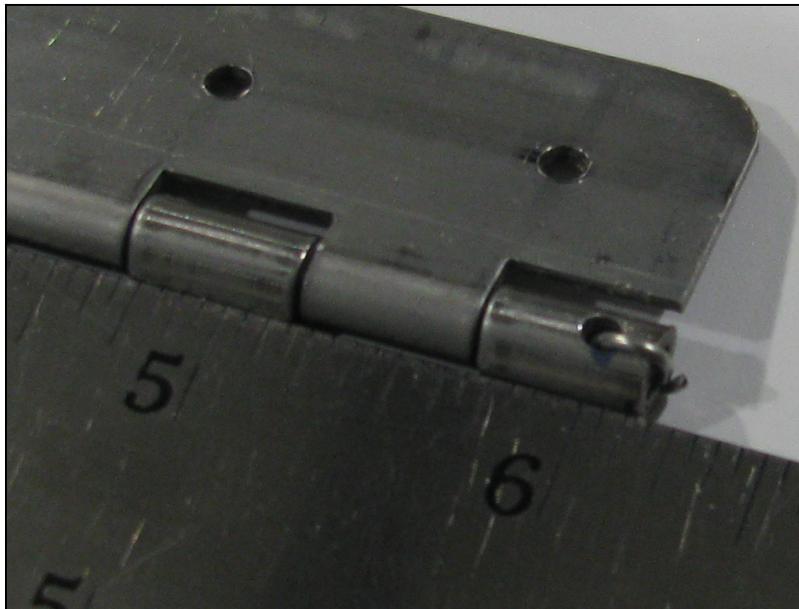
Figure 3. Safety wire pin keeper.

1. Use a small punch to drive the hinge pin back into the hinge leaf. The pin is shorter than the leaf so you must inspect both ends to make sure the pins are equally seated in the hinge leaf.
2. Drill a 3/32" hole near the end of the outboard leaf rolls on each elevator hinge. This hole should be approximately center 1/8" from the end of the leaf roll. **See figure 3.**
3. Use a short piece of 0.032 safety wire to create a loop thru the hole. This will act as a keeper and not allow the pin to work out of the hinge leaf. **See figure 3.**
