Confidential Inspection Report

LOCATED AT: 5 Harvard Ct
RSM, CA 92688

PREPARED EXCLUSIVELY FOR: I. M. Homeowner

INSPECTED ON: Sunday, January 28, 2018

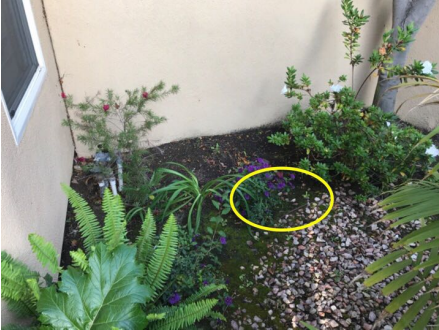
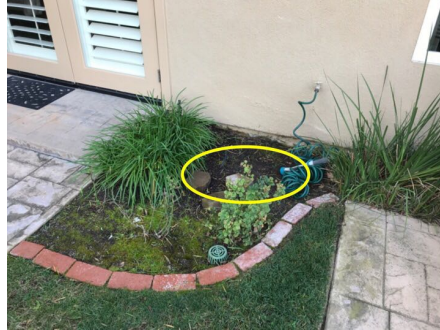
32: Signs of previous pooling water at low spots within 6' of the foundation. This is a moisture intrusion hazard. Recommend correction by a landscape contractor.

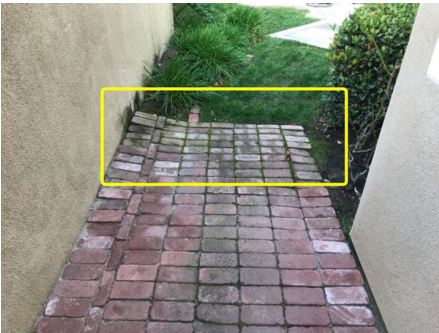
34: Trip hazard on walkway. Someone will trip and injure themselves. Recommend repair or replacement by a general contractor.

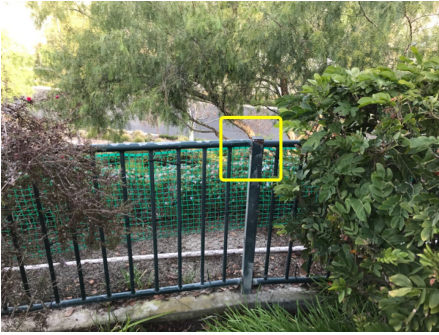
36: Metal fence is showing areas of rust. Fence will prematurely deteriorate. Recommend repair or replacement by a general contractor.

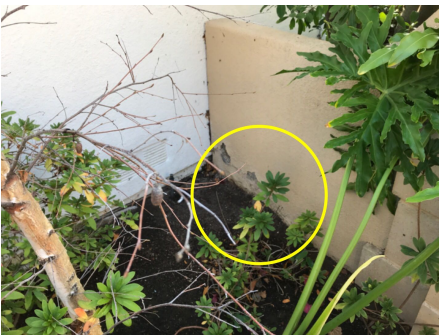
37: Water damage observed. This is a moisture intrusion hazard. Recommend repair or replacement by a general contractor.

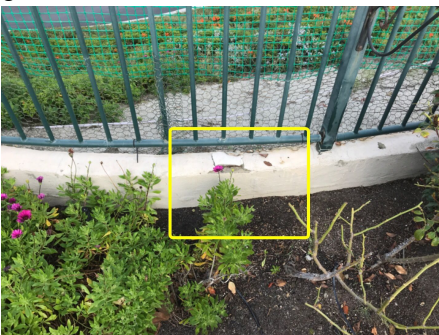
38: Damaged retaining walls observed. Fencing will eventually fail. Recommend repair or replacement by a general contractor.

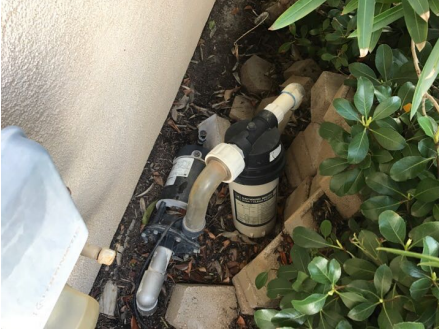
41: Abandoned water feature equipment, beyond the scope of this inspection. Ask seller and check the disclosures for information about this.

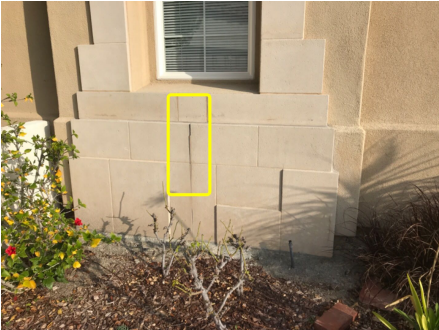
43: Siding damage. Recommend repair or replacement of damaged sections to keep moisture and insects from harming structure, by a general contractor.

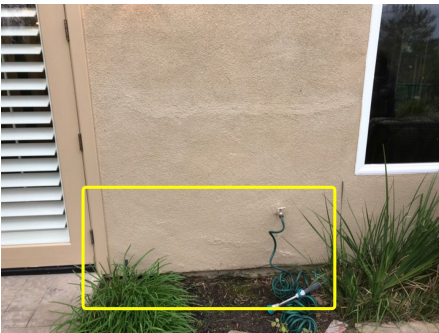
44: Siding water damage. Unable to tell if there is additional hidden damage behind the siding. Recommend further evaluation / repair or replacement of all siding to keep moisture and insects from harming structure by a general contractor.

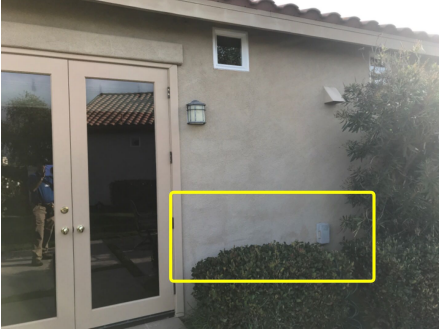
45: Water from the roof is staining the siding. This is due to the lack of a functional gutter system. This is a moisture intrusion hazard. Recommend installing gutters by a roofing contractor.

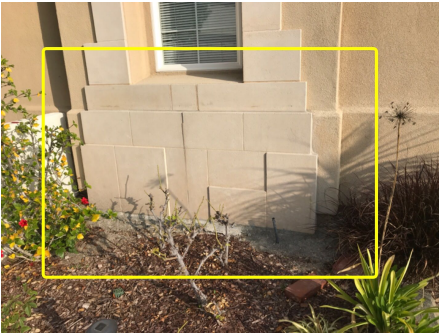
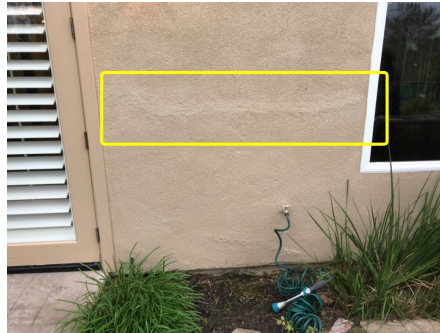
46: Evidence of repairs observed. Unable to determine the effectiveness of these repairs. Unable to tell if there is additional hidden damage behind the wall. If this repair concerns you, I recommend contacting a general contractor for further evaluation and / or repairs.

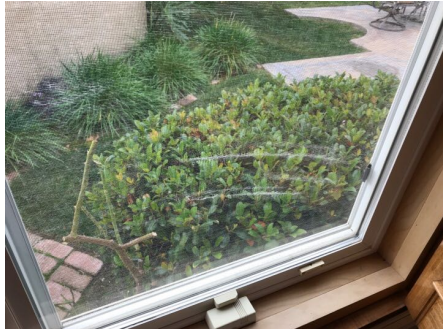
50: Damaged window screen observed. Functional screens keep insects out. Recommend repair or replacement by a general contractor.

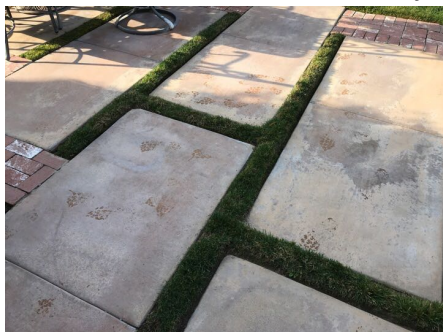
54: Trip hazard on patio. Someone will trip and injure themselves. Separated slabs should be flush with the surface. Recommend correction by a general contractor.

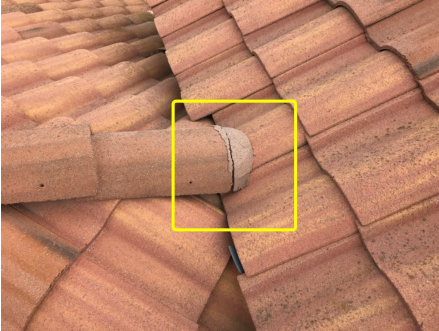
58: Mud cap deteriorating. This is a moisture intrusion hazard. Recommend repair or replacement by a roofing contractor.

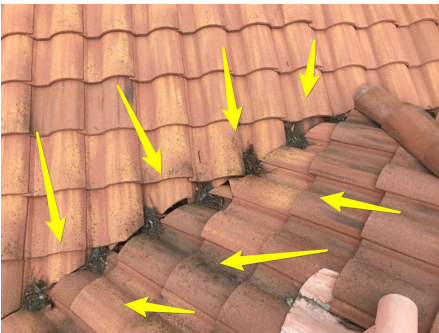
59: Valleys are closed. There is not enough room in the valleys for debris to clear. Anything that impedes the water from leaving the roof, increases the chances of a leak. Recommend correction by a roofing contractor.

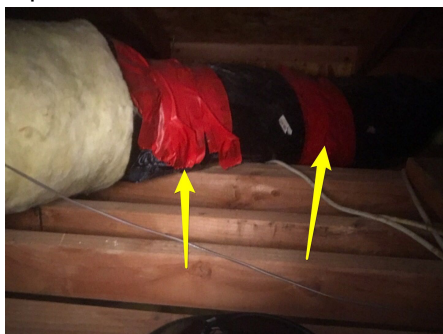
74: Evidence of repairs observed. Recommend you ask the seller about this condition and/or check the disclosures. If this repair concerns you, I recommend contacting a roofing contractor for further evaluation and / or repairs.

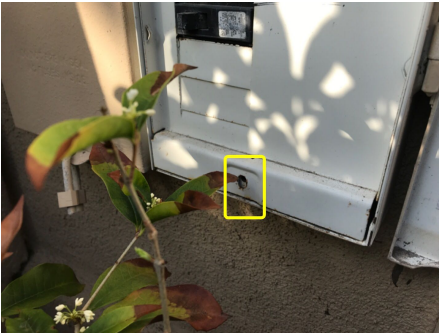
86: Panel cover screw missing. Panel cover should be secured to the panel. This is a shock hazard. These screws should be approved, flat tipped screws. Screws can be purchased at any home-improvement store.

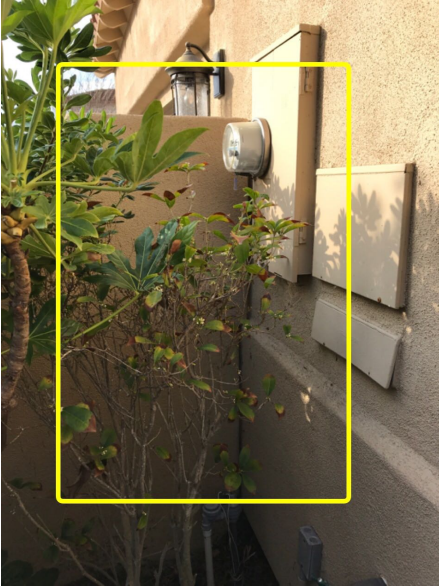
87: Access to electrical panel is blocked, there should be a 30" wide by 36" deep cleared area in front of the panel (all the way to the ground). Recommend you clear the area in front of the panel for safety purposes.

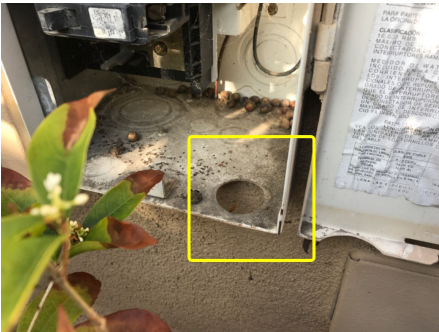
89: Open knockout in the panel. Open knockouts need to be covered inside the panel box. They should be covered to keep pests out of the panel box and to avoid shock hazard. Recommend you have all knockouts covered correctly by an electrician.

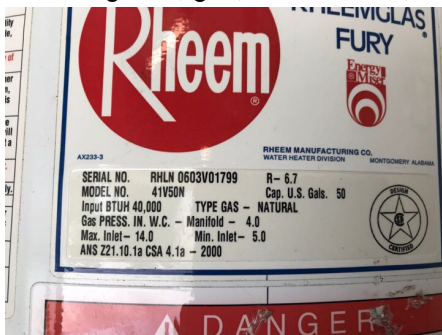
102: 50 gallon, gas, water heater, manufactured by Rheem.

103: Water heater is approximately 15 years old. The average life of a water heater is 12 years in Southern California.

104: Water heater has exceeded its designed life expectancy of 12 years. I make no warranty, guarantee or estimation as to the remaining useful life of this unit. Budget for replacement in the near future.

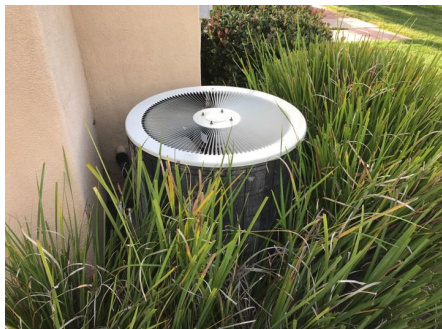
126: There is an unordinary amount of vegetation blocking the compressor unit. Blocking the flow of air around the compressor will degrade its efficiency. Recommend pruning around the compressor.

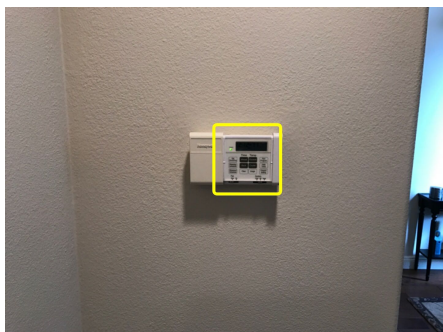
141: Thermostat cover missing. The cover protects the thermostat. Recommend replacement by an HVAC contractor.

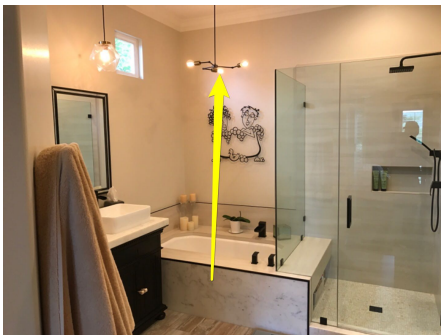
170: Pendant lighting within 3' of the tub and less than 8' above the tub. Do not grab this electrical device while standing in water. This is a shock hazard. Recommend moving or removing the pendant lighting by an electrical contractor immediately.

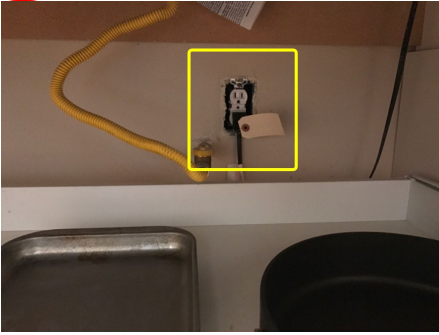
195: Missing receptacle cover plate. This is a shock hazard. Recommend installing for safety.

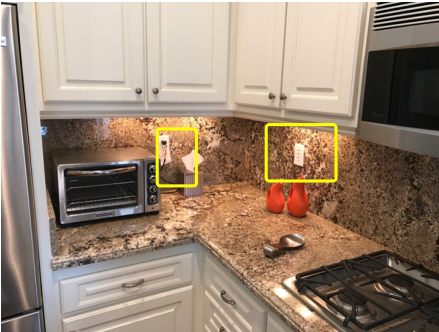
196: Some of the receptacles serving the kitchen countertop do not have GFCI protection. This is a shock hazard. Recommend correction by an electrical contractor.

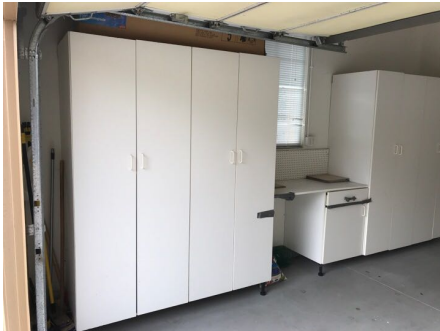
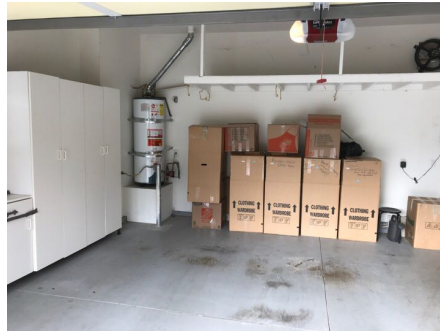
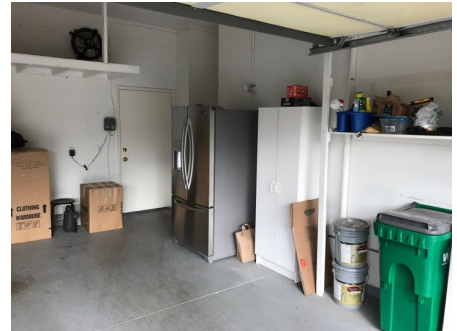
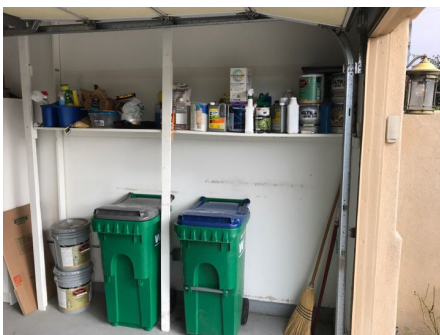
204: Limited inspection, garage contained a large volume of personal items. I was unable to see many parts of the garage. Make sure you inspect these locations after the personal items are removed.

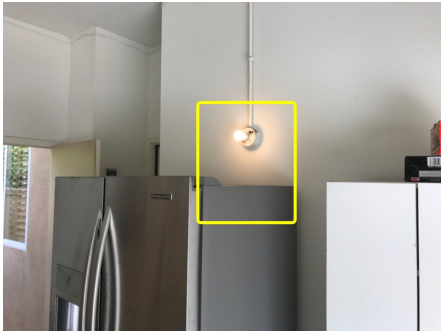
212: Light is an exposed bulb. Due to the near proximity of combustible material, this is a fire hazard. Recommend having an electrician replace with a proper protected lighting fixture.
