ISLAND MARINE GROUP, LLC

REPORT OF A MARINE SURVEY

2006 TIARA YACHTS 32 OPEN

"FOLLOW ME"

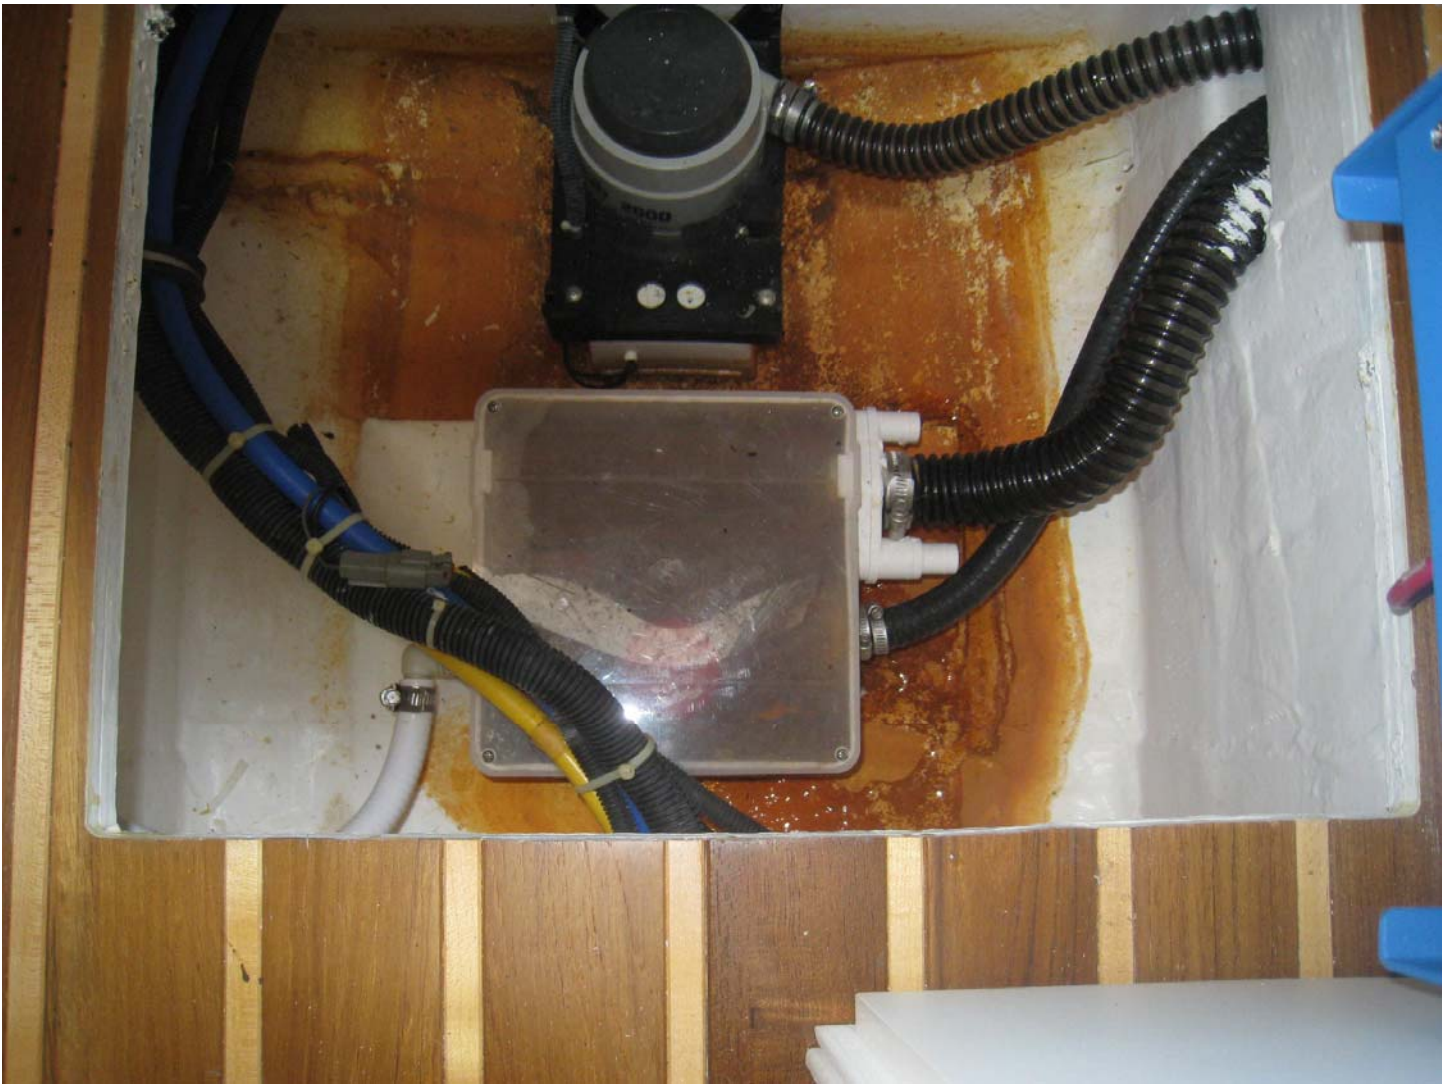
Galley and head wash basin drain overboard through the hull side. The shower and air conditioner condensate drain into a shower sump. §C-3 Shower sump fails to drain when filled with water. The over current protection for this could not be determined. Either a fuse or circuit breaker could be defective. If not the pump or float switch might be defective.

SUMP COLLECTION BOX IS FULL OF WATER AND PUMP DOES NOT ACTIVATE. IT APPEARS THAT WATER COLLECTS IN THIS AREA. THE RUST APPEARS TO COME FROM THE AIR CONDITIONING CONDENSATE. WHEN ENOUGH WATER COLLECTS, IT IS EMPTIED BY THE BILGE PUMP.

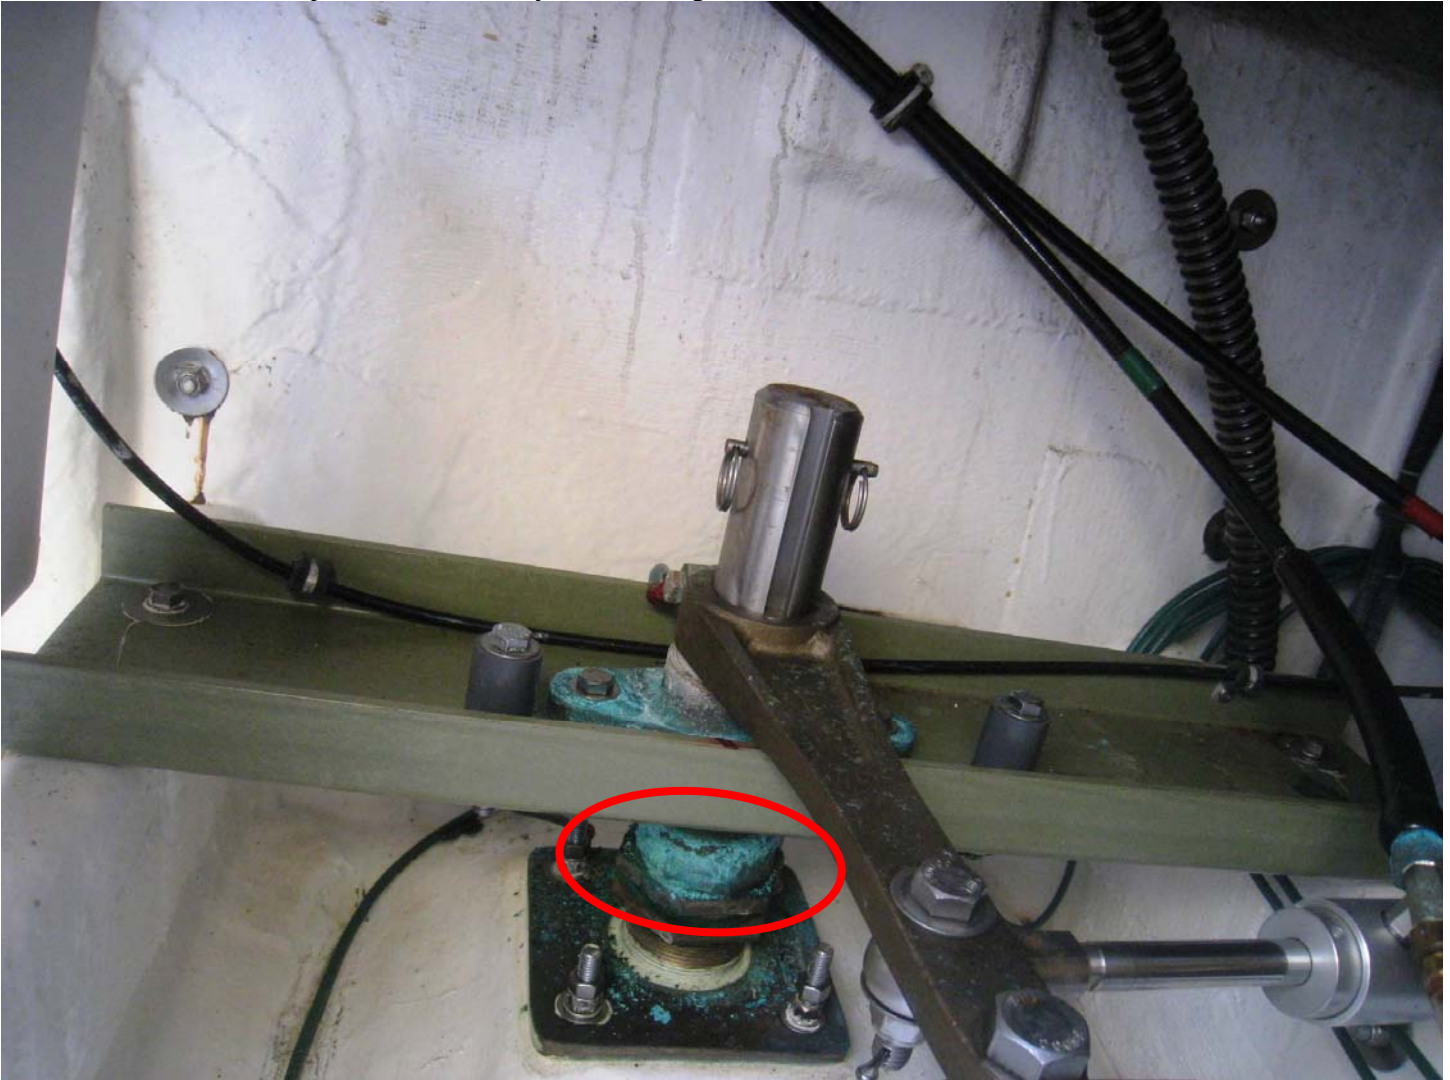
Mounted on composite beam attached to the boat structure. **§C-4** Rudder post shows some signs of minor corrosion at the top seal. Disassembly and cleaning is recommended at the next haul out.

§C-4 Rudder post upper seals show corrosion

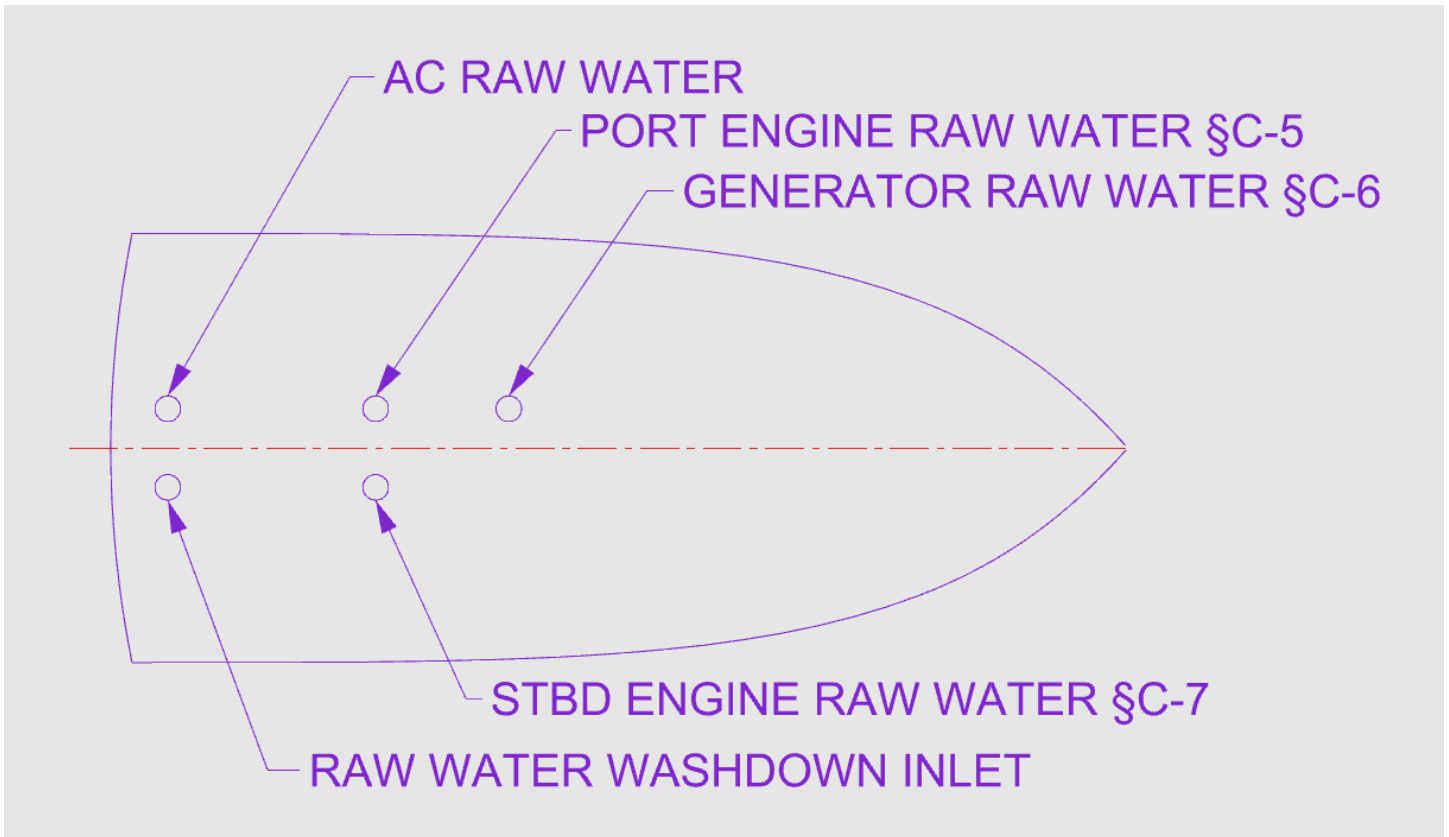
§C-5, 6 & 7 Ball valves are stuck in the open position.
