Inspection Report

Property Address:
508 Franklin Dr
San Marcos TX 78666

PROPERTY INSPECTION REPORT

By: Mark Havelka 20755 / Austinspect, Inc. 8/26/2019

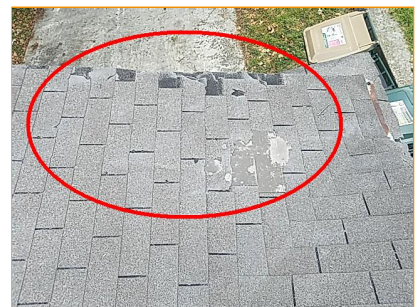
C. Item 6(Picture)

(1) Damaged shingles were observed at various areas of the roof covering. Recommend further evaluation and repair by a qualified roofing contractor.

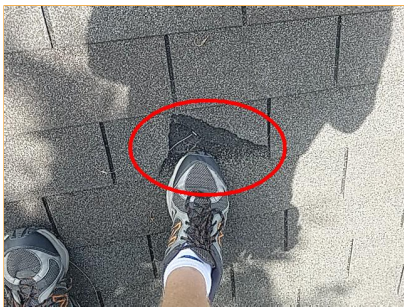
C. Item 7(Picture)

(2) The sheathing was soft under-foot at various areas of the roof covering. Repair or replace all damaged building materials. Additional damage may be present that was not visible to the inspector.

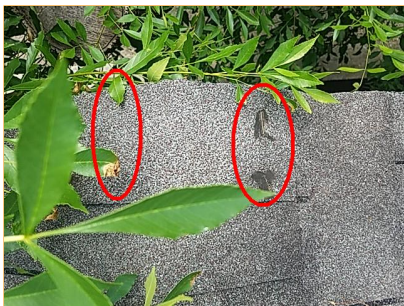
C. Item 9(Picture)

(3) The shingles appear to have been secured with staples. Although both nails and staples have historically been used to secure shingles, staples are usually not recommended in areas subject to high winds. They are also not allowed by most building codes. Fastening shingles with staples may void the manufacturer's warranty against wind damage.

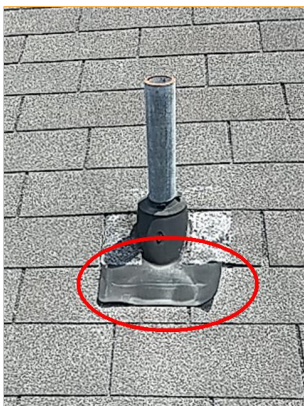
C. Item 10(Picture)

(4) Secure and seal any loose flashing.

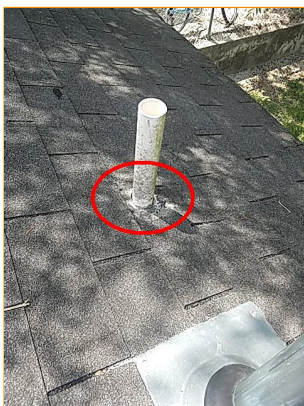
C. Item 13(Picture)

(6) There was no roof jack present at the plumbing vent for the washing machine drain line. Rot was observed at the roof sheathing beneath this area. Recommend further evaluation and repair by a qualified roofing contractor. Additional damage may be present that was not visible to the inspector.

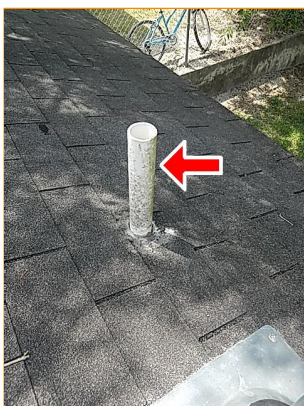
C. Item 14(Picture)

(7) Recommend painting PVC roof plumbing vents to prevent UV deterioration.

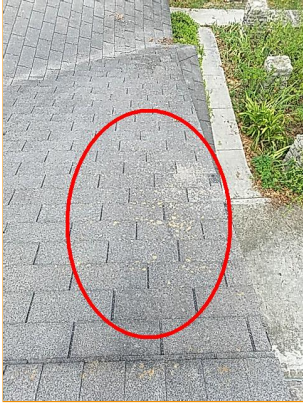
C. Item 15(Picture)

(8) Algae growth was observed at one or more areas of the roof covering.

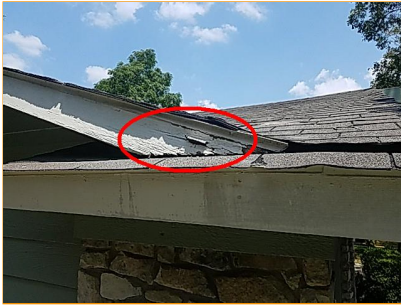
D. Item 3(Picture)

(2) Rot was observed at the fascia in one or more areas of the roof perimeter. Repair or replace all damaged and rotten wood.

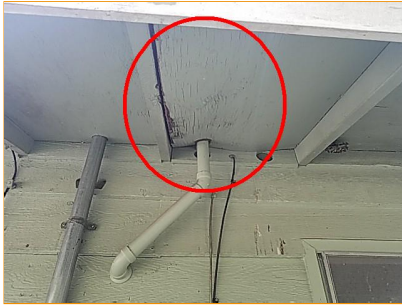
D. Item 8(Picture)

(5) Water staining and rot were observed at the roof sheathing beneath the plumbing vent for the washing machine. Repair or replace all damaged building materials. Additional damage may be present that was not visible to the inspector.

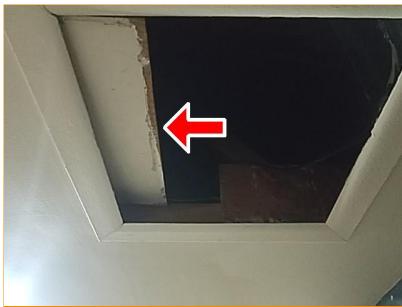
D. Item 9(Picture)

(6) The attic access cover does not meet today's fire code standards to separate the garage from the living area. Drywall is recommended for this application.

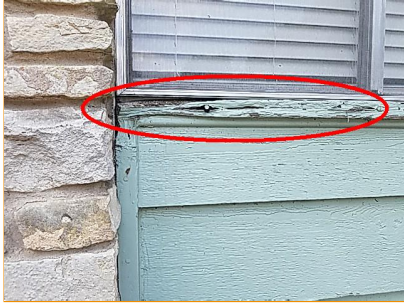
E. Item 1(Picture)

(1) Rot was observed at the siding and/or wood trim in one or more areas. Replace or repair all damaged and rotten wood. Additional damage may be present that was not visible to the inspector.

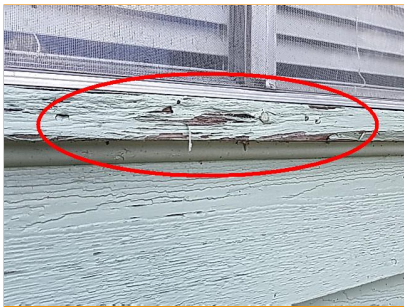
E. Item 2(Picture)

(2) The paint is failing and/or worn at one or more areas of the exterior wood. I recommend prepping and painting at all exposed areas to prevent rot.

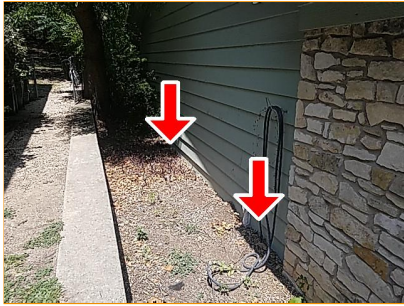
E. Item 7(Picture)

(4) Exterior finishes should be installed 2" from any hard walking surface and 4" or greater above grade. The inspected home has some areas that do not meet these standards. Correct/repair as needed. The siding is in contact with the ground in some areas. Because the siding is in contact with the ground, it is possible for framing to be deteriorated. We did not inspect behind this siding.

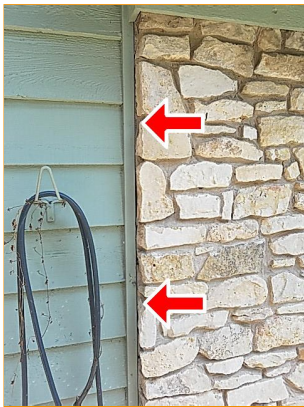
E. Item 10(Picture)

(5) Re-seal caulk at all wood trim-to-masonry connections to prevent rot and water penetration.

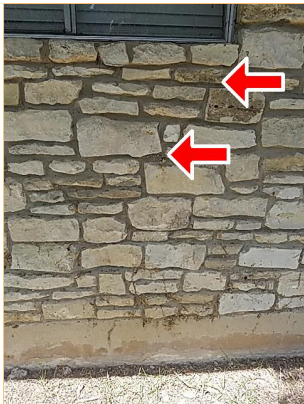
E. Item 16(Picture)

(7) Cracks were observed in the mortar at one or more areas of the masonry veneer. Mortar improvements are recommended to prevent water penetration.

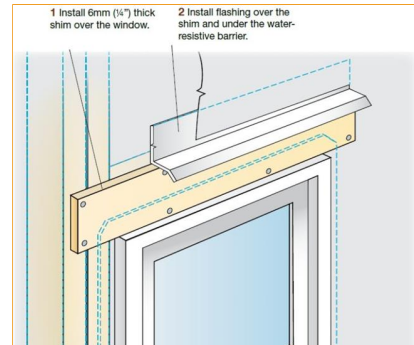
E. Item 20(Picture) Flashing

(8) Approved corrosion-resistant flashing shall be installed continuously above all projecting wood trim. The inspector was unable to verify the presence of proper flashing over windows and doors installed in the exterior siding.

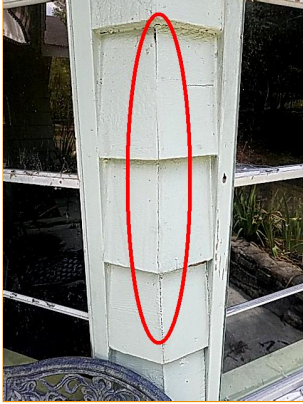
E. Item 21(Picture)

(9) Seal caulk at all siding seams to prevent rot and possible water penetration

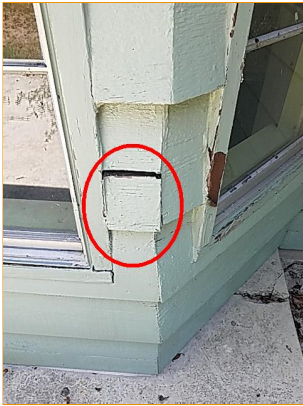
E. Item 22(Picture)

(10) Secure any loose exterior siding.

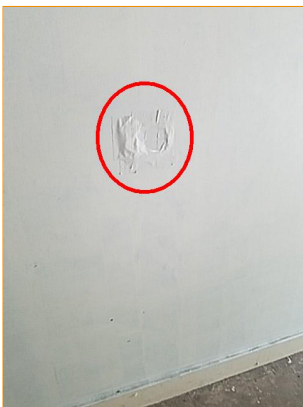
E. Item 23(Picture)

(11) Un-workmanlike repairs were observed at one interior garage wall.

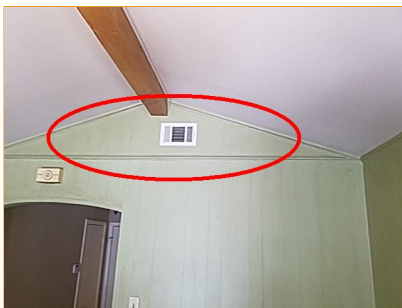
E. Item 27(Picture)

(14) Temperature anomalies were observed at one or more interior walls. This may indicate that these areas are inadequately insulated.

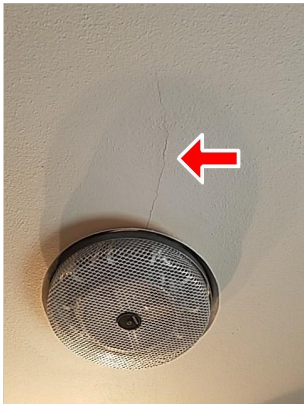
F. Item 1(Picture)

(1) Settlement was observed at one or more ceiling areas.

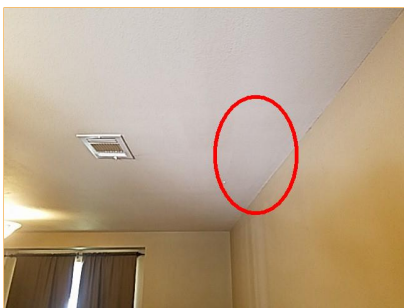
F. Item 3(Picture)

(2) Temperature anomalies were observed at one or more ceiling areas. This may indicate that these areas are inadequately insulated.

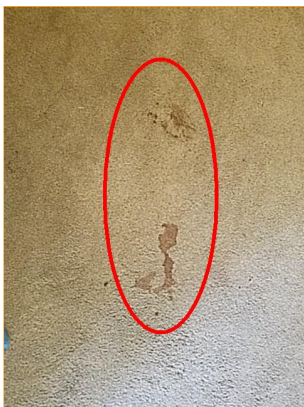
F. Item 11(Picture)

(3) Stains were observed at one or more areas of the interior carpet.

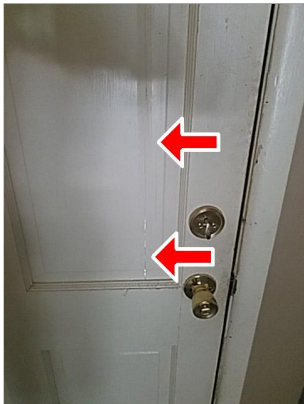
G. Item 1(Picture)

(1) Damage was observed at the front exterior door.

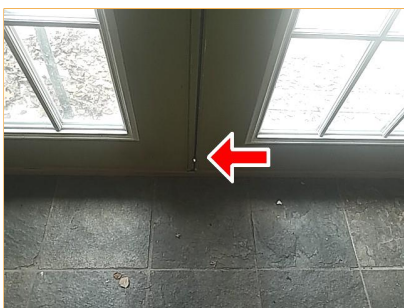
G. Item 3(Picture)

(3) Daylight was present around one or more doors to the exterior. Weather stripping and/or adjustment is needed.

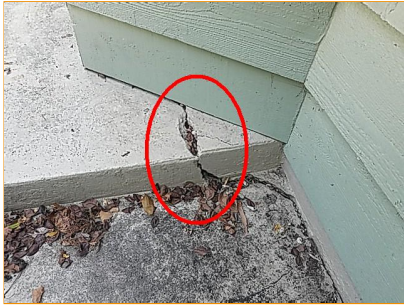
K. Item 3(Picture)

(2) Significant settlement was observed at the rear patio.

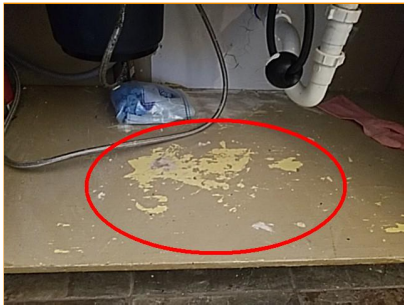
L. Item 1(Picture)

(1) Water staining was observed at cabinet and/or cabinet decking under one or more sinks. No active leaks were observed at the time of the inspection. Replace all damaged building materials as needed. Damage can be hidden from view. Some damage may be present that is not visible to the inspector.

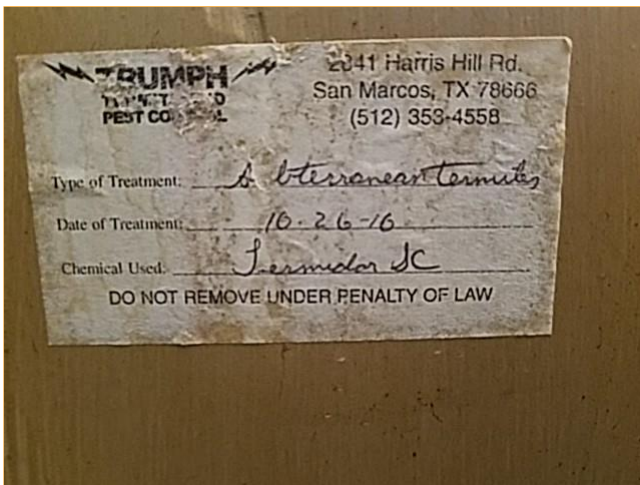
L. Item 2(Picture)

(2) A previous termite treatment sticker was observed at the cabinet under the kitchen sink. Drill holes for termiticide were also observed at the front porch. Recommend continued monitoring by a licensed pest control contractor. Damage may be present that was not visible to the inspector.

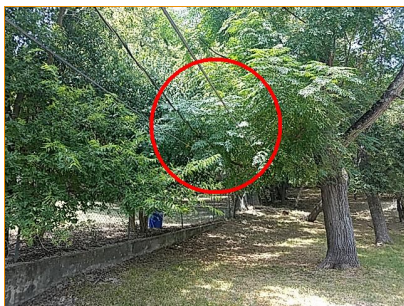
A. Item 2(Picture)

(2) Tree limbs should be trimmed away from overhead service conductors.

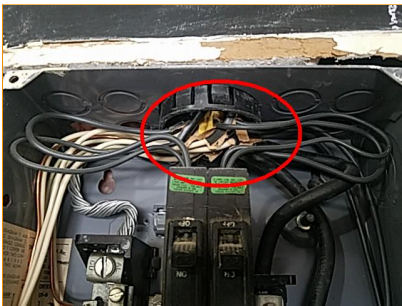
A. Item 11(Picture)

(8) Wiring was bundled in one or more electrical panels. While this is common practice, it is not allowed by today's electrical code.

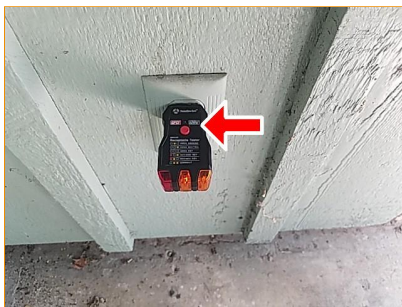
B. Item 1(Picture)

(1) Open grounds were observed at various outlets. Replacing Receptacles to Meet the NEC requires receptacles installed on 15 and 20ampere branch circuits to be of the grounding-type and it requires the grounding contacts of those receptacles to be effectively grounded to the branch circuit equipment grounding conductor [210-7]. However, the Code allows the installation of any of the following installations when replacing a 2-wire non grounding-type receptacle where no ground exists in the outlet box [210-7(d)(3)],

(a) Replace the 2-wire receptacle with another 2-wire receptacle.

(b) Replace the 2-wire receptacle with a GFCI-type receptacle and mark the receptacle with the words "No Equipment Ground."

(c) Replace the 2-wire receptacle with a grounding-type receptacle where protected by a GFCI protection device (circuit breaker or receptacle). Since the grounding terminals for the receptacles are not grounded, the receptacles must be marked with the words "GFCI Protected" and "No Equipment Ground."

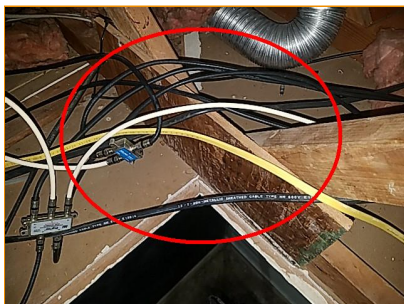
B. Item 4(Picture)

(3) Electrical wiring should be secured away from attic access to prevent damage

(A) Where Run Across the Top of Floor Joists. Where run across the top of floor joists, or within 2.1 m (7 ft) of floor or floor joists across the face of rafters or studding, in attics and roof spaces that are accessible, the cable shall be protected by substantial guard strips that are at least as high as the cable. **Where this space is not accessible by permanent stairs or ladders, protection shall only be required within 1.8 m (6 ft) of the nearest edge of the scuttle hole or attic entrance.**

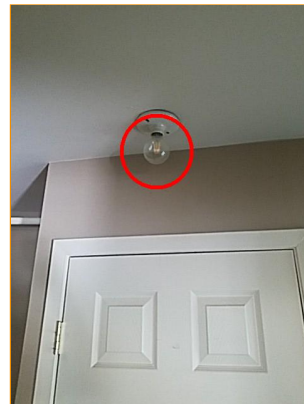
B. Item 9(Picture)

(6) Bulb shields were missing at one or more light fixtures. Bulb shields are recommended at all exposed bulbs.

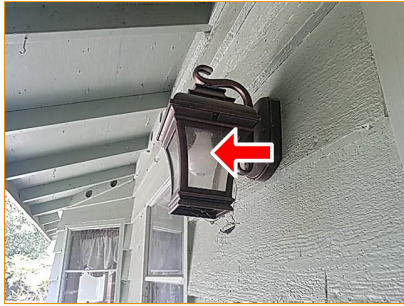
B. Item 10(Picture)

(7) Bulbs were missing or inoperable at one or more light fixtures.

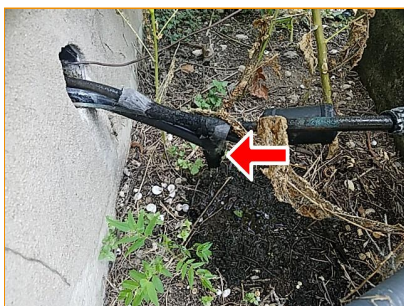
B. Item 1(Picture)

- (1) The average life of an HVAC system is 15 years. The system on the inspected home is over 15 years old. We cannot determine how long this system will last, only how it performs at the time of the inspection.
- (2) The condensate drain line should extend at least 3' from the foundation.

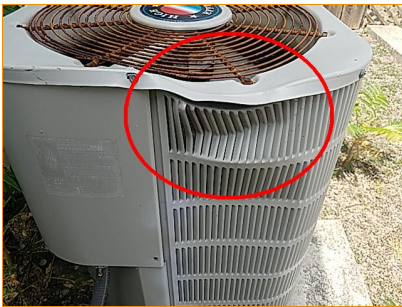
B. Item 4(Picture)

(5) Significant dents were observed at the AC condenser housing.

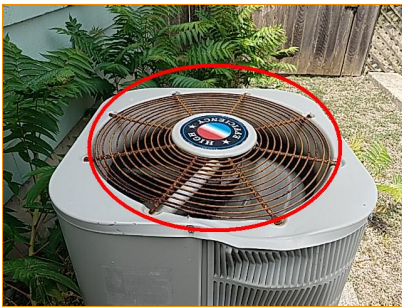
B. Item 5(Picture)

(6) Rust was observed at the top of the condenser housing.

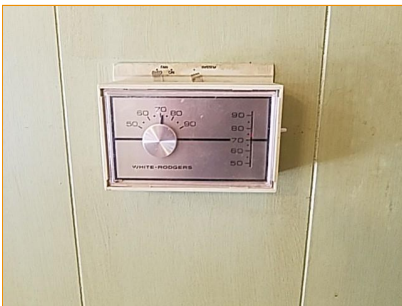
B. Item 6(Picture)

(7) A programmable thermostat is recommended to improve comfort and efficiency.

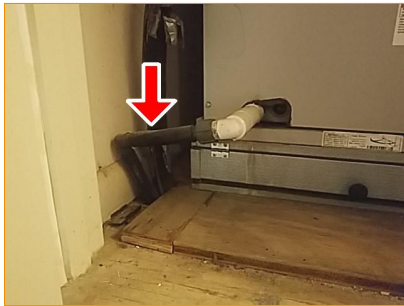
B. Item 7(Picture)

(8) Insulate the condensate drain line at the HVAC unit and in the return area.

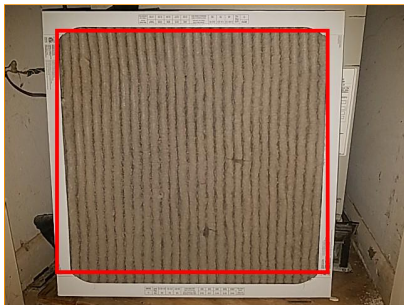
C. Item 1(Picture)

(1) The return filter(s) are dirty and need to be replaced. Filters should be replaced regularly.

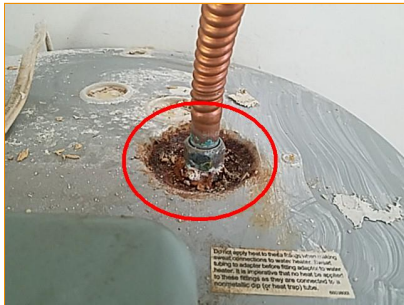
C. Item 1(Picture)

(1) Corrosion was observed at the fittings at the top of the water heater.

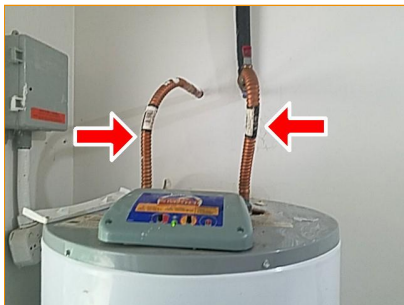
C. Item 2(Picture)

(2) Insulate water lines at the top of the water heater to prevent freezing.

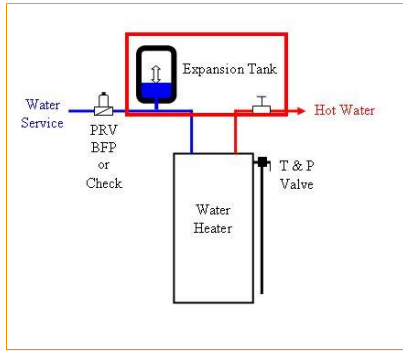
C. Item 3(Picture) Expansion Tank

(3) The water heater did not have a thermal expansion tank installed to prevent a possible leak at the T&P or "pop-off" valve.

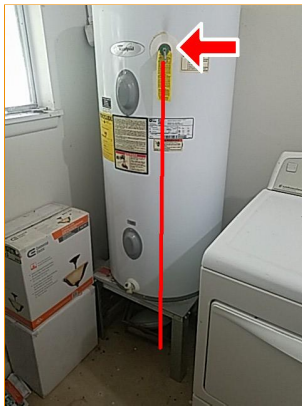
C. Item 4(Picture)

(4) The T&P (Temperature and Pressure) valve on the water heater needs a 3/4 copper or CPVC pipe to extend within 6 inches of the floor or exterior soil grade for safety.

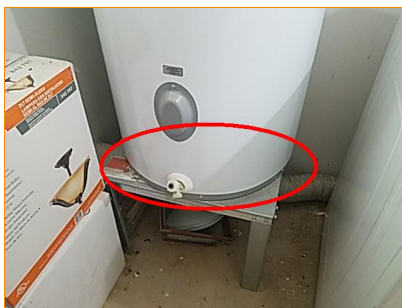
C. Item 5(Picture)

(5) There was no exterior-terminating drain pan present under the water heater. IRC P2801.5 Required pan. Where a storage tank-type water heater or a hot water storage tank is installed in a location where water leakage from the tank will cause damage, the tank shall be installed in a galvanized steel pan having a material thickness of not less than 0.023 inch (0.6010 mm) (No. 24 gage), or other pans approved for such use. Listed pans shall comply with CSA LC3.

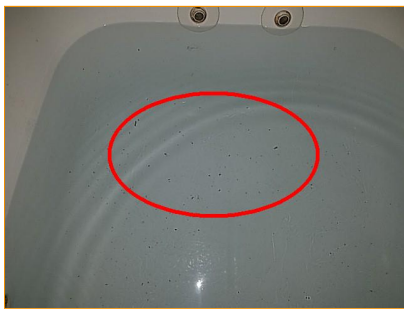
D. Item 1(Picture)

(1) Debris was present in tub jets. Clean before use.

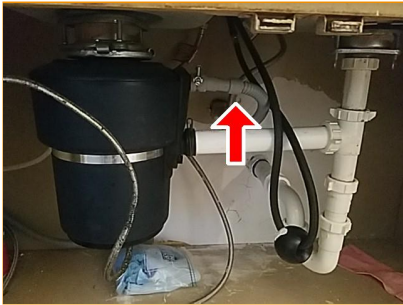
A. Item 1(Picture)

(1) It is recommended that the dishwasher drain line be kept strapped/looped upward, forming a sanitary drain loop, thus preventing debris from sink drain lines and the garbage disposal from entering the dishwasher drain line.

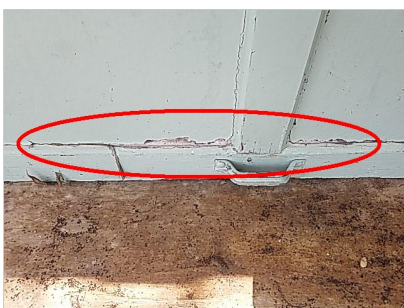
G. Item 3(Picture)

(2) The paint is failing and/or worn at one or more areas of the exterior wood. I recommend prepping and painting at all exposed areas to prevent rot.

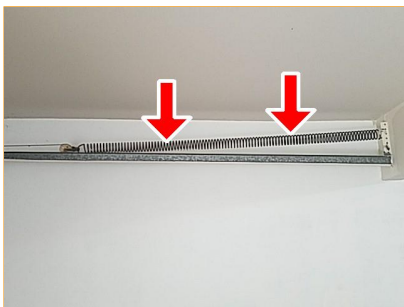
G. Item 4(Picture)

(3) Recommend safety cables at tension springs for overhead garage doors.
