### **Lake Service Report**

Property Name:	Mirror Lake	AES Represent	AES Representative:		Greg B. & Philip R	
Service Date:	6/21/18	Service Time:		8:42 a.m	_	
				10:20a.m.		
Water Temperature:	78 Degrees					
Visibility:	30''					
Water Level	Full Pool					
Trash Collected:	Abundant					
Weather Conditions	sunny					
<b>Outlet Debris Cleared</b>	: Clear					
Lake Dye Applied:	N/A	Amount Applied:	N/A			
Pond Fertilizer Applie	d: <u>N/A</u>	Amount Applied:	N/A			
Fish Feeders Checked	: <u>N/A</u>	Amount Applied:	N/A

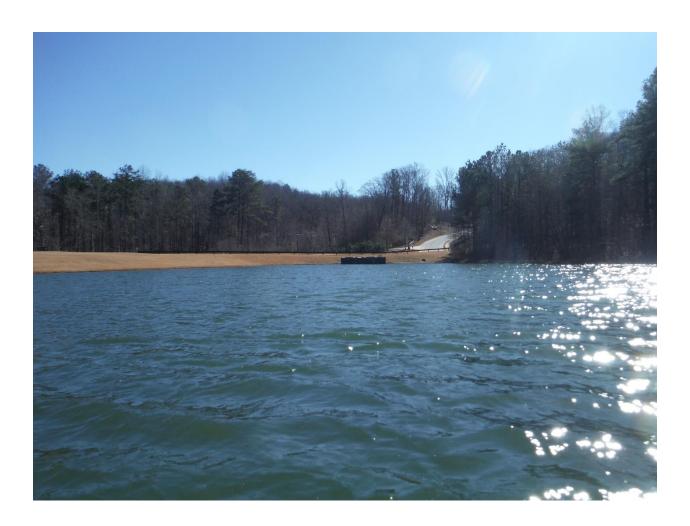
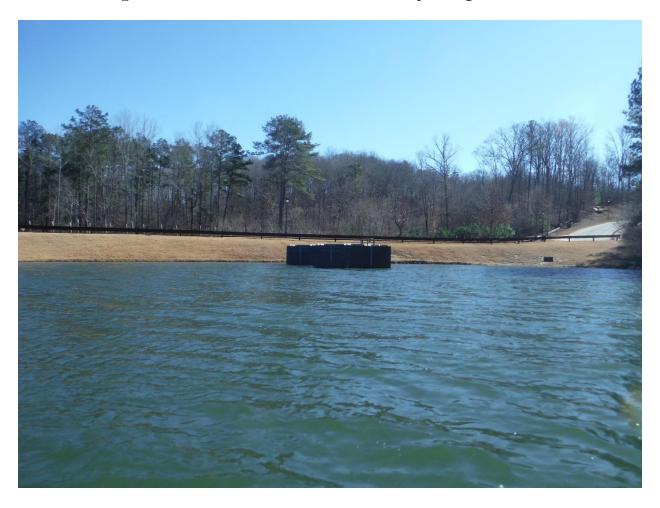
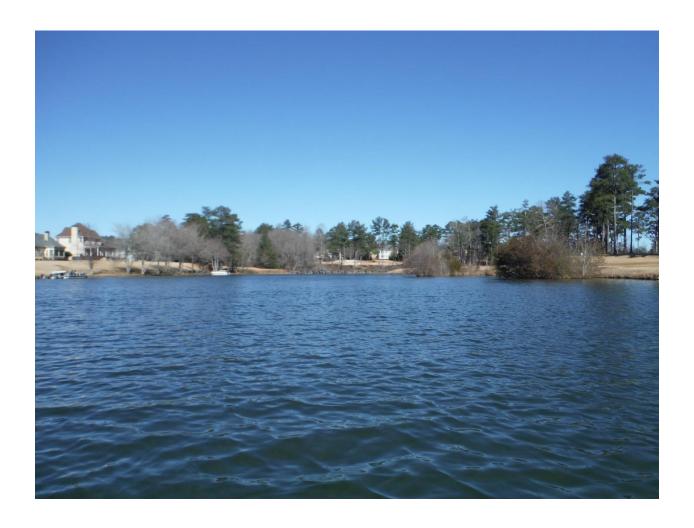
Comments: Today the lake looked to be in great condition. We removed large amounts of manmade debris from the shore line of the lake. No other issues found.
