Bono Energia S.p.A.

***INSPECTION REPORT
OF
BONO ENERGIA
WATER TUBE BOILER
AT BADRA OIL FIELD
CPF PHASE 1***

***Baghdad-Iraq
June 2013***

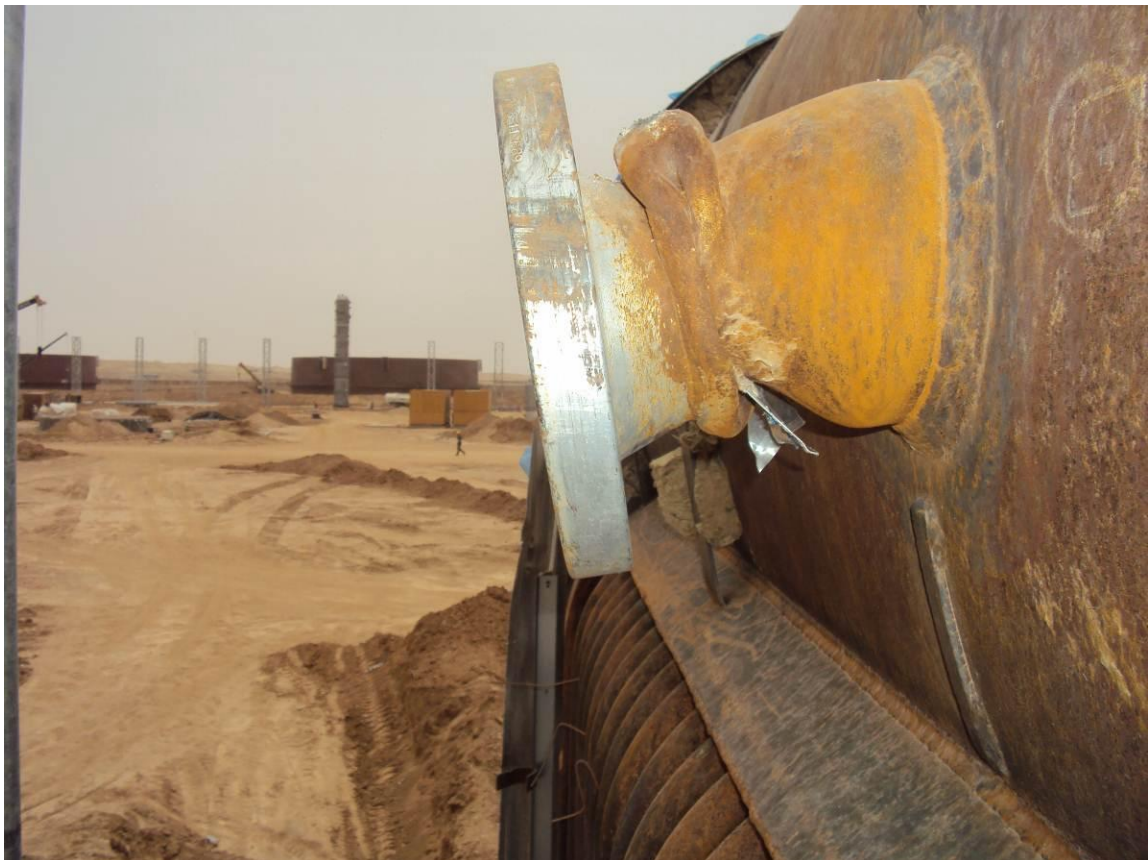
photo no. 1

Boiler feed water inlet nozzle (4" size) showed a severe damage in form of folds and tear in the nozzle connecting pipe body. In addition the structural frame I-Beams located at the top of the steam drum seemed to be severely damaged. (See photos no. 1, 2 & 3 below). On the other hand the rest of boiler steam drum nozzles and shell plates showed no indications of damage from outside.

1. Remove the nozzle “A1” (ref. Attachment 1 & Photo no.1).
2. Prefabricate a new nozzle “A1” (ref. Attachment 1).
3. Weld the prefabricated new nozzle following proper WPS.
4. Remove the cyclones from the Steam drum (ref. Photo no.4).
5. Remove the internal plates from the Steam drum (ref. Photo no.4).
6. Remove the demisters from the Steam drum.
7. Close with blind flange and gaskets all the nozzles.

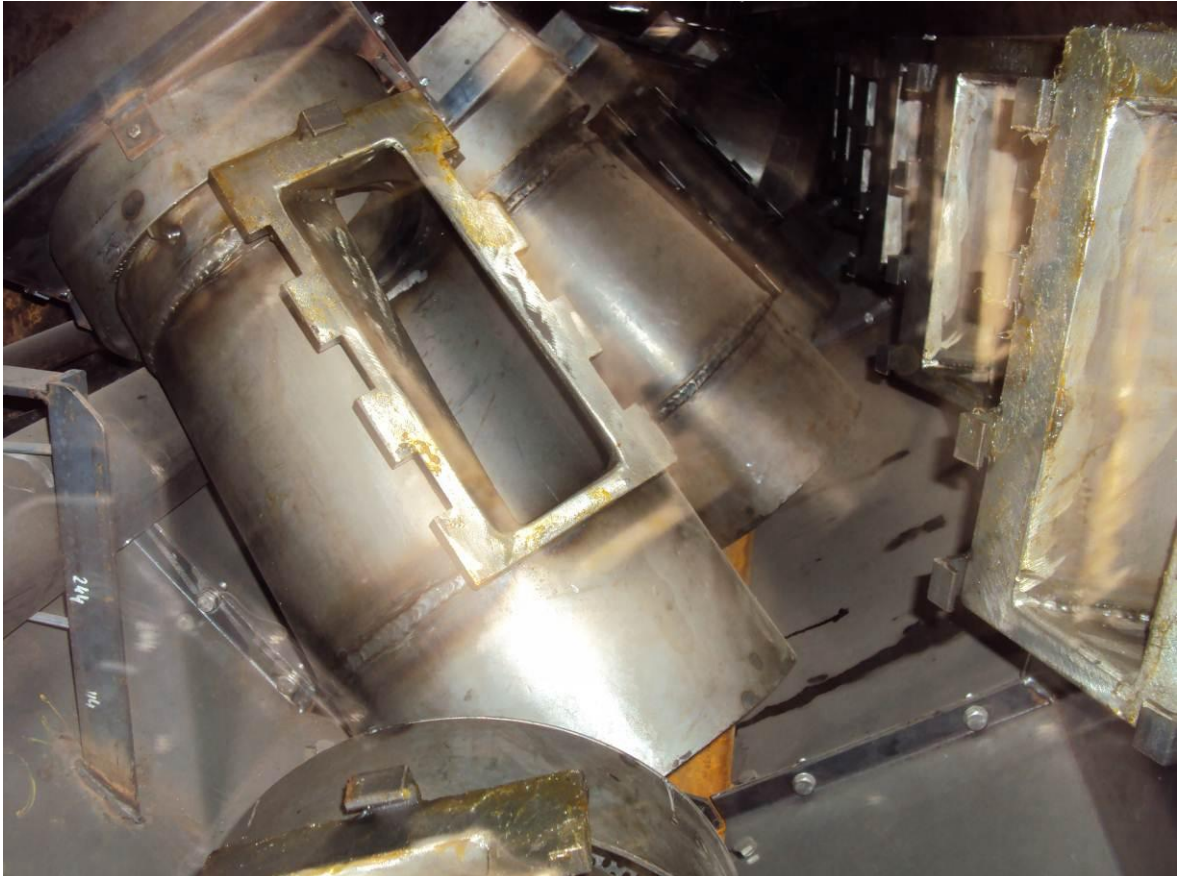
photo no.4

Steam drum cyclones seemed to be displaced (disassembled) from their positions due to boiler tilting during the falling accident. On the other hand cyclones and the rest of drum internals showed no significant indications of damage. (See photo no. 4 below).

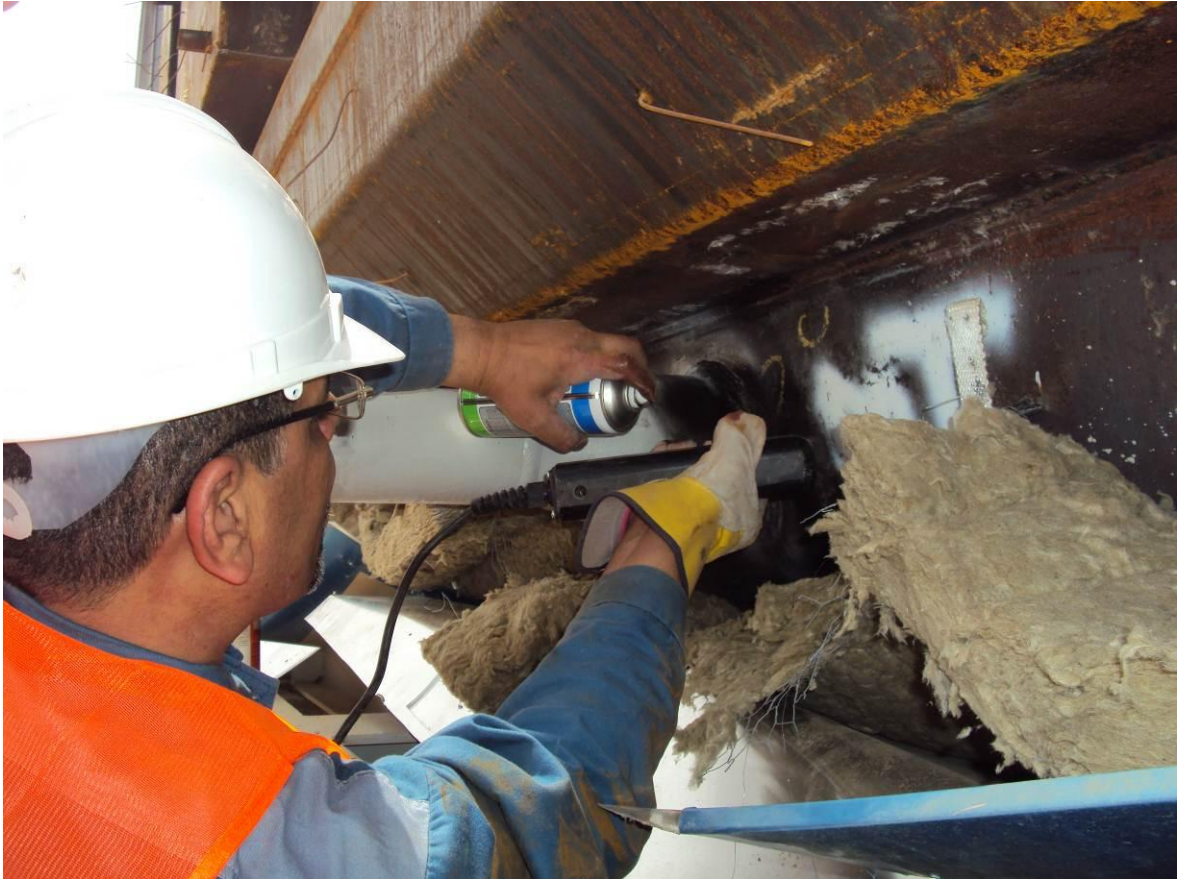
Water drum shell plates, water preheater nozzles (4" size) and the drum drains (2" size) nozzles showed no indications of damage. (See photo no.5 below).

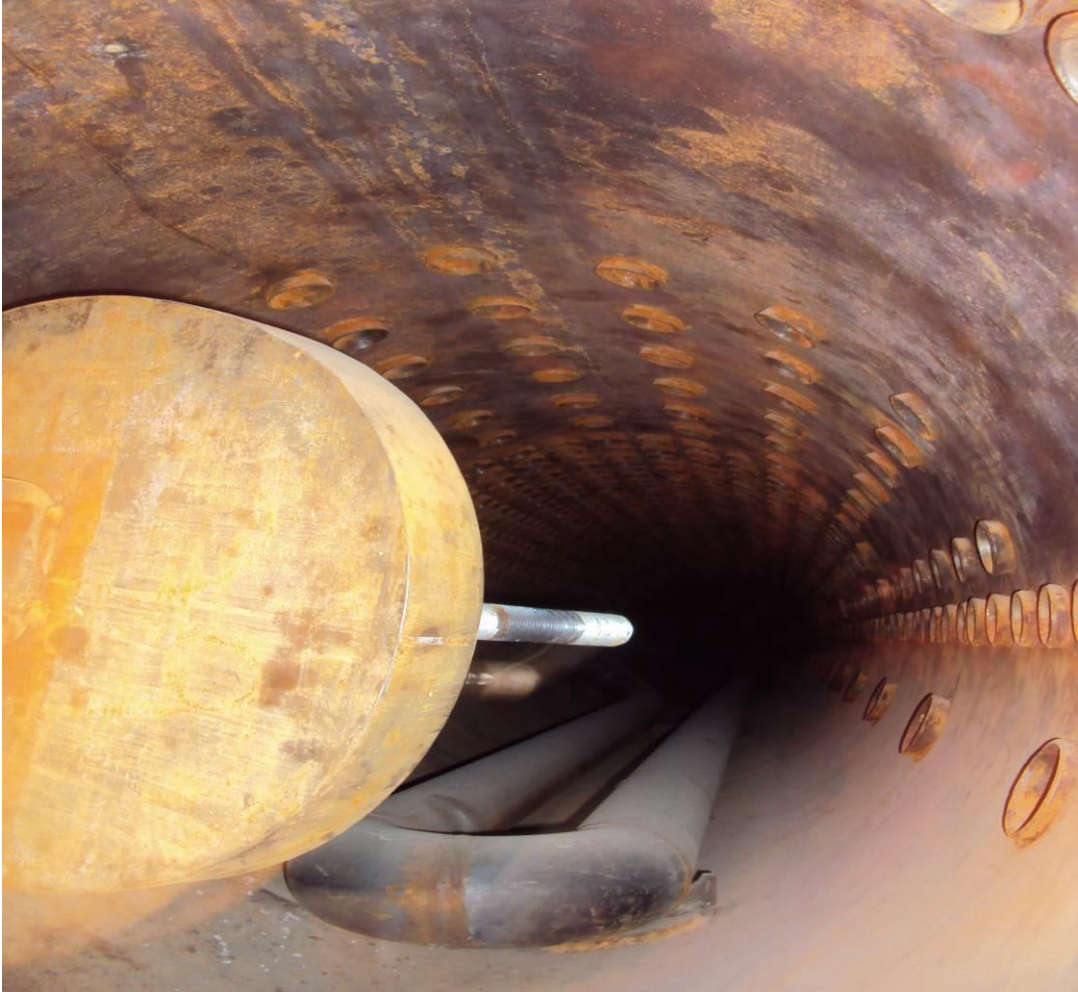
photo no.6

Water drum internally showed no indications of damage. Water preheater pipe and its supports seemed not to be affected by the accident. (See photo no. 6).

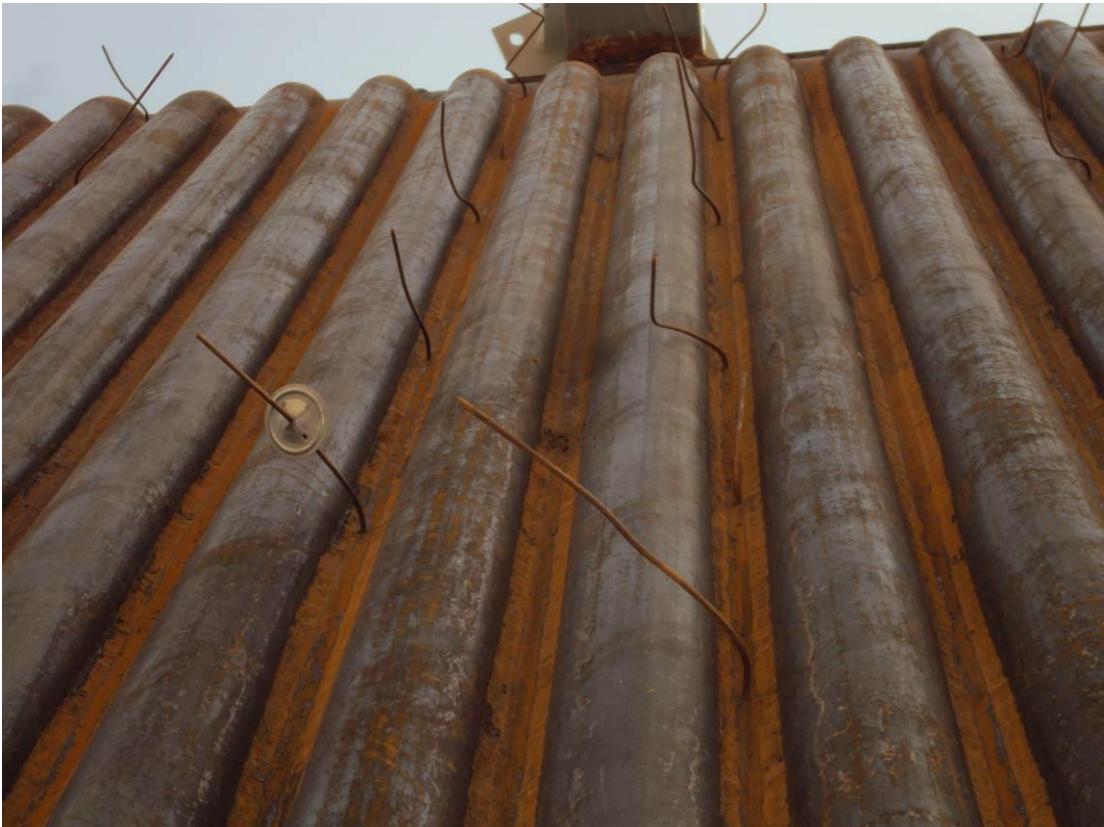
photo no.7

Convective Bundle external side wall tubes showed no indications of damage due to the falling accident. Tubes straightness seemed to be in a satisfactory condition. Tubes membrane seal welds showed no indications of significant damages or holes due to the accident. Wall inspection door seemed be serviceable, while the supporting arm is damaged. (See photos no. 7, 8 & 9).

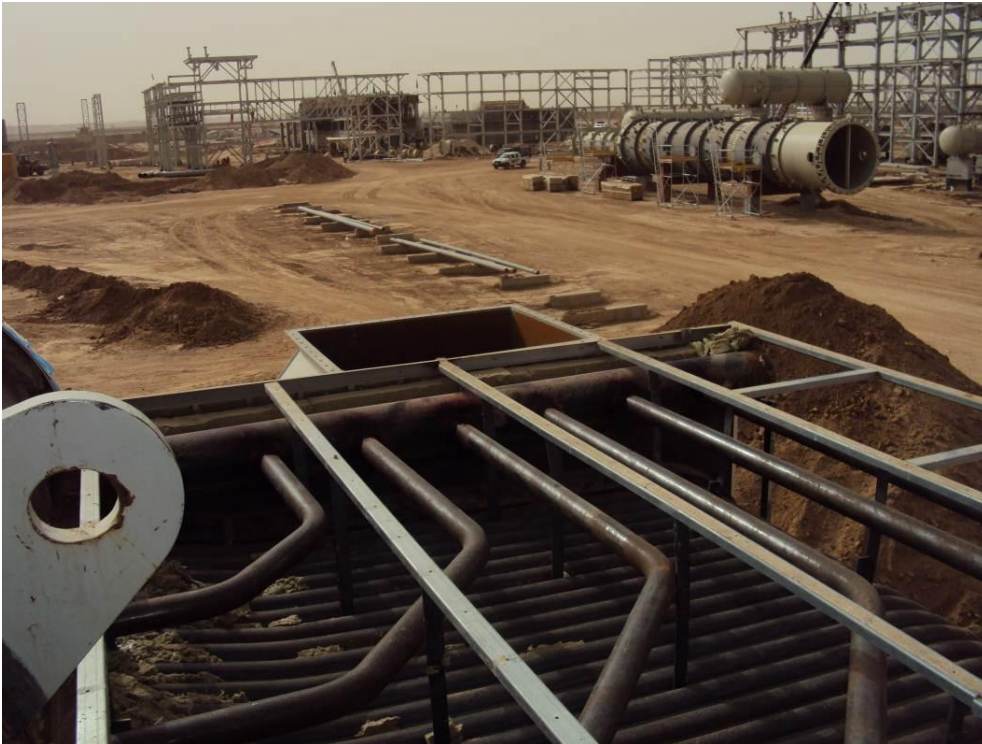
photo no.10

D-Shape wall components (Roof tubes, Left side tubes) externally seemed not to be affected by the accident, no indications of damage observed. Tubes straightness seemed to be in a satisfactory condition. Tubes membrane seal welds showed no indications of significant damages or holes due to the accident. (See photos no. 10 & 11).

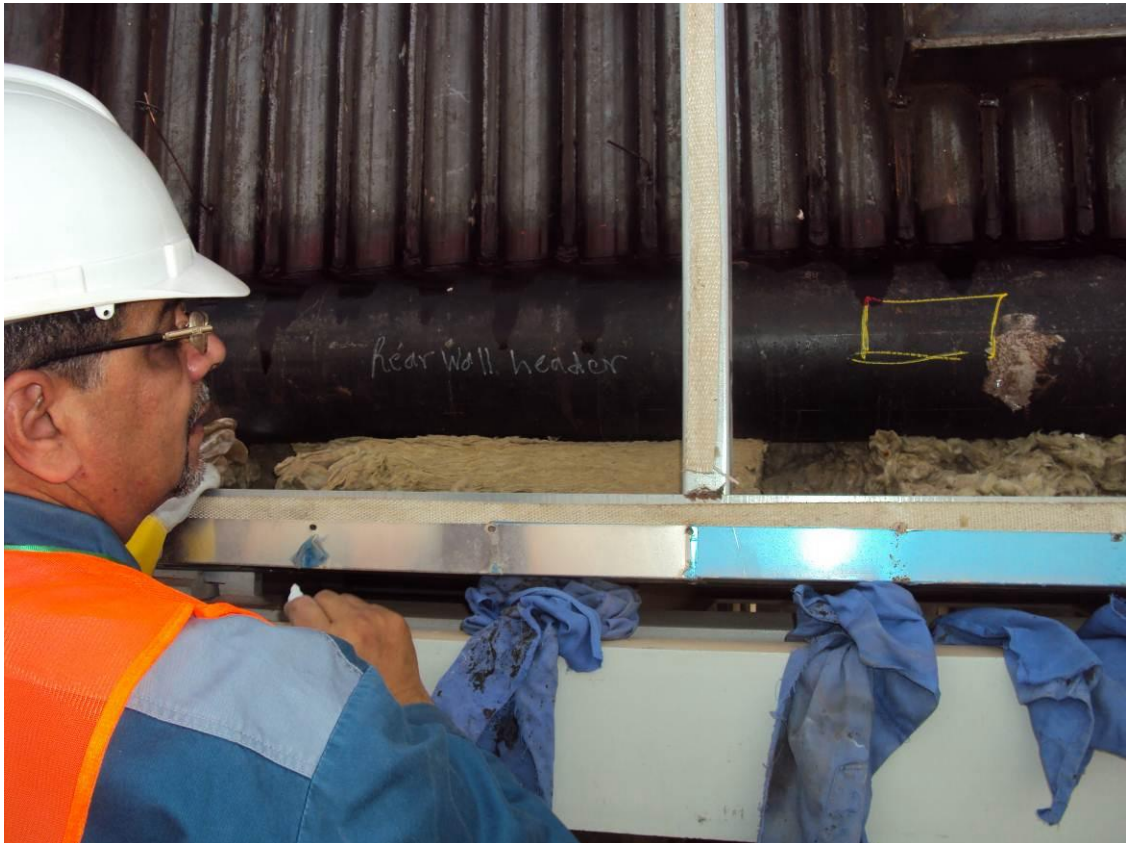
Photo no. 12

Rear wall tubes externally seemed not to be affected by the accident, no indications of damage observed. Tubes straightness seemed to be in a satisfactory condition. Tubes membrane seal welds showed no indications of significant damages or holes due to the accident. Wall inspection wall seemed be serviceable. (See Photo no. 12).

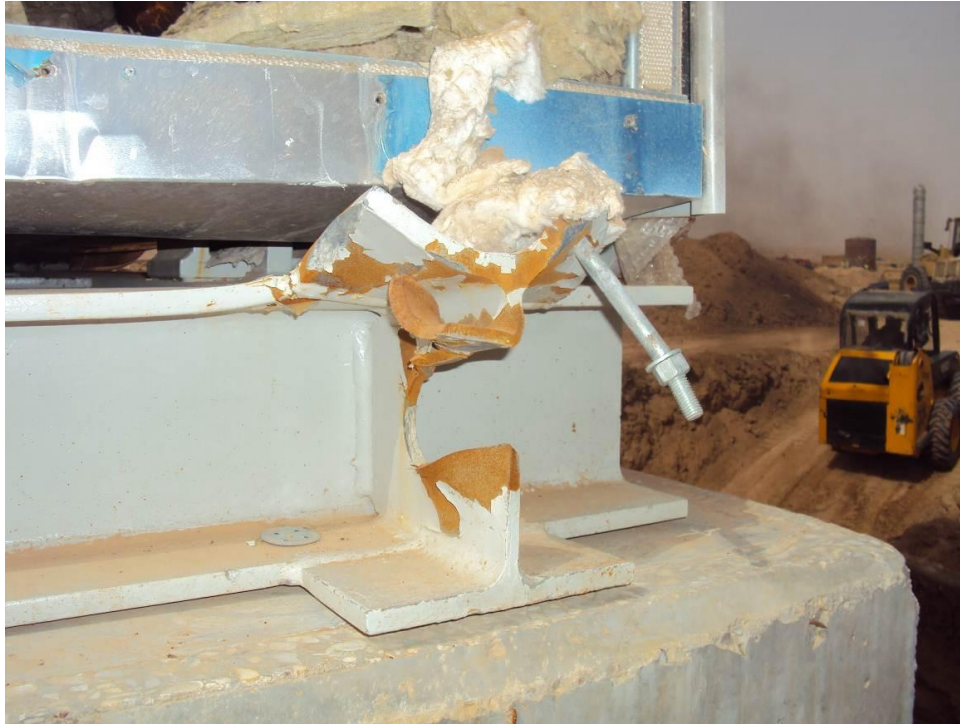
Photo no.13

Boiler-base frame structural elements (I-Beams) right side ends underneath the right side wall tubes showed sever extent of damage in form of warps and tears due to the accident. In addition most of the boiler sliding support guides tack welds seemed to be cracked or broken. On the other hand the rest of parts the base frame seemed not to be affected by the accident. (See photos no. 13 & 14).

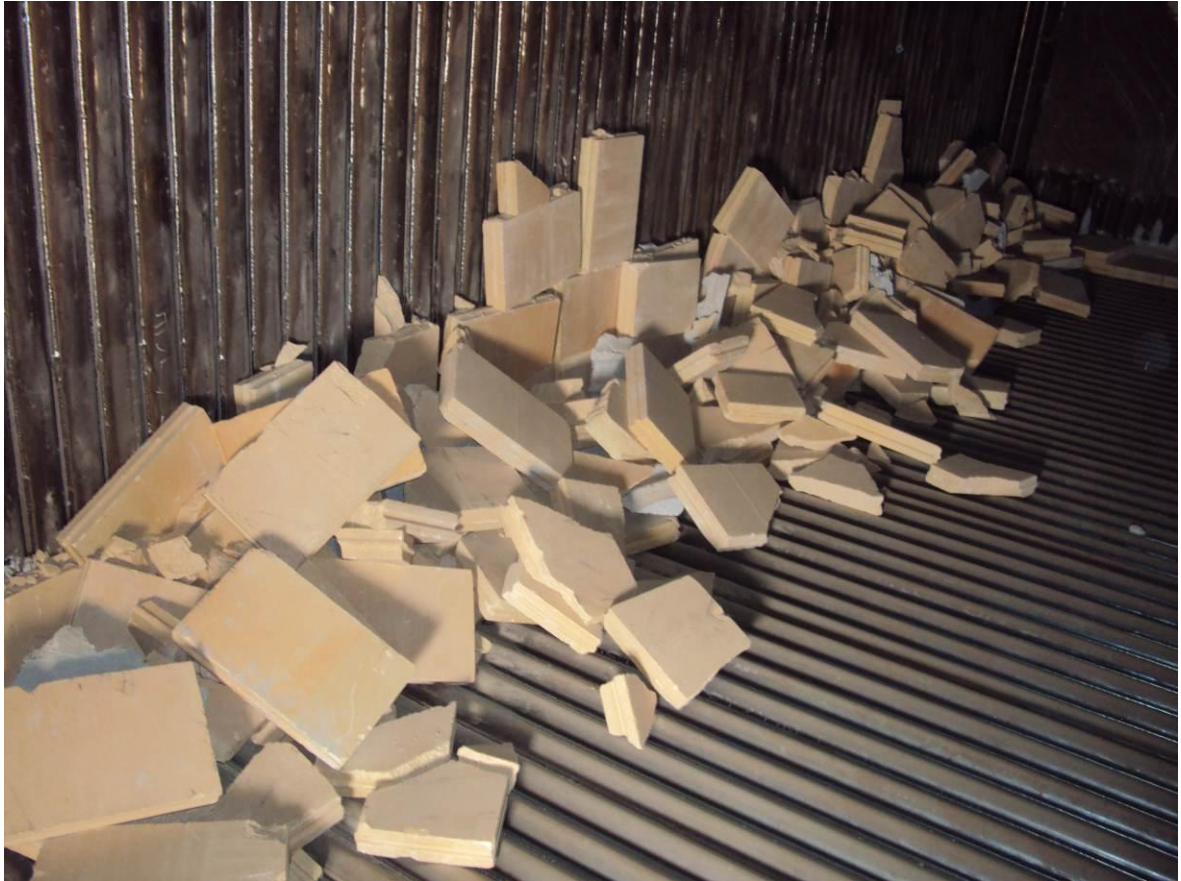
Photo no.15

Furnace bottom refractory tiles seemed to be completely displaced and most of them seemed to be deteriorated (broken) due to the boiler tilting during the accident. (See Photo no. 15).

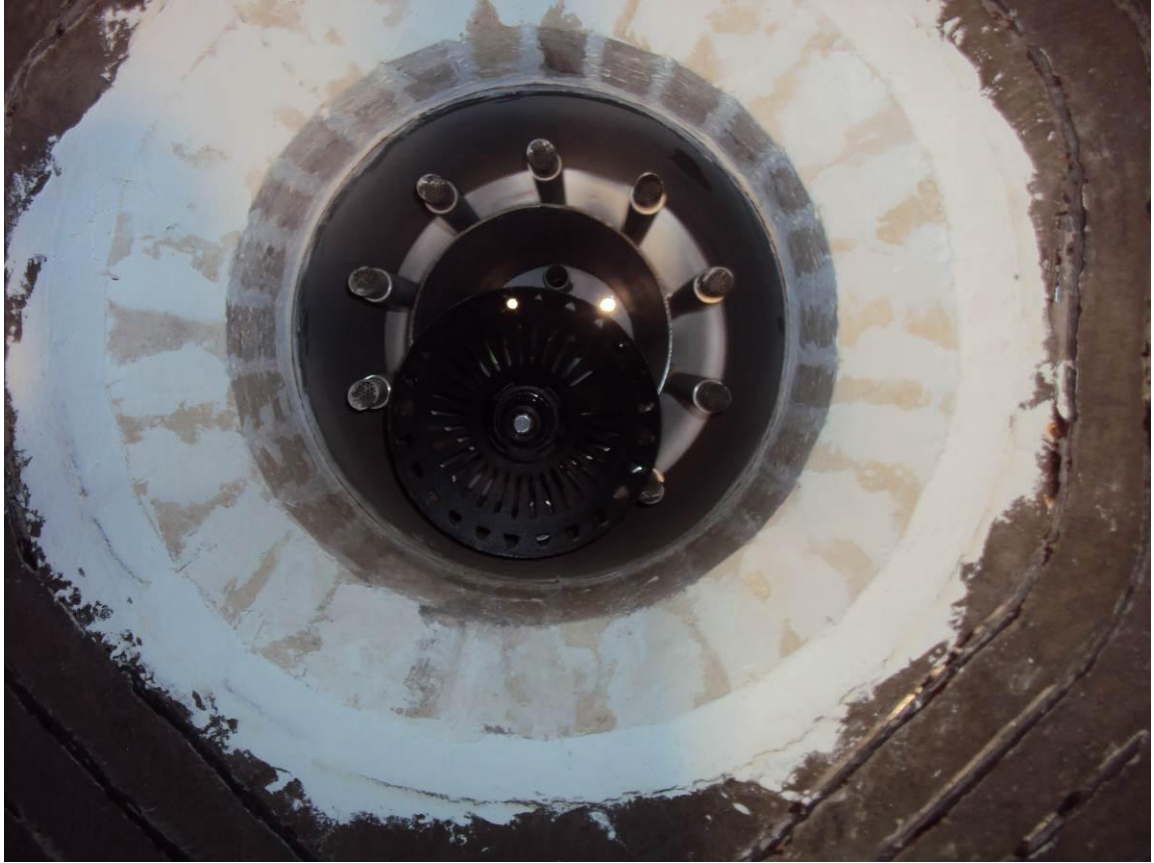
Photo no.16

The burner throat refractory seemed not to be affected by the accident. (See photo no. 16).

On the other hand in Photo no. 16 above it's clear that a damage has occurred to burner central diesel oil gun (it is not in center correct position).

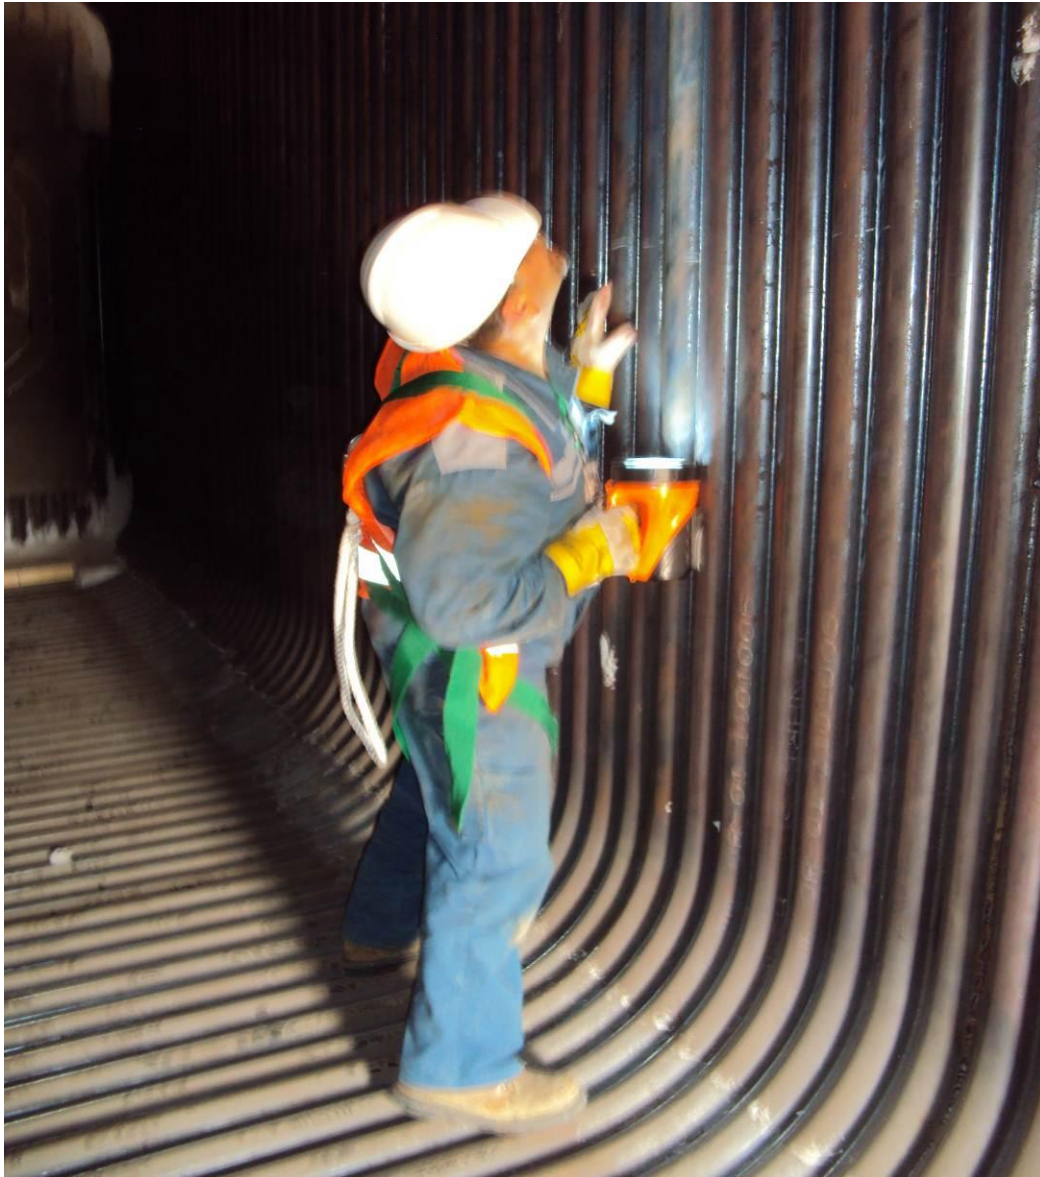
Photo no.17

On the other hand the “D” shaped membraned tubes, the Front wall, and the rear wall of the furnace showed no significant indications of damage due to the accident.

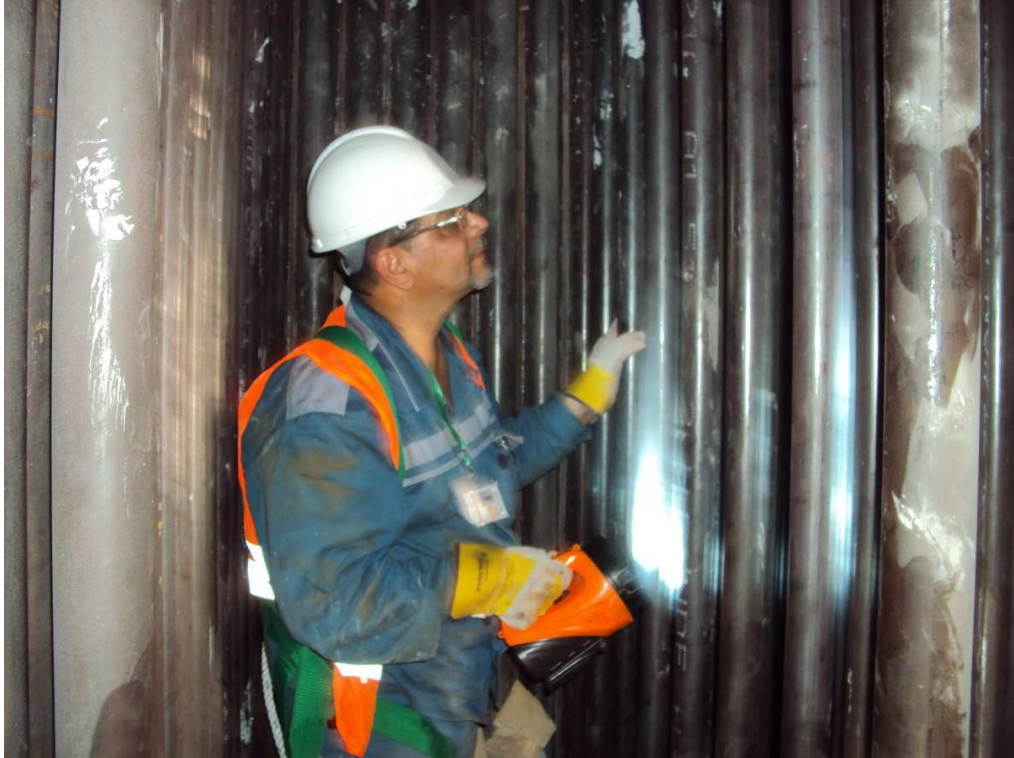
Photo no.20

Boiler convective bundle tubes showed no visible indication of damage. Tubes rows seemed to be straight and no visible indication of tubes pull out from the water drum holes was present. (See photos no. 20 & 21).

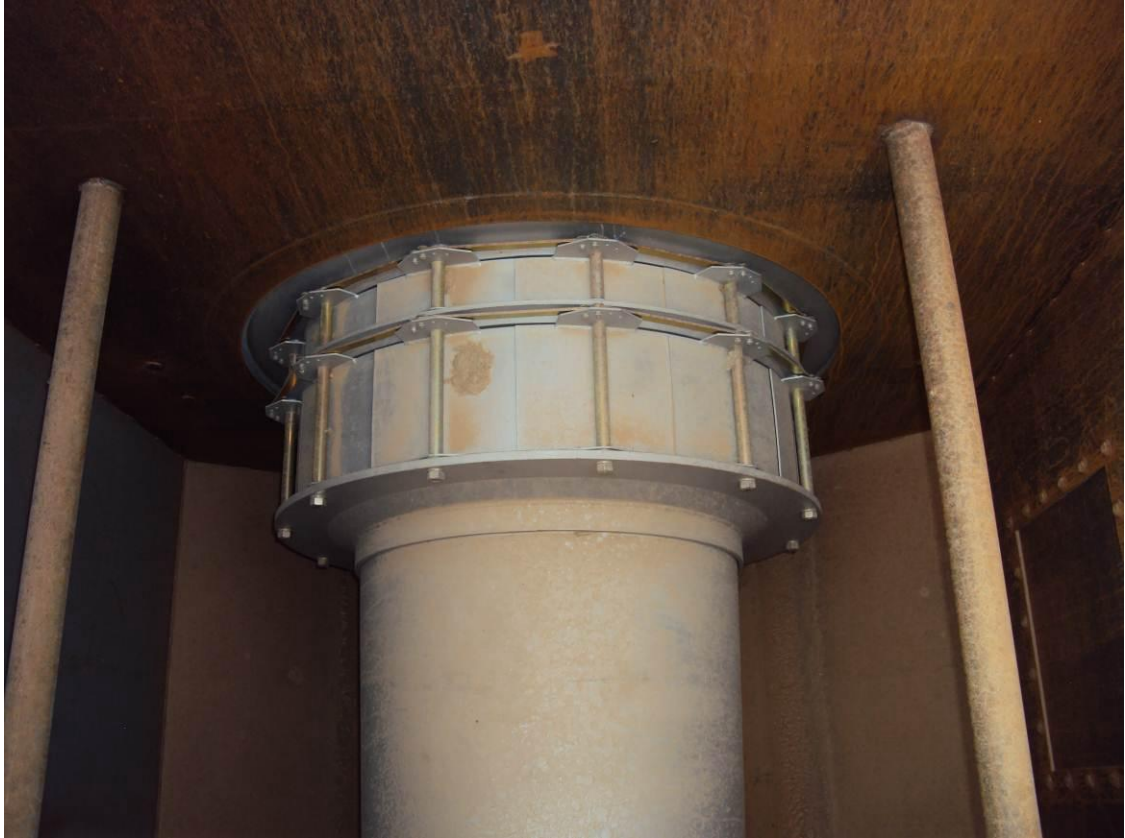
Photo no.22

Wind box and burner associated parts showed no visible indications of damage due to the accident. Burner air register seemed not to be affected by the accident. (See photos no. 22).

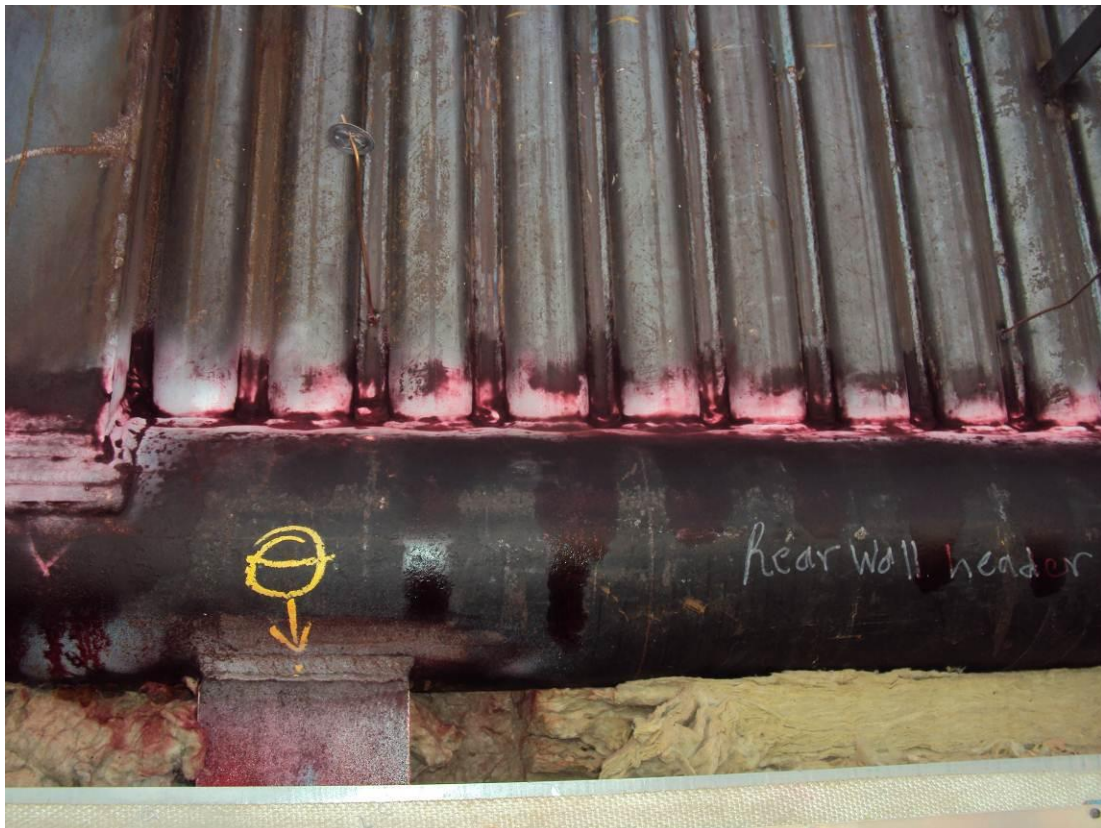
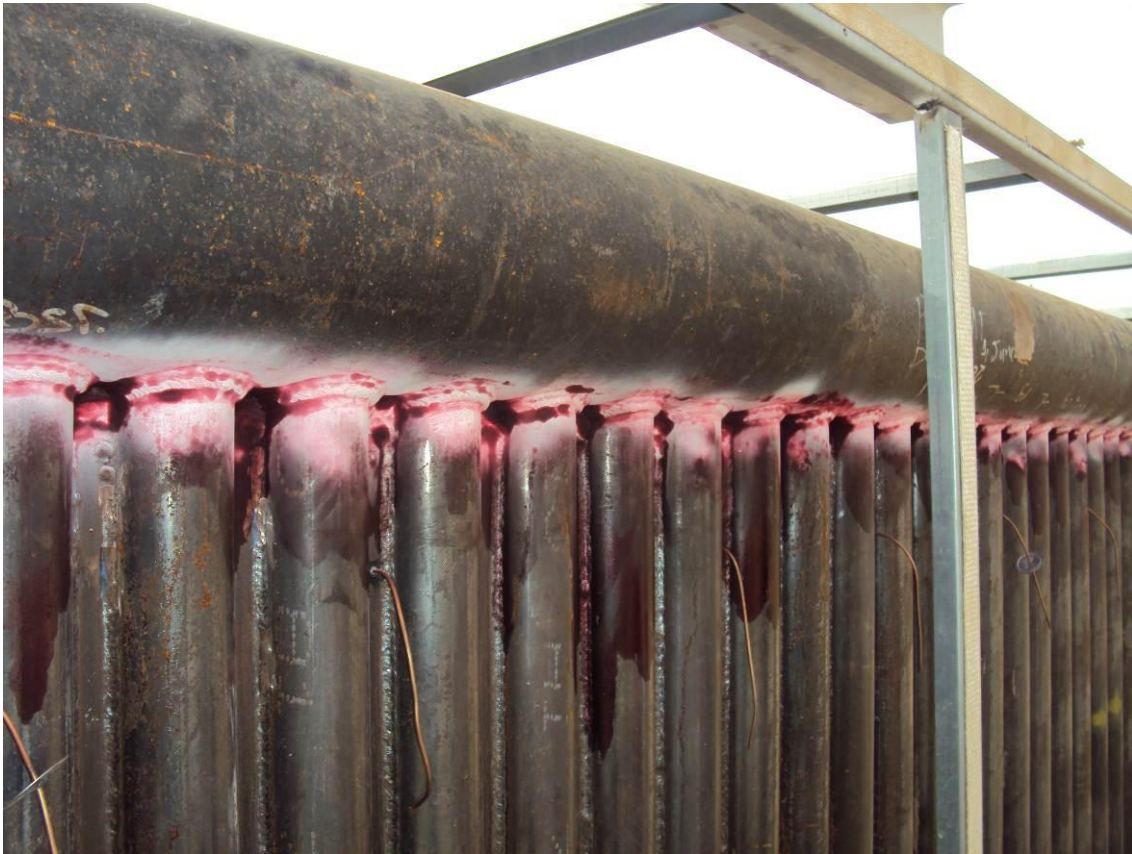
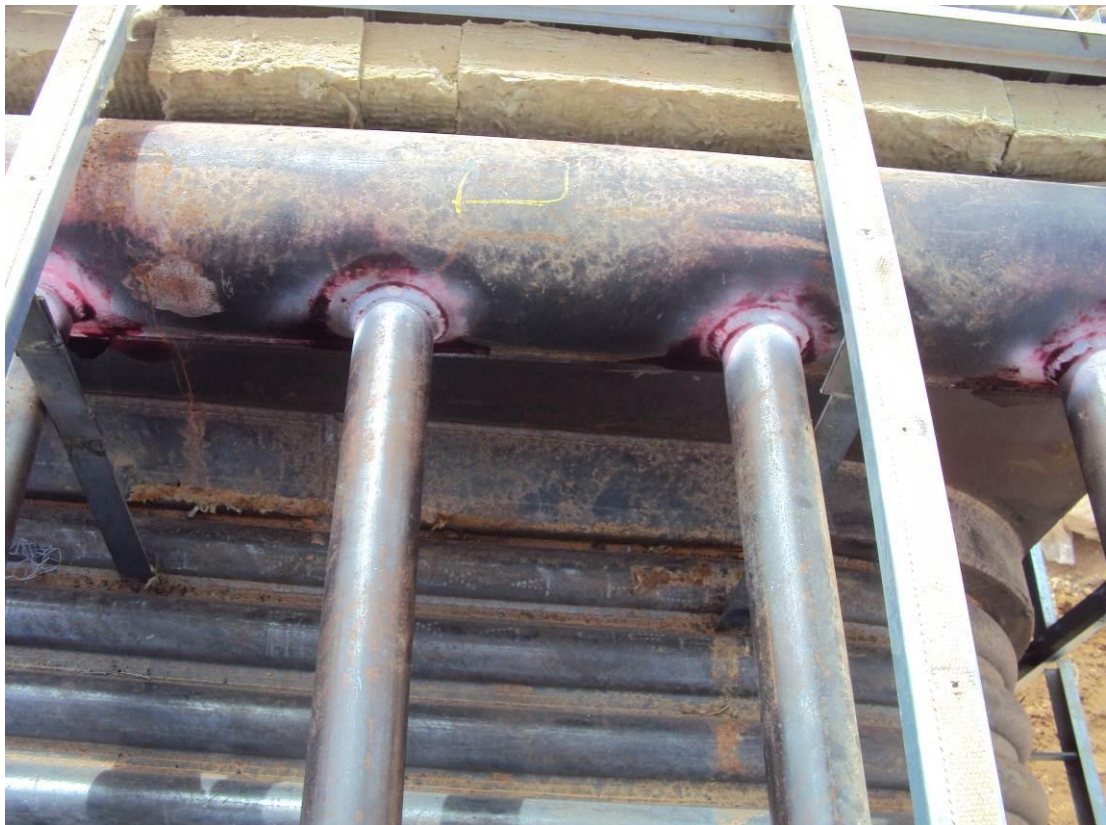
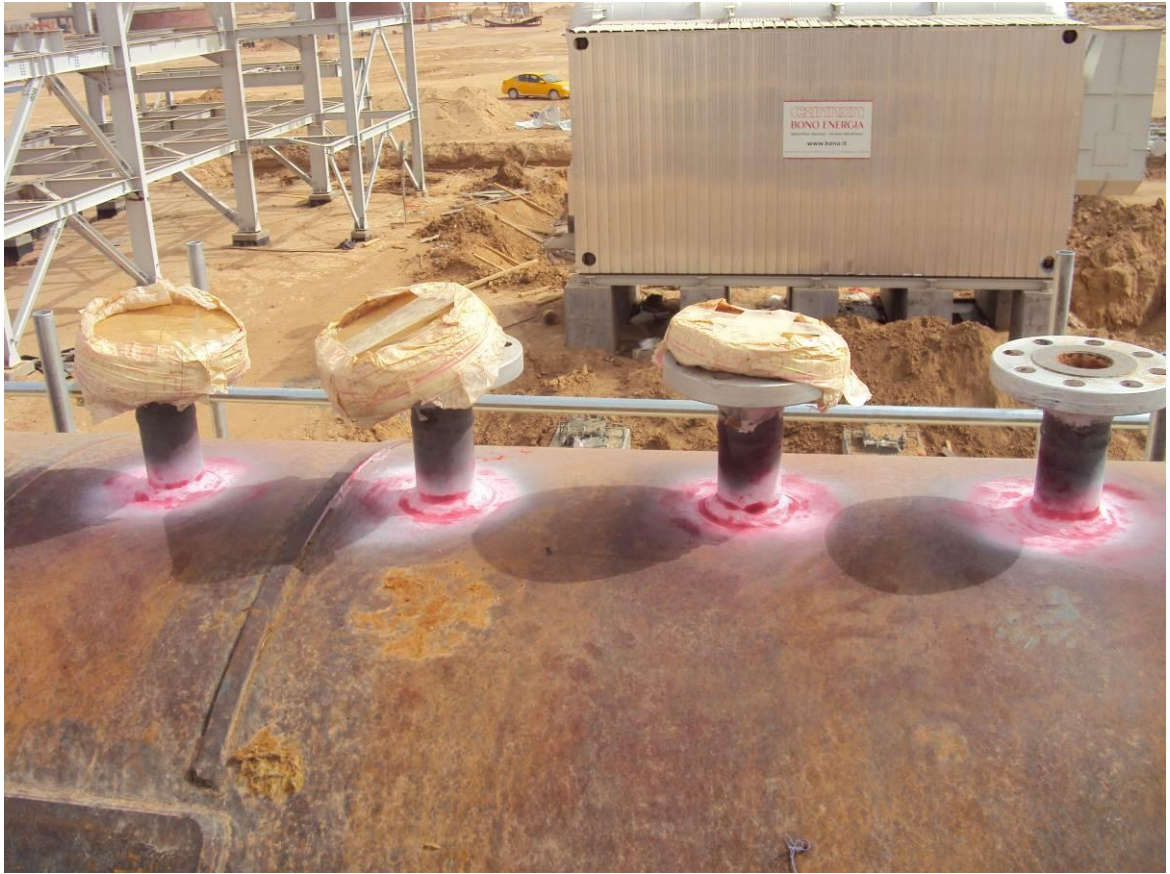
The following boiler welds were (PT) examined and showed no significant indications of defects:

- Rear wall tubes to the lower header welds.
- Rear wall tubes to the upper header welds.
- Rear wall lower header to the end cap weld.
- Rear wall lower header to feeding tubes welds.
- Front wall lower header to feeding tubes welds.
- Rear wall upper header to the feeding tubes welds.
- Rear wall upper header to the end cap weld.
- Front wall upper header to the feeding tubes welds.
- Steam drum upper nozzles to the drum welds.
- Water drum preheater nozzles to the drum welds.

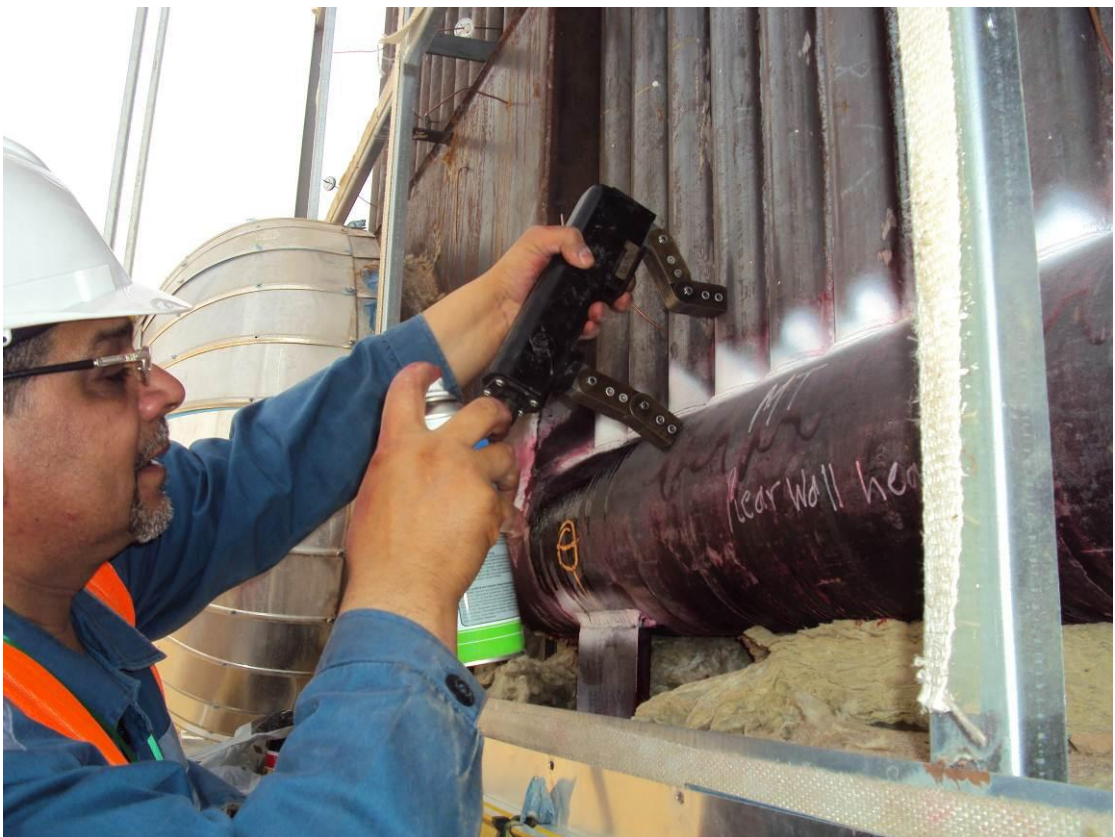
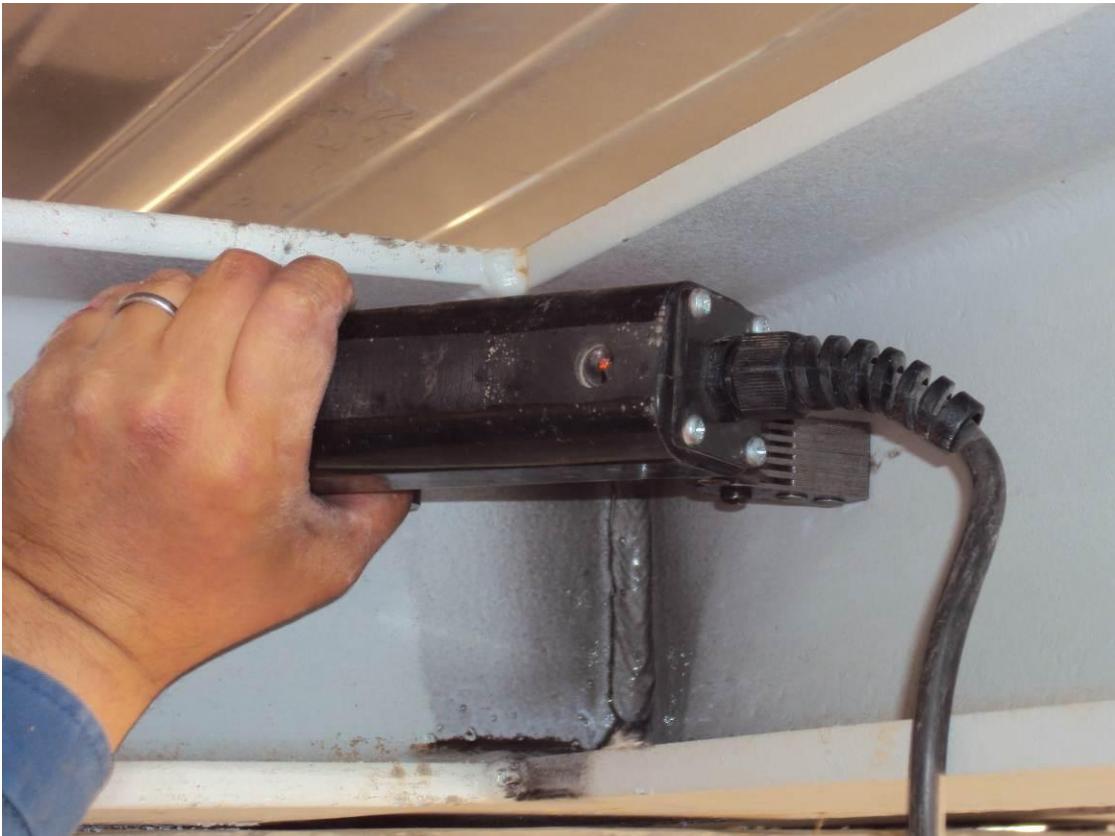
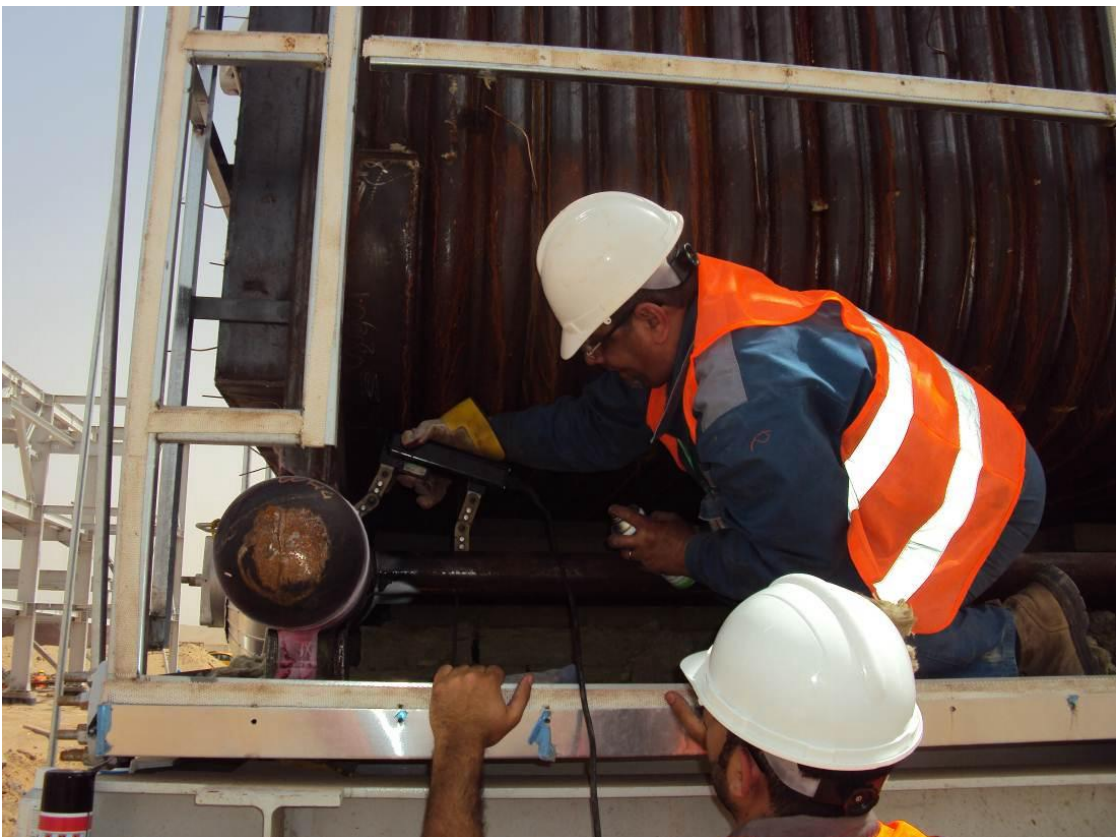
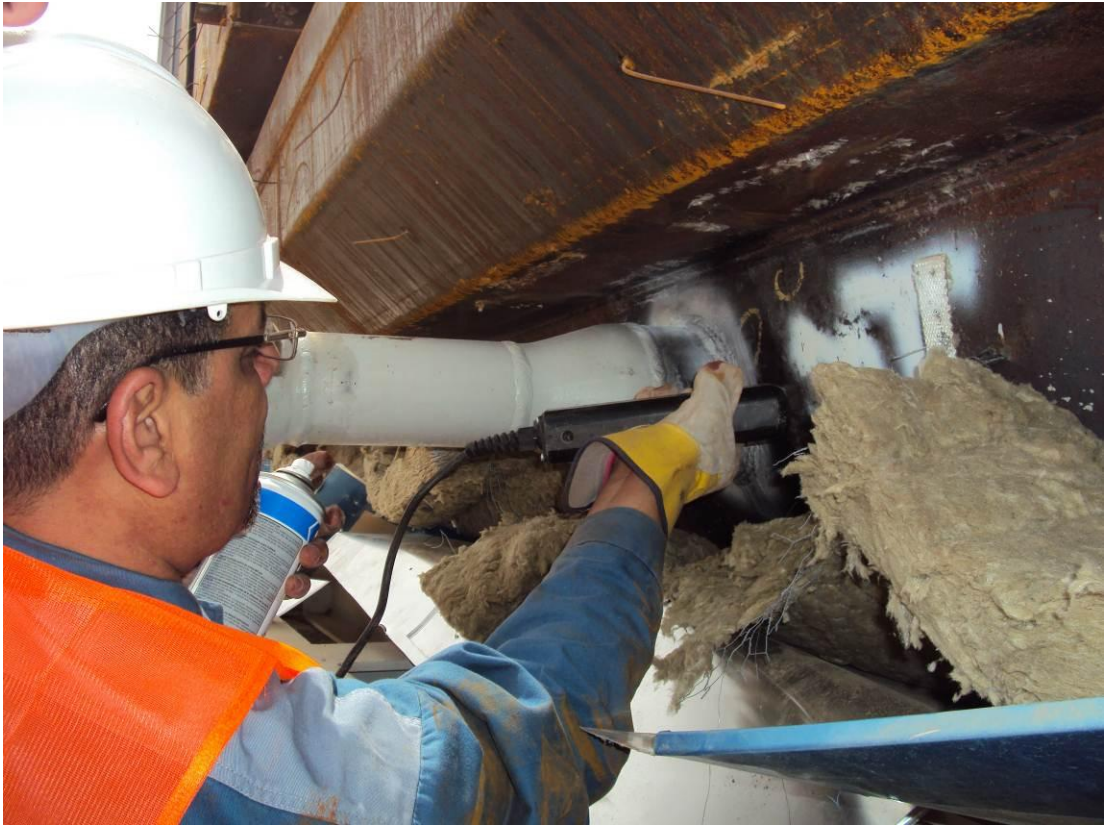
The following boiler welds were (MT) examined and showed no significant indications of defects:

- Boiler Base frame fillet welds.
- Rear wall tubes to the lower header welds.
- Rear wall tubes lower header to supports welds.
- Rear wall tubes to the upper header welds.
- Rear wall lower header to the end cap weld.
- Rear wall lower header to feeding tubes welds.
- Front wall lower header to feeding tubes welds.
- Rear wall upper header to the feeding tubes welds.
- Rear wall upper header to the end cap weld.
- Front wall upper header to the feeding tubes welds.
- Steam drum upper nozzles to the drum welds.
- Water drum water preheater nozzles to the drum welds.
- Water drum fixed support to the base frame fillet weld.
