Bono Energia S.p.A.

***INSPECTION REPORT
OF
BONO ENERGIA
WATER TUBE BOILER
AT BADRA OIL FIELD
CPF PHASE 1***

***Baghdad-Iraq
June 2013***

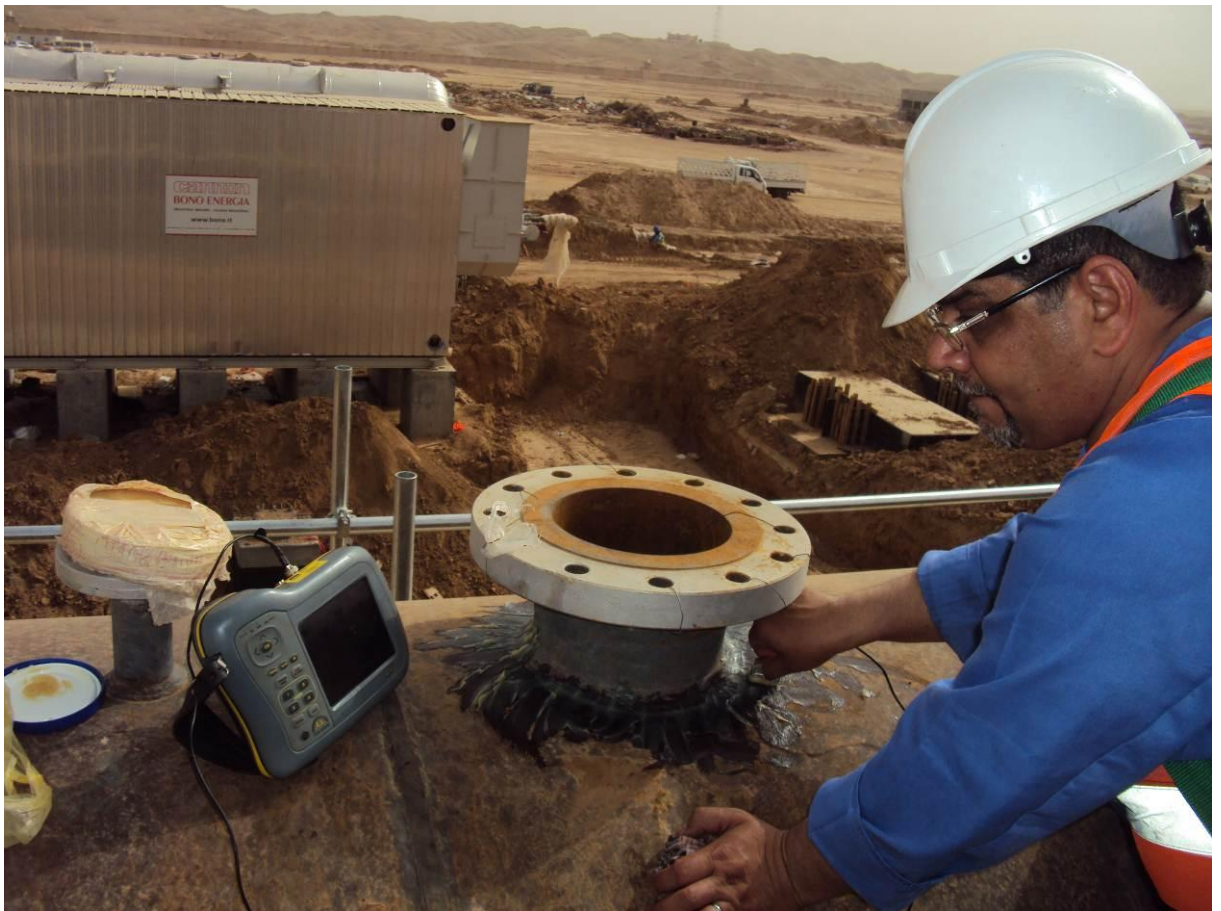
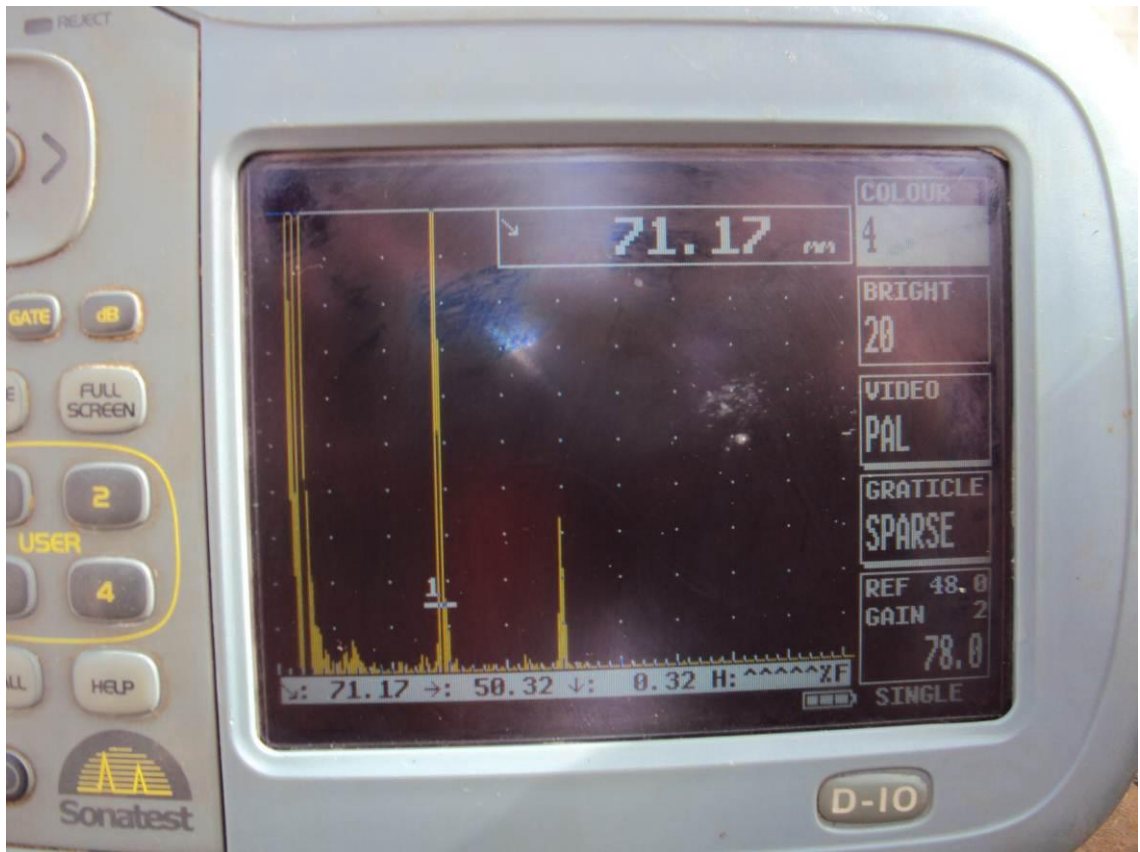
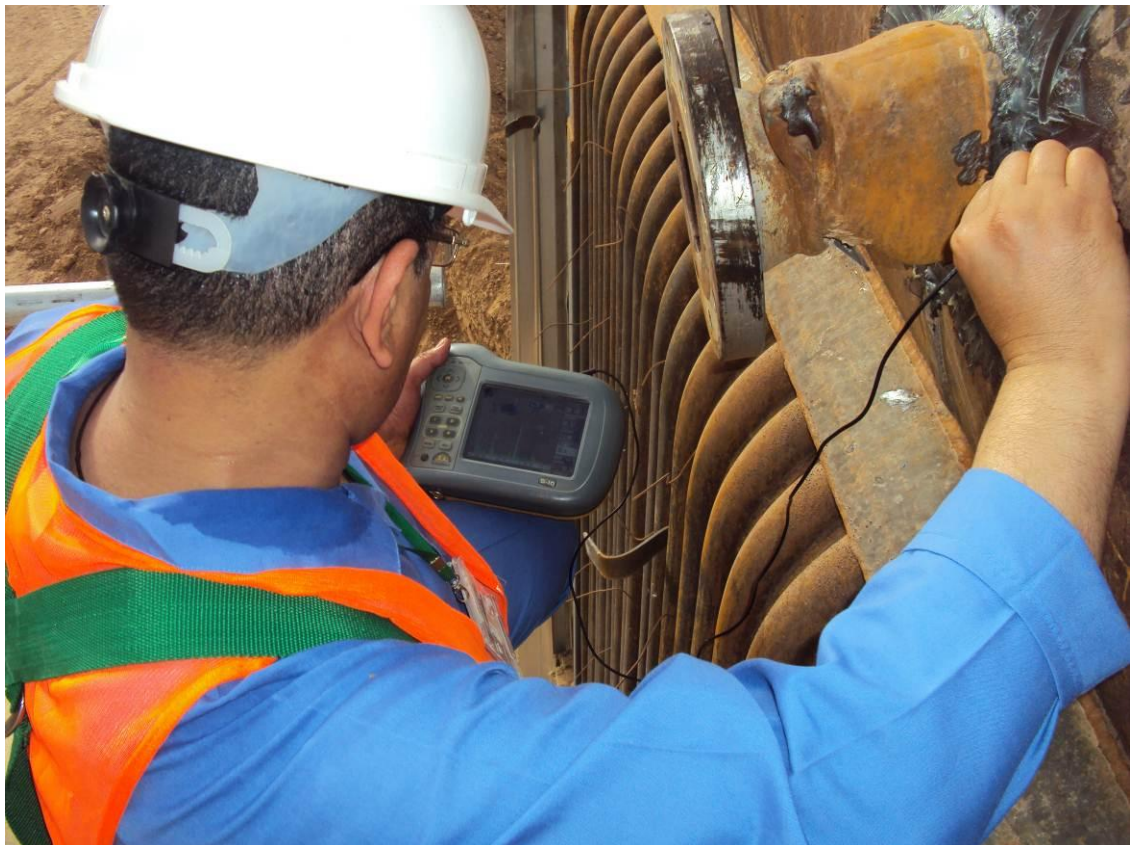
The following nozzles were (UT) examined and showed no significant indications of defects:

- Water drum preheater nozzles to the drum welds.
- Steam drum upper nozzles to the drum welds.
- Boiler feed water nozzle to the drum weld.

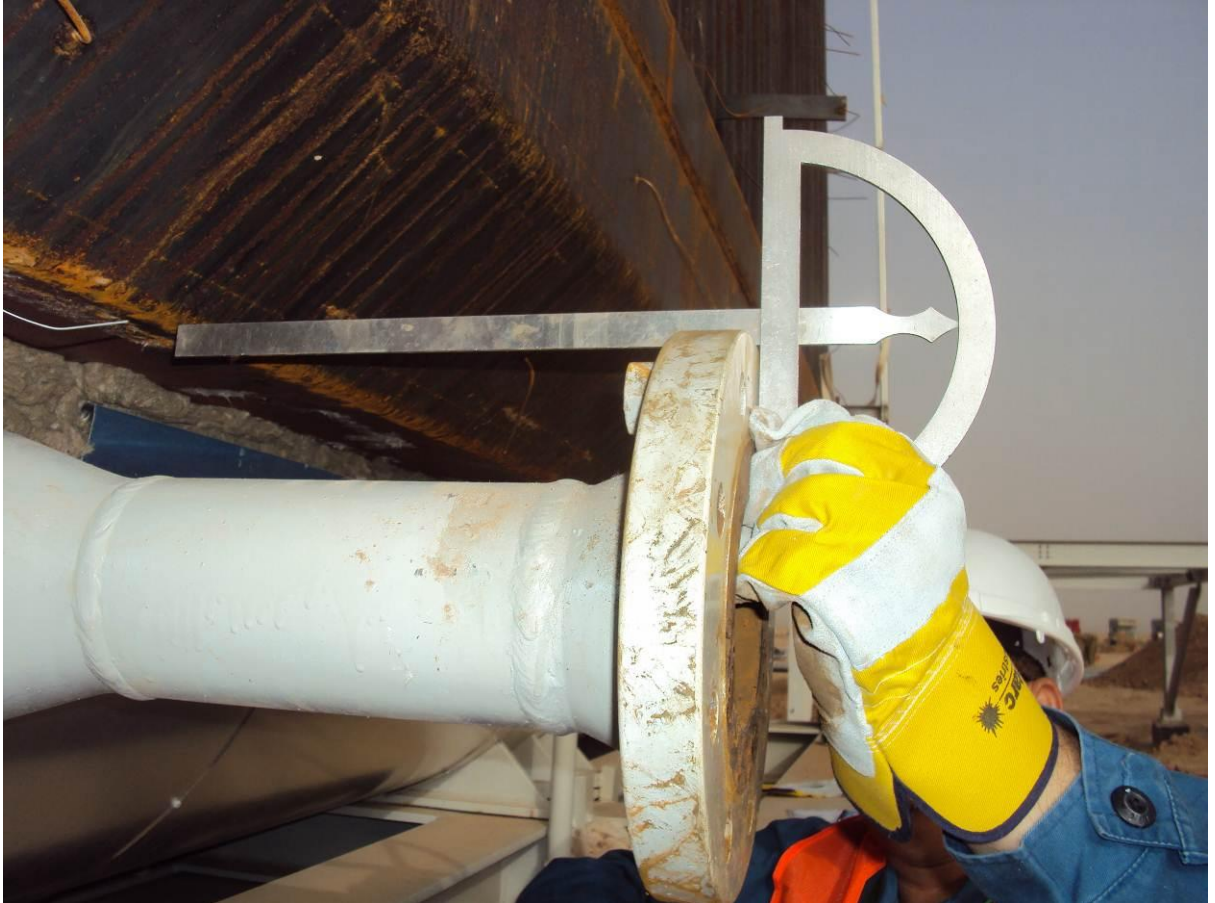
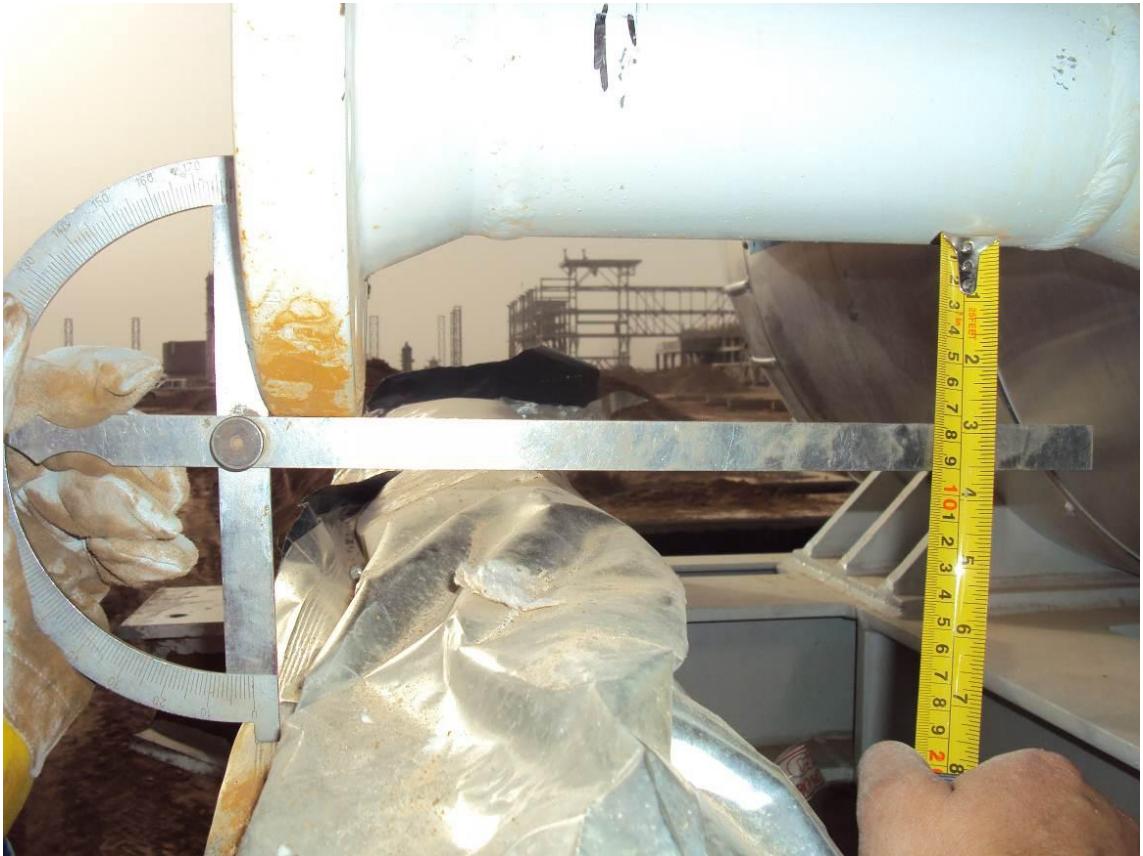
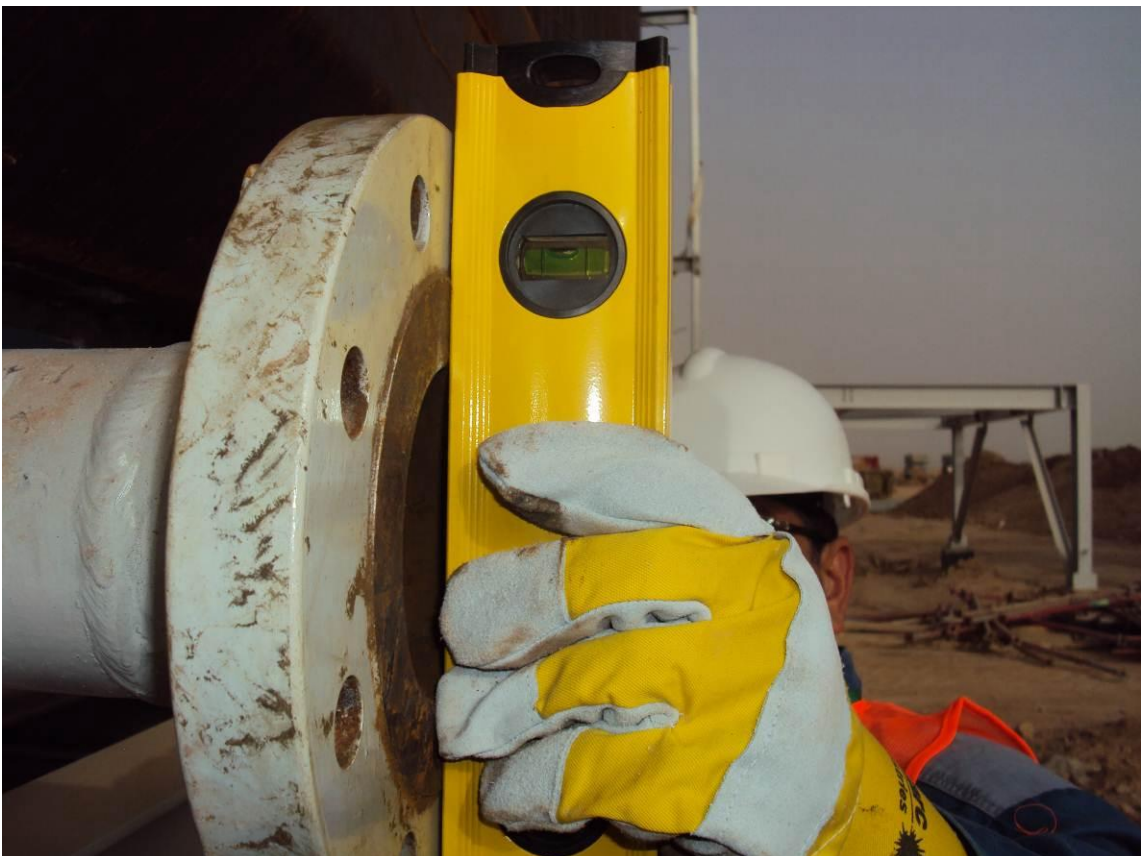
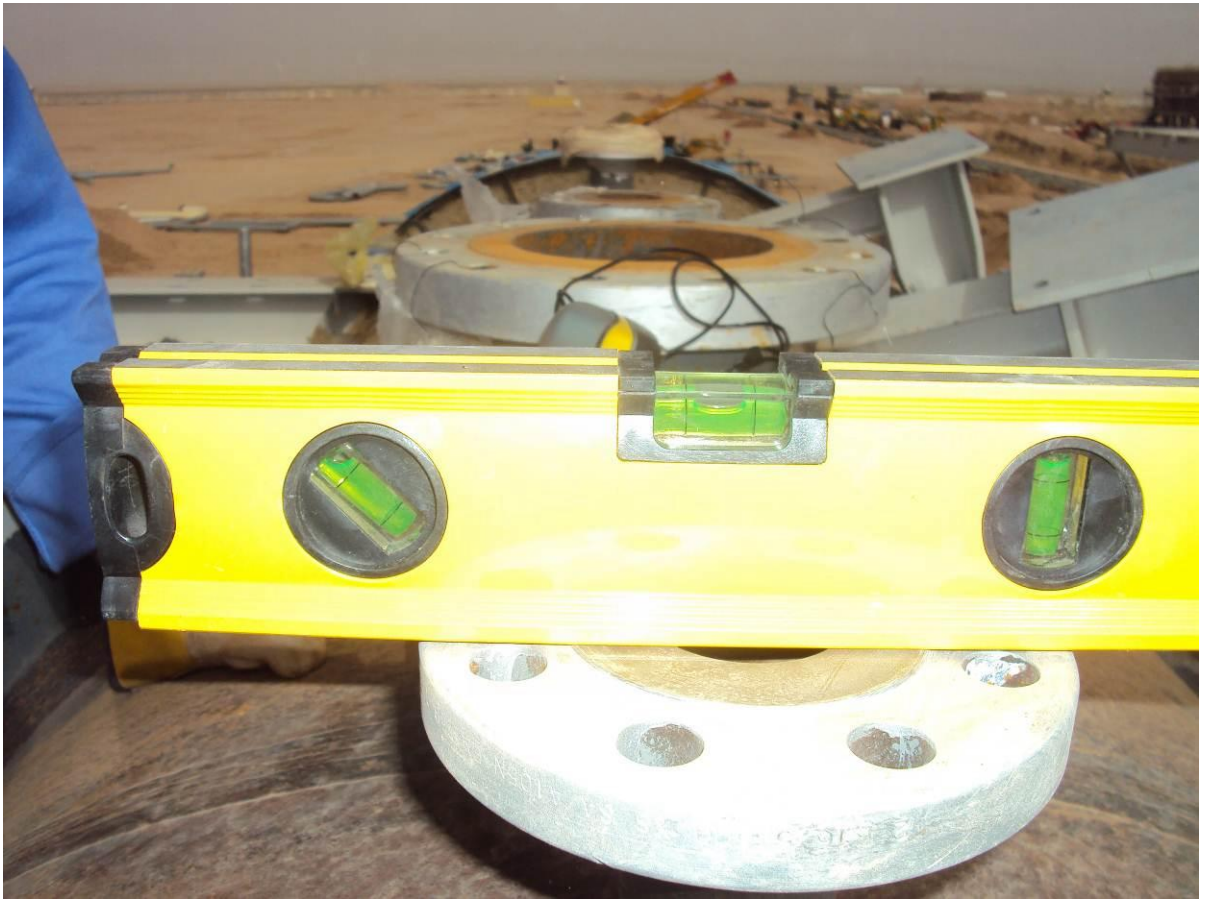
Dimensional measurements were taken to the boiler steam and water drums associated nozzles for the purpose of checking straightness and alignment. Excluded the steam drum feed water nozzle, the rest nozzles straightness and alignment seemed to be in a satisfactory condition. (See photos no. 34, 35, 36, & 37).

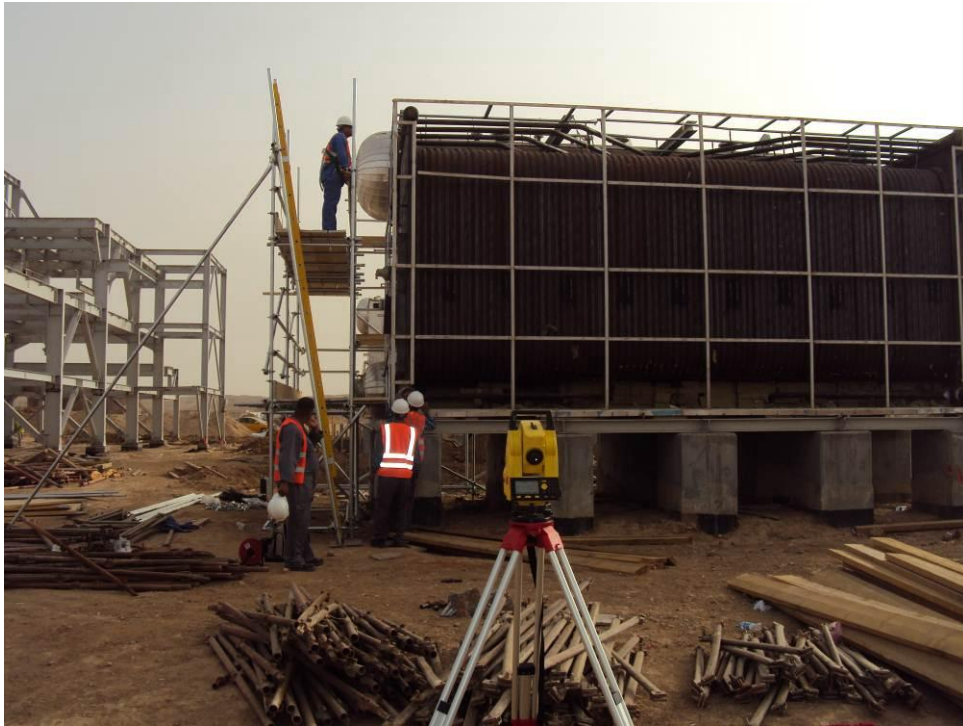
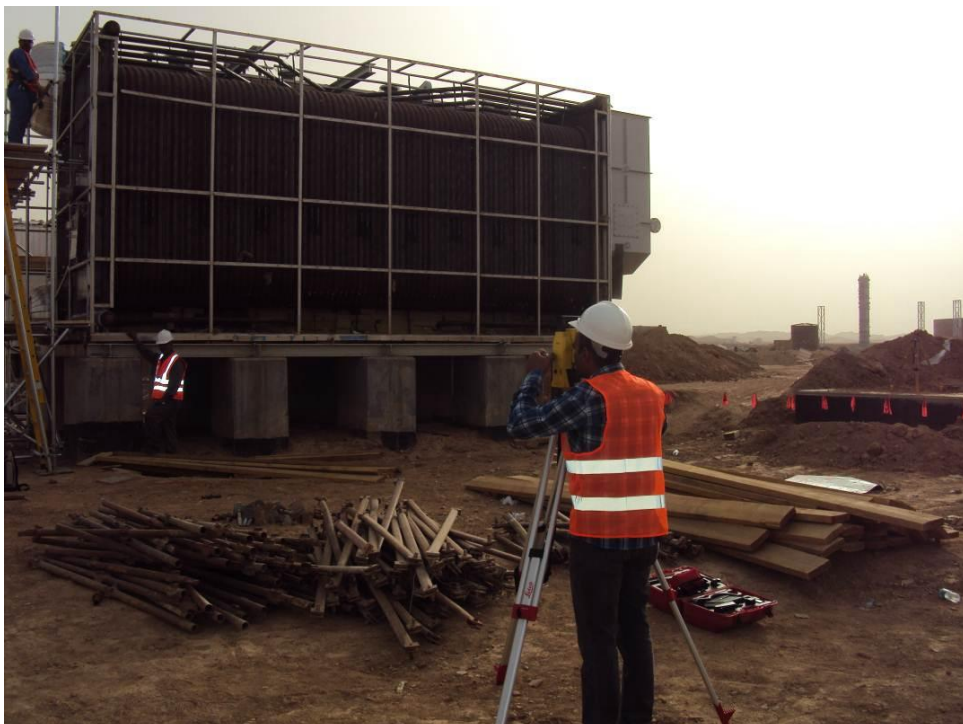
A theodolite type Leica CTB 101 having serial no. (0726839) of R300 M was used for checking the boiler steam and water drums center link (concentricity) after the accident. Survey revealed no displacement in the steam drum and water drum centers with respect to each other on both vertical and horizontal axis. (See photos no. 38 & 39).
