Confidential Inspection Report
12345 Sample Way.
Sample AZ 12345

October 12, 2012

Prepared for:
Sample Inspection

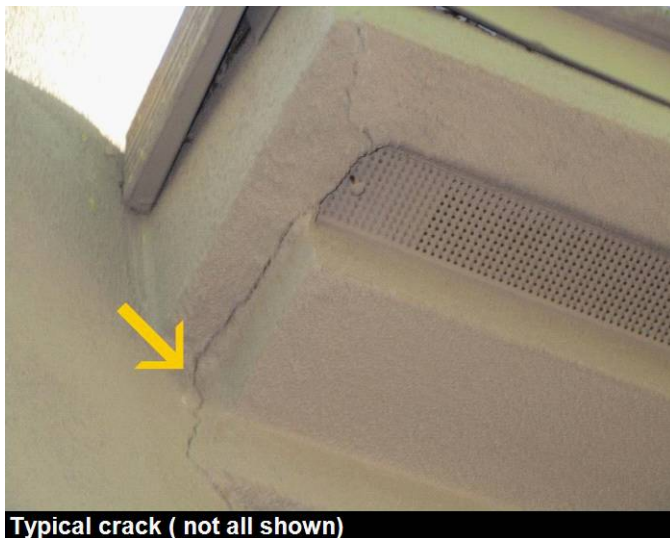
Cracks noted at stucco wall areas are typical settling type cracks.

Typical crack (not all shown)

Recommend monitoring and sealing as needed to prevent water intrusion.

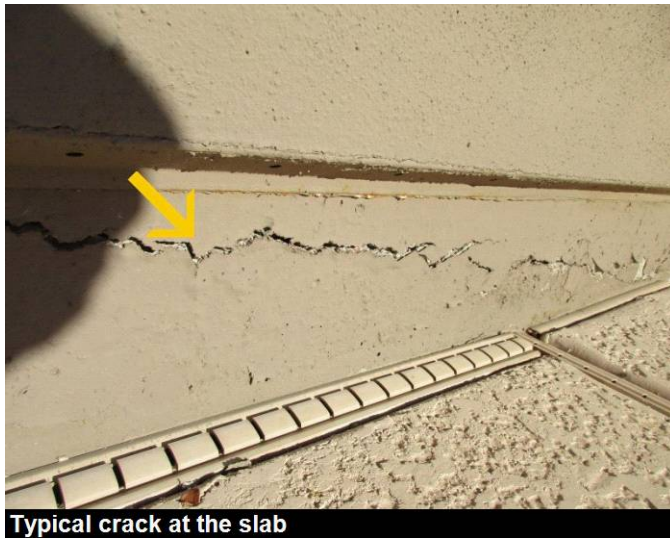
Typical cracks are noted

Typical crack at the slab

Recommend Monitor and Repair as needed.

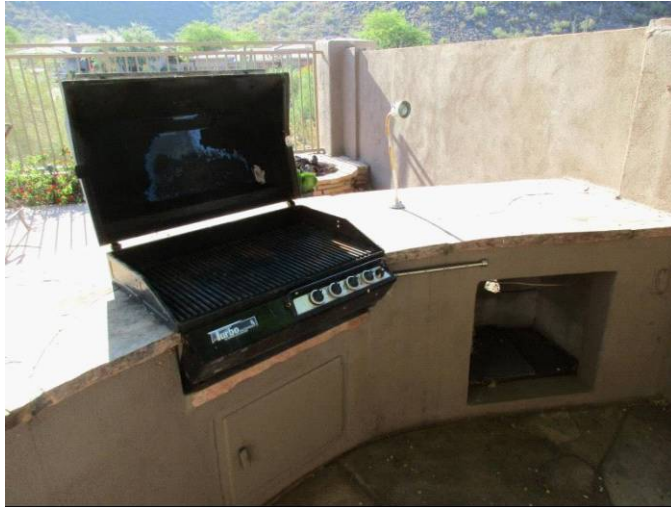
Gas type BBQ, Gas Line type
BBQ is in generally good condition with the following noted exception (s):
a) Inoperable burners / valves. This is an older BBQ. Recommend replacing the BBQ.
b) Igniter failed when tested. Recommend Repair.

BBQ

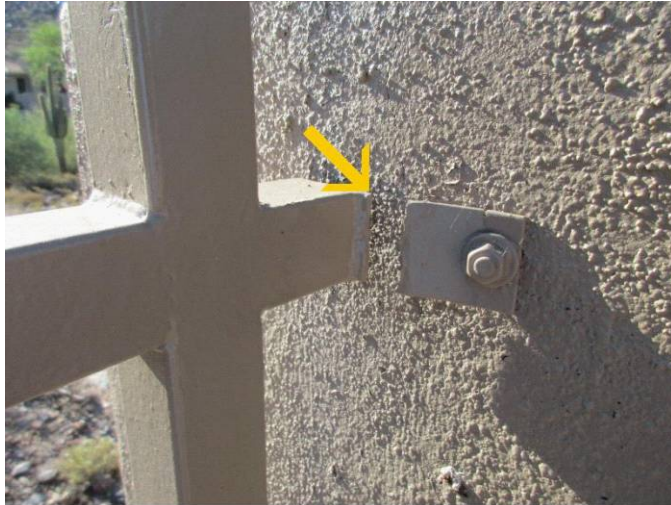
Broken fence (connector) at the southeast fence at the back yard.

Broken connector.

Recommend repair.

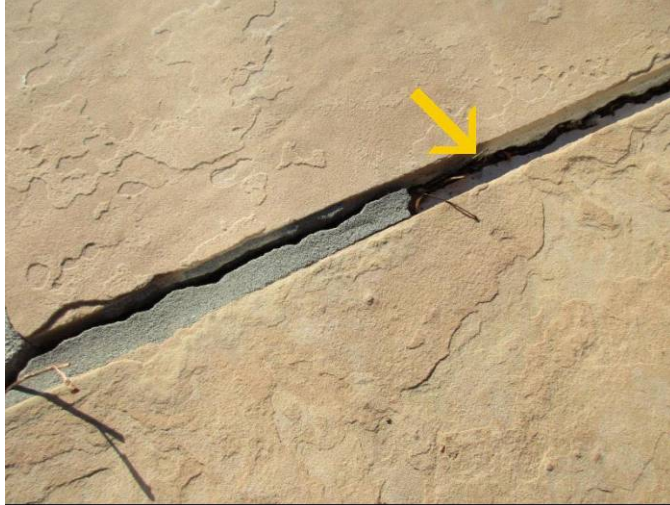
Pool Deck observed in generally good condition with the following noted exception(s):
Some missing / cracked grout at various areas.
Recommend Repair.

Missing grout (not all shown)

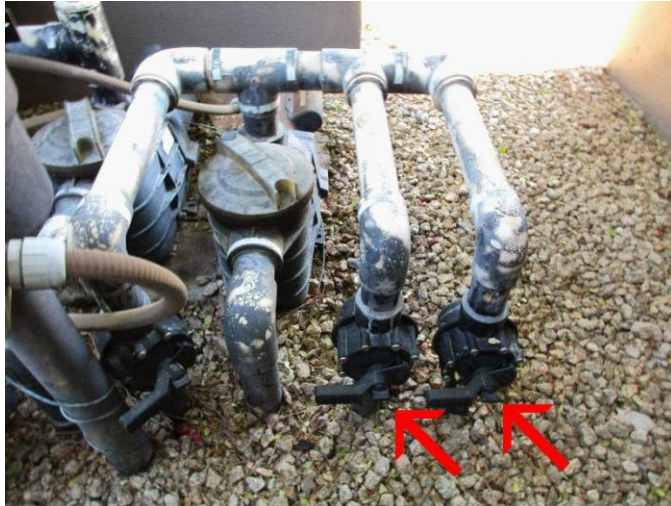
Leaking observed at 2 of the 3 valves for the water features. Recommend further evaluation by a qualified pool contractor and repair as required.

Leak areas

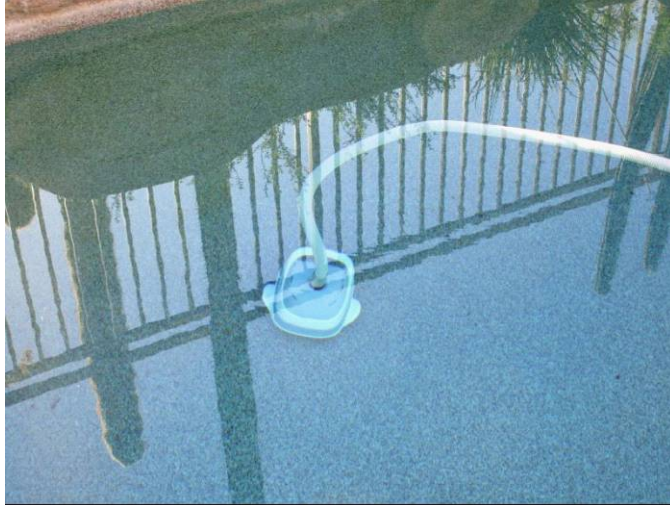
Pool vacuum

Vacuum Cleaning system equipment tested inoperable at time of this inspection. Recommend further evaluation by a qualified pool contractor and repair as required.

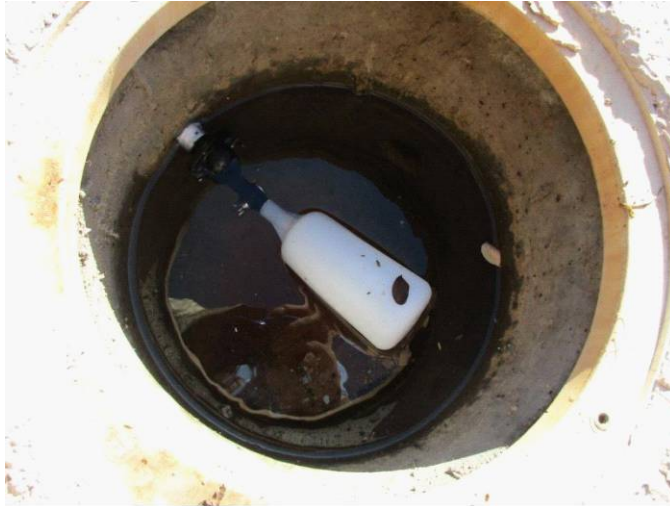
The auto filler does not completely shut off. Recommend Repair.

Auto filler.

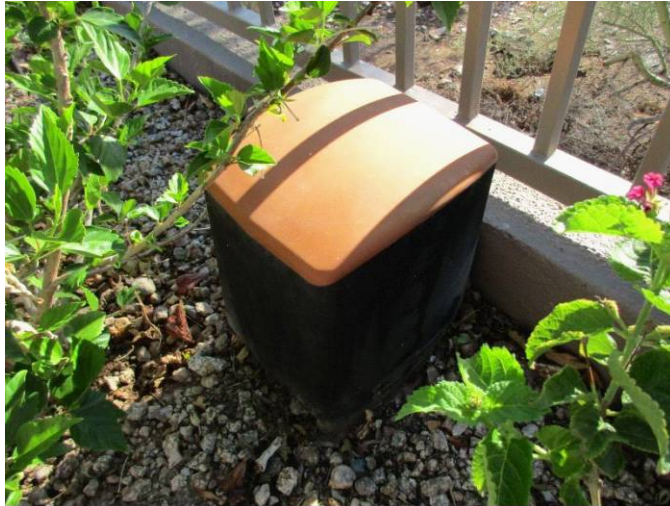
Spa light tested inoperable.
Pool light tested inoperable.
Recommend further evaluation by a qualified pool contractor/and/ or licensed electrician and repair as required.

Fiber optic tower.

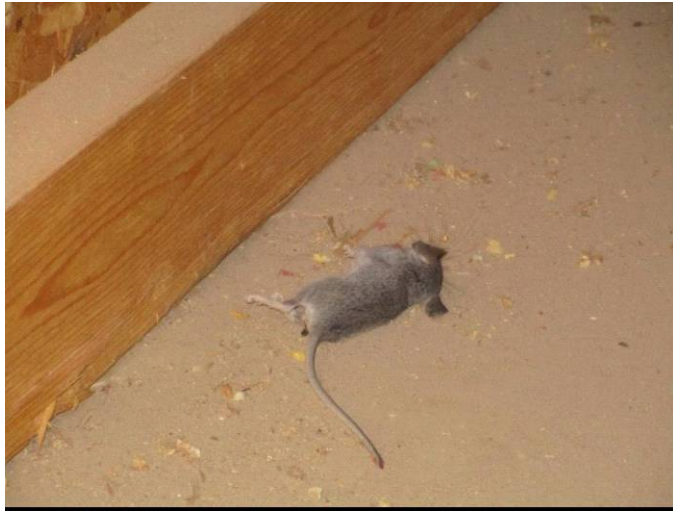
Dead mouse noted in the attic. Unable to determine if there are more, or active mice in the attic.

Dead mouse

Recommend contacting a licensed pest control specialist for remediation.

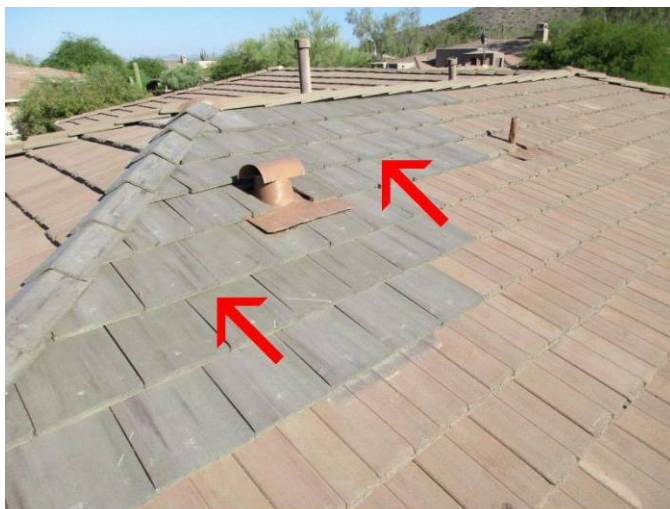
Tile roofing material observed in good condition with the following noted exception(s):
The roof has had many repairs. The area at the east roof (near the ridge area) has many replaced tiles. The seller stated the roof was repaired and has a warranty. Unable to fully determine if all the repairs under the tile have been done properly and / or do not leak when raining (due to dry conditions at the time of the inspection).
Recommend reviewing history of past repairs including cause and any repair warranties with seller. If the whole roof is not covered by the warranty or the repair work order is dubious, the Inspector recommends a complete roof evaluation by a licensed roofing contractor and repair as required.

Example of repaired area (not all shown)

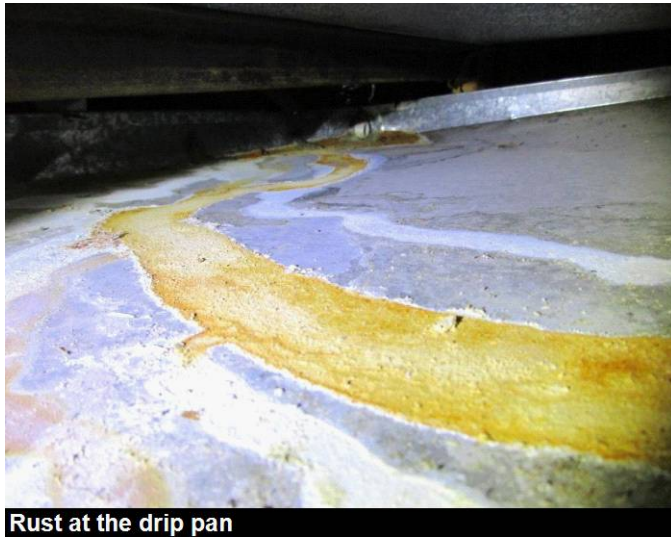
Rust noted at the south units drip pan indicating past leakage.

Rust at the drip pan

Recommend reviewing history of area with seller including any past service/repair.

Recommend further evaluation. Repair may be required by licensed HVAC contractor.

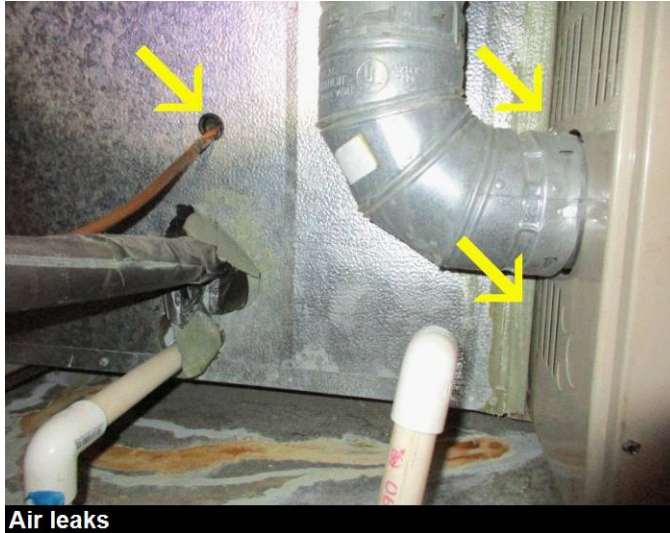
Air leaks noted at both air handler units- Sealing is recommended.

Air leaks

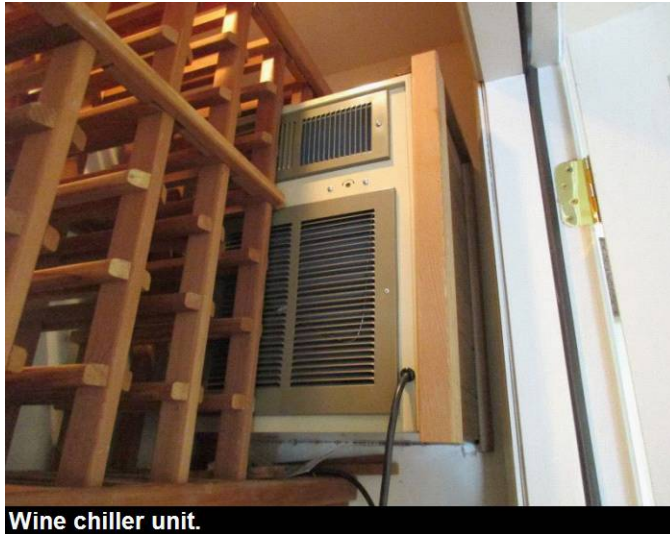
There is a wine chilling room off of the formal dining room. The air conditioning unit does not cool the room and needs repair. Recommend further evaluation by a qualified and/or licensed HVAC contractor and repair/replace as required.

Wine chiller unit.

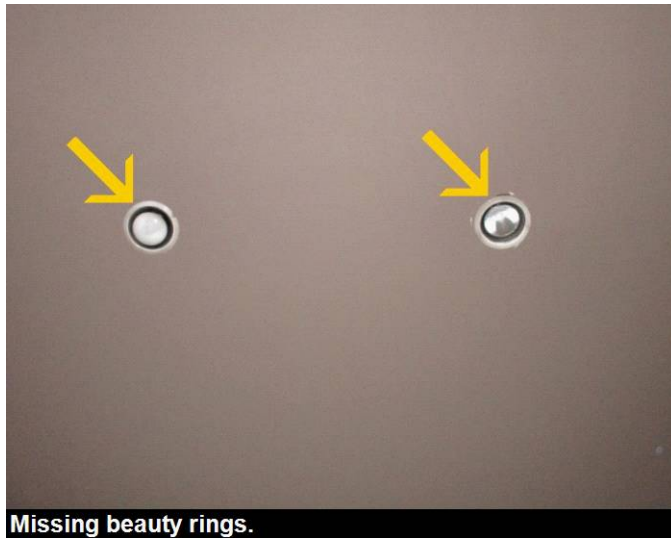
Missing beauty rings.

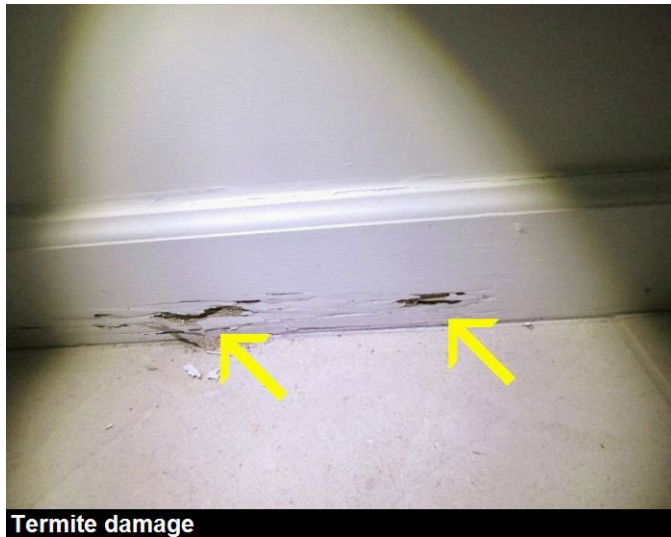
**Termite damage at the master bedroom closet (see the termite report).
Recommend replacing the base board as needed.**

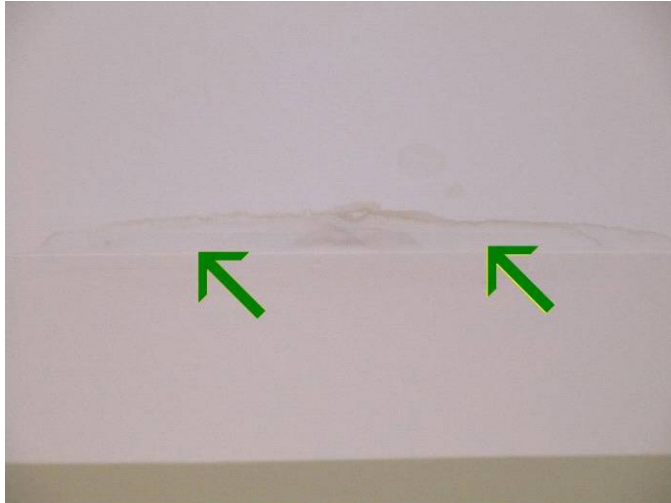
Stain at the master bathroom (not all)

Recommend reviewing history of past ceiling repairs / stains at the kitchen area, the north spare bedroom close (near the supply register) and the stains at the master bathroom areas including cause with the seller. Further repair as needed (see also the roof report).

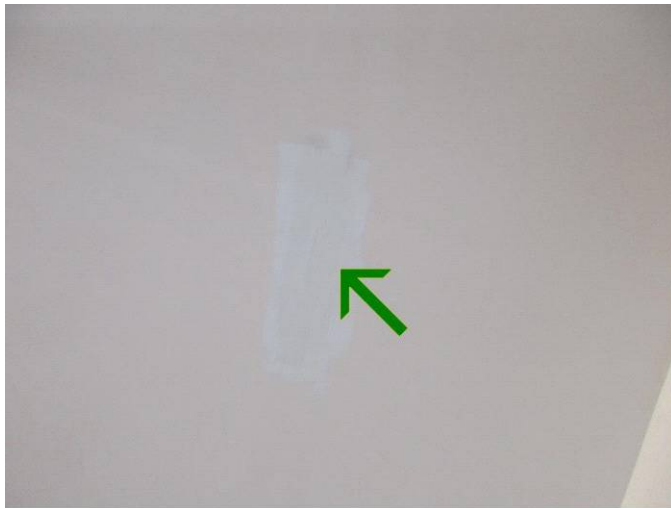
Repair at the kitchen area.

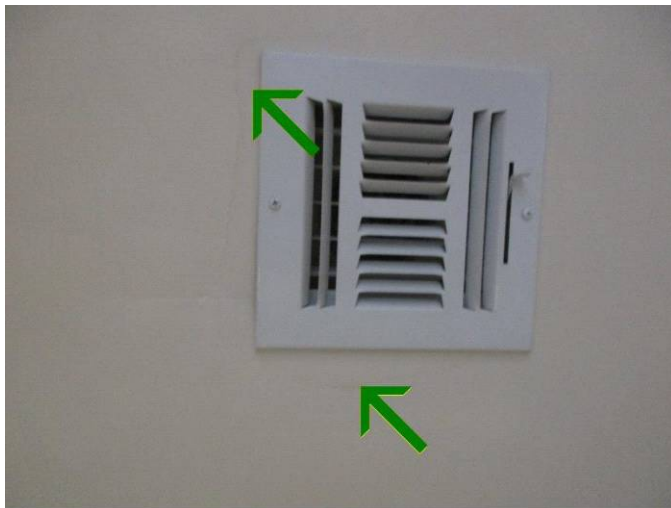
Stains at the ceiling

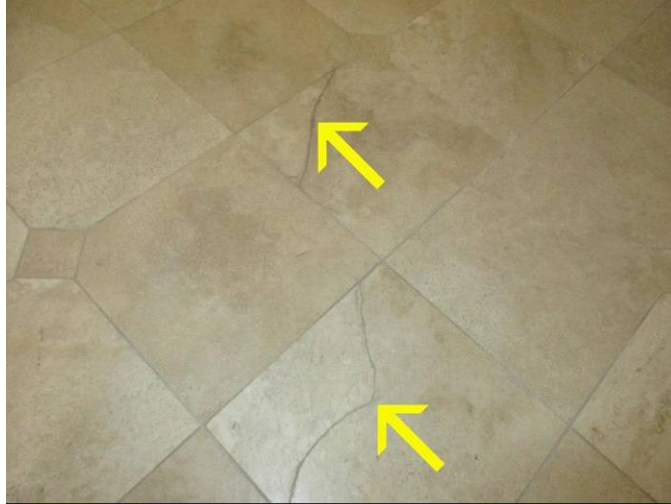
Example of cracked tiles.

Recommend replacing all cracked tiles.

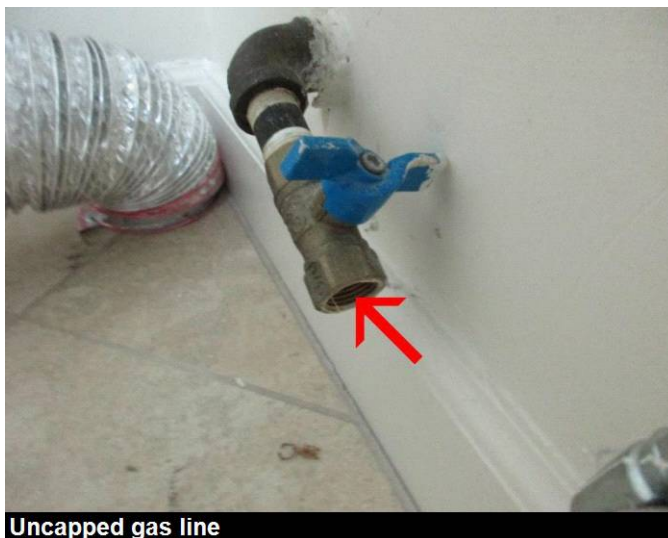
Uncapped gas line
