Condition & Valuation Survey.

"Margaritaville"
1990 Hatteras, 54 MY Extended Deck

Gary Friend, MMS, SA
on
10/26/2009 and 12/05/2009

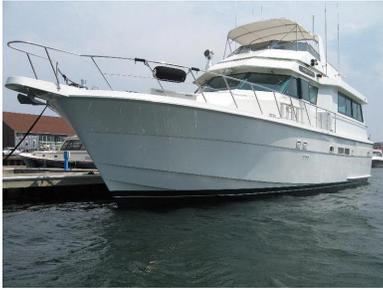
Port bow

<i>Construction material:</i>	Fiberglass composite construction, with painted gunnel from the rub rail to the water line.
<i>Hull surface condition:</i>	Excellent condition, well protected and no severe external scratches chips or abrasions observed.
<i>Damage observed:</i>	No damaged areas present on hull at this time.
<i>Stem:</i>	Good condition on external inspection.
<i>Rub rail:</i>	Fiberglass with stainless steel cap, in good condition.
<i>Exhaust vents:</i>	Yes in place and vents in good condition.
<i>Swim platform:</i>	Fiberglass construction mounted with stainless supports, attached and well secured.
<i>Boarding ladder:</i>	Stainless steel drop down ladder mounted on swim platform. well secured in good condition.
<i>Comments:</i>	Hull from gunnel to water line shows evidence of good maintenance and has very little wear.

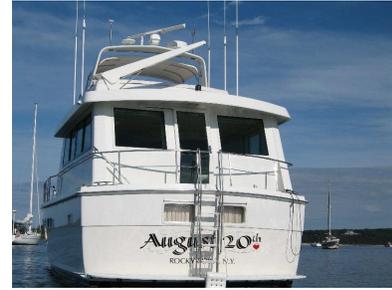
Transom

Hull to deck joint: Not observed due to limited access.
Bilge compartment: Clean and dry.
Stringers: Hull stiffness provided by FRP covered wooden longitudinal stringers that run the length of the vessel. Complete inspection not possible due to limited access. Stringers were observed in the engine compartment and under cabin sole and are well glassed into hull where visible. No soft spots, separation, cracks rotting or splitting observed. Limber holes appear to be adequately sealed where visible.
Bulkheads: Bulkheads are in good condition with no damage observed in any compartments that allowed bulkhead inspection. Complete inspection of all bulkheads is not possible due to limited access. About 20 % of the vessels bulkheads were visible to inspect.
Stem: Solid stem, no cracks or separation as viewed from the forward chain locker.
Inside of transom: Good condition, no damage or water staining was observed around fittings mounted through the transom.

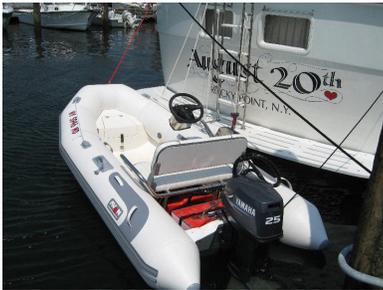
State validation sticker: Current until 6/2010.
Length: 11 feet 9 inches.
How mounted: Deck chocks.
Condition: Excellent like new condition.

2007 Avon /Yamaha 25 o/b

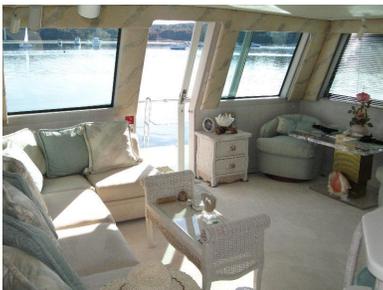
Fabric & cushions: Ultra leather and fabric, in excellent condition, no tears or staining observed.
Salon furnishings: Chairs, Coffee table, L-shape couch.
Light fixtures: 12 volt cabin lights throughout the vessel. 110 volt lamps also available.
Washer / Dryer: Whirlpool, dual washer dryer combo unit.
Comments: Interior is in excellent condition and shows very little use.
