## PROPERTY INSPECTION REPORT

**Prepared For:** Sample Report  
(Name of Client)

**Concerning:** , Austin, TX  
(Address or Other Identification of Inspected Property)

**By:** Richard H Craycroft, Lic #5069 02/12/2016  
(Name and License Number of Inspector) (Date)

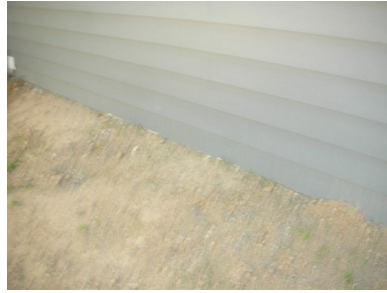
The foundation lacks the required height above finished grade. Foundations shall be a minimum 4" above grade where masonry veneer is used, and a minimum 6" above grade for all other wall materials. This condition will lead to water penetration of the structure and should be considered for correction ASAP. (IRC R404.1.6)

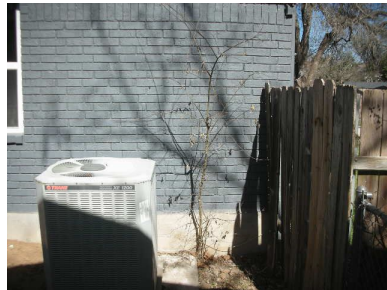
There are trees growing in close proximity to the foundation perimeter. Trees will cause desiccation of the soil and potential lifting of the foundation by a developing and growing root system.

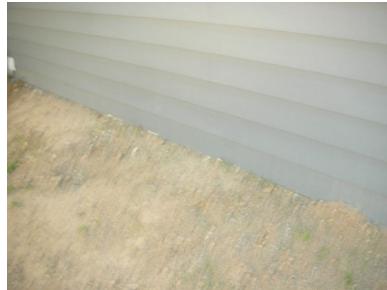
Grade is in contact with exterior cladding or lacks 4" of clearance to masonry walls or 6" of clearance to all other siding materials as required by IRC R404.1.6. This condition will permit water intrusion into the wall assembly, water damage to structural elements, and is considered to be a conducive condition for termite infestation.

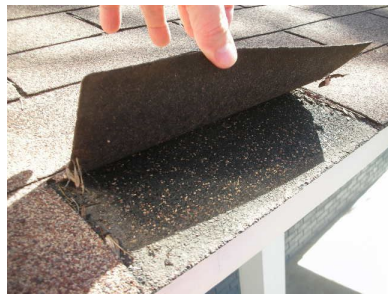
The starter course is not installed as per manufacturer's specifications. Improper installation will result in wind damage to shingles.

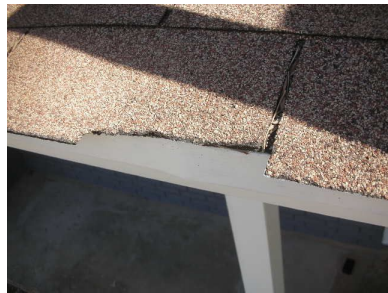
There are damaged shingles at the drip edges.

The drip edge flashing is installed improperly. At drip edges, the roof underlayment should be over the drip edge flashing not under the flashing in order to allow water to flow over the joint.

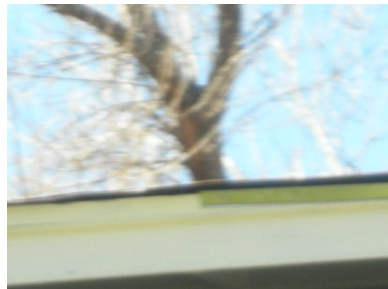
The drip edge flashings are loose and missing at many areas. Shingles do not lay flat on th roof at the drip edge flashings.

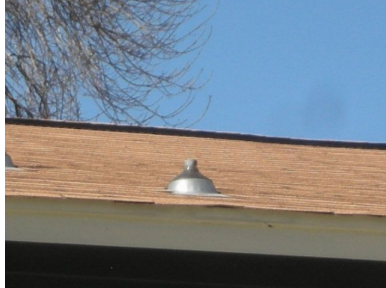
Plumbing vents should extend no less than 6" above the roof surface.

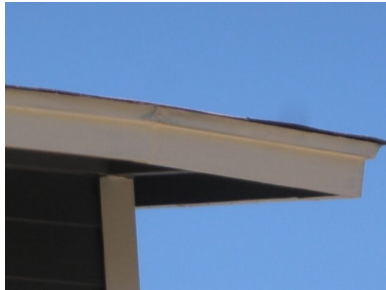
There are deflections in the roof surface and the eaves are sagging.

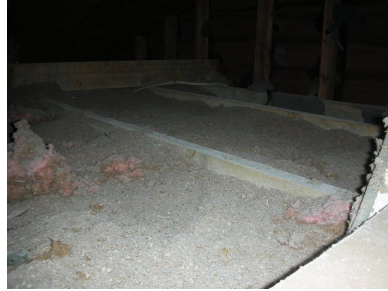
Insulation is minimal by current standards. Energy efficiency of structure can be greatly increased with additional insulation coverage.

There are insulation voids in the attic resulting in excess thermal transfer to conditioned air spaces and a resultant loss of thermal efficiency of the structure.

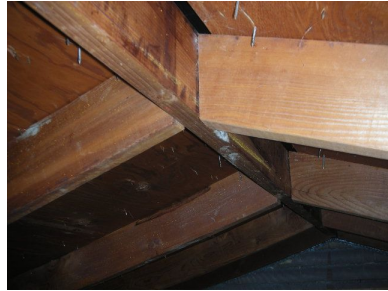
Rafter width cut ends exceed that of ridge boards resulting in open toe joints. This may contribute to splitting of rafters under load at the compression joint. (IRC R802.3)

There are framing gaps at a number of areas.

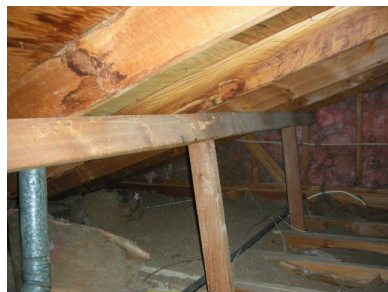
The purlins are undersized for the rafters supported. Currently, purlins must be equal in dimension to the rafter supported. The struts supporting the purlins lack backers to stiffen the struts. (IRC R802.5.1)

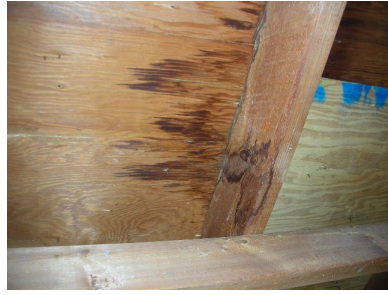
The roof decking is stained at a number of locations. Some decking has been replaced.

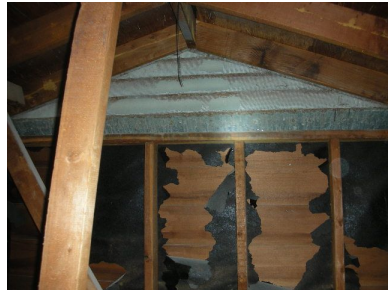
The gable vent screens are damaged. The side wall moisture barriers are missing and damaged.

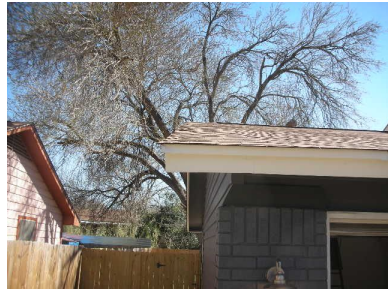
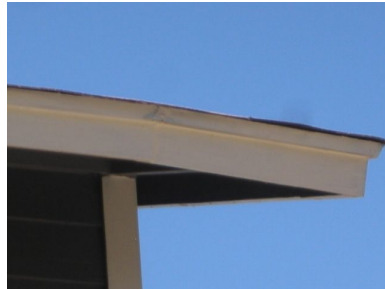
There are deflections in the roof surface and the eaves are sagging.

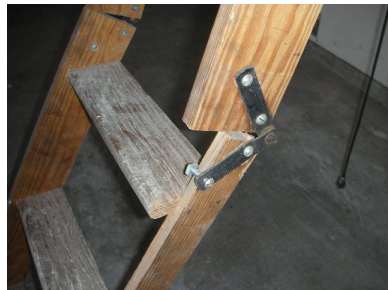
The attic ladder is damaged and in an unsafe condition. Replacement is recommended.

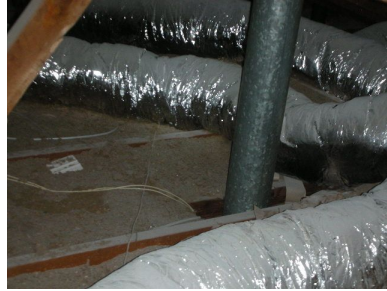
The furnace vent chase is not fire blocked with non combustibile material. This will facilitate the rapid spread of fire throughout the structure and is a safety hazard. (IRC R1003.19)

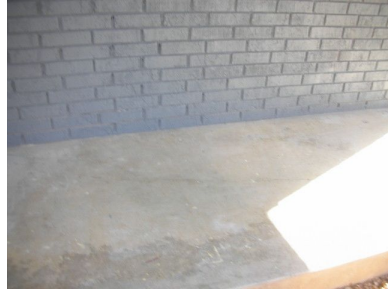
Weep holes are missing at the bases of the exterior masonry wall assemblies at various locations. Weep holes are required at intervals of 33" for proper drainage and to allow a path for dispersal of accumulated moisture from bulk water intrusion or water vapor condensation inside of the wall assemblies. (IRC R703.7.6)

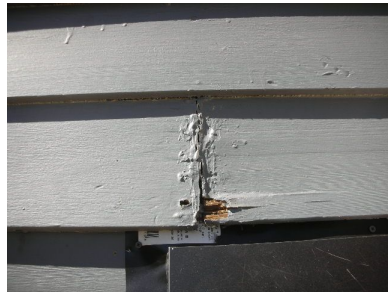
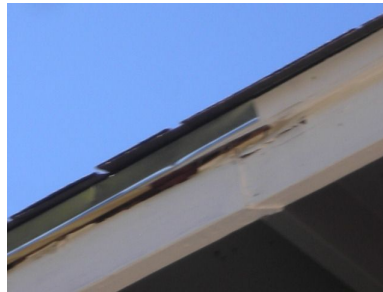
There is water damage to various areas of the siding, trim and/or fascia. Hardboard siding present. This type of siding is composed of wood fiber, waxes, resins and glues. It is not a water proof material. Edges and rear of panels are not primed or sealed and therefore are susceptible to water damage. It is essential that all surfaces be properly sealed and painted in order to extend lifespan. Regular maintenance will help extend life of product.

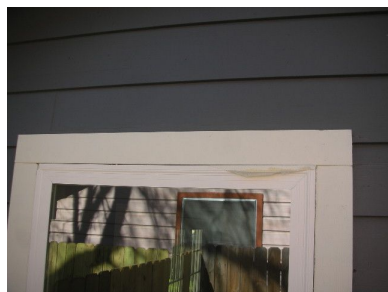
Head flashing is not present above the projecting exterior wall trim at windows and doors as required. Head flashing is required to prevent bulk water penetration of the exterior wall assemblies at these vulnerable areas and to protect the trim from exposure and water damage. IRC R703.8(4)

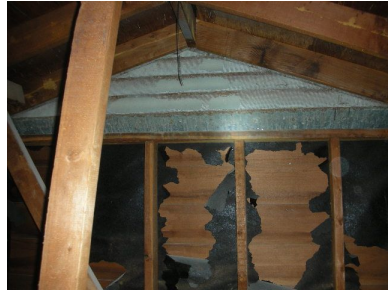
The attic gable side wall moisture barriers are missing and damaged.  
 Cracking and bowing to interior sheet rock is indicative of structural settling.  
 The drywall tape, float, texture, and finishes are inconsistent.

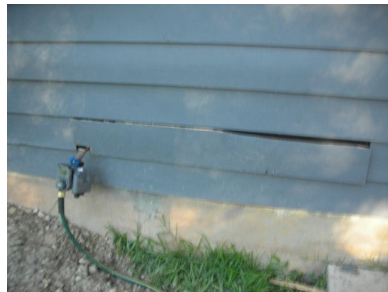
Siding is damaged at the rear.

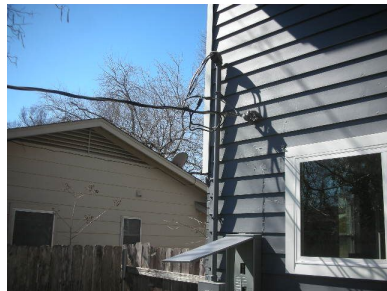
The service drop and drip loops are less than the minimum 10 feet above grade as required by code. Safety hazard.

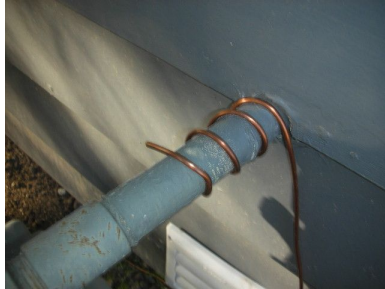
There is no gas bond CLAMP. The gas system bond is not attached to a clean surface free of paint, etc. This will inhibit electrical conductivity. (IRC E3611.5)

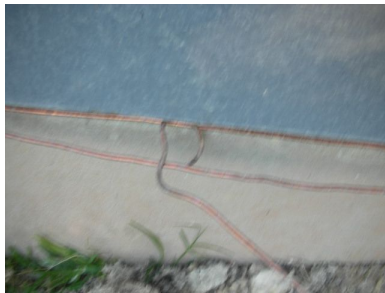
The cold water bond is not attached to the copper plumbing system.

The breakers lack required circuit identification labeling. All circuits must be legibly marked as to their clear, evident, and **specific purpose** (NEC 408.4).

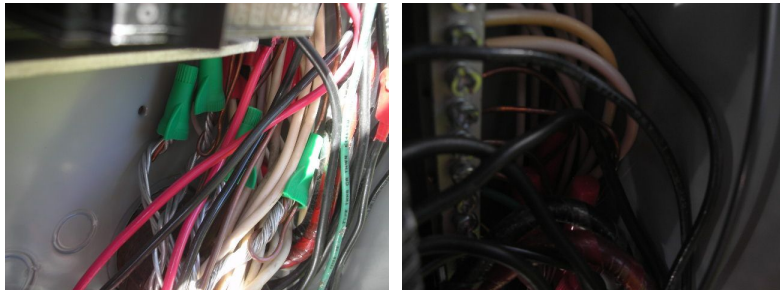
Copper to Aluminum wiring connections in the panel have improper wire nuts. Code requires these connections to be made only with purple wire nuts approved for this type of wire connection.

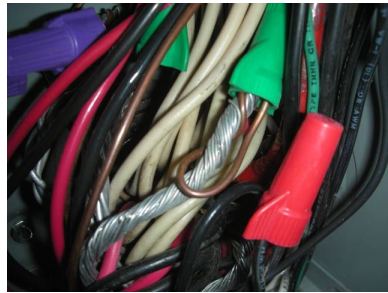
ALL Al/Cu connections MUST BE PURPLE WIRE NUTS.

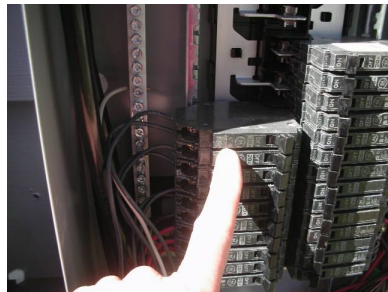
A 30 amp breaker is attached to 12 gauge wire. The maximum allowed over current protection device allowed for 12 gauge wiring is a 20 amp breaker.

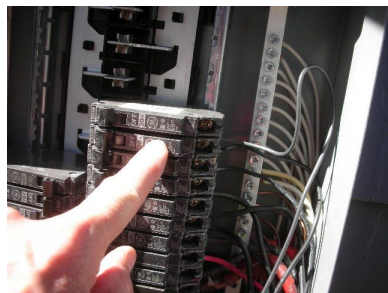
A 20 amp breaker is attached to 14 gauge wire. The maximum allowed over current protection device allowed for 14 gauge wiring is a 15 amp breaker.

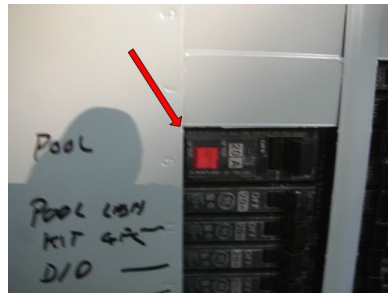
This breaker does not serve the pool pump motor circuit.

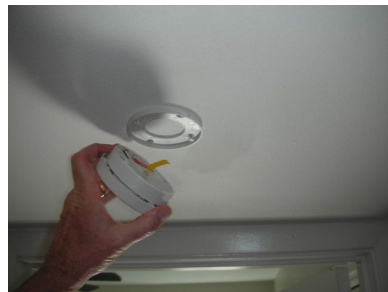
The smoke alarms are not hardwired or interconnected.

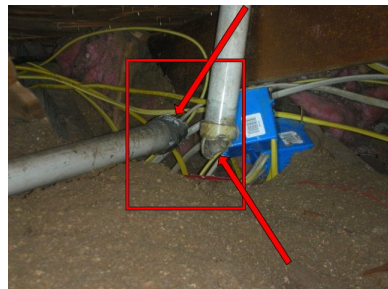
There are open junction boxes in the garage attic. All wire splices and terminations are required to be contained within approved sealed junction boxes (NEC 300.15).

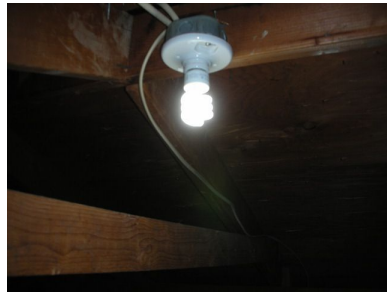
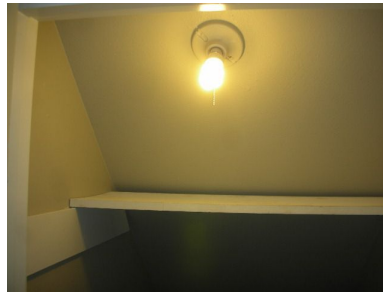
Install protective cages or globes on all exposed attic and closet lights to prevent physical damage. Fire Hazard.

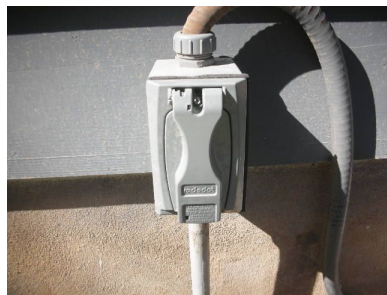
Replace the exposed exterior receptacle cover(s) with a wet location rated, "in use", "bubble cover". NEC 406.9(2).

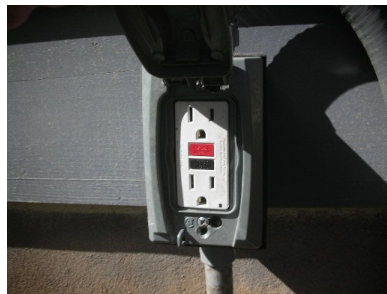
Weather Resistant (WR) receptacles are not present at all required locations. NEC 406.9: ALL receptacles located in damp and wet locations are required to be WR rated and clearly marked. WR receptacles are not present at the pool light GFCI receptacle.

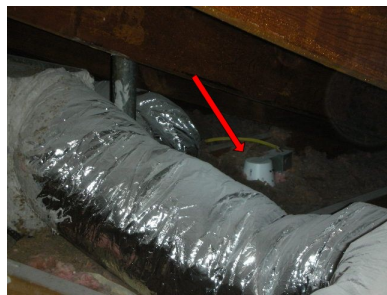
Non IC Rated can lights have been installed in the insulated ceilings. These lights must have insulation shields providing 3" of clearance to all materials, or be IC Rated for installation in an insulated ceiling. [410.116(B)]

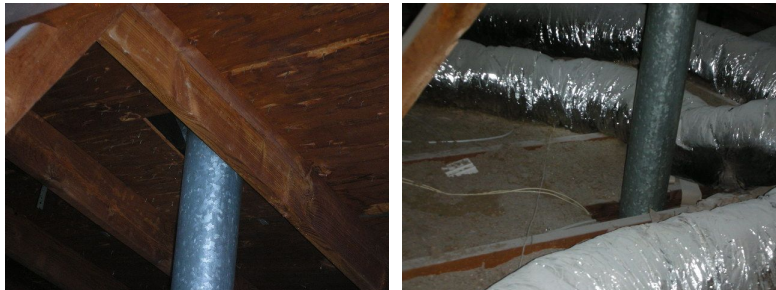
The furnace exhaust vent lacks required clearance to flammable materials. Type B exhaust vent requires a minimum of one inch clearance to all materials, particularly combustible materials.

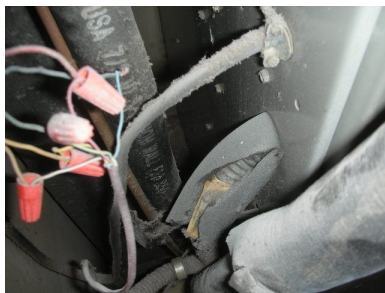
Gas line lacks required hard steel gas pipe at cabinet wall penetration. Flexible gas lines are not allowed to penetrate enclosures as they may become abraded resulting in a gas leak. This is a potential Safety Hazard. (IRC 2422.1.1).

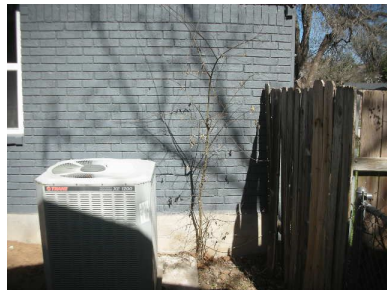
System(s) are beyond the generally recognized typical life span for HVAC systems (circa 1993). Recommend thorough evaluation by a qualified HVAC technician to evaluate the condition of the system(s) and any necessary repairs to extend life and serviceability of the the system(s) prior to closing. Recommend budgeting for replacement in future.

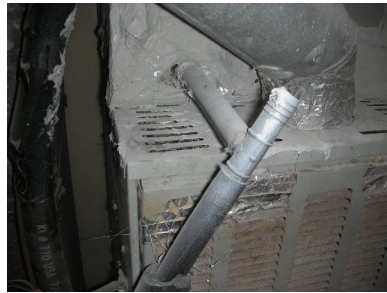
Updraft unit lacks a secondary drain line or float switch. Updraft units are currently required to have two drain lines. In retrofits and older structures this is not practical or not possible due to the location of the unit. In that event, it is recommended that a float switch be installed on the condensation drain line in order to shut the system down and avoid interior water damage in the event of the condensation drain line becoming blocked.

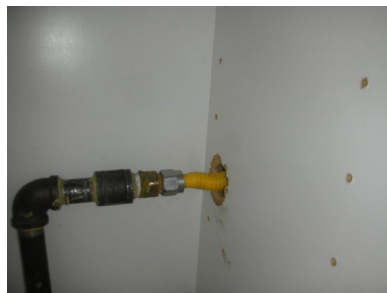
Flex gas lines MAY NOT go through the cabinet.

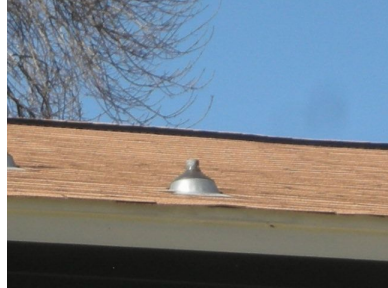
Vent pipes shall extend no less than 6 inches above the roof surface. (IRC P3103.1)

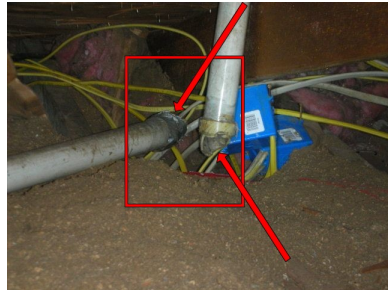
The laundry room plumbing vent is broken and detached at the elbow to the roof riser in the garage attic (there is recent electrical work in the area). This must be properly repaired to prevent water penetration from the roof and sewer gasses from entering the structure. Replace all damaged materials.

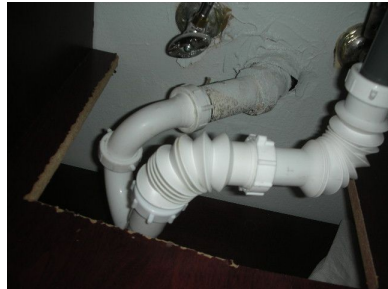
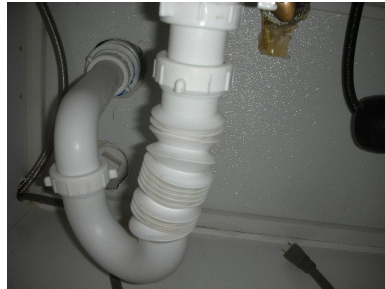
Flexible drain line connector at the sink drain is not approved for permanent use. Drain line pipes are required to be smooth bore to avoid build up in pipes.

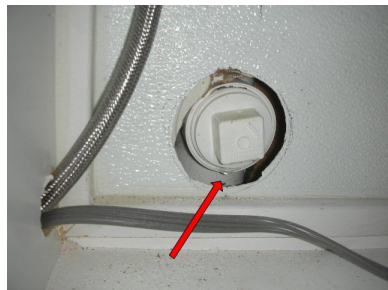
The kitchen sink clean out is leaking.

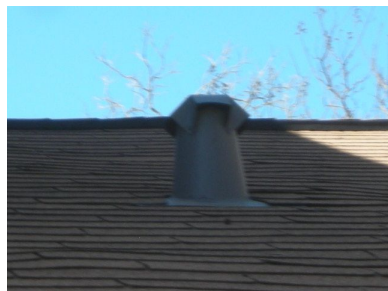
The exhaust vent lacks a required Type B vent cap. Exhaust vents must terminate above the roofline at an approved Type B vent and cap.

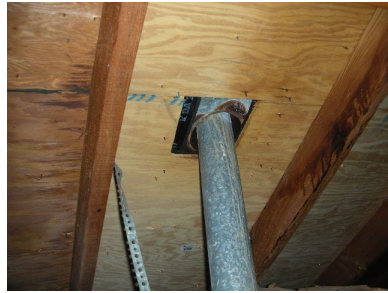
The exhaust vent lacks required clearance to flammable materials. Type B exhaust vent requires a minimum of one inch clearance to all materials, particularly flammables.

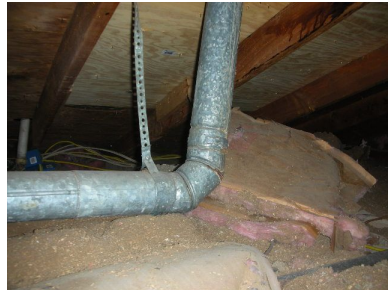
The exhaust vent is in direct contact with attic insulation. An insulation shield of no less than 26 gauge sheet metal shall be installed to provide clearance between the vent and the insulation and extend no less than two inches above the insulation layer in the attic (IRC 2425.4).

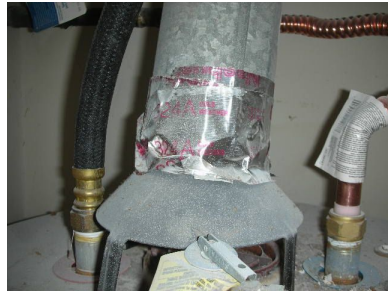
The exhaust vent is not secured to the draft hood properly with screws (IRC 2426.10.7).

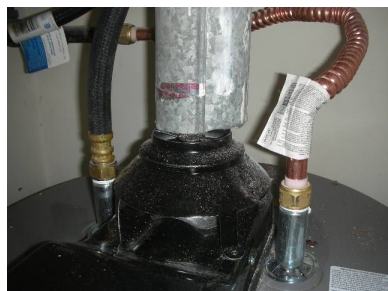
The exhaust vent is not connected to the unit. Exhaust gasses, including carbon monoxide, are spilling into the structure. This must be corrected ASAP. Safety Hazard.

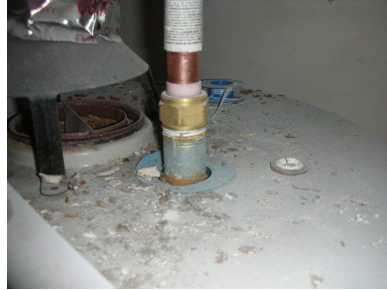
Dissimilar metals used for connections resulting in corrosion and leakage due to electrolytic action. Absence of dielectric union connectors is allowing advanced corrosion and periodic leakage. Galvanized steel pipe nipples are more than likely heavily corroded at interior reducing pressure and flow.

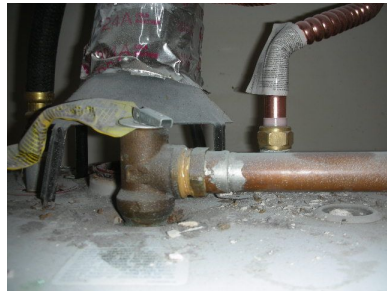
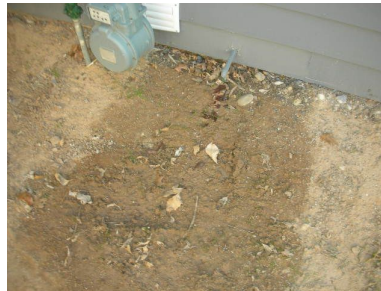
The T/P Valve is leaking. This is a sign of failure and may require replacement of the water heater.

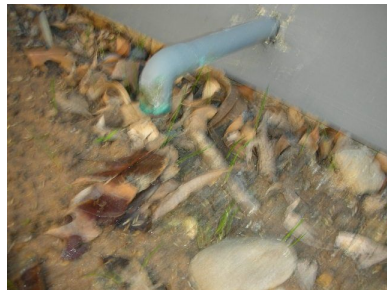
The T/P drain line terminates improperly. The drain line must terminate no less than 6" nor more than 24" above grade. IRC P2803.6.1

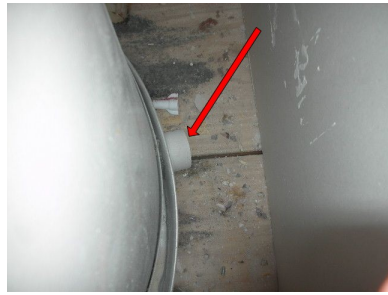
The drip pan drain is not plugged or plumbed to the exterior of the structure. Plumb the pan drain to a suitable approved disposal point. (IRC P2801.5.2) Alternatively, plug the pan drain and install a water cut off device that can be plumbed to the supply line, detects water in the drip pan, and shuts the water supply to the water heater off.

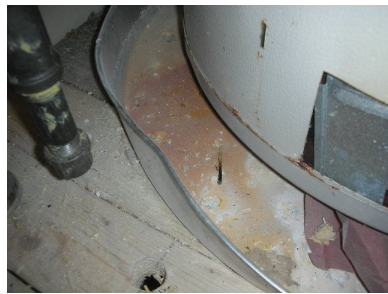
There is rust in the drip pan indicative of leakage.

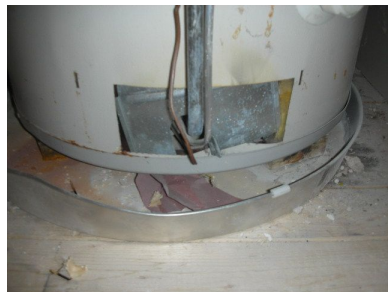
The combustion chamber cover is missing.

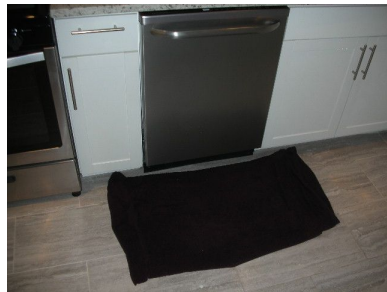
The dishwasher failed to cycle properly and leaked profusely. The Inspector soaked up the water and disabled the unit to help prevent water damage to the structure. DO NOT use the dishwasher.

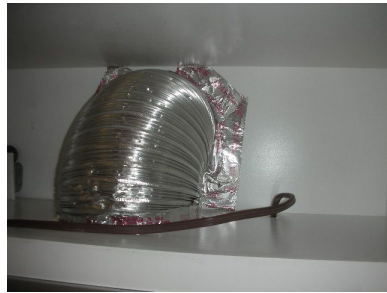
Vent connection is flexible aluminum. Vent pipe is required to be constructed of solid metal of proper gauge, smooth bored, with no protruding connectors (IRC M1503.2).

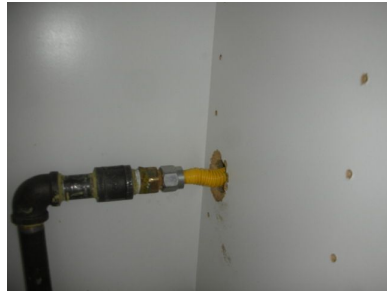
The flexible gas line passes through the adjacent cabinet. This is never allowed. Solid metal gas pipe is the only material allowed to pass through structures.

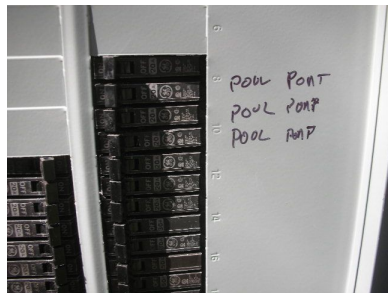
The pool/spa pump motor circuits are not GFCI Protected as currently required. [NEC 680.21(C)]

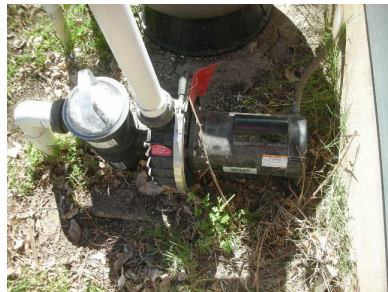
The pump motors and other equipment lacks required bonding and grounding. Code requires that all electrical pool equipment be bonded and grounded. (NEC 680.26)
