Part IV: BARANGAY SURVEYS, PENINSULAR & NEAR ISLANDS

Methodology

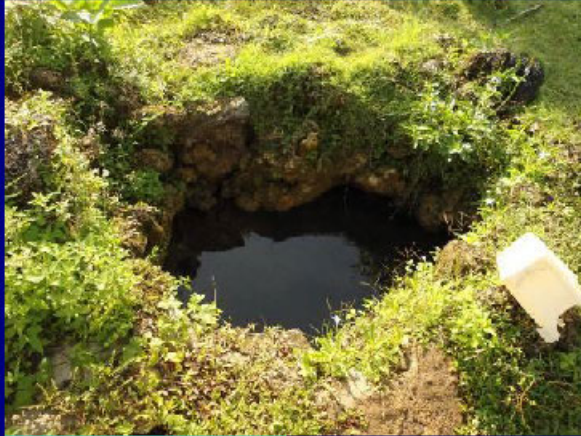
Well 9 Bucao **Grade 1**

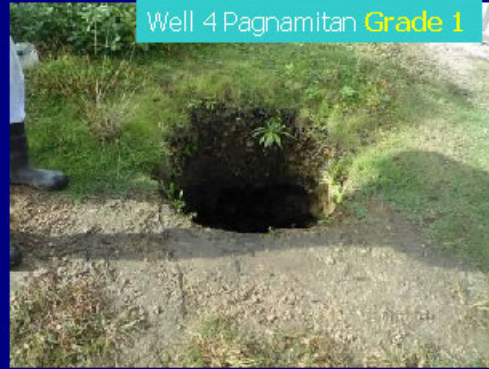
Well 4 Pagnamitan **Grade 1**

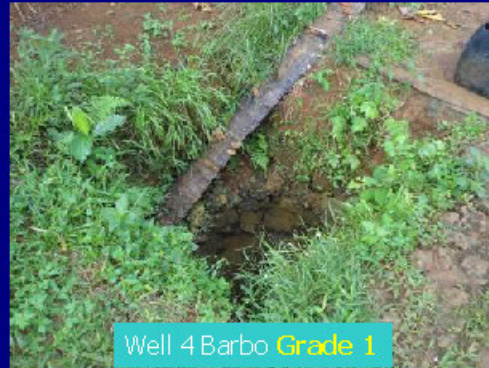
Well 4 Barbo **Grade 1**

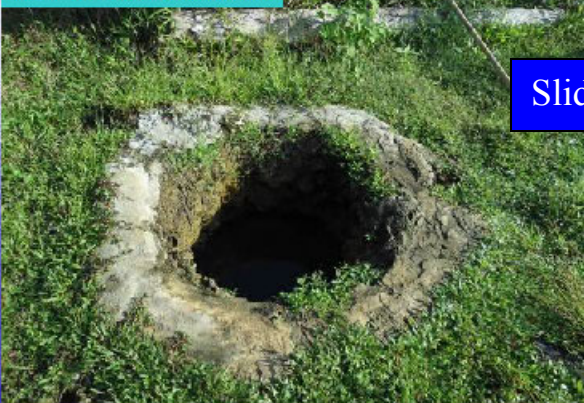
Well 7 Bucao **Grade 2**

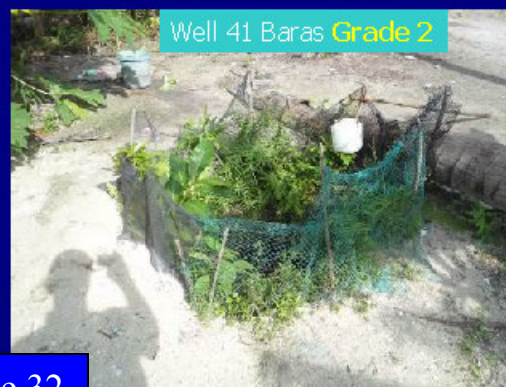
Well 41 Baras **Grade 2**

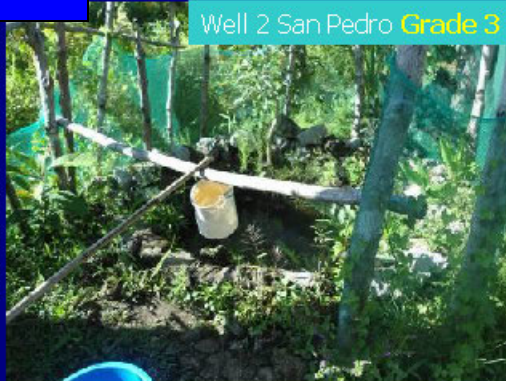
Well 2 San Pedro **Grade 3**

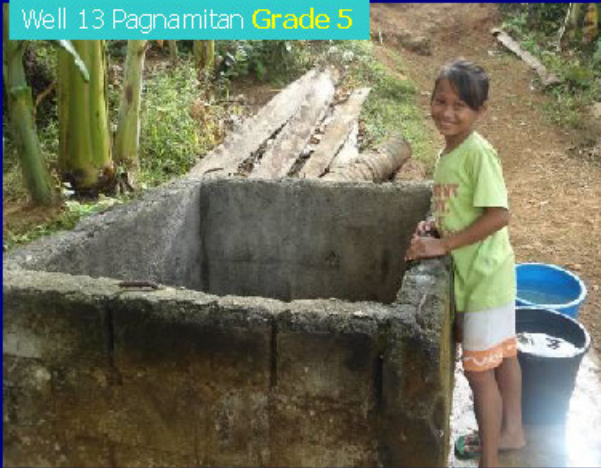
Well 13 Pagnamitan **Grade 5**

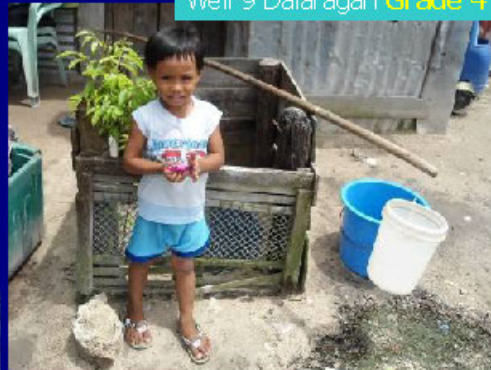
Well 9 Dalaragan **Grade 4**

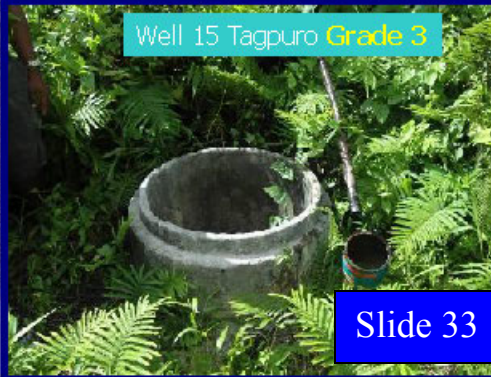
Well 15 Tagpuro **Grade 3**

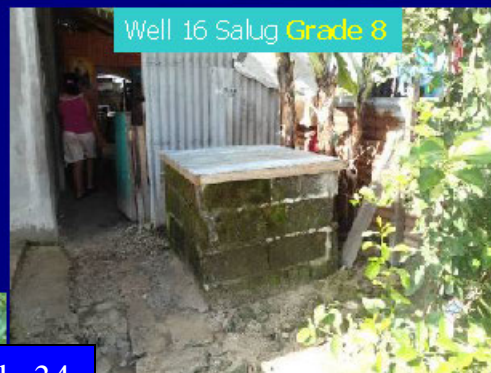
Well 16 Salug **Grade 8**

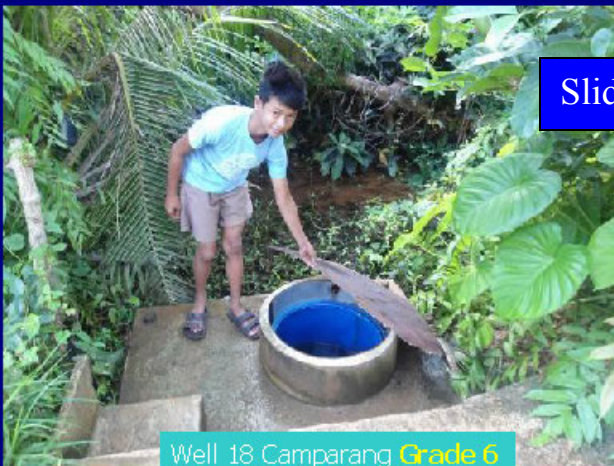
Well 18 Camparang **Grade 6**

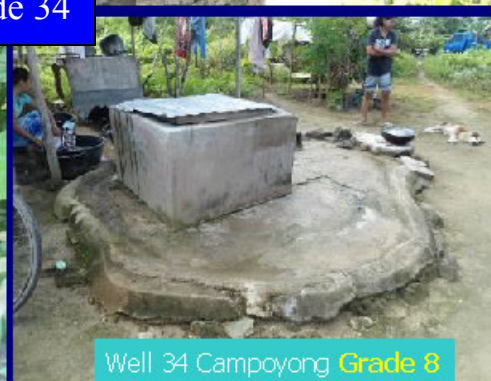
Well 34 Campoyong **Grade 8**

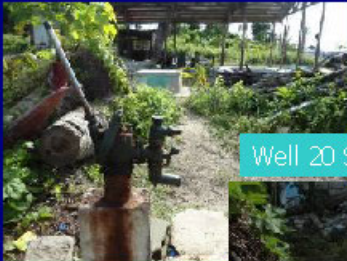
Well 20 Sapao **Grade 10**

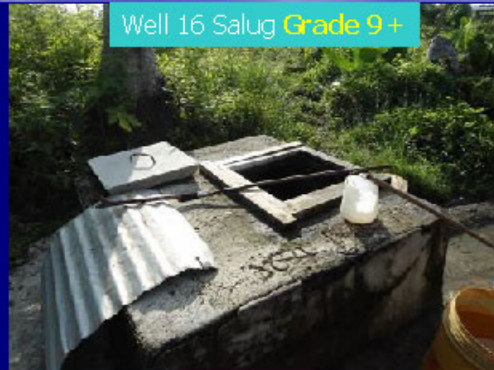
Well 16 Salug **Grade 9+**

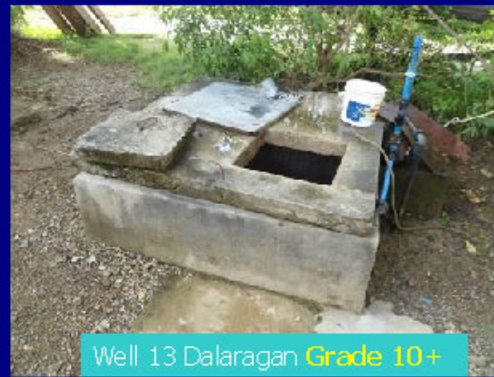
Well 13 Dalaragan **Grade 10+**

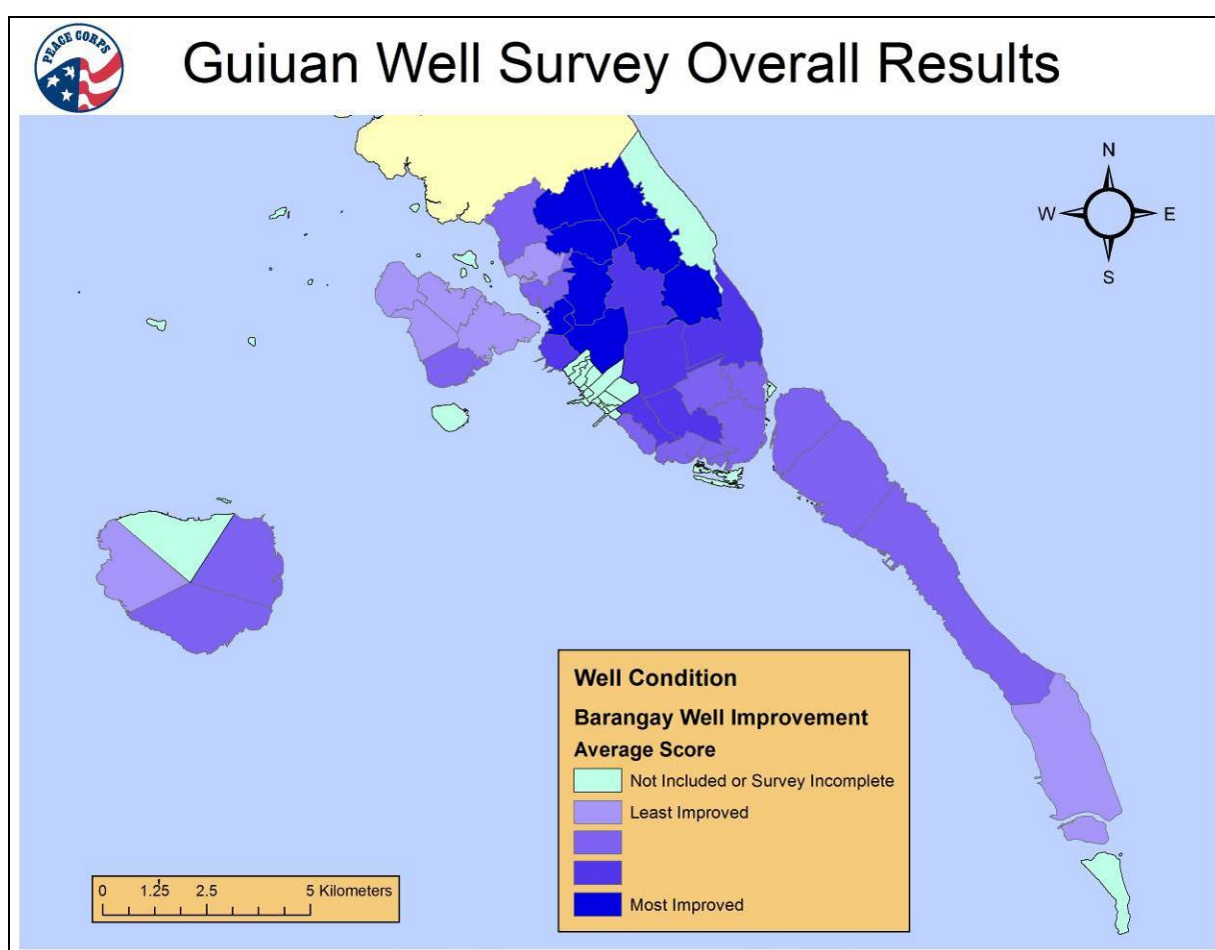
Figure 17: Guiuan Well Survey Overall Results

condition of Victory Island has not been surveyed. The surveyor also omitted the downtown areas. The surveys of barangays of Homorawan and Suluan were incomplete and the qualitative data is not included in the overall results. The table in Figure-23 and map in Figure-17 below presents the overall sampling results. The highest most improved wells on average are found in the higher elevations and in barangays with fewer wells. Fortunately, the more improved wells and the most secured are found in the major recharge areas. The sample size is represented in the second map, Figure-18.
