# New Southern Home Inspection

## Property Inspection Report

Property address: **123 America Blvd.**

Inspection date: **Friday, March 13, 2015**

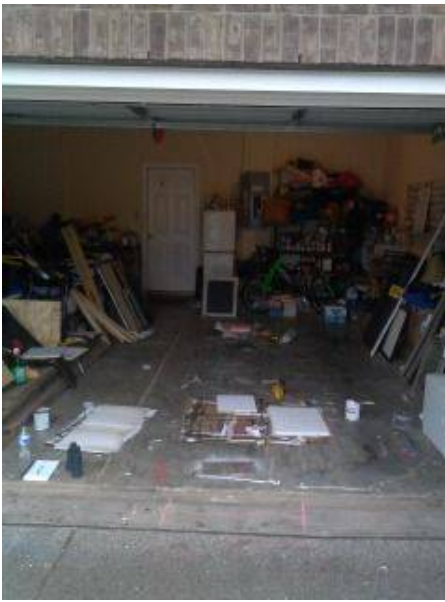
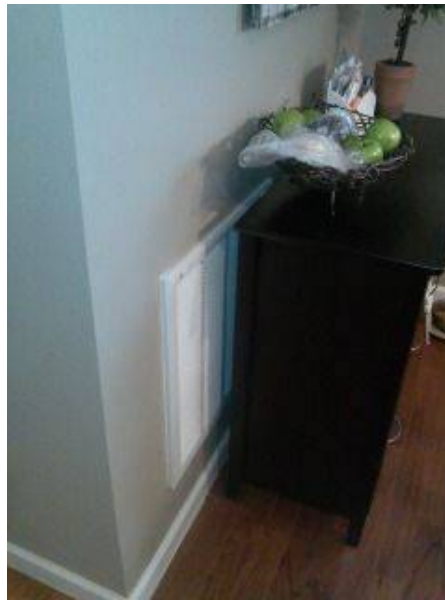
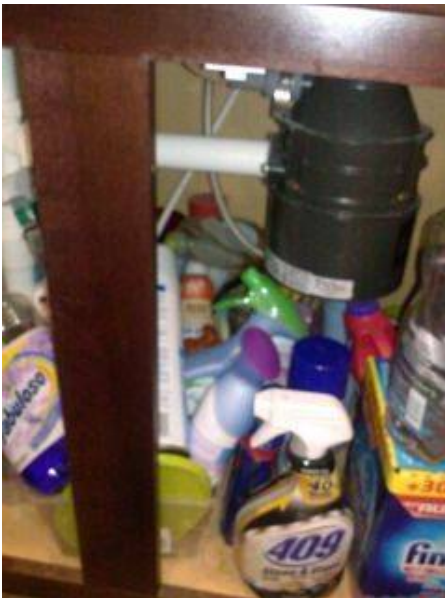
Many areas and items at this property were obscured by furniture and/or stored items. This often includes but is not limited to walls, floors, windows, inside and under cabinets, under sinks, on counter tops, in closets, behind window coverings, under rugs or carpets, and under or behind furniture. Areas around the exterior, under the structure, in the garage and in the attic may also be obscured by stored items. The inspector in general does not move personal belongings, furnishings, carpets or appliances. When furnishings, stored items or debris are present, all areas or items that are obscured, concealed or not readily accessible are excluded from the inspection. The client should be aware that when furnishings, stored items or debris are eventually moved, damage or problems that were not noted during the inspection may be found.

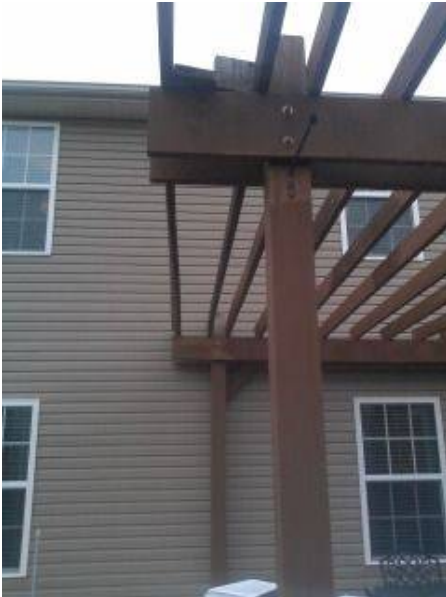
Photo 2-1

One or more deck, patio and/or porch covers were deteriorated, substandard, non-standard and/or over-spanned. Recommend that a qualified person repair or replace as necessary, and per standard building practices.

Inspector noted various rafters at the rear patio pergola may be over spanned, are warped and appear to be pulling loose from the lintel framing. The columns adjacent to the home do not appear to have proper footings installed and appear to be attached to the concrete patio with unapproved metal brackets and fasteners.

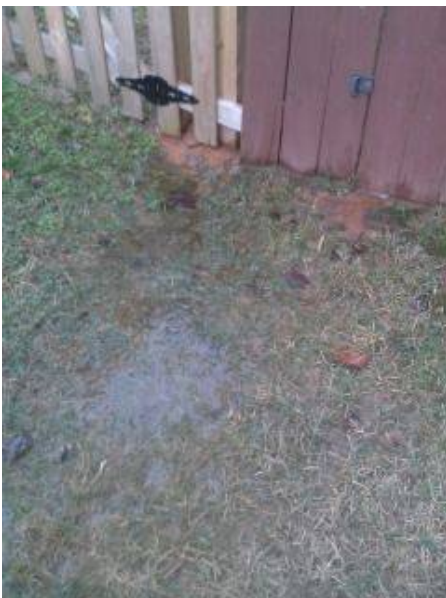
Photo 3-1

Significant amounts of standing water was visible along the left side of the property, and no drain was visible. Recommend that a qualified person repair as necessary. For example, installing one or more drains, or grading soil and or trenching to shed water accumulations away from structure.

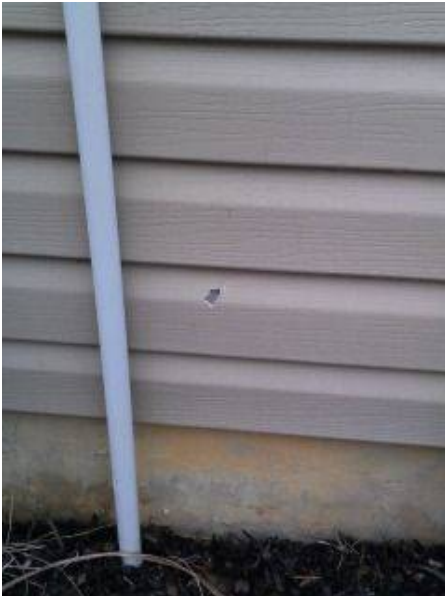
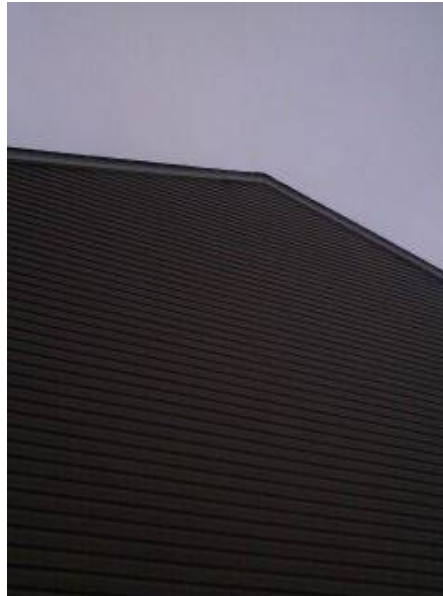
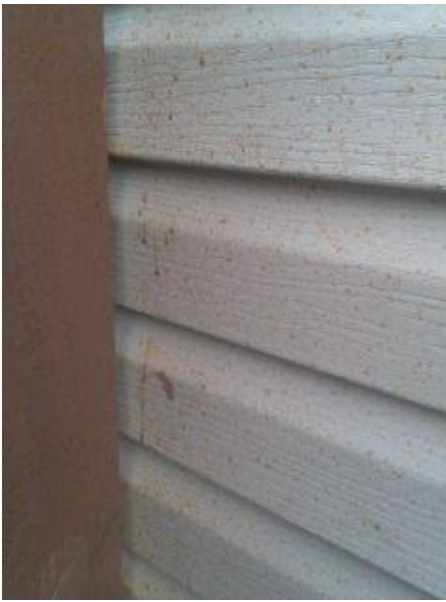
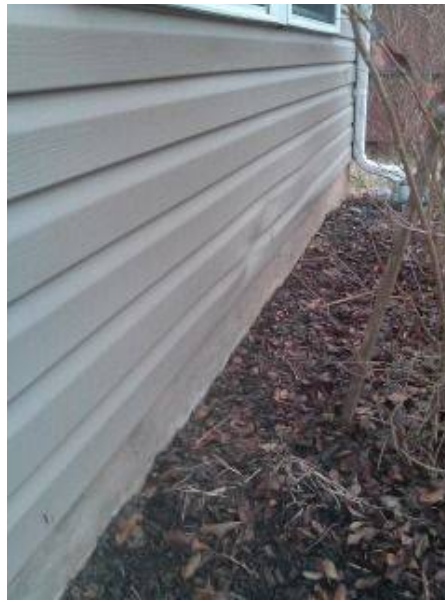
Some sections of siding and/or trim were warped and/or damaged. Recommend that a qualified person repair, replace or install siding or trim as necessary.

There is mechanical damage to the vinyl siding along the right side and left side around the electric meter area, the left rear vinyl siding is warped or loose and the left side metal fascia is loose near the peak area.

The inspector also noted various sections of the vinyl siding has paint/stain over sprayed from the apparent painting/staining of the fencing and rear patio pergola areas.

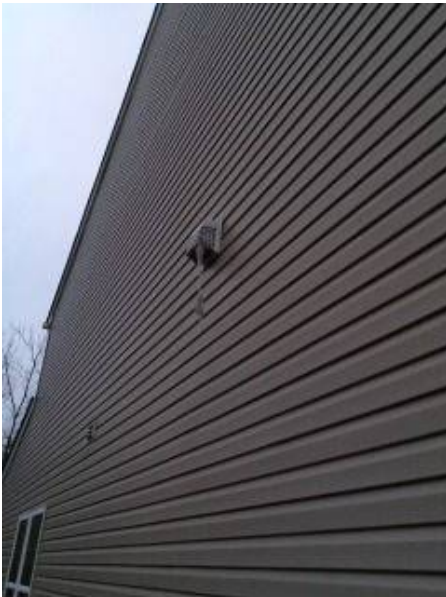
**Photo 5-1**

One or more exhaust duct end caps were clogged with debris. Their purpose is to prevent unconditioned air from entering the building, and keep out birds, rodents and bugs. Blocked ducts can cause fan motors and/or clothes dryers to overheat and can pose a fire hazard. Recommend that a qualified person repair or replace caps as necessary.

Located along the left side exterior.

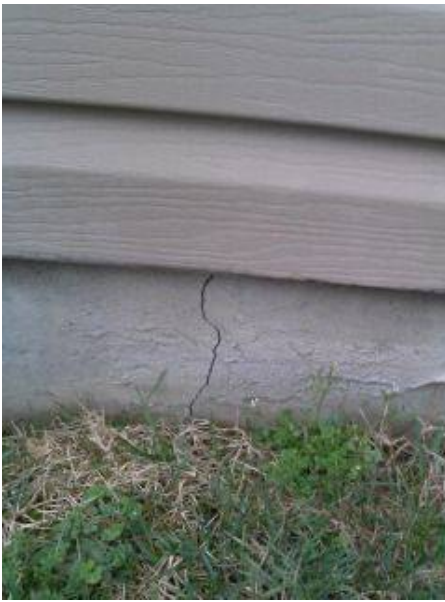
**Photo 6-1**

One or more minor cracks (1/8 inch or less) were found in the foundation along the right and left side. These didn't appear to be a structural concern, but recommend sealing them to prevent water infiltration and monitor them in the future. Numerous products exist to seal such cracks including hydraulic cement, non-shrinking grout, resilient caulks and epoxy sealants.

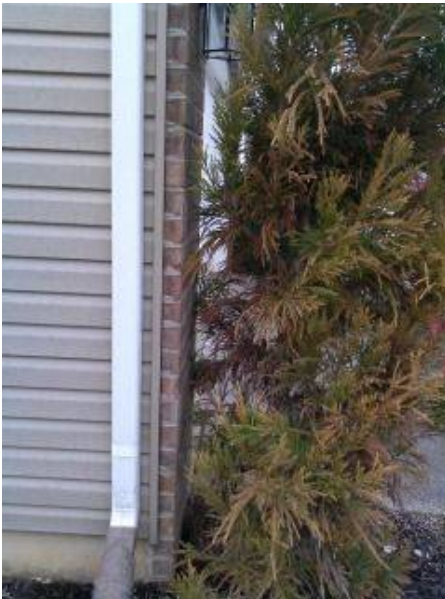
**Photo 7-1**

Vegetation such as trees, shrubs and/or vines was in contact with or close to the building exterior. Vegetation can serve as a pathway for wood-destroying insects and can retain moisture against the exterior after it rains. This is a conducive condition for wood-destroying organisms. Recommend pruning, moving or removing vegetation as necessary to maintain at least 6 inches of space between it and the building exterior. A 1-foot clearance is better.

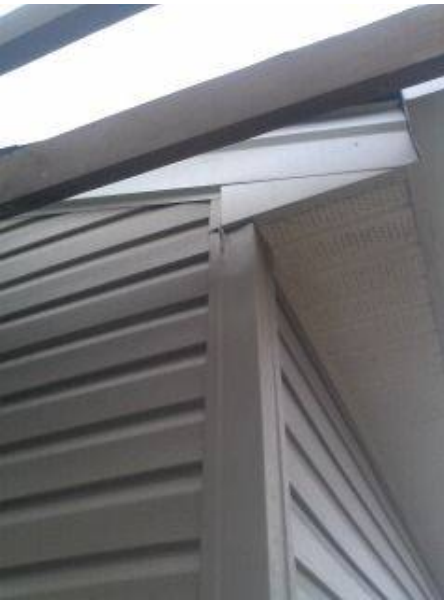
Photo 8-1

Caulk was deteriorated in some areas. For example, around windows, around doors, at siding butt joints, at siding-trim junctions and/or at wall penetrations. Recommend that a qualified person renew or install caulk as necessary. Where gaps are wider than 1/4 inch, an appropriate material other than caulk should be used. For more information, visit: <http://www.reporhost.com/?CAULK>

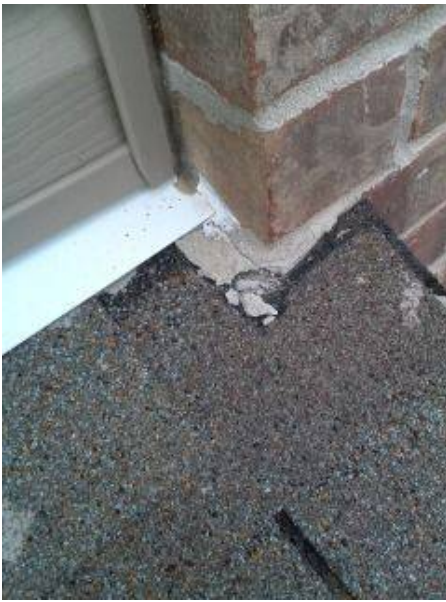
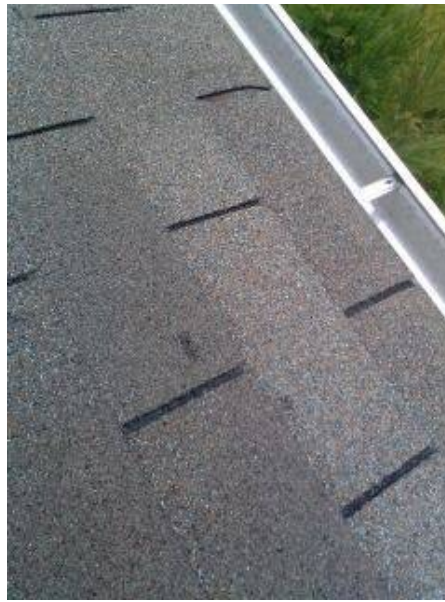
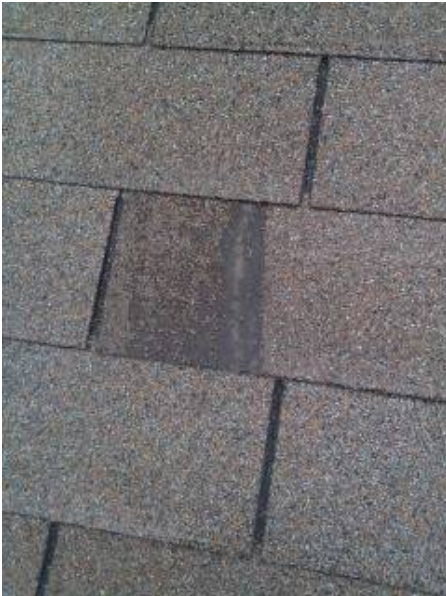
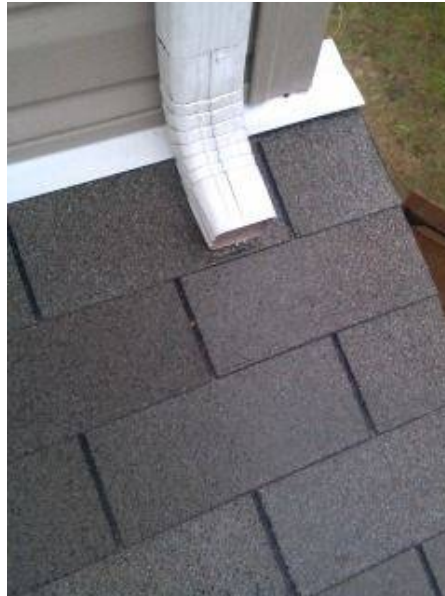
Some composition shingles were damaged. Leaks can occur as a result. This is a conducive condition for wood-destroying organisms. Recommend that a qualified contractor repair as necessary. For example, by replacing shingles.

Inspector noted lifting shingles in various locations, mechanical damage to the shingles along the front and rear lower roof areas, evidence of possible hail and or storm damage in various locations of the shingles, evidence of previous repair to the right front side upper roof area, there is flashing and or caulking needed along the front lower roof/brick veneer/vinyl siding junction areas to prevent water penetration. The inspector also recommends pipe extensions be added to the rear upper downspout to the lower roof gutter area to prevent premature wear and tear to the shingles. Recommend further evaluation for possible repairs by a licensed qualified roofing contractor prior to closing.

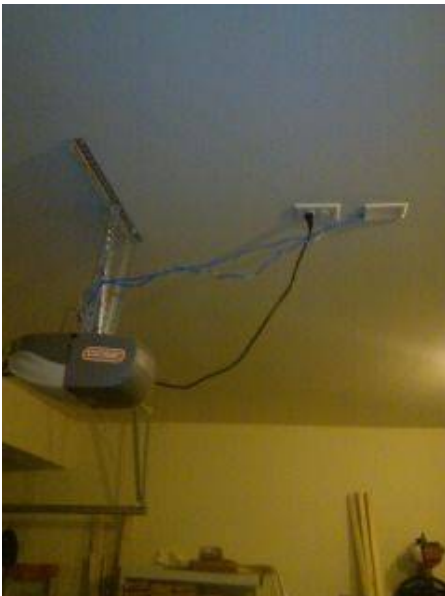
Photo 12-1

The automatic door opener's cover plate and or wiring appeared substandard. Recommend that a qualified contractor evaluate and repair or replace as necessary.

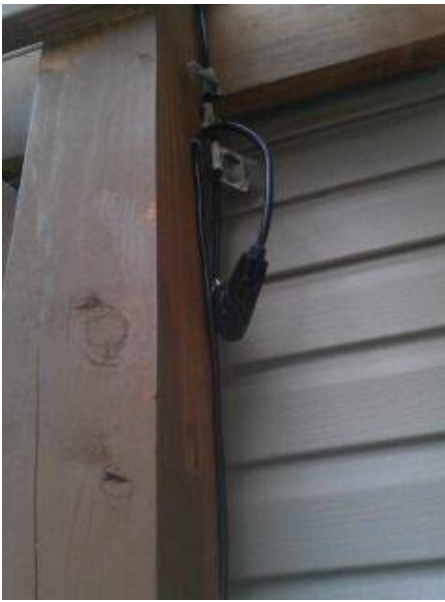
**Photo 13-1**

Extension cords were being used as permanent wiring along the rear patio pergola area. They should only be used for portable equipment on a temporary basis. Using extension cords as permanent wiring is a potential fire and shock hazard, and indicates that wiring is inadequate and needs updating. Extension cords may be undersized. Connections may not be secure or weather resistant resulting in power fluctuations, damage to equipment, overheating and sparks that could start a fire. Recommend that a qualified electrician repair per standard building practices and eliminate extension cords for permanently installed equipment and fixtures.

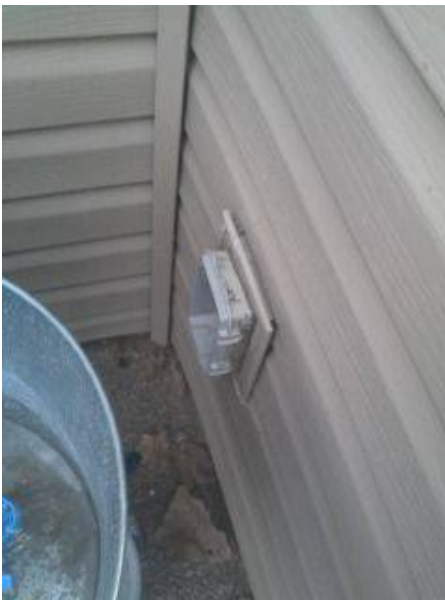
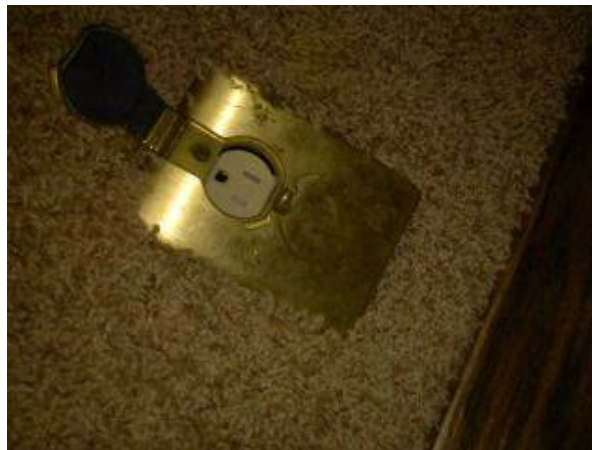
- 
- 14) 🛠️ The weather cover for the rear patio outlet was missing or broken. These weather covers are intended to keep out water, contain fire and prevent electric shock from occurring due to exposed outlet to the elements. The upstairs floor outlet is loose in the outlet box. Recommend that a qualified person repair as necessary.

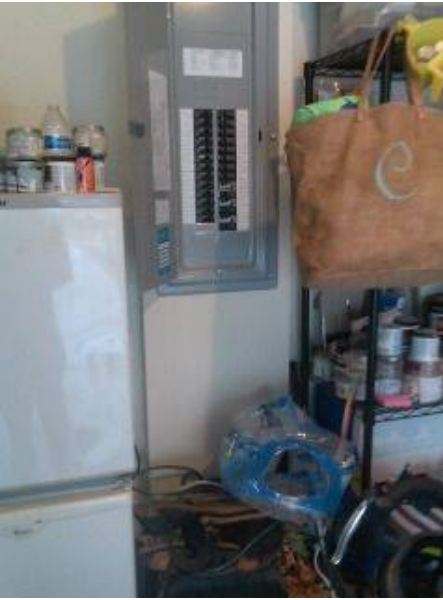
Photo 16-1

- 
- 16) 🛠️ The inspector was unable to open and evaluate panel(s) #B because items were blocking access. These panel(s) are excluded from this inspection. Recommend that repairs, modifications and/or cleanup should be made as necessary so panels can be opened and fully evaluated.

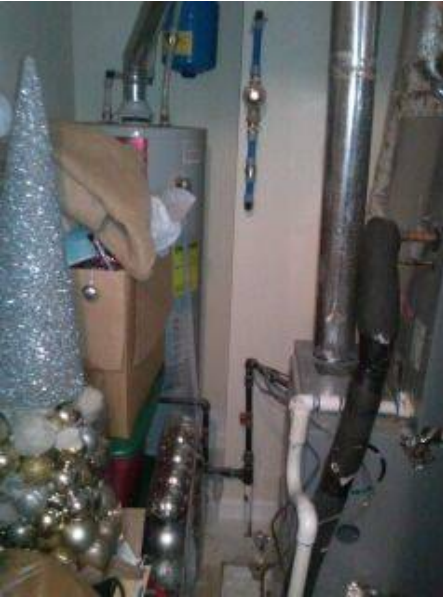
**Photo 18-1**

Combustible materials and owner belongings were found too close to the sides and/or front of the furnace cabinet. General guidelines require the following clearances:

This is a potential fire hazard. Recommend any or all of the following as necessary:

- Research manufacturer's installation instructions to verify minimum allowable clearances
- Move combustible materials or have a qualified person make repairs as necessary

Recommend full evaluation and or service by a licensed HVAC contractor prior to closing.

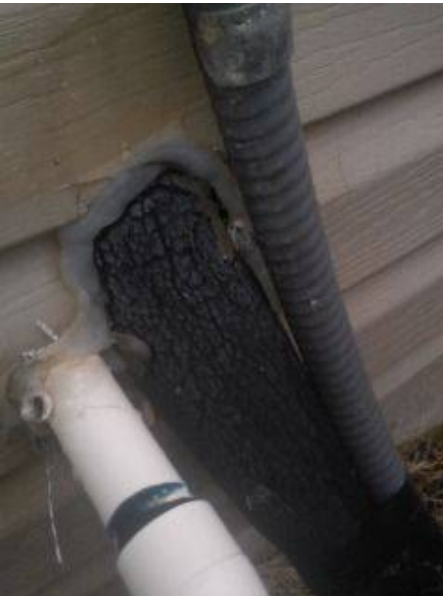
**Photo 19-1**

Insulation on the heat pump or air conditioning condensing unit's refrigerant lines was deteriorated or missing in some areas. This may result in reduced efficiency and increased energy costs. Recommend that a qualified person replace or install insulation as necessary.

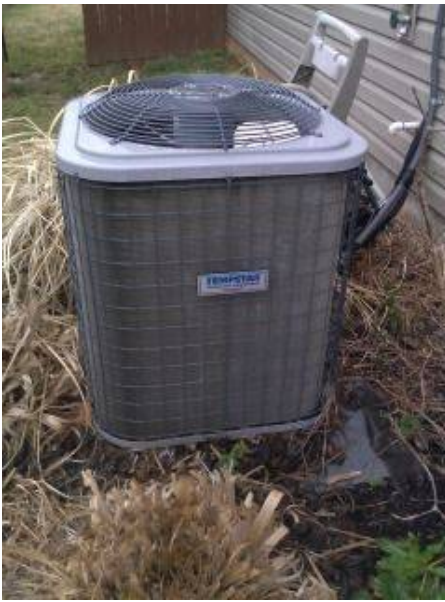
Photo 20-1

Vegetation such as trees, shrubs and/or vines were too close to the heat pump or air conditioning condensing unit. There should be at least 12 inches of clearance on all sides and at least 4-6 feet above. Inadequate clearance around and above can result in reduced efficiency, increased energy costs and/or damage to equipment. Recommend pruning and/or removing vegetation as necessary.

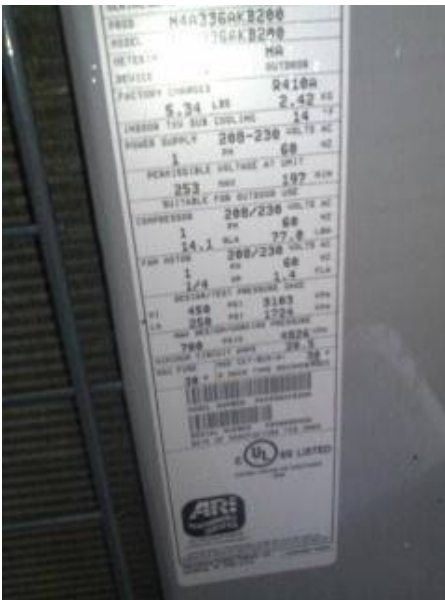
Photo 21-1

21) **i** The outdoor air temperature was below 65 degrees Fahrenheit during the inspection. Air conditioning systems can be damaged if operated during such low temperatures. Because of this, the inspector was unable to operate and fully evaluate the cooling system. Recommend contacting a licensed HVAC contractor for full evaluation prior to closing.

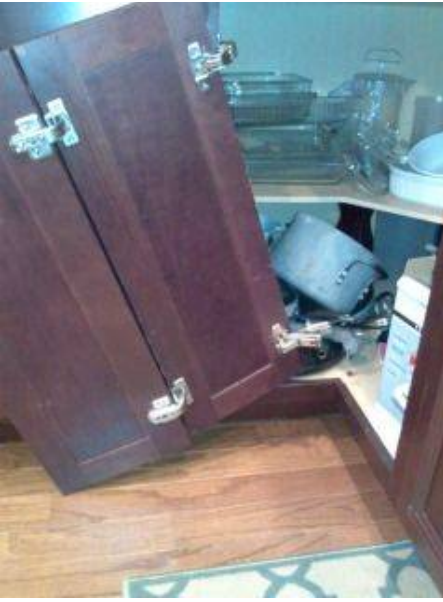
Photo 25-1

The floor cabinet door hinge was damaged or broken. Recommend that a qualified person repair or replace as necessary.

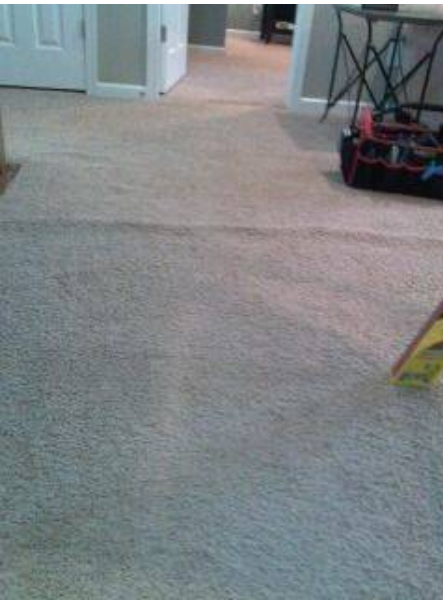
**Photo 30-1**

- 30) 🛠️ 🚧 Carpeting in one or more areas upstairs was loose and posed a trip hazard. Recommend that a qualified contractor repair as necessary. For example, by stretching or replacing carpeting.

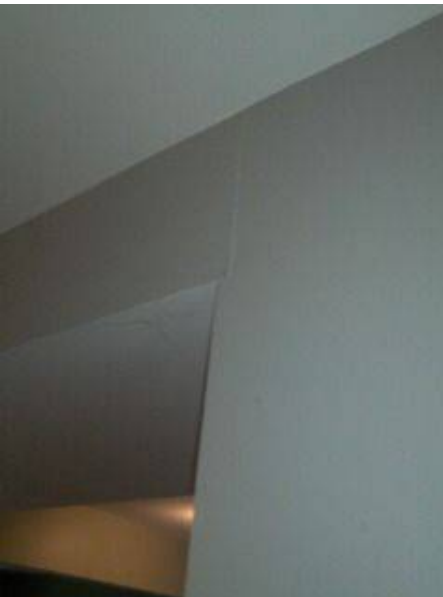
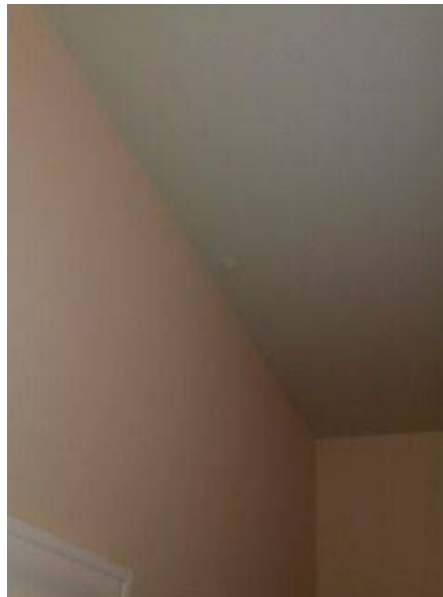
Minor cracks, nail pops and/or blemishes were found in walls and/or ceilings in one or more areas. Cracks and nail pops are common, are often caused by lumber shrinkage or minor settlement, and can be more or less noticeable depending on changes in humidity. They did not appear to be a structural concern, but the client may wish to repair these for aesthetic reasons. For recurring cracks, consider using an elastic crack covering product:

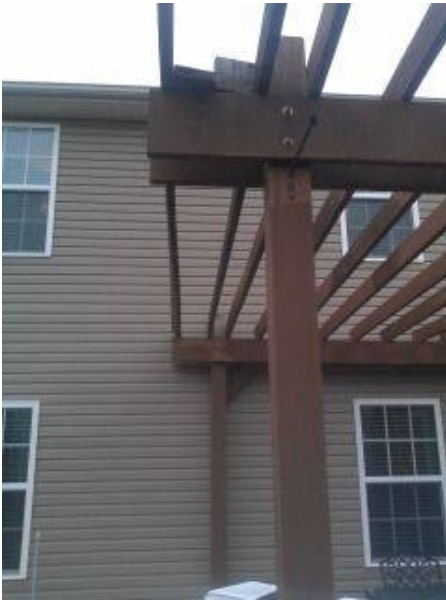
Photo 2-1

- One or more deck, patio and/or porch covers were deteriorated, substandard, non-standard and/or over-spanned. Recommend that a qualified person repair or replace as necessary, and per standard building practices.

Inspector noted various rafters at the rear patio pergola may be over spanned, are warped and appear to be pulling loose from the lintel framing. The columns adjacent to the home do not appear to have proper footings installed and appear to be attached to the concrete patio with unapproved metal brackets and fasteners.

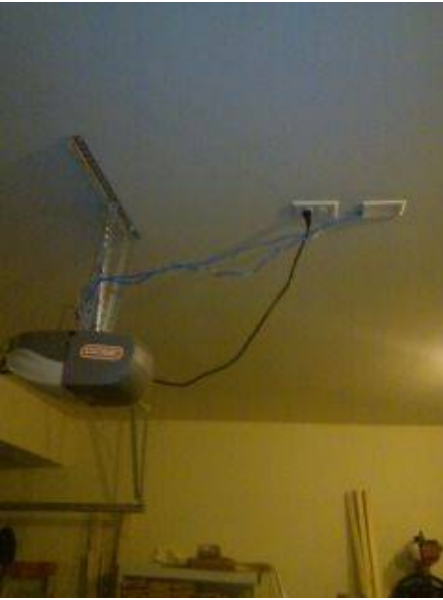
Photo 12-1

- The automatic door opener's cover plate and or wiring appeared substandard. Recommend that a qualified contractor evaluate and repair or replace as necessary.

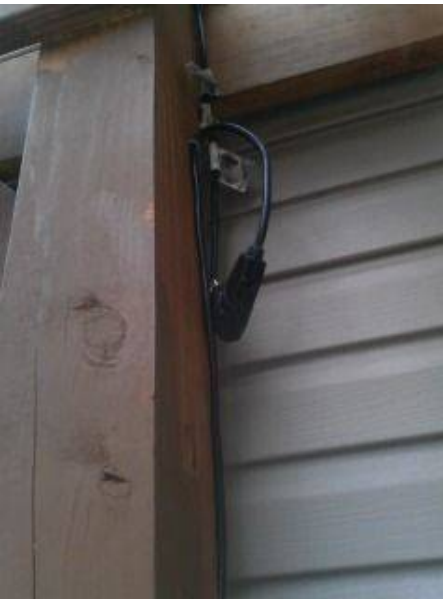
Photo 13-1

- Extension cords were being used as permanent wiring along the rear patio pergola area. They should only be used for portable equipment on a temporary basis. Using extension cords as permanent wiring is a potential fire and shock hazard, and indicates that wiring is inadequate and needs updating. Extension cords may be undersized. Connections may not be secure or weather resistant resulting in power fluctuations, damage to equipment, overheating and sparks that could start a fire. Recommend that a qualified electrician repair per standard building practices and eliminate extension cords for permanently installed equipment and fixtures.

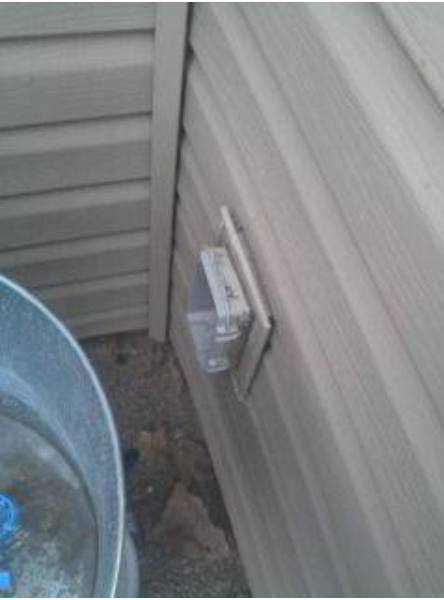
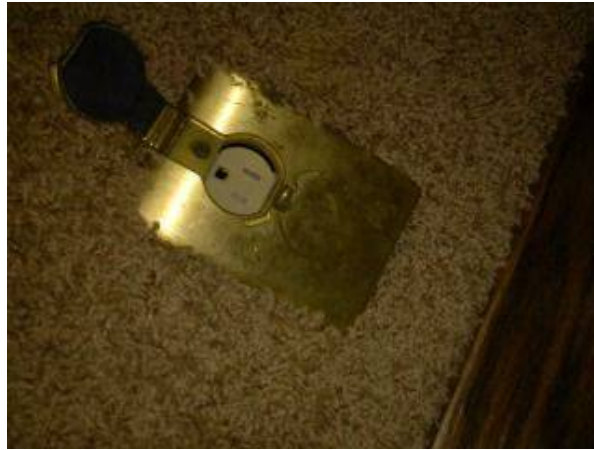
- The weather cover for the rear patio outlet was missing or broken. These weather covers are intended to keep out water, contain fire and prevent electric shock from occurring due to exposed outlet to the elements. The upstairs floor outlet is loose in the outlet box. Recommend that a qualified person repair as necessary.

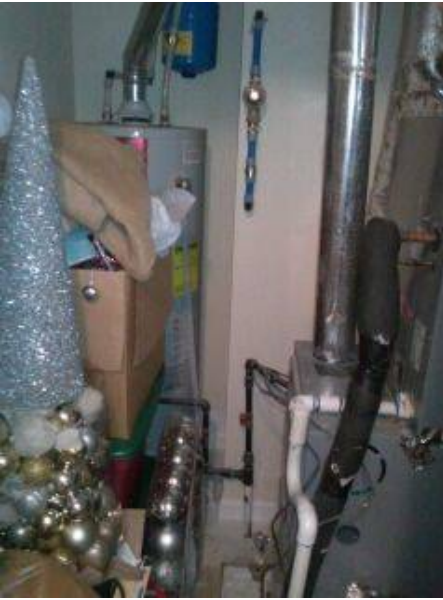
Photo 18-1

- Combustible materials and owner belongings were found too close to the sides and/or front of the furnace cabinet. General guidelines require the following clearances:

This is a potential fire hazard. Recommend any or all of the following as necessary:

- Research manufacturer's installation instructions to verify minimum allowable clearances
- Move combustible materials or have a qualified person make repairs as necessary

Recommend full evaluation and or service by a licensed HVAC contractor prior to closing.

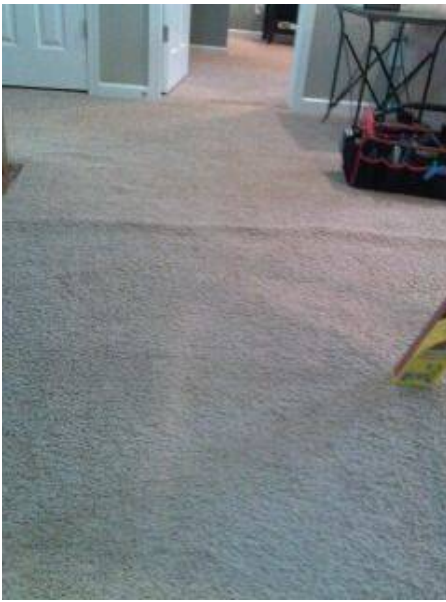
Photo 30-1

30 🛠️ - Carpeting in one or more areas upstairs was loose and posed a trip hazard. Recommend that a qualified contractor repair as necessary. For example, by stretching or replacing carpeting.
