# **Inspection Report**

Property Address: 10 Test Report Ln. San Antonio TX 78257

# **PROPERTY INSPECTION REPORT**

Prepared For:	Sample Report			
	(Name of Client)			
Concerning:	10 Test Report Ln., San Antonio	o, TX 782	257	
	(Address or Other Identification of Insp	pected Pro	operty)	
By:	David M. Stanteen TREC Lic. # 10158	/	12/6/2014	
	(Name and License Number of Inspector)		(Date)	
	(Name, License Number of Sponsoring Inspector)

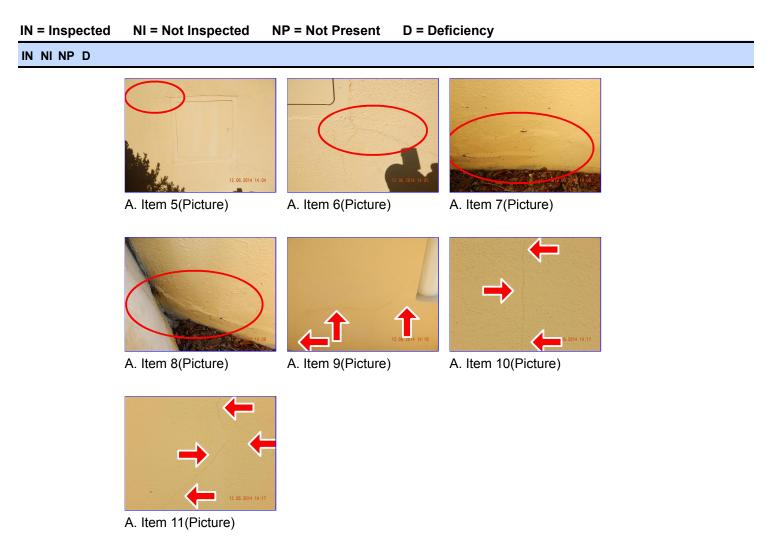
A. Item 4(Picture)

(3) Cracks noted in the parging layer on the front, rear and sides of home side(s) of the home. These cracks appear to be typical cracks with no visible displacement. Seal and repair to prevent further flaking and deterioration. (Parging is a surface coat of cement, which will not only make the foundation look better, but it will also help keep out moisture; preventing further cracking, chipping and flaking)
