Preliminary Engineering Report Water System Improvements for the Florida River Estates Homeowner's Association, Durango, Colorado PWSID No. CO0134300

APRIL 2, 2018

Senior Engineer: Bruce Honisch, P.E.
Project Engineer: Robert Harries, P.E.
Project Number: 17-195

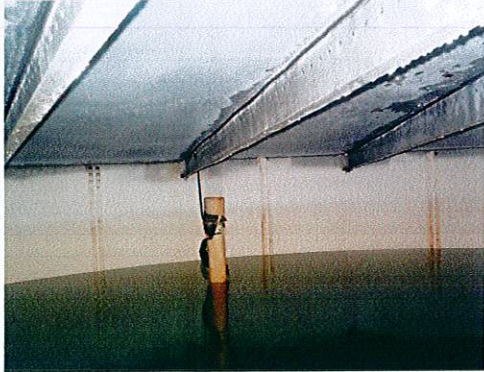
8. Roof interior: Structural deficiencies, any irregularities or other failure?	<input type="checkbox"/> Y <input checked="" type="checkbox"/> N		Roof interior in good condition.

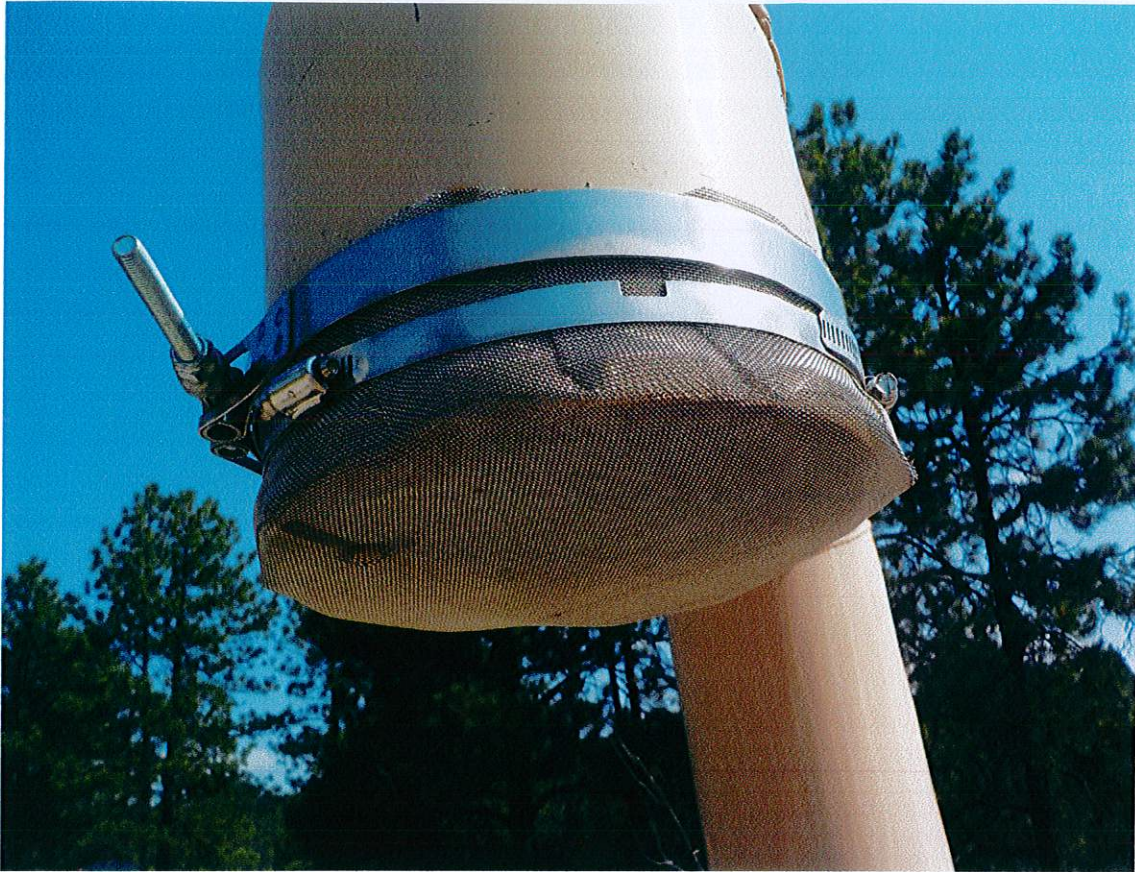
Vent screen is in place, securely fastened.

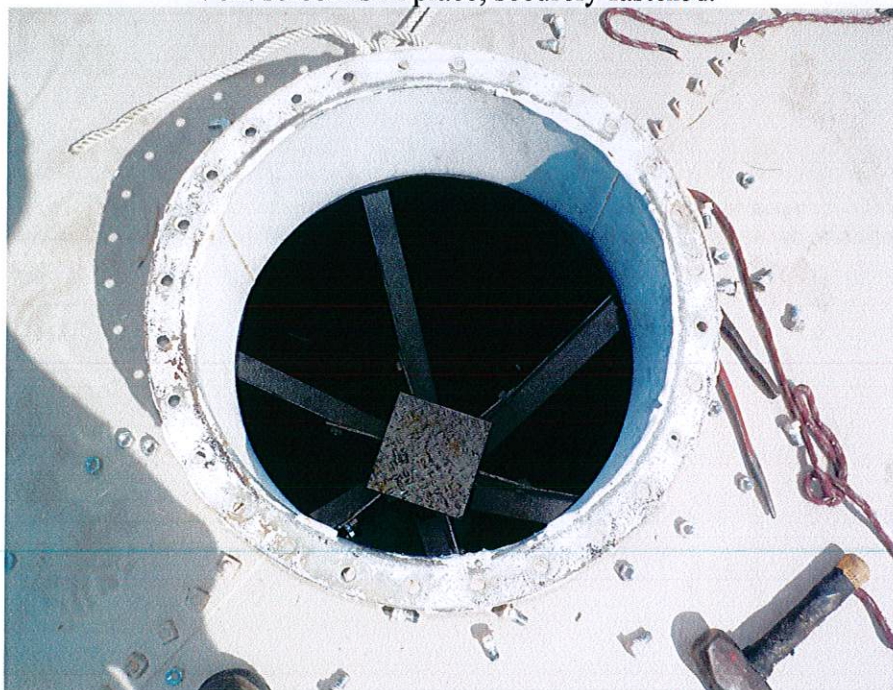
Removal of the vent is required to allow interior access

Recommendations: We recommend cathodic protection be installed to control corrosion at the shell bolted seams. We recommend the installation of a roof hatch. The roof vent removal for entry is an unsafe entry method. The external ladder handrails need to be extended 3' above the landing surface. CW Divers can provide these recommended improvements. Inspect the reservoir in 4 years. For any questions regarding this inspection, contact Bill Donohue at 505-330-2531.

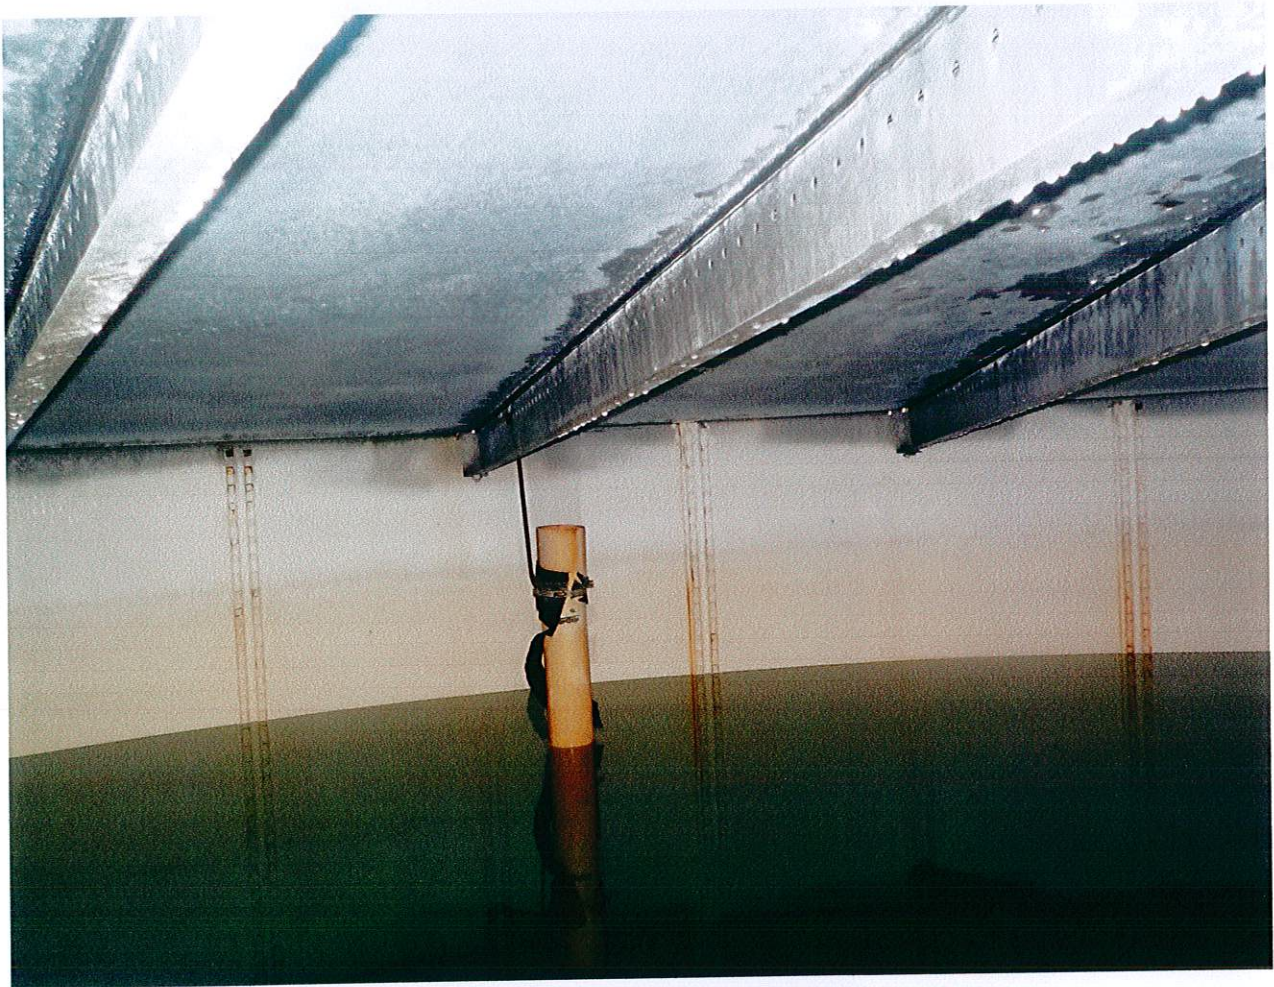
Rafters and ceiling plates are galvanized in good condition
