SERVICE INSTRUCTION

Service Instruction No. 1290F
(Supersedes Service Instruction No. 1290E)
Engineering Aspects are
FAA DER Approved

SUBJECT: Repair of Oil Leakage at Crankcase Thru-Stud Locations; Assembled and Unassembled Engines.

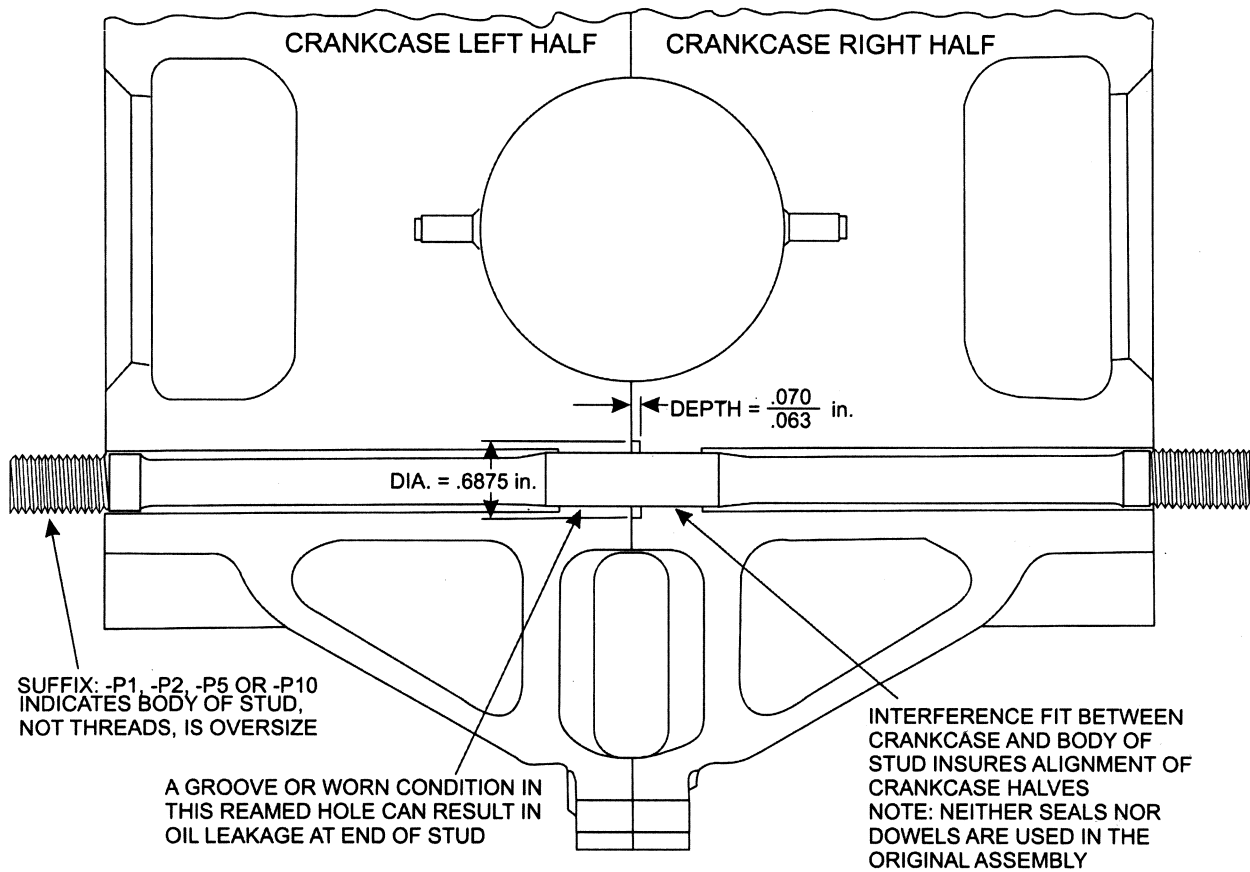
Figure 1. Section Through Crankcase at Thru-Stud Location Showing Dimensions of Recess for the P/N 72075 Oil Seal

Engines listed in the MODELS AFFECTED section of this publication achieve crankcase alignment thru the interference fit of the body-fit-thru-studs and the crankcase thru-stud bores located in the main bearing webs. This interference fit is illustrated in Figure 1 which shows a section through the crankcase at a thru-stud location; note the two halves of the crankcase are supported at the parting surface by the body of the stud. Evidence of oil on the crankcase or cylinder mounting flange which can be traced to a thru-stud location indicates that the seal formed by the interference fit between the stud and the crankcase is incomplete. This can be the result of an oversized bore or a groove traced in the bore during installation of the thru-stud.

3. Assemble the P/N ST-463-5 stop collar on the ST-463-1 counterbore. Set the stop collar to allow the counterbore to cut to a depth of .063/.070 inch. Refer to Figure 1.

5. Clean the seal recess and thru-stud bore of all chips and shavings. Use a small abrasive stone to smooth the edge of the recess.
6. Measure the depth of the recess with a depth micrometer. Insure the depth is within the dimensions specified in step 3 and illustrated in Figure 1.
