Barangay Summaries

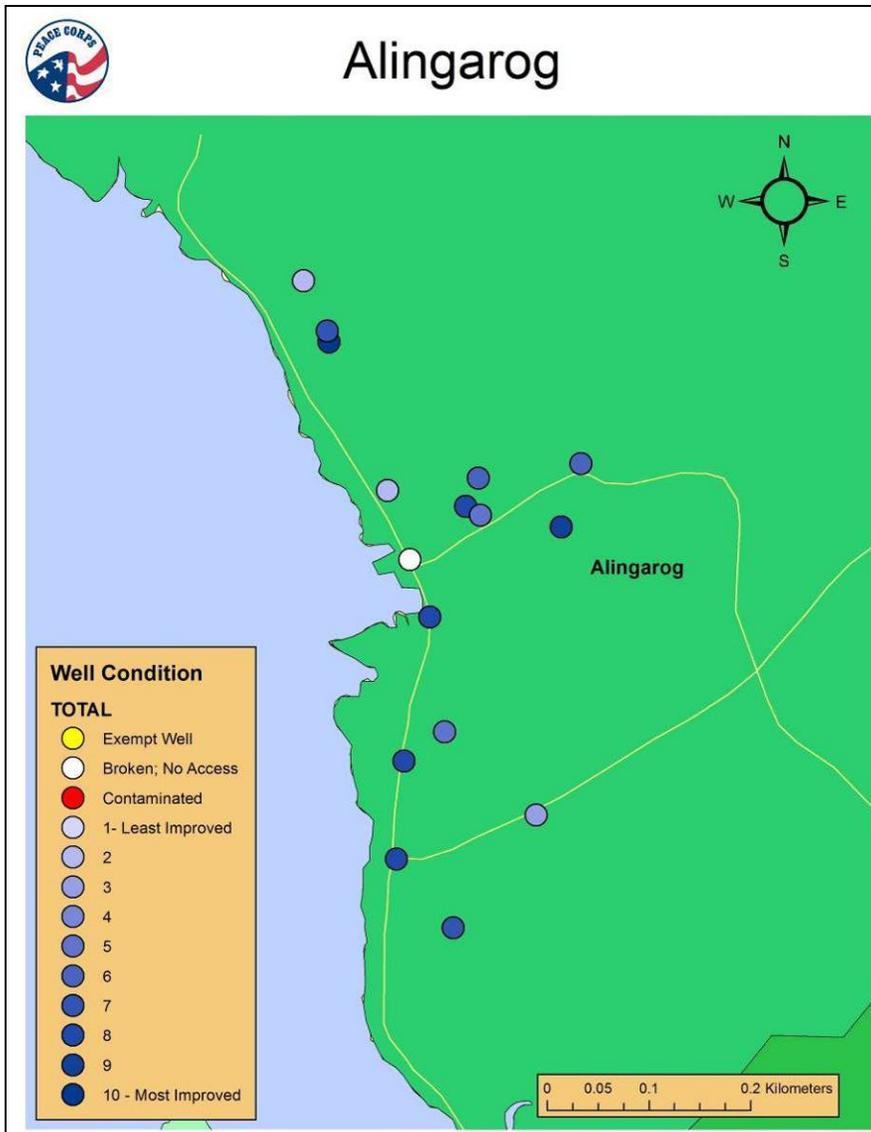
Issues: Iron in water

Alingarog is in the Northwest corner of the Peninsula along the Leyte Gulf coast. The water table is less than a meter from the surface. The inaccessible well at the plaza is the BWS. Even though the solar pump and tank are destroyed, the residents should still be able to access water at the manual pump

Priorities: Replacement of Barangay Water System; Repair Well-07 at Plaza.

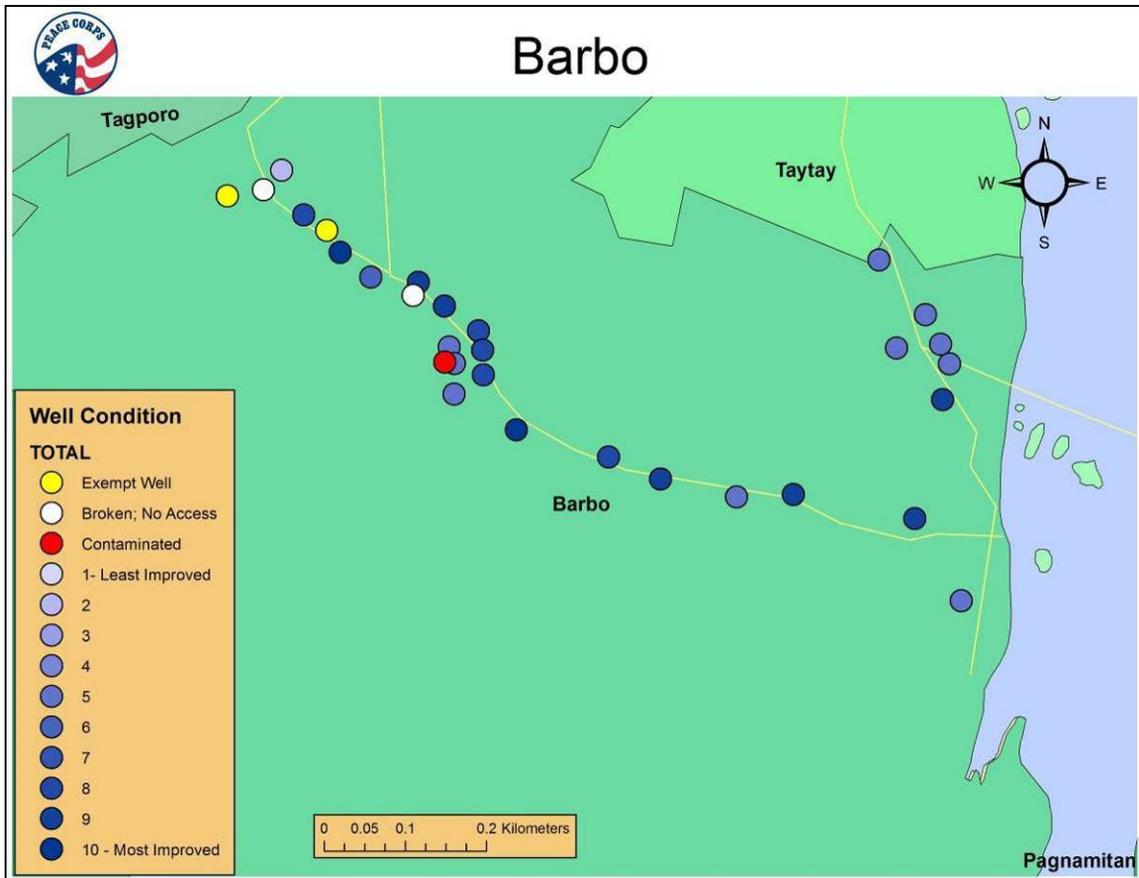
Issues: Broken pumps in common areas, No BWS, Contaminated Well.

Barbo is at the southern tip of the Peninsula and contains the connecting bridge to Calicoan Island. Wells are mainly of open with "Jetmatic" pumps. There are MWS connections along the national road as well as the coastal road to the south. Well-03 (natural setting) and Well-05 (superior construction) are possible candidates for preservation in their current state. Well-18 is remarkable due to its superior designed cover. The barangay captain was instrumental in its improvement.

Priorities: Clean Contaminated Well-13; Restore Well-01.

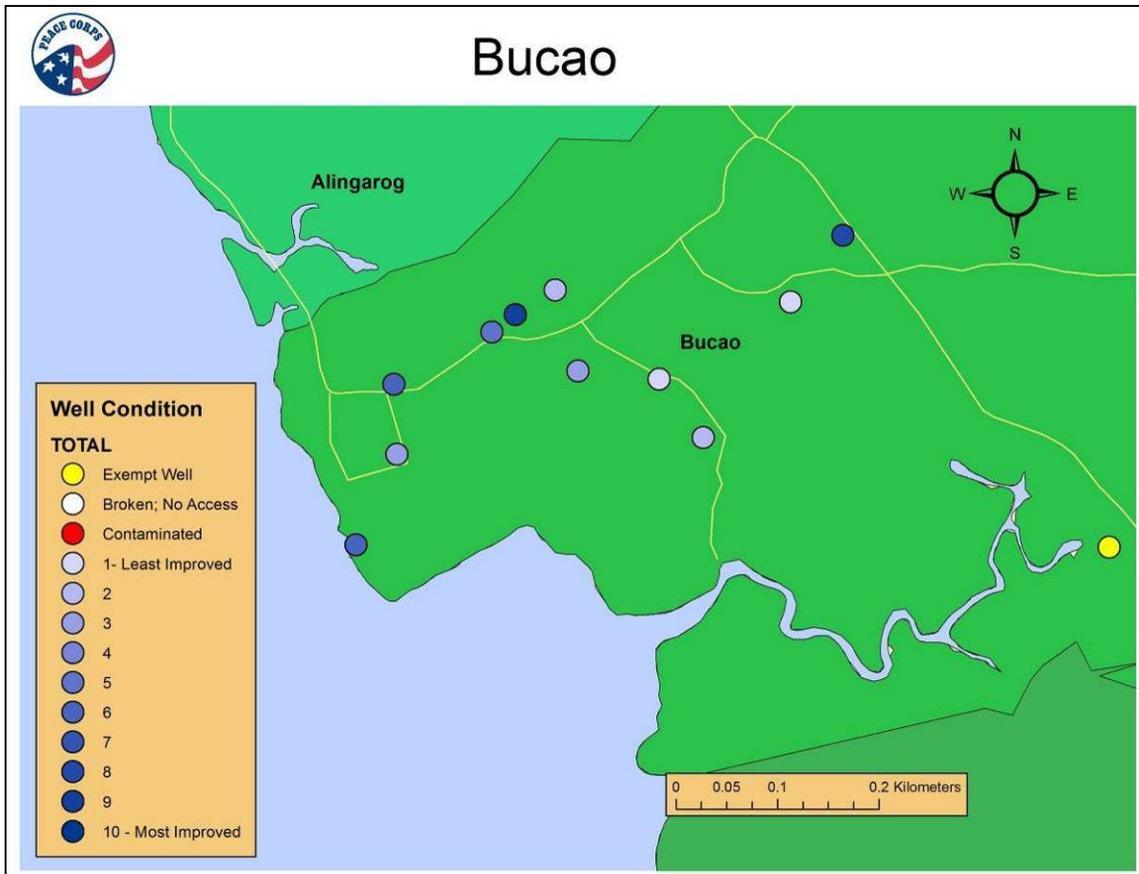
Issues: Few improved wells. No BWS.

Bucao is located on the Leyte Gulf side, northwest on the Peninsula. The BWS was destroyed by the Typhoon and has not been replaced. There is one well with a pump that is centrally located that residents rely upon for water for utility purposes. There is a spring on the way to Cagdara-o with some improvements; however it is only useable at low tide. It is generally trashed.

Priorities: Restore BWS. Improve Wells, Clean Litter from spring area.

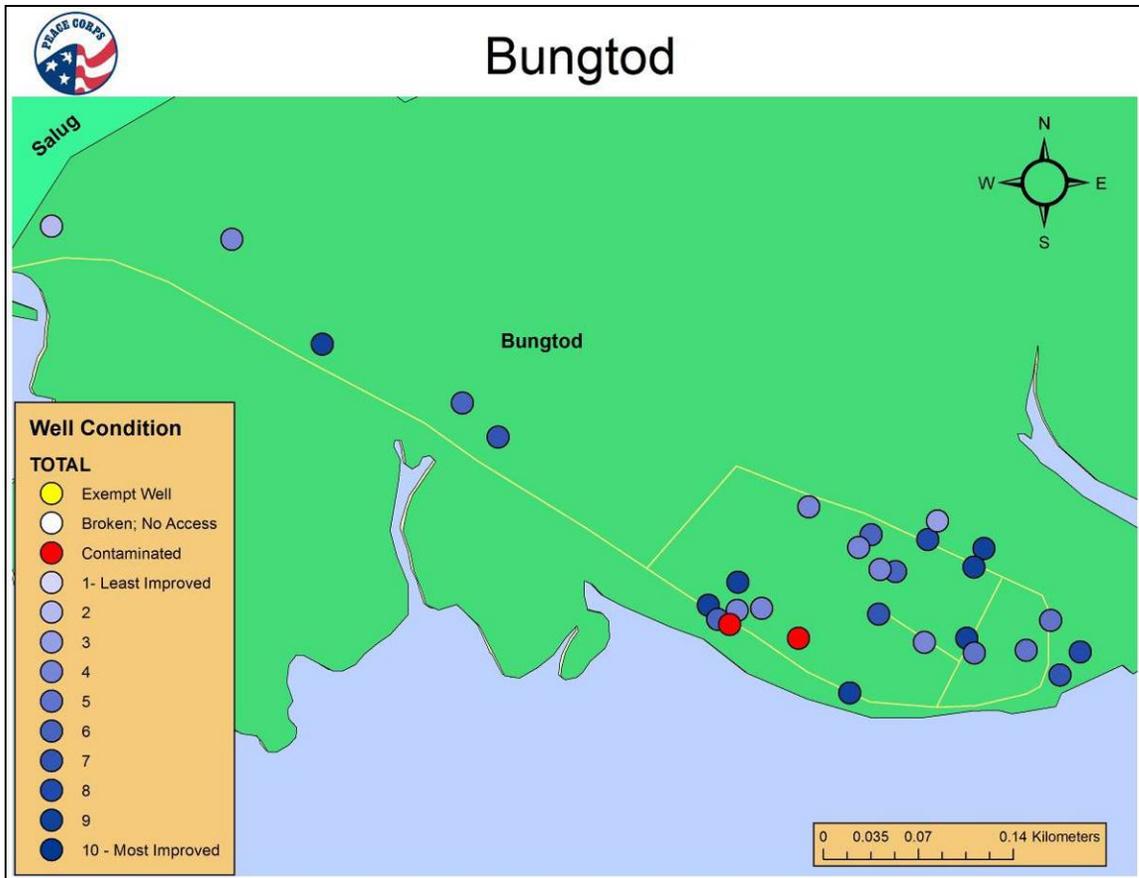
Issues: Contaminated, Well-17 & Well-19. Extensive erosion at base of wells from Typhoon evident.

The two contaminated wells are on Yolanda affected properties.

Priorities: Clean and restore contaminated wells, well covers and aprons

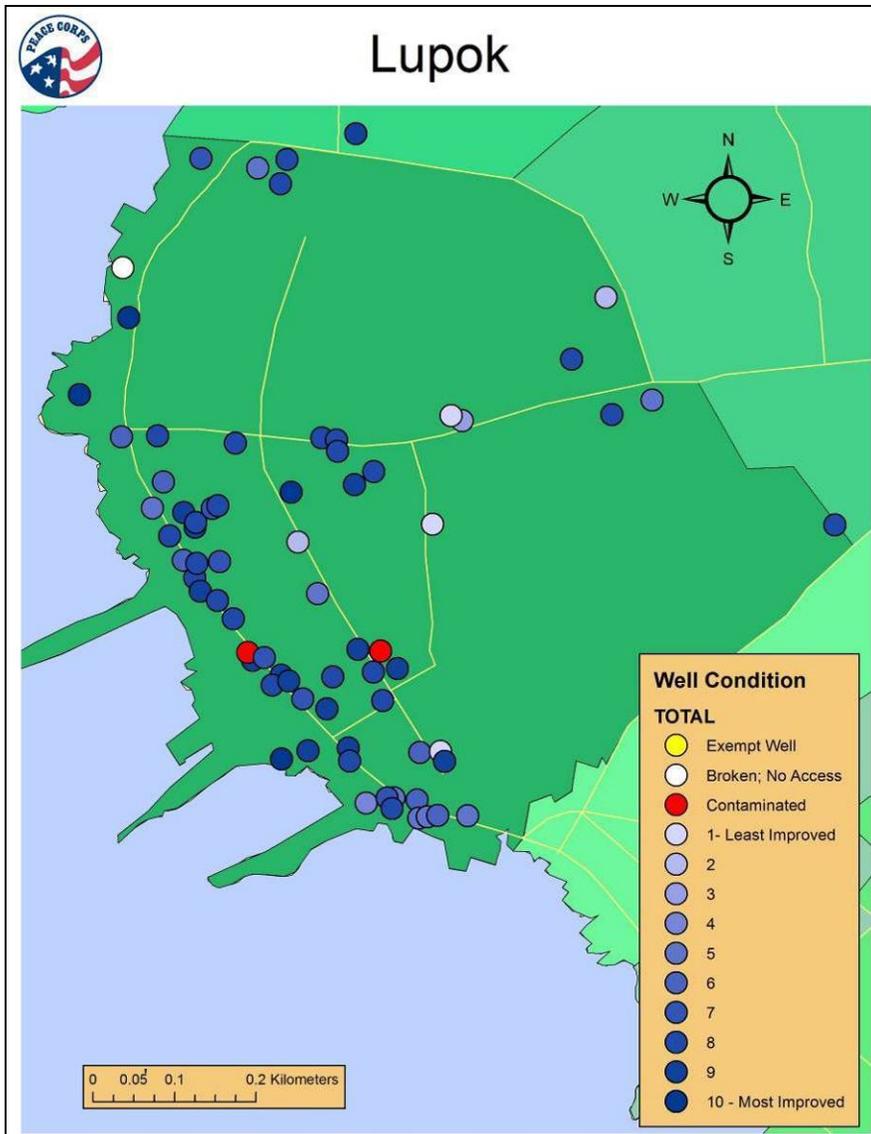
Number of Wells Sampled: 70
 Average Improvement Score: 6.8
 Issues: Contaminated and Uncovered wells.
 Priorities:

There is a contaminated well along the main road that is evidently a remaining cleanup task from the Typhoon (Well-34). What appears to be a contaminated well (Well-15) near the elementary school may be a overgrown planter box. The surveyor may be erroneous in counting this as a well. Lupok has one of the best designed wells (Well-20) the surveyor has found on the survey trail.

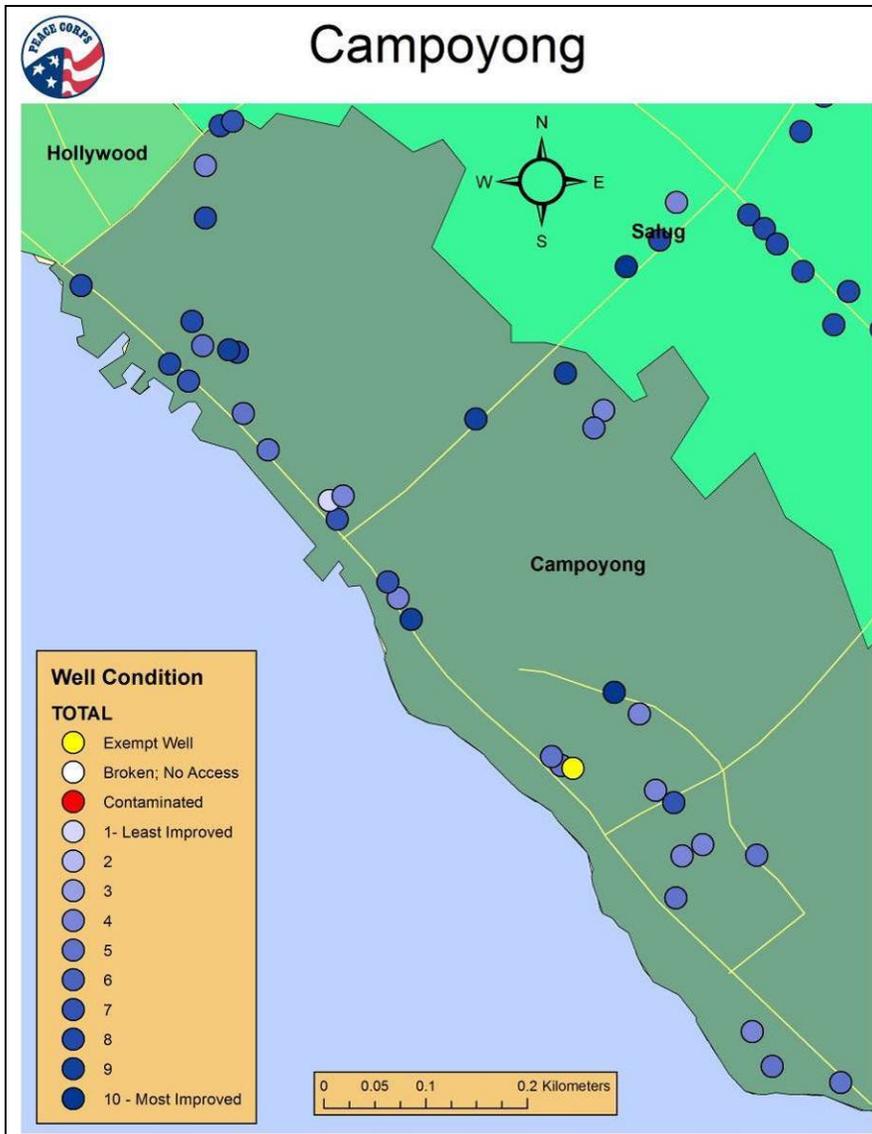
Issues: Large number of damaged, or deteriorating wells.

Campoyong is located adjacent to the downtown area and transitions from a rural fishing village to dense populated affluent residential streets along the southwest coast of the Peninsula. Consequently the wells are better taken care of as the surveyor goes from south to north. Well-11 is a possible candidate for preservation as is.

Priorities: Implement Continuous Improvement.

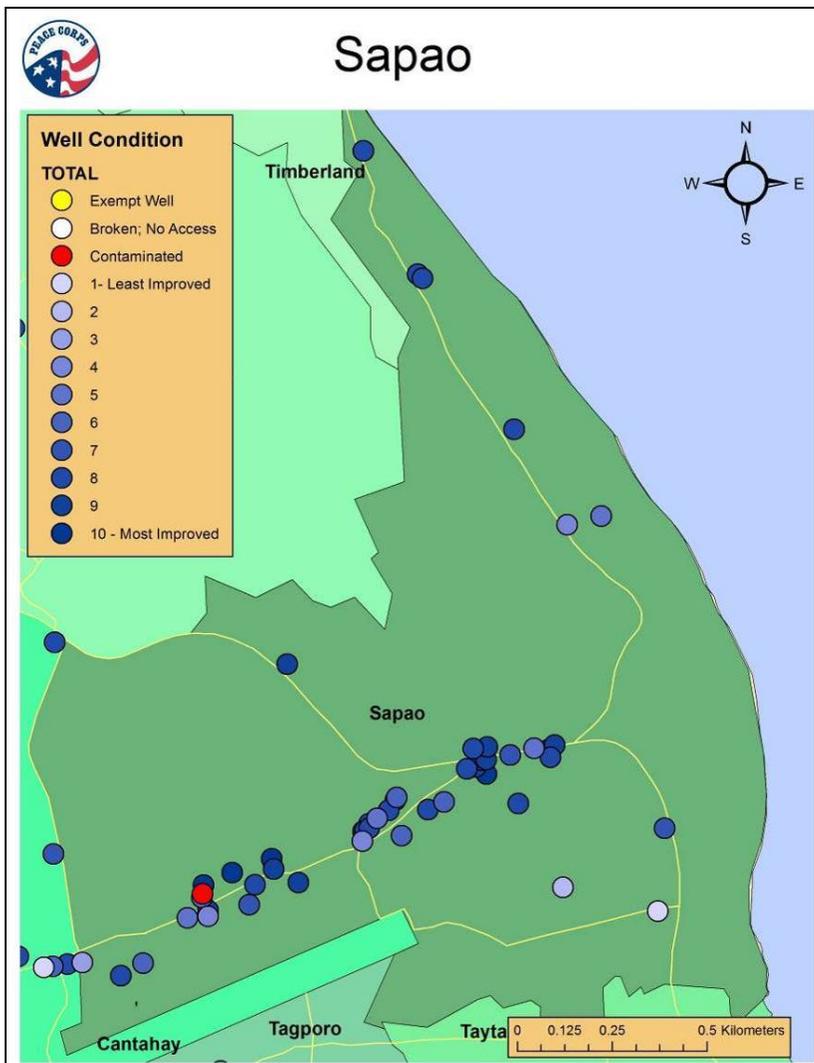
Issues: Dirty and Uncovered Wells, mis-placed graveyard

Sapao also has a narrow strip of land that borders the Pacific and is a showcase for the spectacular cliffs of the Pacific Ridge and Timberland. Waterflow and wells are scarce there as is the population. Denser populated areas of Sapao, like Cantahay, also occupy the impervious surfaces associated with the old airfield. Sapao also has extensive sand mining activities near the end of the runway. The large amount of sand may have been imported by the US Navy as an "arrestor" material in the case airplanes overshoot the runway. This convergence of resources supports numerous concrete block operations. The surveyor found Blacksmithing in Sapao. There is an "un-sanctioned" and poorly maintained graveyard at the eastern tip of the runway. Well-12 has been converted to a garbage receptacle. Well-20 has been designated as a drinking water well. A healthy but localized patch of heavily forested highland protects it. Many wells in Sapao are of exemplary design. Some are undeveloped, un-maintained. The MWS serves many residents in Sapao.

Priorities: Clean and secure wells community water sources. Well-50 on the road to Taytay serves 7 families and is in disrepair.

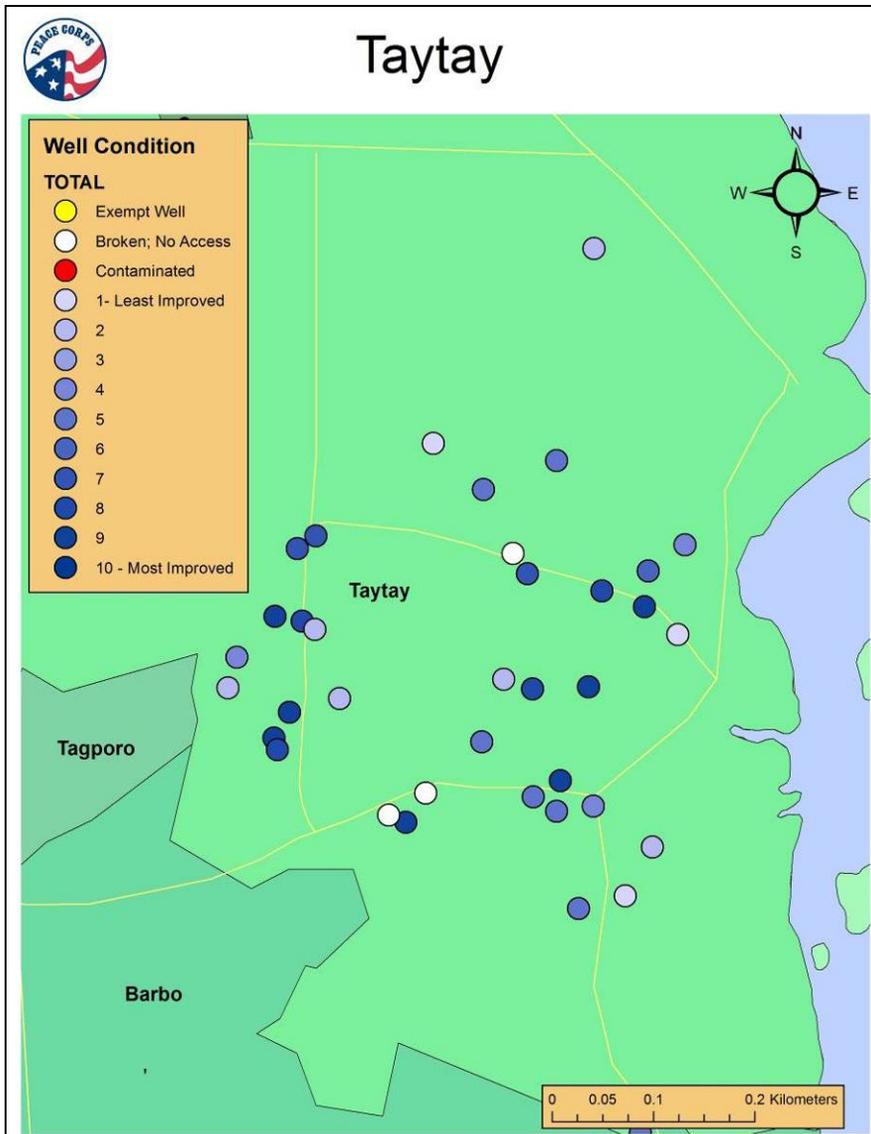
Taytay is a peninsular barangay on the southeast coast. Its wells tend to be unimproved with two wells that are at risk becoming contaminated. Well-2 and Well-35 should be secured as a priority.

Priorities: Continuous Improvement; Well-35 appears neglected and without a steward.

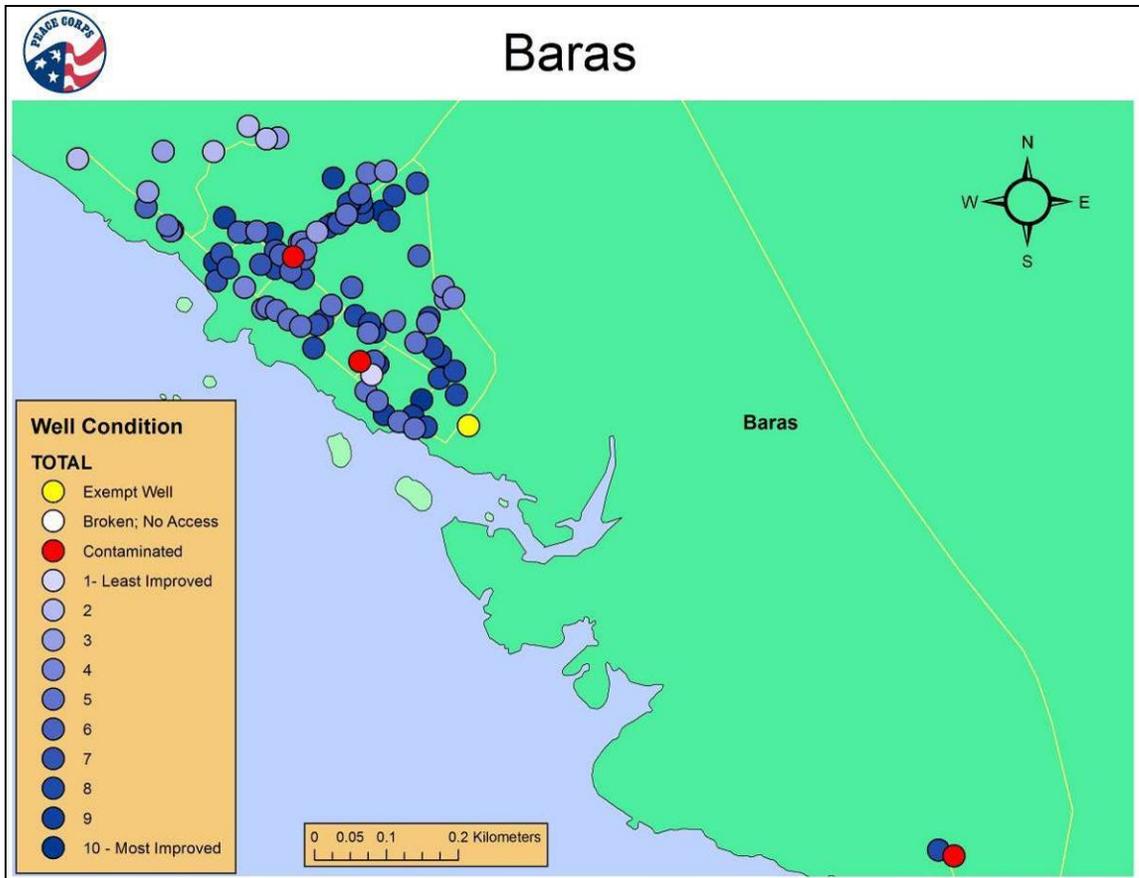
Issues: none specific; contaminated unsecured wells

Overall the well score is low. Covers were not common. With so many wells, this simple improvement will go for to secure the aquifer for. There are three wells that are abandoned and contaminated: Well-24, home left abandoned after Yolanda; Well-78, well at plaza converted to debris container; Well-91, see description in body of report above.

Well-42 and Well-43 have been "improved" with old motorcycle tires. This practice was observed in a couple of other barangays. The problem with old tires stacked one upon another to form a well shaft is that it forms a breeding habitat for mosquitoes. As water is drawn up with a bucket, water will slosh to the side filling the tire with stagnant water that will attract insects and other animals looking for a nook or cranny to occupy. It is better to leave a dug well with its natural matrix walls than to apply old tires.

Priorities: General Improvement Plan.

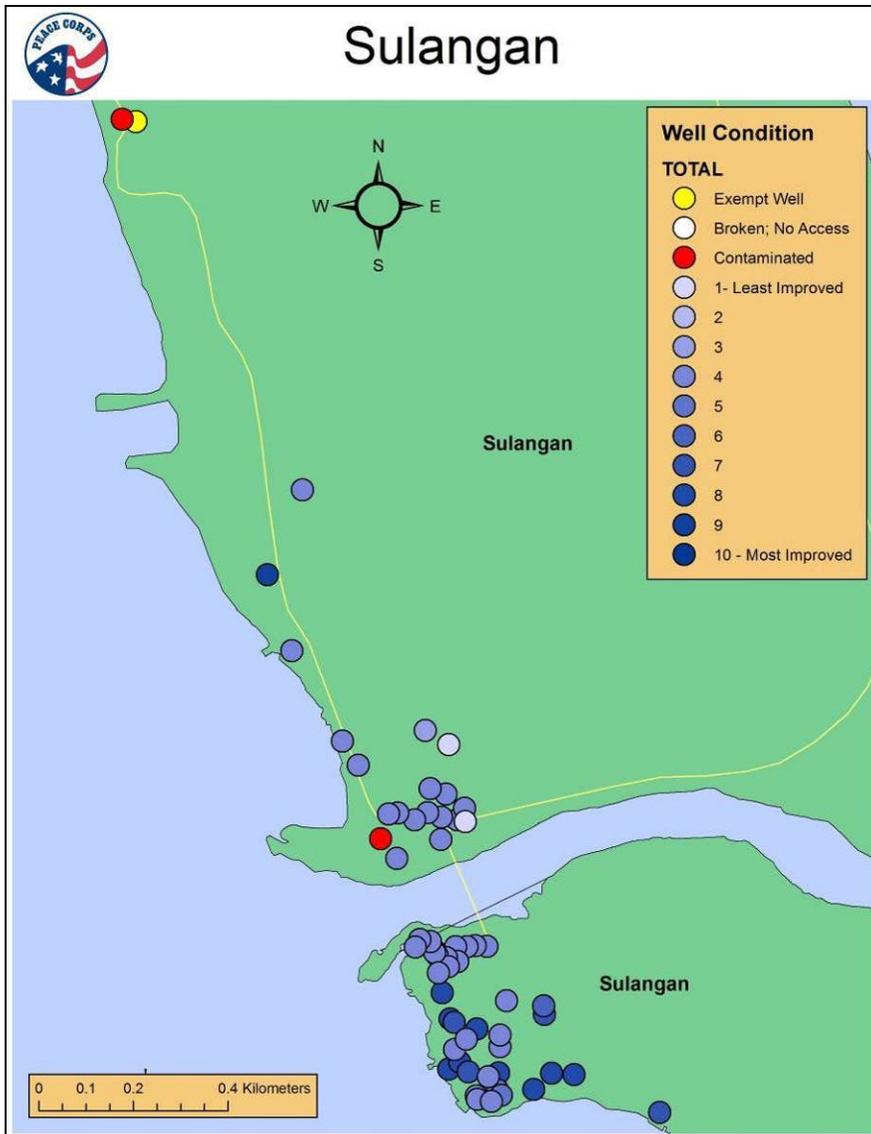
Issues: Salt water intrusion

Sulangan is at the southern tip of Calicoan Island and has a large number of improved wells without pumps nor covers. There are two parts to Sulangan, north and south of the bridge. To help decrease the possibility of further salt intrusion the MWS is piped 10 or so kilometers south from the pumping stations in the highlands of the peninsula. The remote supply coupled with a widely dispersed and bucket draw from shallow wells is a best case scenario for minimizing salt intrusion. As noted earlier, the wells north of the bridge, are supplied with fresh water on the high tides. This phenomena may occur south of the bridge, but was not noted by the residents or observed by the surveyor.

The surveyor found two contaminated wells, both north of the bridge: Well-52 and Well-59. Well-59 is adjacent to the well nominated for preservation.

Priorities: General Improvement, Cover the wells, etc.

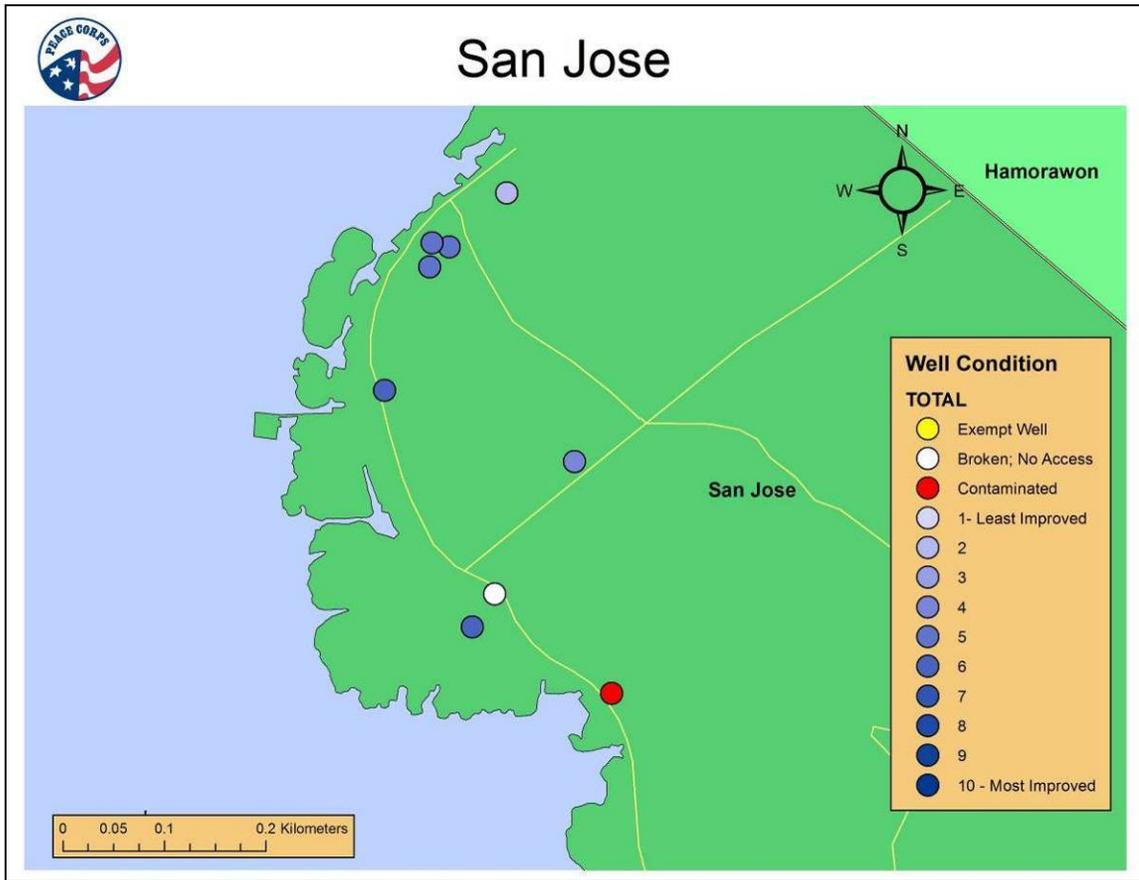
Issues: Deterioration in BWS water piping.

San Jose has a spring capture box as a BWS and piping throughout the barangay proper. Consequently there are fewer dug wells as primary water sources. Water is abundant so maintenance of piping doesn't seem to be a problem. The flow of water is controlled by sticking a stopper into the end of a hose. Faucet leaks are repaired with electrical tape etc. As noted earlier, it is difficult to determine whether the condition of the pipes is storm related or just delayed routine maintenance.

One contaminated well (Well-1) was observed at a Yolanda affected residence.

Priorities: Fix leaks

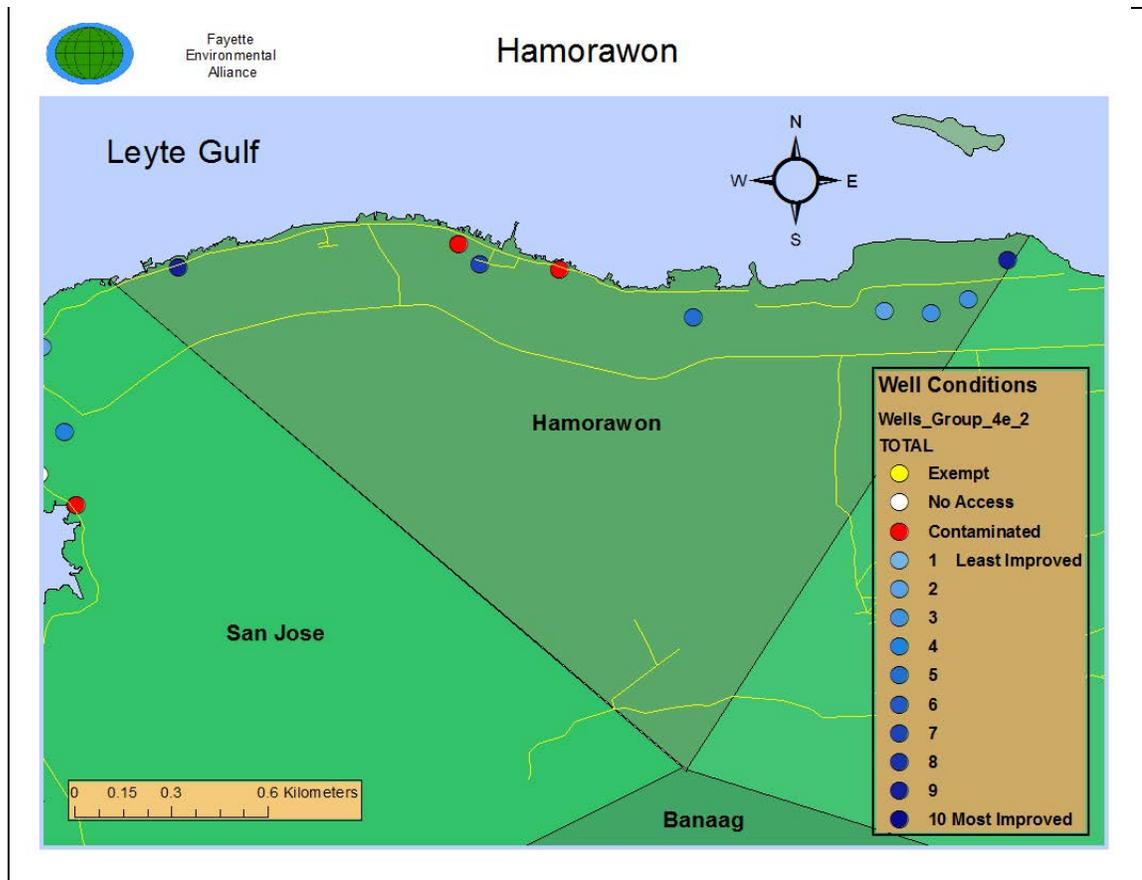
Issues: leaking pipes

As with other locations with a large amount of flexible pipes, routine maintenance is needed. The hose end stopper is not a reliable way to control water flow. Indeed the water is so plentiful in Homorawon that controlling the flow anywhere is not an issue.

Homorawon has a two contaminated wells observed among the wells surveyed, the eastern half of the barangay was surveyed July 15, 2018 on a revisit, average scores are a result of the 2014 and 2018 surveys.

Priorities: Control and improve access at streams.
