CCR Unit: SCA #2 Ash Landfill

Owner: Sunnyside Cogeneration Associates

Annual Inspection: January 2019

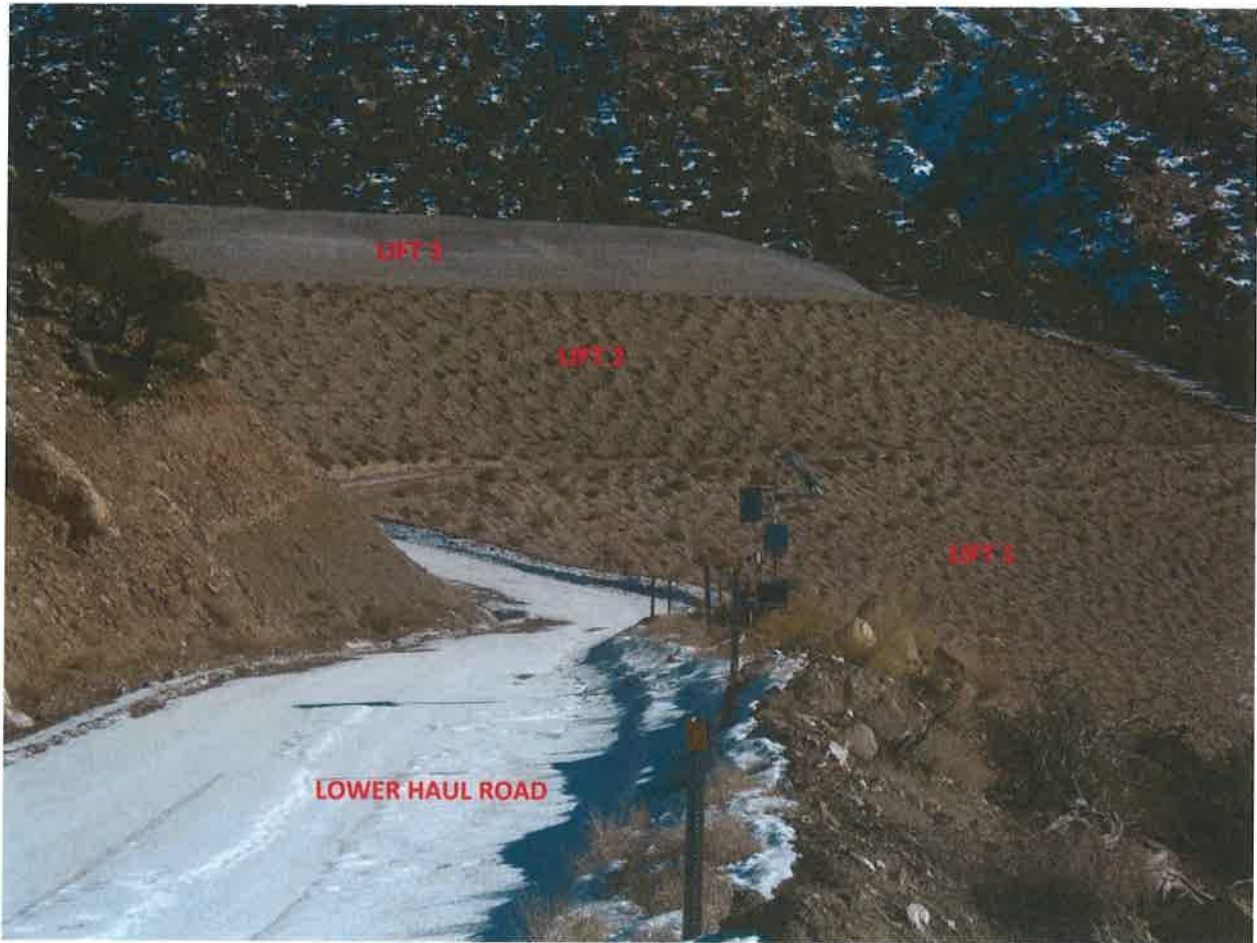
SCA#2 Ash Landfill –looking southeasterly

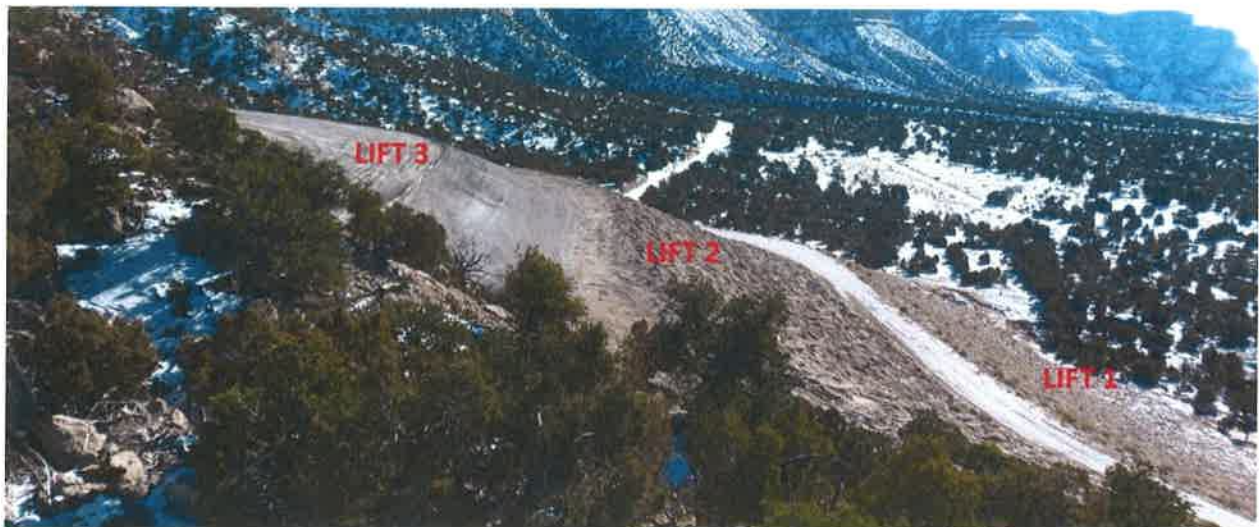
SCA#2 Ash Landfill – west face looking southerly
Lift #1 and #2 covered and seeded, vegetation is growing. Lift #3 in process

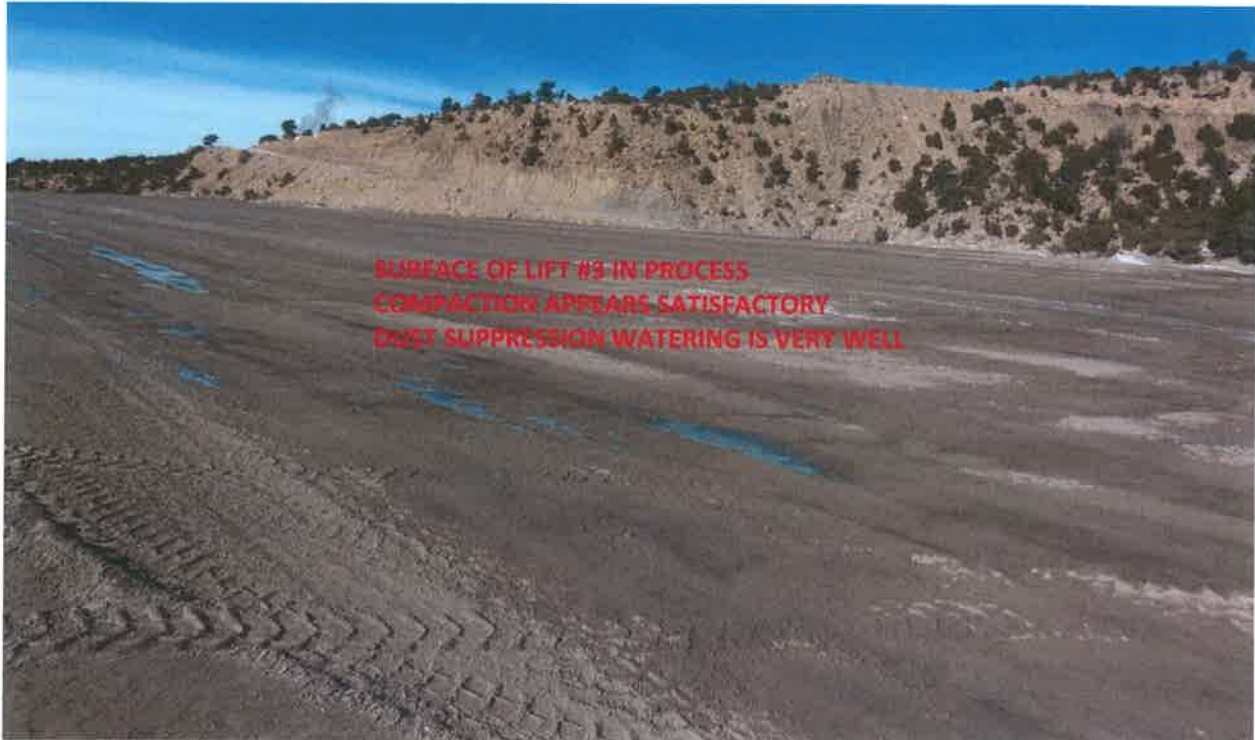
Surface of Lift #3 in process – photo looking northwesterly

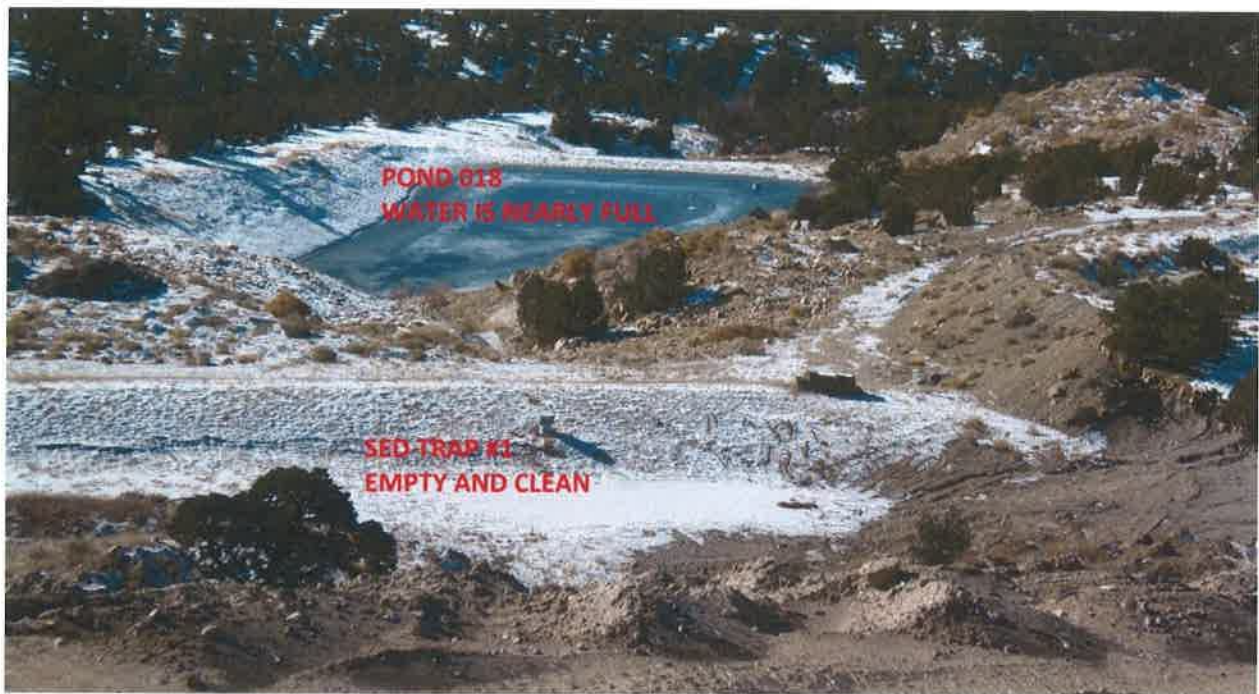
Sediment Pond 018, located west of Sed Trap #1 – photo looking westerly

Recent storms with ice reducing the evaporation and pond appears nearly full of water.

No discharge in 2018

Sediment Trap #1 is empty and clean, water flows from trap to pond in normal open condition.
