STUCCO MOISTURE TESTING REPORT

Stucco Scope

Gonzales, LA

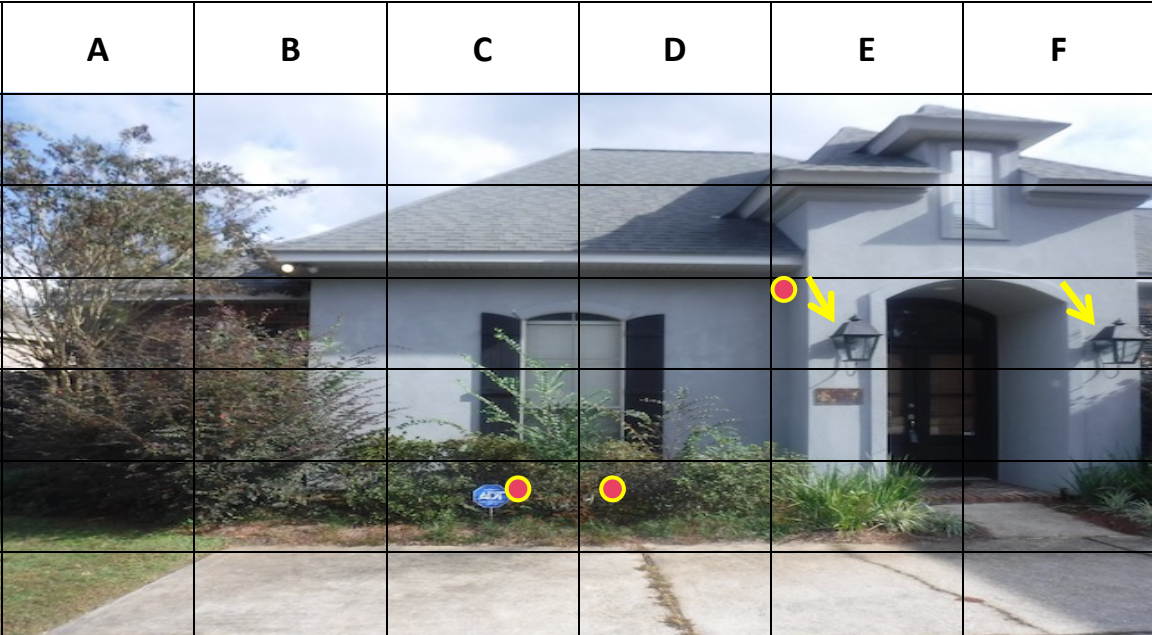
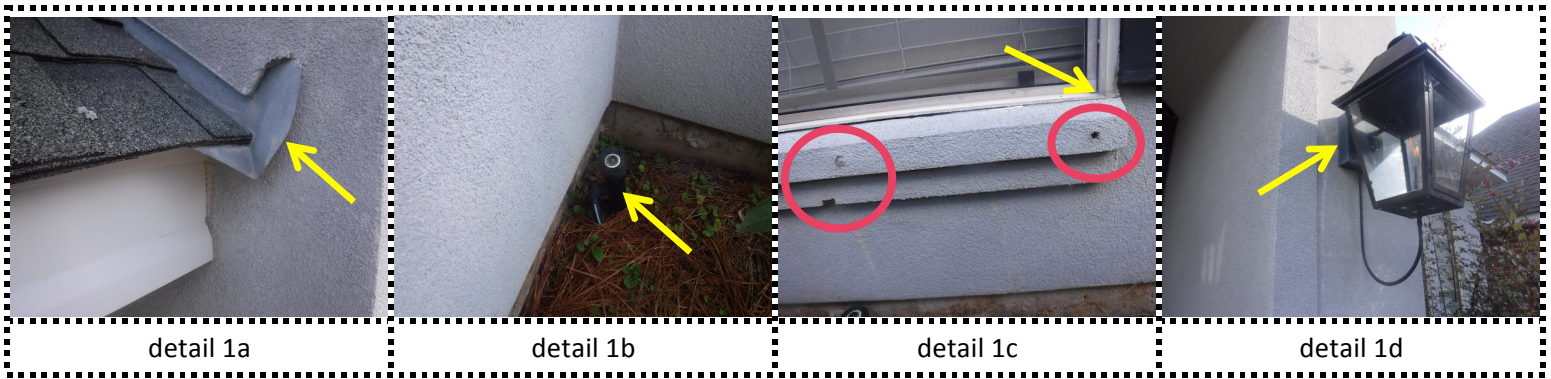
Grid Location	Elevation #1	Moisture Reading
E3	Area where moisture probe was made under kickout flashing. Kickout flashings and fascia terminations lack proper sealants. Recommend properly sealing all kickout flashings and all fascia terminations. (detail 1a)	16% Firm
Note	Sprinkler system positioned close to stucco walls was observed. Ensure all sprinkler heads are far enough away from, and are facing away from stucco system. (detail 1b)	
C5	Area where moisture probe was made under window lower left. Foam trim band is pulling away from window and rusted metal fasteners are backing out of band due to moisture intrusion. Recommend further evaluation and repair as needed. (detail 1c)	40% Firm
D5	Area where moisture probe was made under window lower right. Windows lack proper sealants. Recommend sealing all window perimeters and miter joints.	31% Firm
E3 & F3	Exterior light fixtures lack proper sealant. Recommend having all exterior light fixtures, utility penetrations, and any other penetrations through the stucco system properly sealed. (detail 1d)

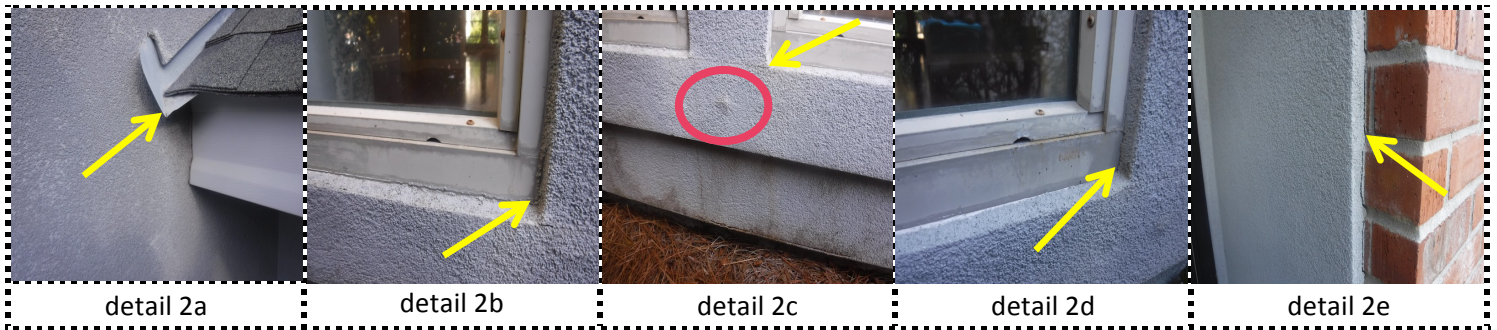
Grid Location	Elevation #2	Moisture Reading
B3	Area where moisture probe was made under kickout flashing. Recommend properly sealing all kickout flashings and all fascia terminations to help prevent moisture intrusion. (detail 2a)	9% Firm
C5	Area where moisture probe was made under window lower left. Moisture damage to the substrate is present. Repair is needed. Recommend having window perimeters and miter joints sealed upon completion of repairs.	40% Soft to None
C5	Area where moisture probe was made under window lower right. Moisture damage to the substrate is present. Repair is needed. (detail 2b)	40% Soft
C5	Area where moisture probe was made under window lower left. Moisture damage to the substrate is present. Repair is needed.	40% Soft to None
D5	Area where moisture probe was made under window lower left. Stucco cracking and backing out metal fastener was also observed. Moisture damage to the substrate is present. Repair is needed. (detail 2c)	35% Soft

D5	Area where moisture probe was made under window lower right. Moisture damage to the substrate is present. Repair is needed. (detail 2d)	37% Firm
E3-E5	Brick/stucco transitions lack proper sealants. Recommend sealing all transitions/terminations where stucco meets dissimilar materials. (detail 2e)
