CASE STUDY

RELIABILITY IMPROVEMENT PROJECT

MULTI-STAGE FABRICATED CENTRIFUGAL BLOWERS

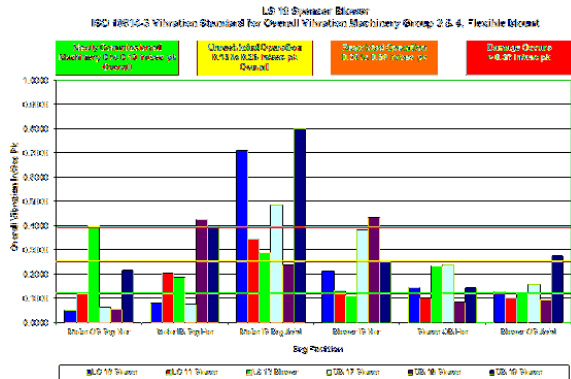
The blower OEM's published vibration limits were 0.275 in/sec pk which is slightly higher than ISO's Unrestricted Operation Limit. As shown by the chart, **Figure 5**, there were many points exceeding this limit.

At the beginning of the project, the most recent data for overall vibration in/sec pk were reviewed are shown in **Figure 5** for the six motor-blowers. Vibration limits are per ISO 10816-3 Machinery Group 2 & 4, Flexible Mount.

Figure 5. Periodic Vibration Monitoring Overall Data. Vibration Limits Per ISO 10816-3 Group 2 & 4, Flexible Mount.

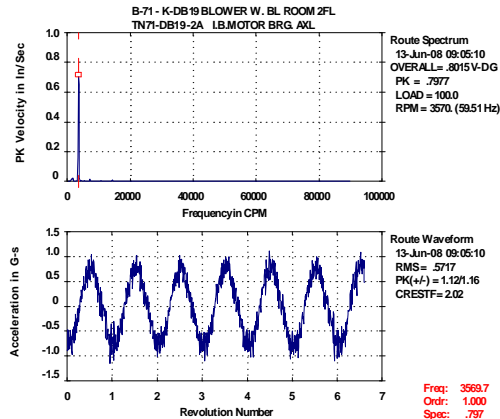
A frequency spectrum and time waveform for DB 19 Blower Motor IB Brg Axial is shown in **Figure 6**. Most vibration energy was 1X the motor run speed frequency which could indicate unbalance, misalignment, resonance, bowed rotor, worn bearings, etc. The spectrum and waveform data alone were not sufficient to diagnose the cause of the high vibration.

Figure 6. Frequency Spectrum and Time Waveform, DB 19, Motor IB Brg Axial.

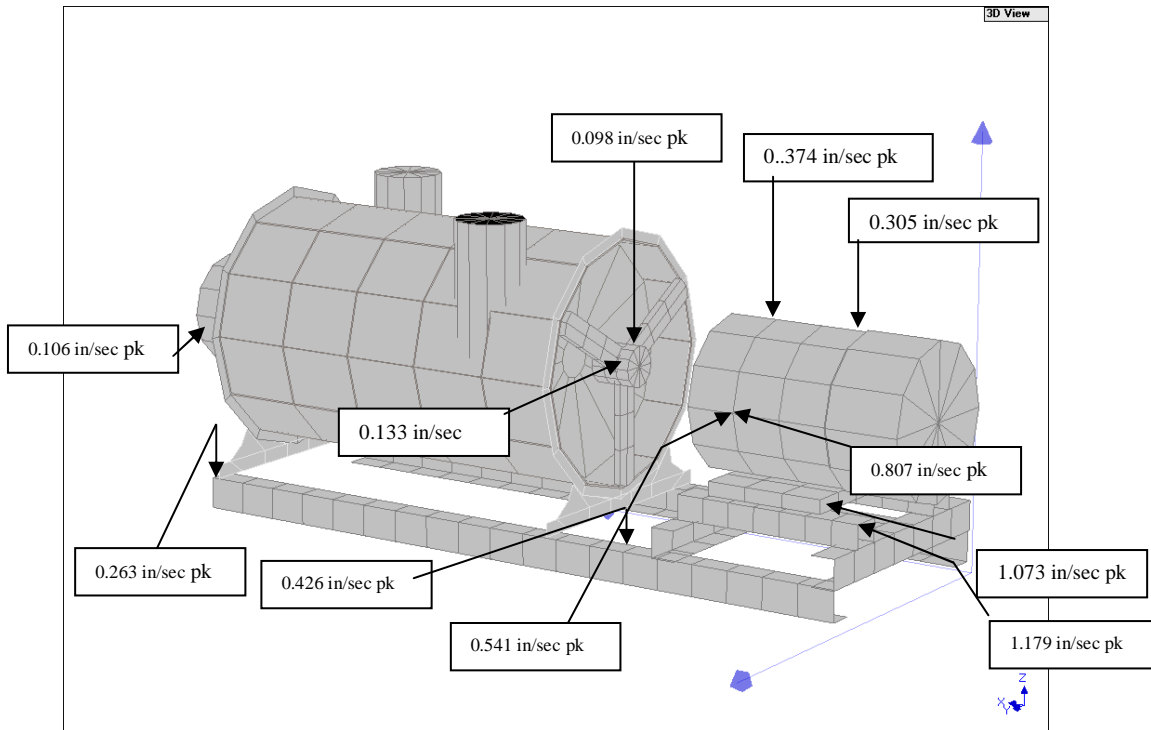
ODS DB 19 Blower: The ODS model for DB 19 Blower 1X run speed with some data points labeled is shown in **Figure 8**. Very high amplitude vibration was measured on the motor in the axial, vertical and horizontal directions. Axial vibration measured 1.073 in/sec pk on the motor feet and 1.179 in/sec pk on the frame supporting the motor. The blower frame vibration also had high amplitude vibration at most points (two points are labeled in **Figure 8**).

The animation of the ODS model showed flexing of the frame and out of phase movement of the motor relative to the blower inboard bearing housing. The motor and supporting frame also had a rocking motion in the vertical direction and flexure of the frame.

Figure 8. DB 19 ODS Vibration Amplitudes at 1X Run Speed Frequency.

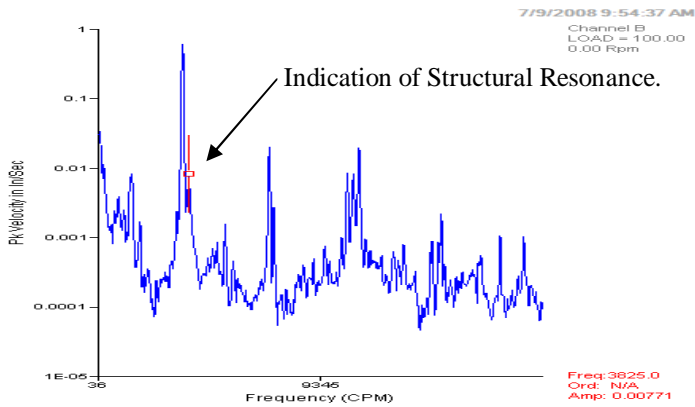
The spectrum shown in **Figure 9** with log magnitude scaling was measured at the motor inboard bearing housing in the horizontal direction. It showed indication of a structural resonance just above the run speed frequency.

Figure 9. Spectrum (Log Mag Scaling) at DB 19 Motor IB Brg

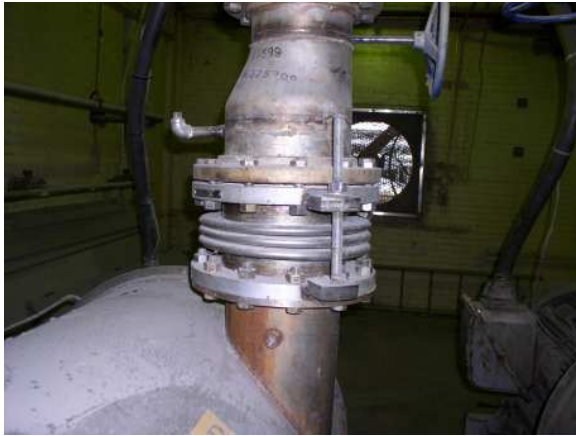
Pipe Strain: Inlet and discharge piping were connected to the blower nozzles using flexible stainless steel bellows. Tie bolts had been added using lugs welded to the flanges of some bellows as shown in **Figures 10 & 11**. Note that the bellows are completely compressed axially.

Bellows expansion joints can accommodate small amounts of axial and lateral movement. They are not designed to compensate for piping misalignment errors. Pipe guides should be installed within four diameters of the joint and then again after fourteen pipe diameters.^{Ref 6} The inlet and discharge piping to the blowers was not restrained so the bellows were transferring pipe movement forces to the blower nozzle flanges.

Figure 10. LS 12 Blower, Compressed Bellows at Intake Nozzle.

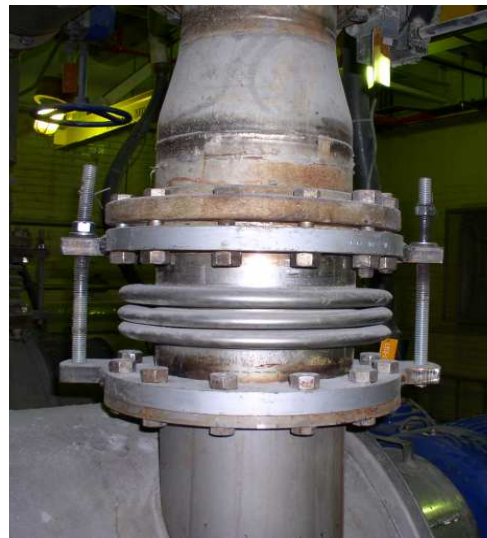
Figure 11. Blower LS 10 Blower Discharge Connection, Bellows Collapsed.

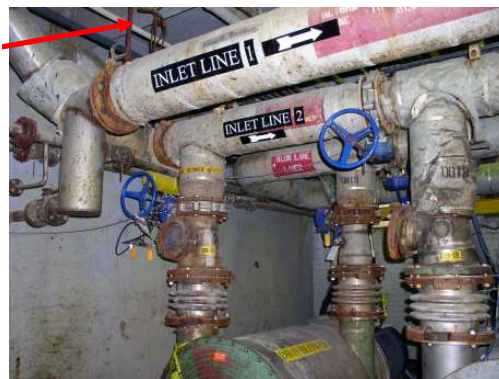
The piping was supported by hangers but not restrained at the blowers to prevent excessive pipe strain on the blower nozzles during thermal growth of the piping, see **Figure 12**.

Figure 12. Piping Connected to Blowlers, Blower DB 19 Shown.

- Piping study to determine piping thermal growth
- Recommendations for piping supports and flexible piping connections to the blower nozzles.
- Obtain allowable blower nozzle loading.

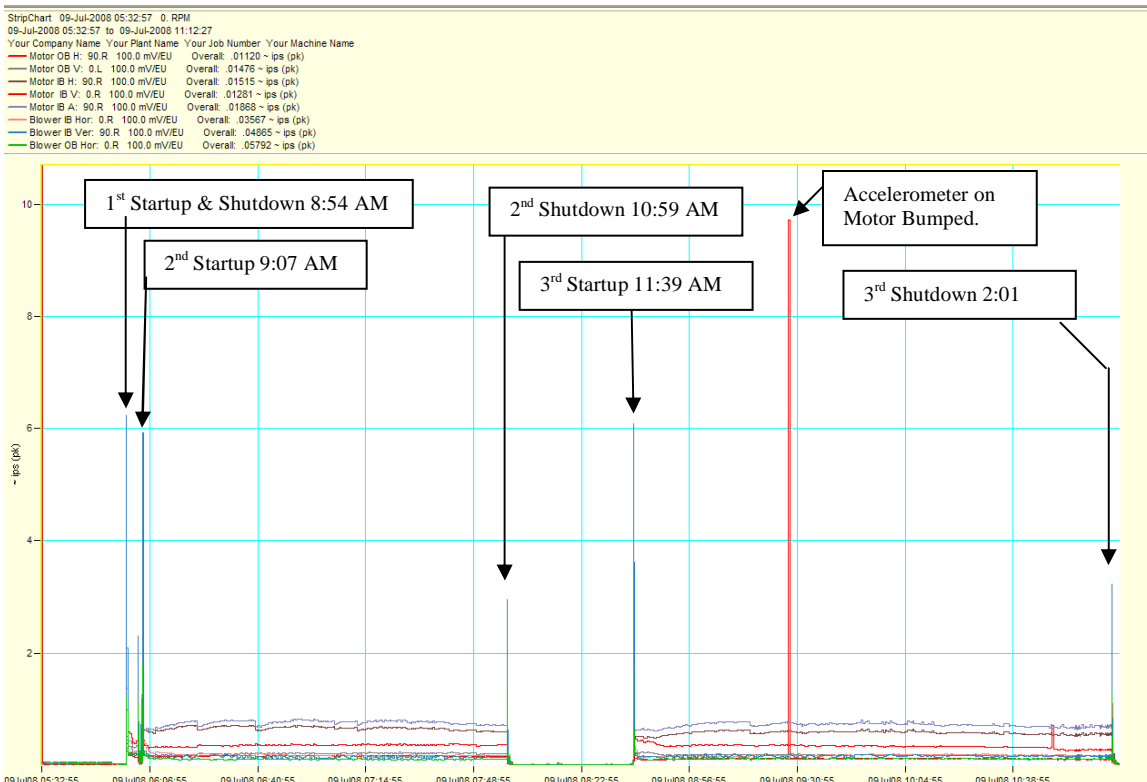
Each startup and coastdown exhibited very high amplitude vibration at the shaft rotational frequency. A resonance or a blower rotor critical speed at 2400 RPM was indicated by the spin up vibration data. The radial vibration response at each blower bearing was in phase in both the horizontal and vertical directions which is in agreement with a rotor 1st mode or 1st critical speed, see the bode' plot in **Figure 15**, blower inboard bearing housing. However, the blower OEM indicated that the rotor critical was about 1600 RPM and our rotor-bearing model (developed later) calculated to about 1660 RPM. A between-bearing rotor rub acting as a third bearing was suspected. This would explain the rotor critical moving higher in frequency.

The amplitude of vibration during passage through the blower rotor critical reached extremely high amplitudes of over 6 in/sec pk at the inboard bearing housing as shown by the overall vibration trend plots in **Figure 14** and the bode' plot in **Figure 15**.

Figure 14. Overall Trend Vibration in/sec pk On DB 19 Blower, Channels 1 - 8.

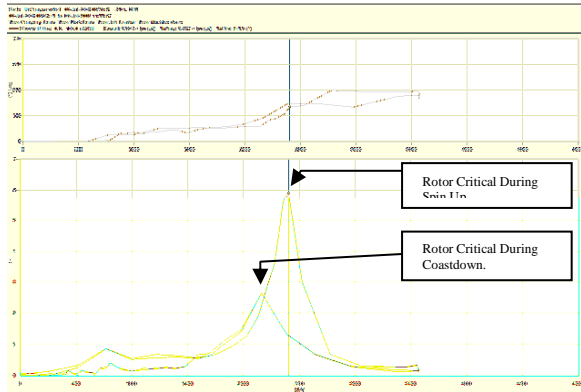
The outboard bearing housing had much lower vibration and the critical speeds were lower at 2271 RPM during spinup and 2161 RPM during coastdown. The reason for this would not become apparent until the rotor model was analyzed with a rub condition at the packing location at the inboard end.

Figure 15: Bode Plot of Blower IB Hor During 3rd Startup and Coastdown. Vibration Amplitude was Very High at About 5.9 in/sec pk. vibration generated by unbalance and misalignment forces.

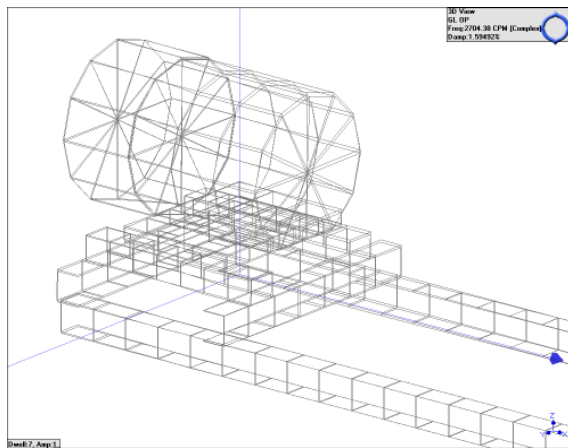
The mode shape of the natural frequency was bending of the skid rails in the vertical direction in the section between the motor support rails and the blower inboard feet mounting, see **Figure 19**. The natural frequency mode shape resulted in rocking of the motor vertically and axially. Excitation of this natural frequency was causing the very high amplitude motor vibration in the vertical and axial directions on the installed blowers.

Figure 19: Animated Mode Shape of Rail & Motor Natural Frequency.

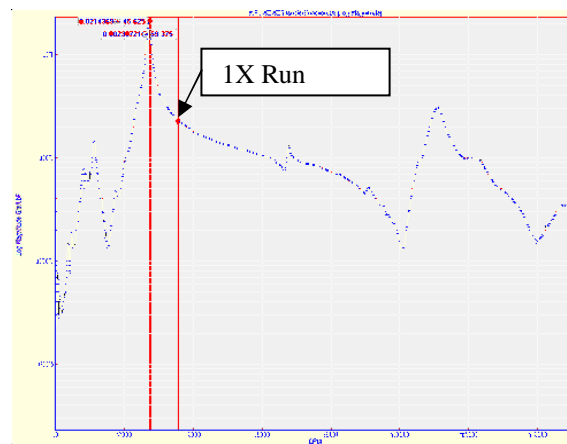
A very responsive natural frequency was identified by the test data frequency response functions (FRF) at 43.5 Hz ~ 2610 CPM. As shown in **Figure 20** the run speed frequency of the motor-blower was within the envelope of the natural frequency which would result in amplification of

Figure 20: FRF on Motor IB Bearing Housing Showing Natural Frequency Near Running Speed.

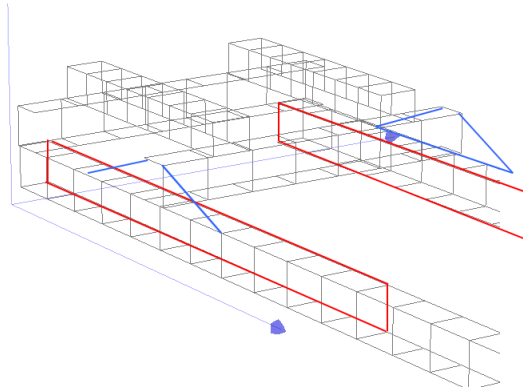
Figure 21: Suggested Stiffen Of the Skid Frame Rails Based on the Modal Test Results.

Stiffening of the skid was recommended by welding 1/4" plate about 55" long to the inside of both frame rails at the motor end, as shown in **Figure 21**. The intent was to box the frame rails increasing the moment of inertia in the Z axis (vertical direction). It was hoped that this would stiffen the rails enough to raise the natural frequency well above the running speed frequency. Plates welded on top of the rails in the locations shown would further

increase stiffness in the Z axis at these locations if required. The decision was made not to modify the existing skid but to make those modifications to a new skid design to stiffen it in this area.

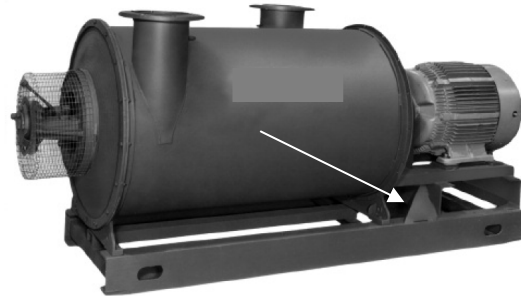
Figure 22. Stiffeners Originally Included in the Blower Design.

It would be discovered later that the blower OEM provided bolt-on stiffeners, as shown in **Figure 22**, but these stiffeners had been removed during maintenance for access to bolts. The stiffeners were not replaced.

amplitude motor vibration in the axial and vertical directions. It was discovered that stiffener plates/gussets originally provided by the OEM had been removed by maintenance personnel to gain access to hold down bolts but these gussets were not replaced.

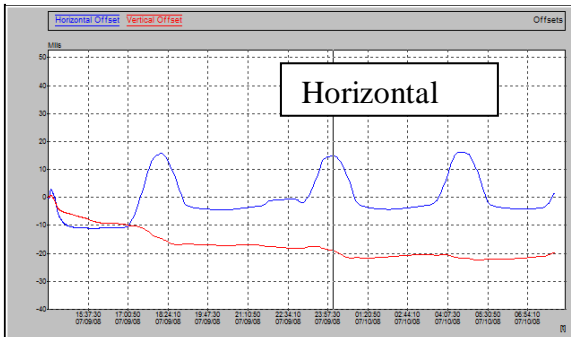
Figure 38. Blower DB19 Cool Down Alignment Data.

The blower was restarted two more time and finally allowed to run for about 2 ½ hours then was shutdown and allowed to cool down overnight back to ambient. Cool down data indicated severe pipe strain in the horizontal direction. The blower is being pushed/pulled. As shown by the data in **Figure 38**, there is a sudden horizontal movement about every 4-6 hours. This movement occurs when the other two blower are shutdown.

The data collection shown in **Figure 38** began just minutes before Blower DB19 was shutdown. Note that the blue line (horizontal offsets) jumps when the other two blowers are shutdown. The pipe strain forces the blowers out of alignment as much as 20 mils during each blower startup.

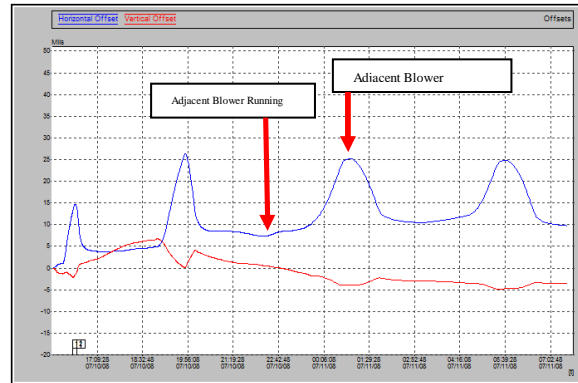
DB18 Cool Down Alignment File: The Permalign^{Ref 7} was setup on this unit after DB 19 was re-aligned and started up. DB18 was started and allowed to reach operating temperature for about 5 hours then shutdown and allowed to cool overnight. The results were very similar to DB19 with the blower being pushed/pulled horizontally when the other two blowers shutdown as shown in **Figure 39**.

Figure 39. Permalign^{Ref 7} Data File for DB18 Blower. Horizontal Movement Occurs When Adjacent Blower Shutdown.

- Permalin data measured on DB18 and DB19 showed over 25 mils relative horizontal movement of the motor and blower during shutdown and cooling to ambient temperature. There were also excessive alignment changes when adjacent blowers cycled on and off caused by thermal growth of the piping pushing/pulling the blowers.

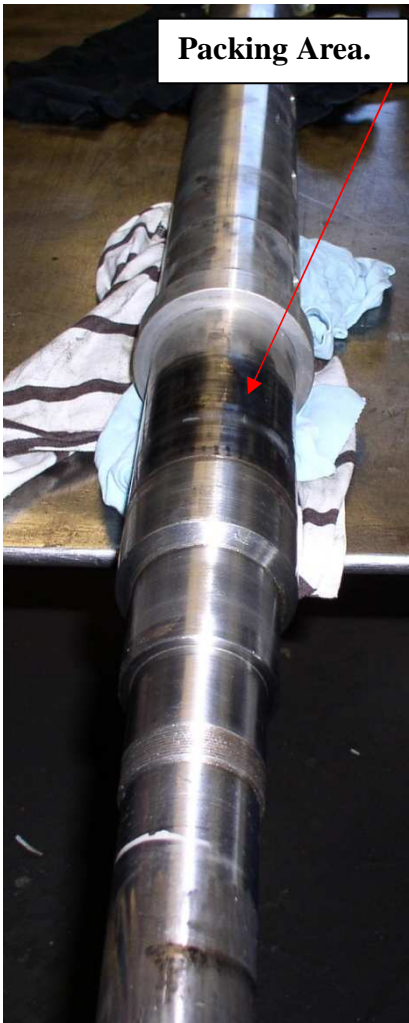
The packing box is the lowest cost but the packing rubbing the shaft causes heat, thermal bowing of the shaft and as calculations and vibration data indicated can shift the rotor critical speed much higher. Up to 30 mils shaft wear is allowed at the packing location per the blower OEM's manual. Packing was used on the six blowers in this analysis.

The shaft is shown after unstacking, see **Figure 42**. There was excessive wear of the packing area, (greater than 30 mils wear).

Figure 21. Shaft Packing Area Discolored by Packing Rubbing.

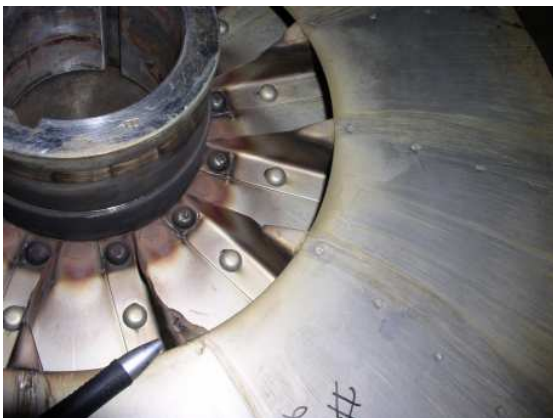
Impeller #2 had minor blade damage, see **Figure 43**. The hub and blades showed heating from previous installation. Fretting corrosion was present in the hub bore indicating a loose fit on the shaft.

Figure 43. Impeller #2 Blade Damage. Note Heating of the Hub Which Occurred During Previous Assembly.

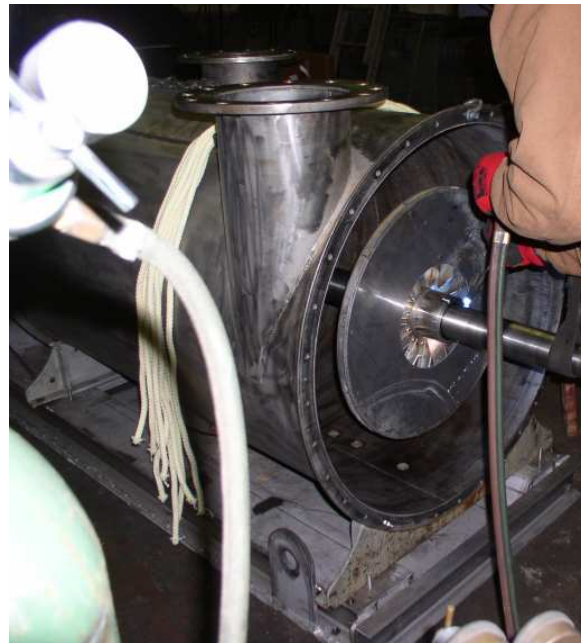
After balancing, the rotor was disassembled and reinstalled in the case. Heating of an impeller hub during reassembly using a torch is shown in **Figure 49**. Rope packing is installed between each stage to reduce leakage at the case/diffuser interface.

Figure 49. Reassembly. Torch Used to Heat Impeller Hub Prior to Sliding Into Position.
