Home Inspection Report

12 Unit, Building Sample Report, NY 12202

Inspection Date:

Wednesday, December 20, 2017

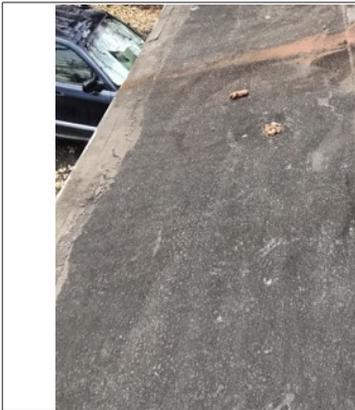
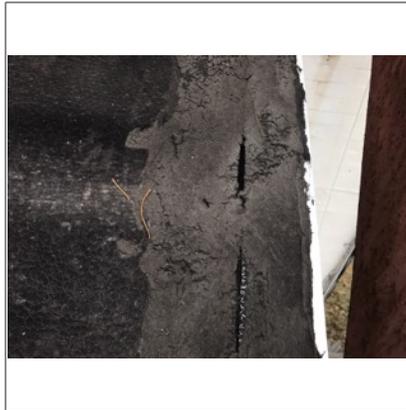
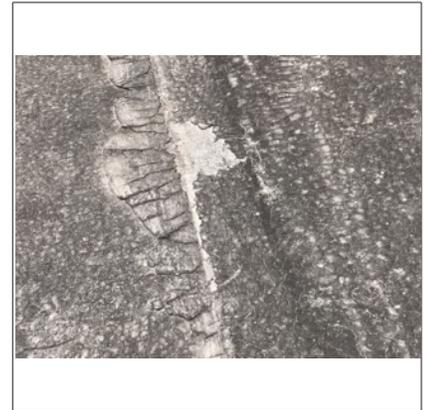
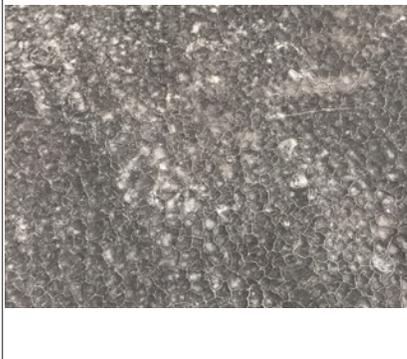
Flat •Prior repairs to the flat roof are evident (this would suggest that problems have been experienced in the past) and the membrane exhibits flaws (blistering and cracking) that are symptomatic of an older flat roof. You should expect periodic patch work as discussed. It should also be cleared and maintained free of debris to reduce roof damage and risk of leaks. A tradesman is recommended for further review as there are significant cracks along the repaired seam that are in need of repair. The flat roof should be examined by a roofing contractor and repair/replacement cost estimated.

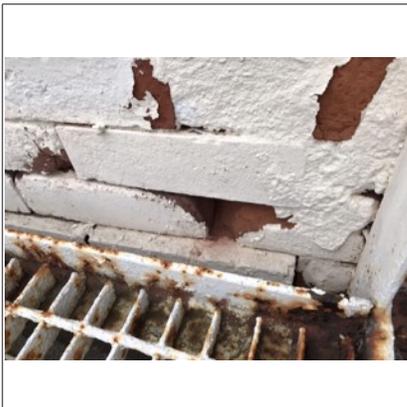
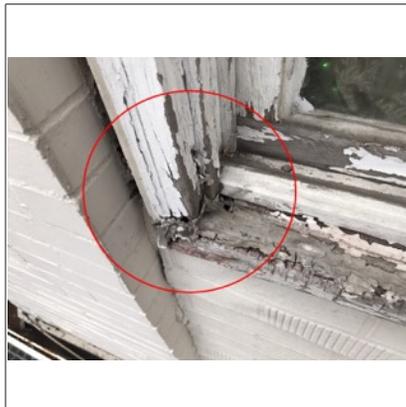
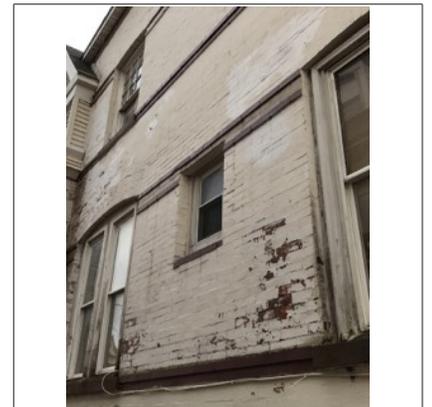
- Ext. walls**
- Damaged brickwork should be repaired to preserve the walls. The exterior brickwork should also be re-pointed (replacement of the mortar between the bricks) to prevent further deterioration.

- The siding should be painted to preserve the building.
 - Siding or wood to soil contact should be avoided around these buildings to reduce insect and rot-damage risk as discussed.

- Localized rot was observed in the wood trim, especially around the windows of these buildings. Following repair of the damaged areas (which should be combined with exterior painting/maintenance) proper maintenance of the wood trim and control of water from roof or surface runoff can avoid further damage. The wood trim should also be painted to preserve the building. These repairs will involve a significant expense.

- The openings in the siding should be sealed and re-secured to avoid moisture and wind-damage.

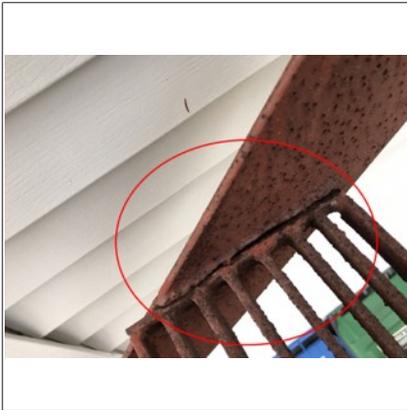
- Porch**
- The openings in the porch railings (the metal railings for the right side porch and the wood railings on the main front porch) are large enough to allow a child to fall through. It is recommended that this be altered for improved safety.

- The front main porch and left side porch have both settled relative to the building proper. This is a common condition that should be monitored. If the porch supports have not already been repaired, replacement may be needed.

- The front porch railings are loose. It is recommended that this be repaired for improved safety.
- Deck**
- One of the metal fire escape steps are rotted and should be replaced as they are unsafe. A steel tradesman is recommended for further review and the costs of repairs and painting of the fire escapes estimated.
