**CCR Unit: SCA #2 Ash Landfill**

**Owner: Sunnyside Cogeneration Associates**

**Annual Inspection: January 2021**

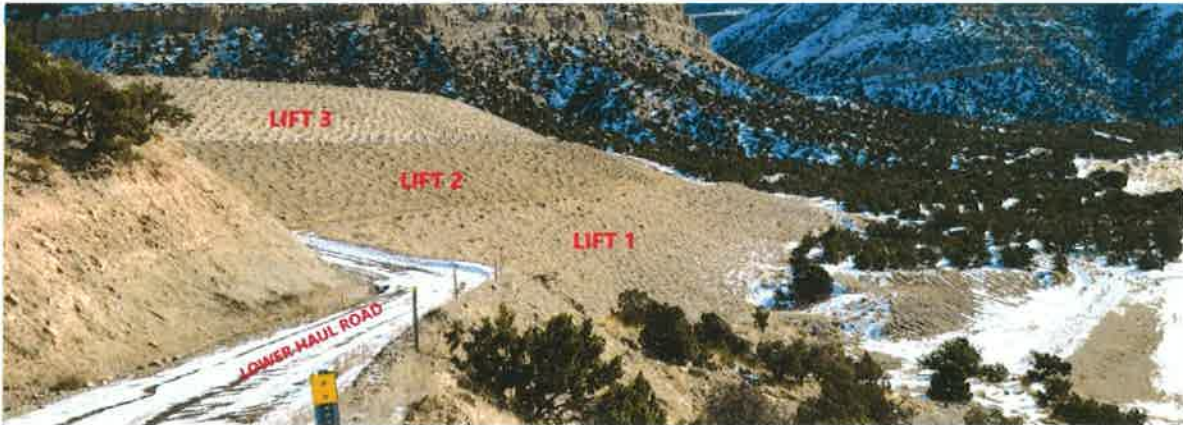
SCA#2 Ash Landfill –looking southeasterly

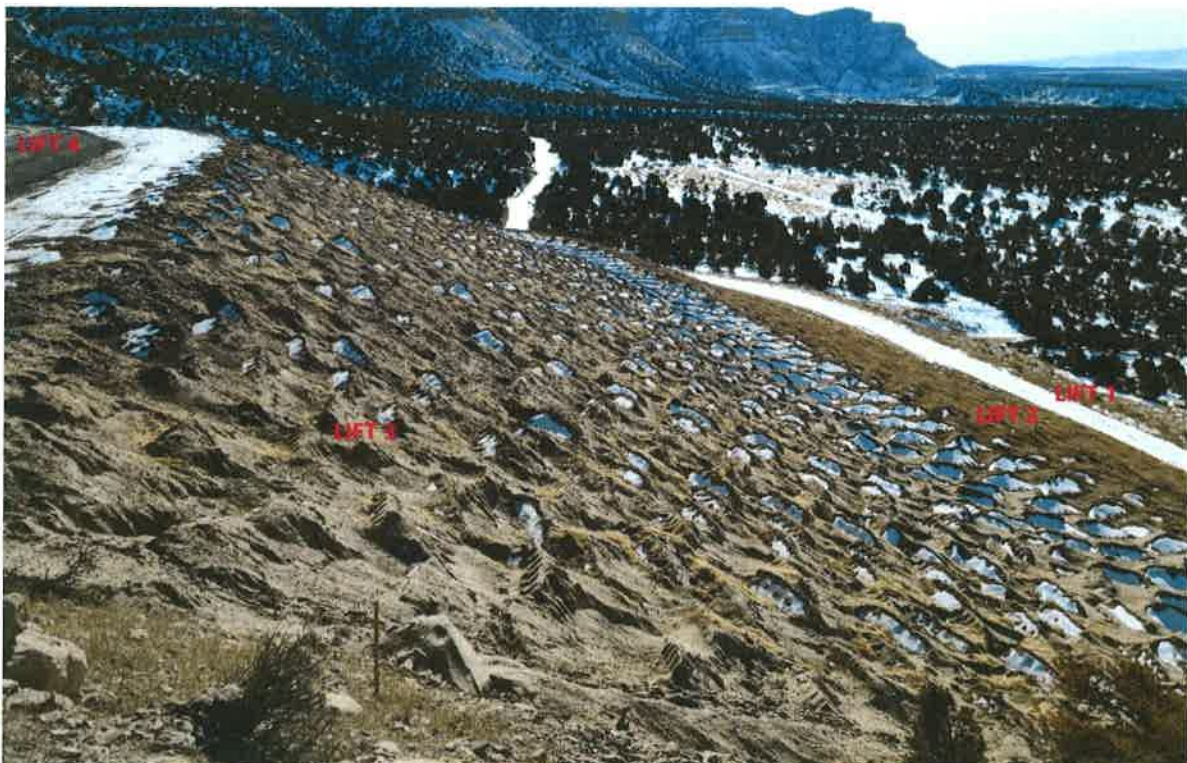
SCA#2 Ash Landfill – west face looking southerly  
Lift #1, #2 and #3 covered and seeded. Lift #4 in process

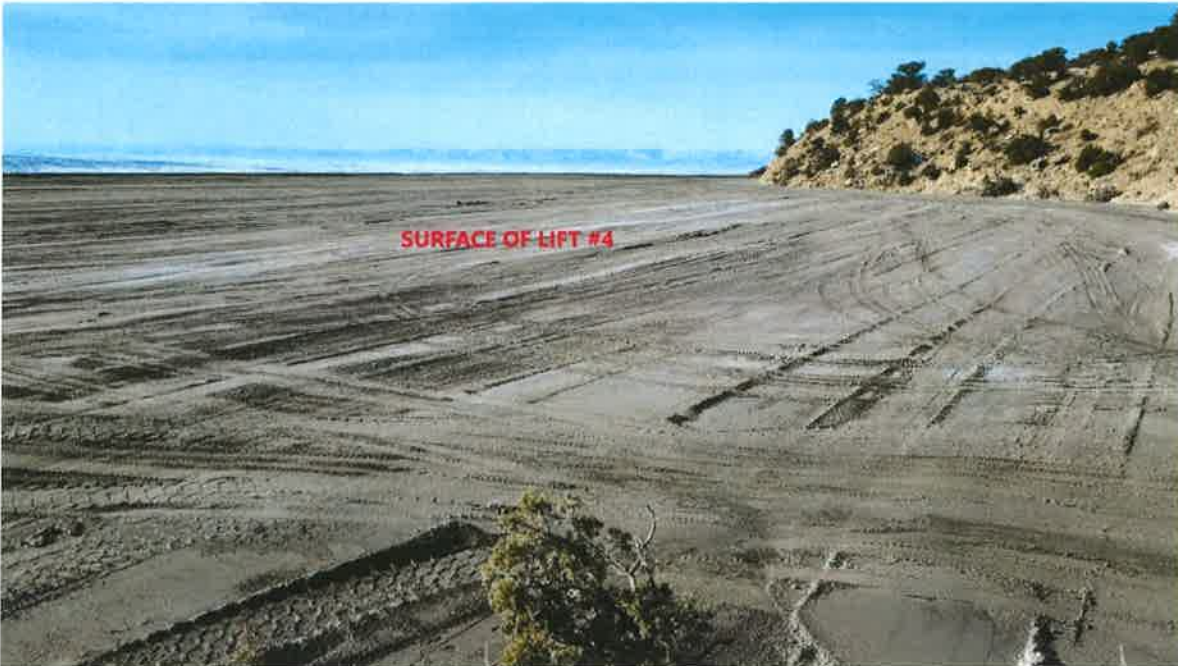
Surface of Lift #4 in process – photo looking northwesterly      January 14, 2021  
Compaction appears satisfactory. Dust suppression appears satisfactory

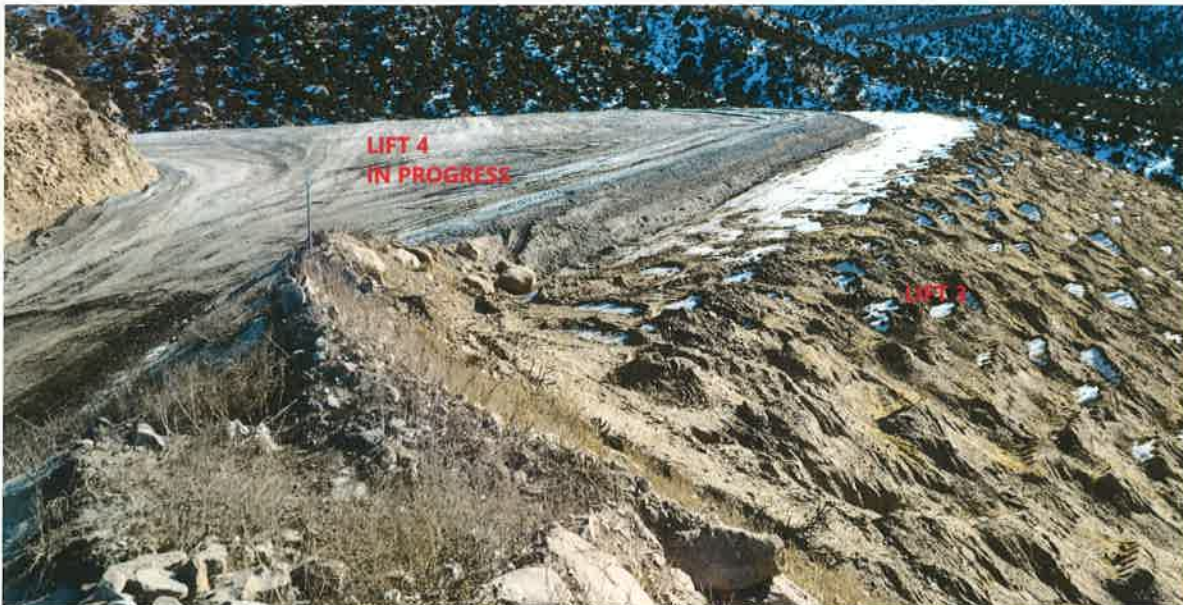
Surface of Lift #4 in process – photo looking south-southeast      January 14, 2021

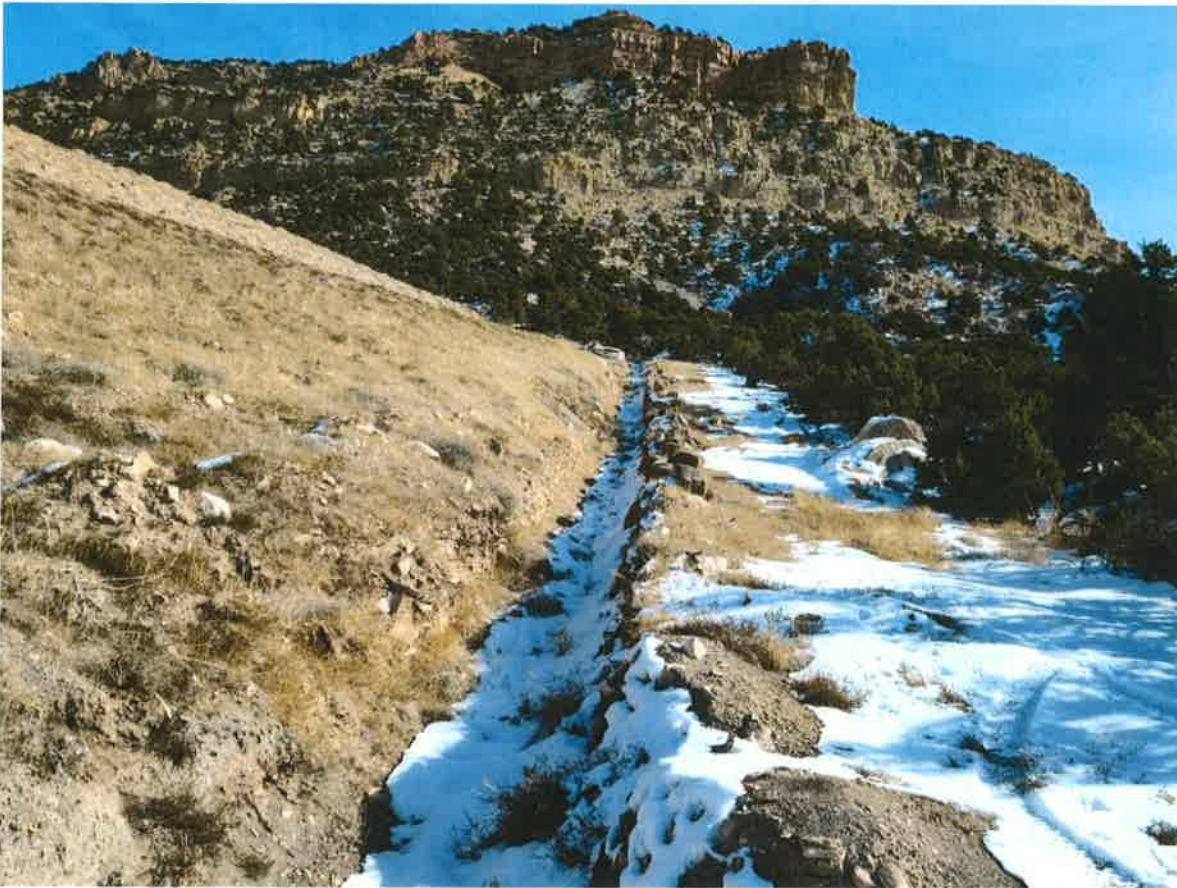
South Perimeter Ditch – looking easterly

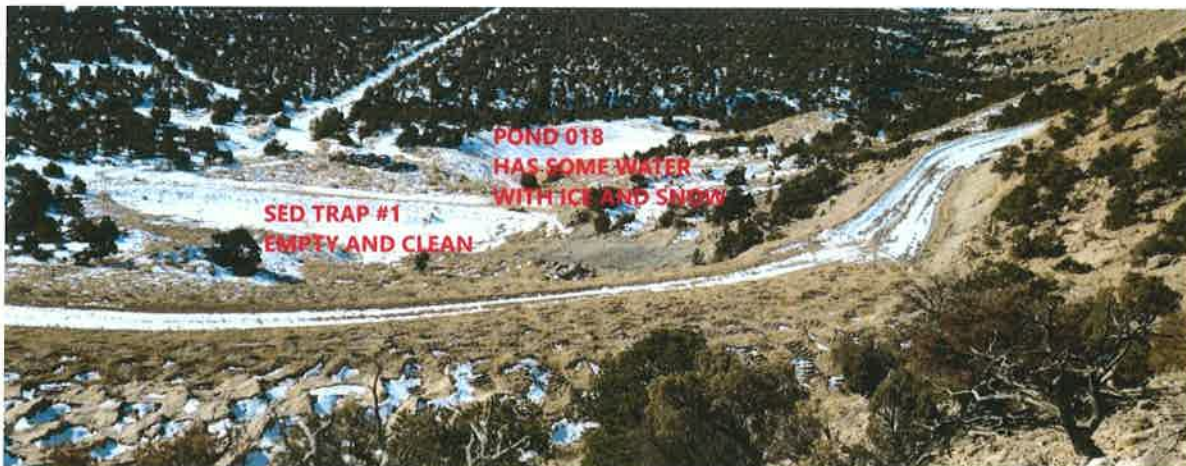
Sediment Pond 018, located west of Sed Trap #1 – photo looking westerly

Pond has water with a surface ice layer and recent snow cover.

No discharge in 2020

Sediment Trap #1 is empty and clean, water flows from trap to pond in normal open condition.
