Mitchell Home Inspections

Your Property Inspection Report

123 Oak Street, Severna Park, MD 21146
Inspection prepared for: Carol Smith
Date of Inspection: 1/13/2015 Time: 1530
Age of Home: 36 years Size: 2100 sq ft
Weather: 30F and Fair

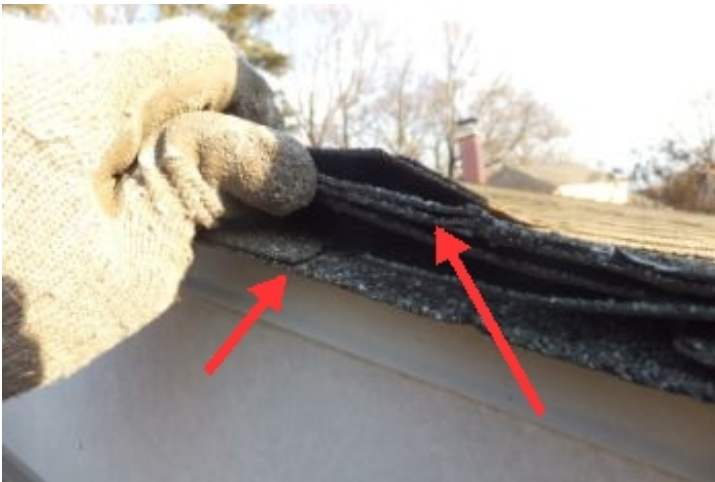
- Roof shingles are 30-year architectural asphalt type. The roof has no discoloration and no signs of wear. Roof appears to be about 5 years old. No major system safety or function concerns noted at time of inspection.
- Roof has two layers of shingles. This is normal for a roof replacement. The next time the roof needs replacement both layers of shingles should be removed.
- There is a soft spot in the sheathing above the foyer. No major concern, but it should be watched and addressed as necessary.

Second layer of shingles

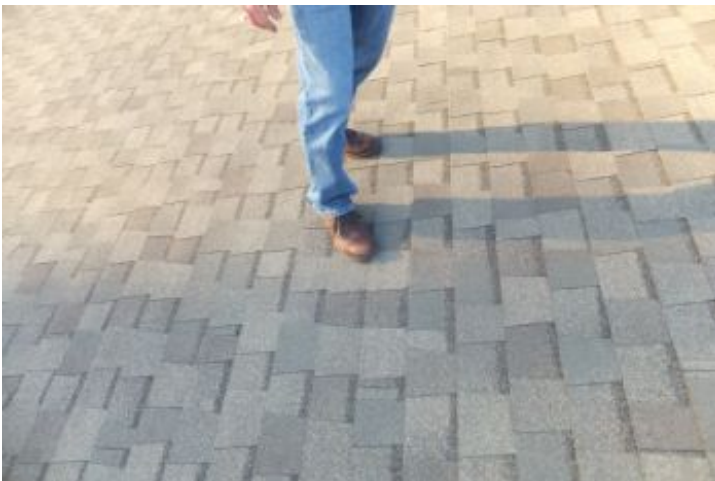
Soft Spot on Roof above foyer

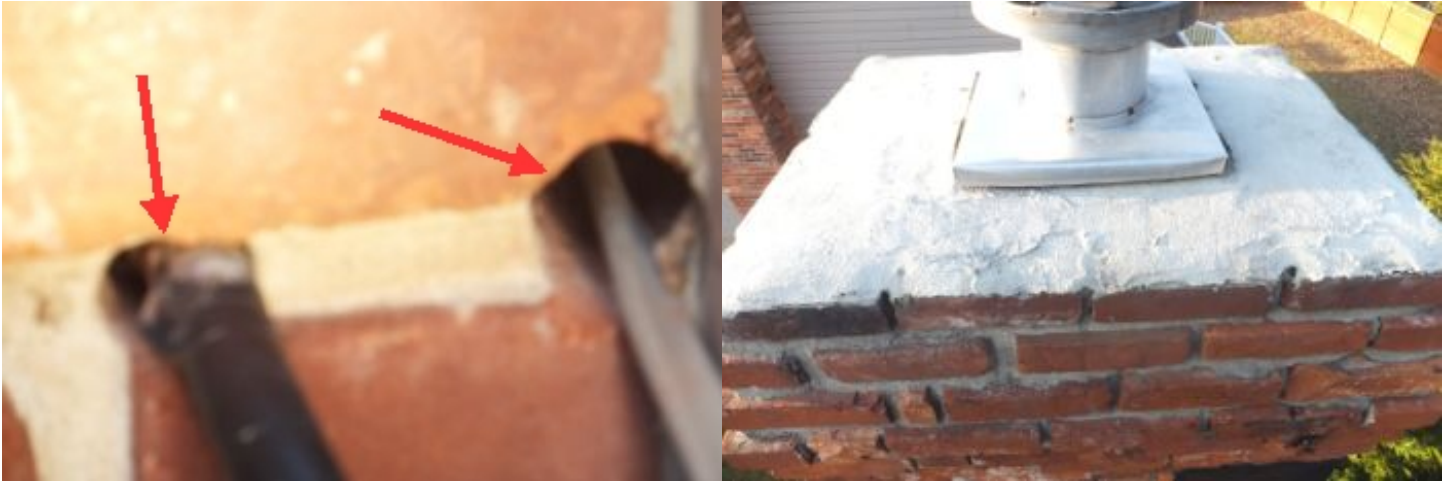
- Flashing at base of chimney appears to be missing. Recommend maintenance to ensure a continued waterproof seal.
- gas and electric penetrations should be sealed.

Gas line and electric cable not sealed

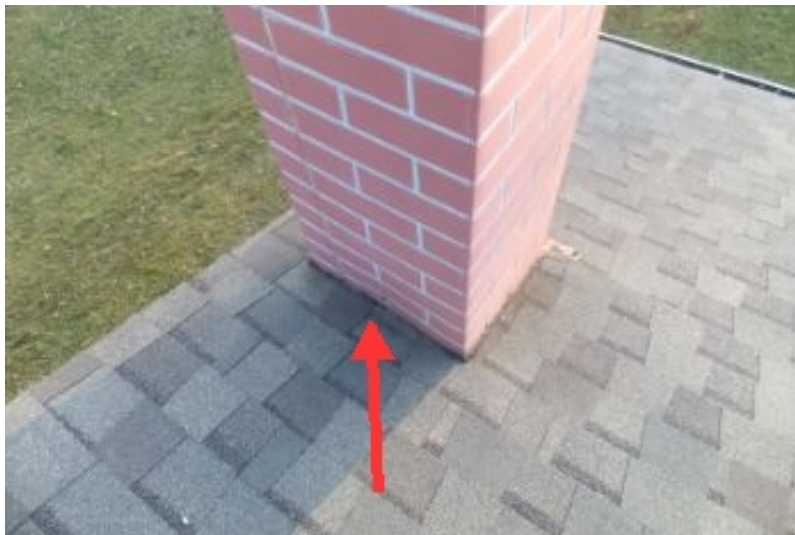
Missing backer flashing

- Water Stains, dry at time of inspection. Could be from the chimney since the backer flashing is missing. Recommend a professional roofer inspect and correct.
- Minor cracks in caulking noted, which is normal for a house of this age.
- "Nail pops" visible in some areas; recommend resetting, or replacing with screws in drywall. This is a fairly common occurrence.
- Minor cracks and nail pops in bedroom storage ceiling. Normal but could be repaired.
- A hole in the Ceiling in foyer closet has been cut out and put back without being properly patched. Recommend proper patching with drywall tape and spackle to prevent air intrusion from outside.

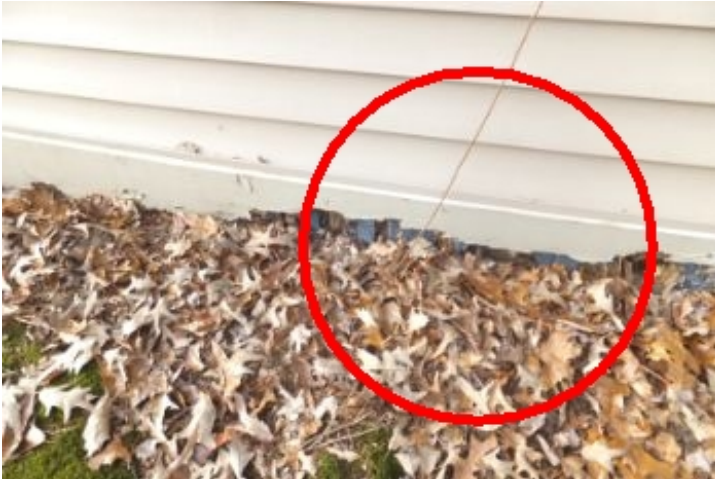
Rotting Siding on back of Storage Shed

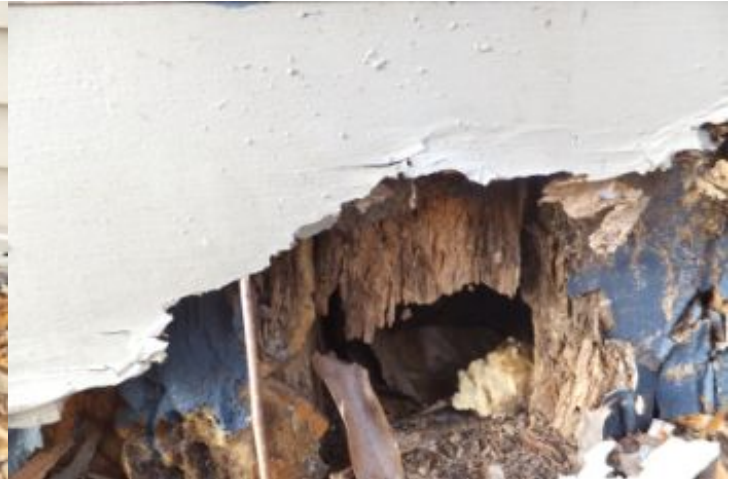
Rotting siding on back of Storage Shed

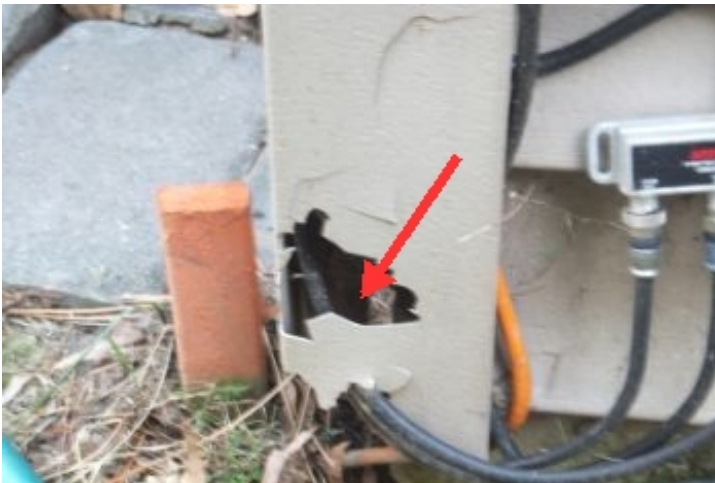
Cracked corner mold on siding

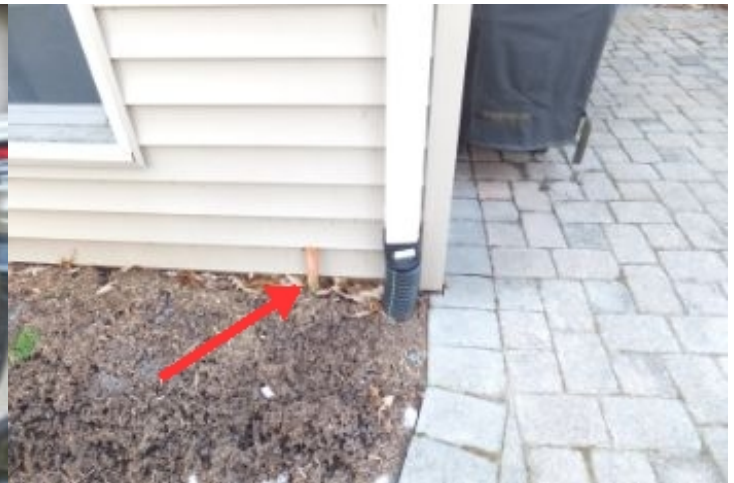
Evidence of treating for Termites

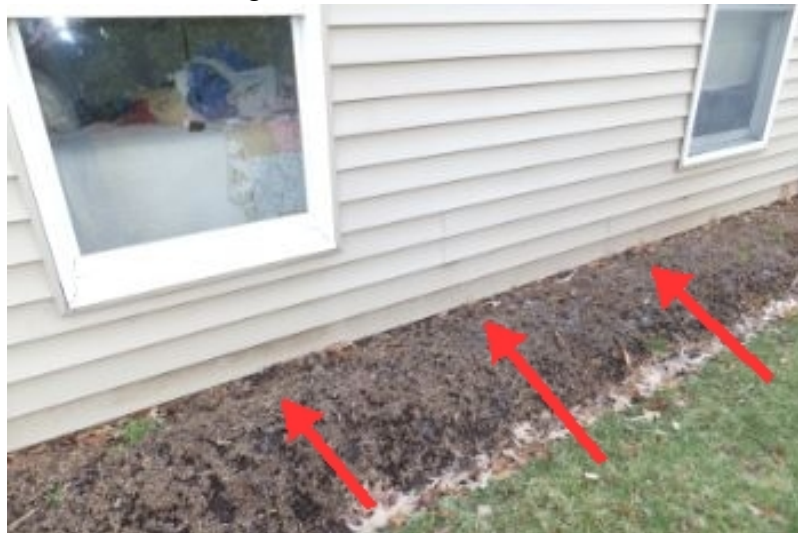
- No major system safety or function concerns noted at time of inspection.
- Vinyl siding corner cracked on North side of home. No concern.
- Siding-Soil contact or proximity. This may provide entrance of moisture or insects to siding. Recommend grading soil so there is at least 6" of space (where practical) between the siding and the soil below and checking for any damaged trim and siding materials.

Earth touching siding

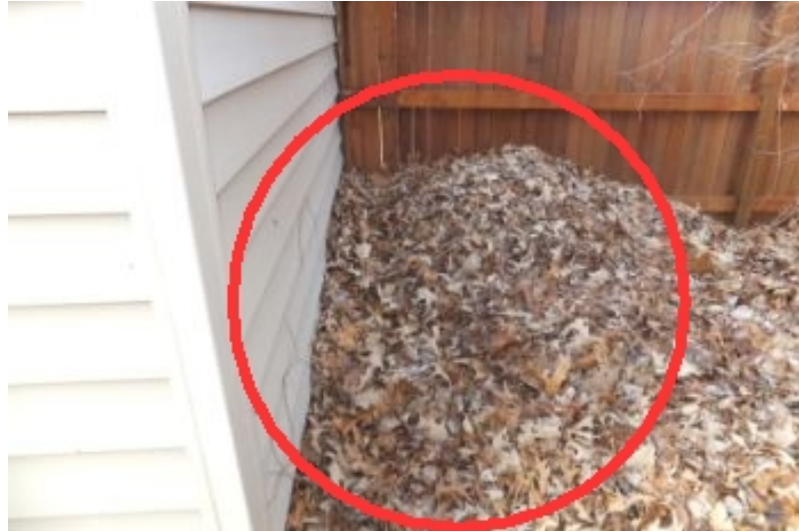
Leaves Piled up on side of Storage Shed

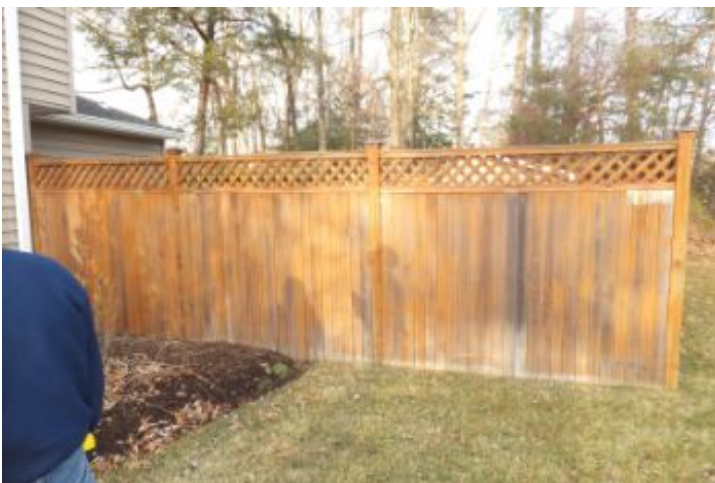
Backyard Fence

- Clean and Seal Fence: Recommend cleaning fence and treating with a waterproof sealant claiming to waterproof, block ultraviolet light, and stop mildew.
- **Railings missing on basement stairwell. Recommend installation of railings for safety.**

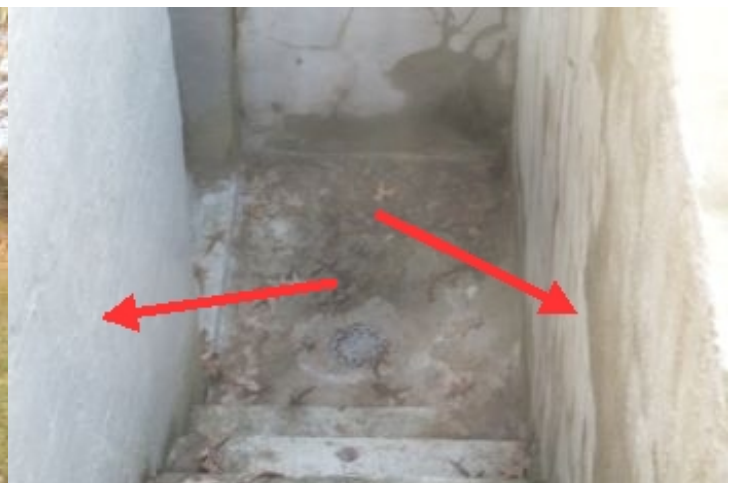
Basement Stair Well without railing

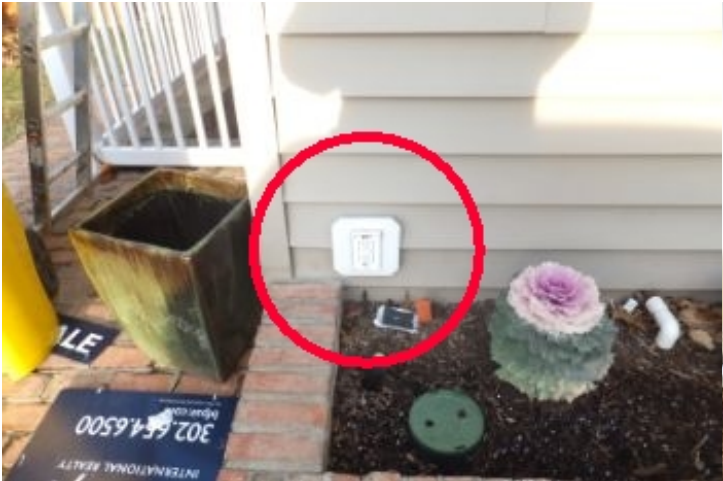
Cover Missing on GFI Receptacle

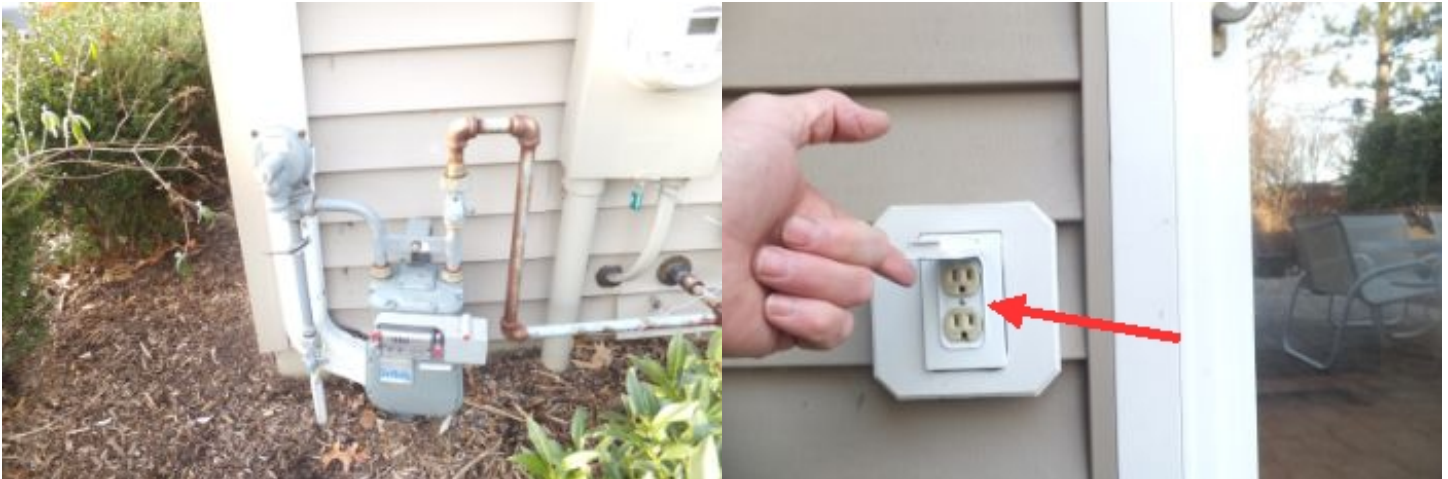
- OUTLETS:
- Outlet damaged or apparently inoperable.
- SERVICE ENTRANCE: Underground
- **GFCI trip test failed. Have electrician evaluate. A GFCI - Ground Fault Circuit Interrupter device protects us from receiving electric shocks from faults in the electrical devices we use in our home.**

Outdoor receptacle not GFCI protected

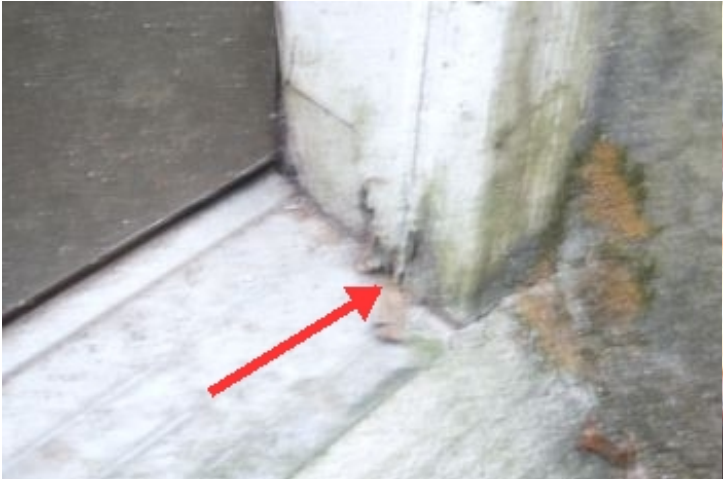
- Front entrance door does not close tightly as light and air can enter. There is a 1/4" gap under door threshold. Recommend adjusting or replacing.
- Stairwell door weather strip damaged and moulding is starting to rot..

Door Moulding rotting

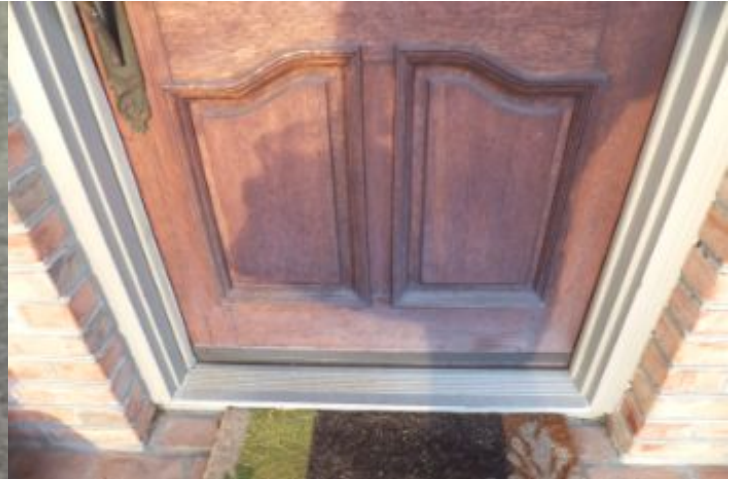
Front door is dry/peeling

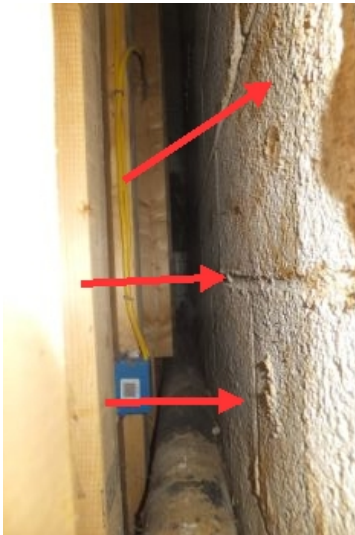
- Inspection Method: Traversed
- Beam Material: Wood
- Insulated at walls.
- Insulated at ceiling.
- Efflorescence visible on concrete, suggesting moisture penetration.
- Soil against house could contribute to water intrusion into house. Flower box on Front (west) side of house does not have drainage.
- There is significant evidence that moisture mitigation work has been done. Recommend checking with seller on the scope of that work.

Efflorescence on basement wall

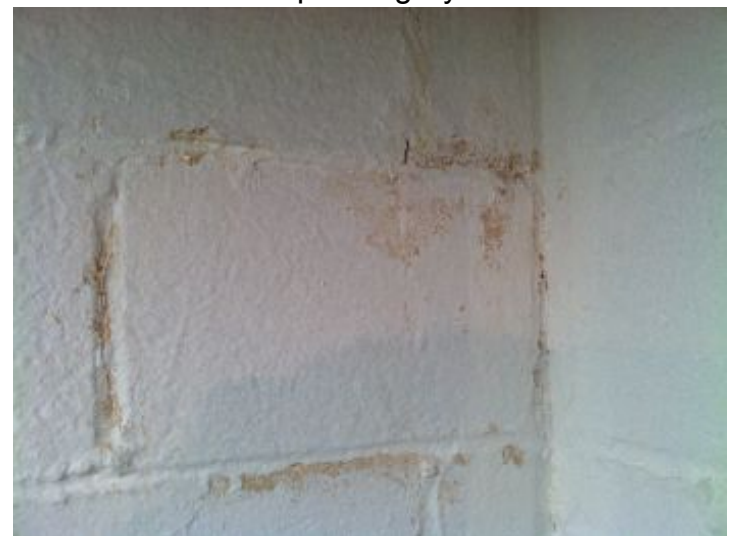
Water Stain on West Wall

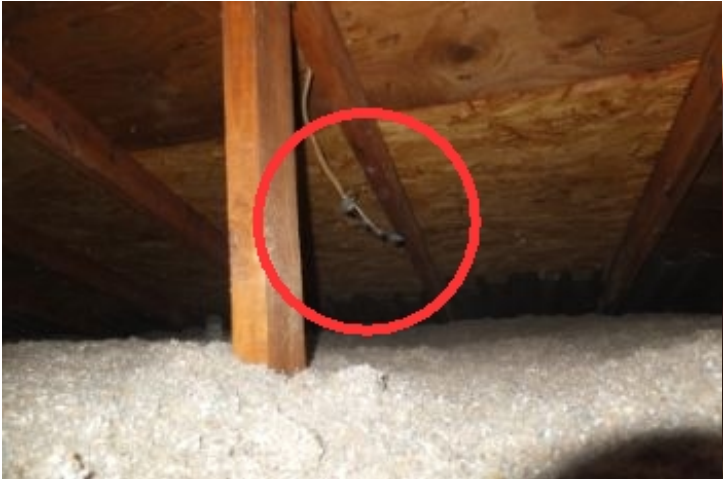
- Viewed from Hatch
- Maintenance Tip: Keep attic hatch sealed/caulked to minimize warm moist air escaping to attic, which could promote conditions conducive to mold growth.
- Blown in Cellulose Insulation
- Laid in Fiberglass Insulation
- Insulation averages about 14-16 inches in depth which achieves an R-Value of about 40.
- Two types of sheathing indicates that some repair work has been done. No concern.
- Just a note that 2"x4" trusses are undersized by today's standards. We look for 2"x6" minimum, but there are no concerns here.
- **Wire ends are outside of a Junction Box, which is a potential shock or electrocution hazard.**

Open electrical conductor

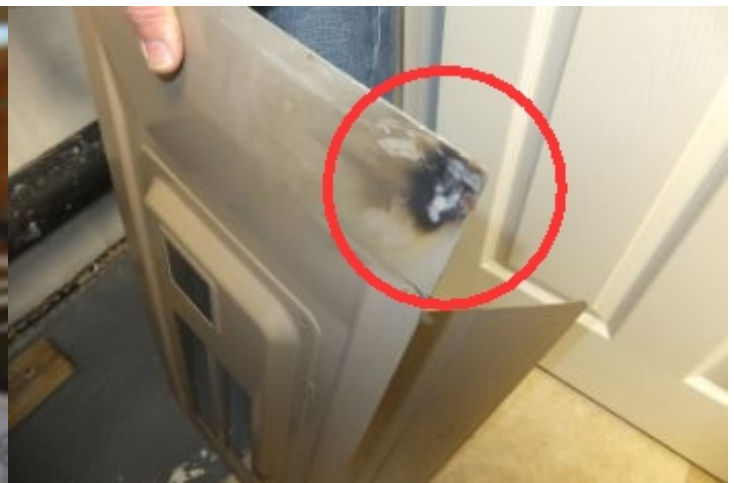
- **Damage to insulation, or arcs / burns inside panel box.**
- **Questionable wiring in panel box. Have licensed electrician evaluate.**

signs of arcing

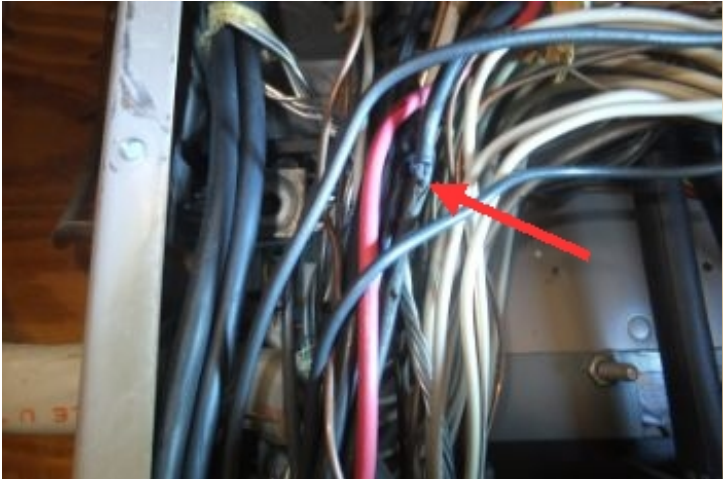
Nicked Insulation

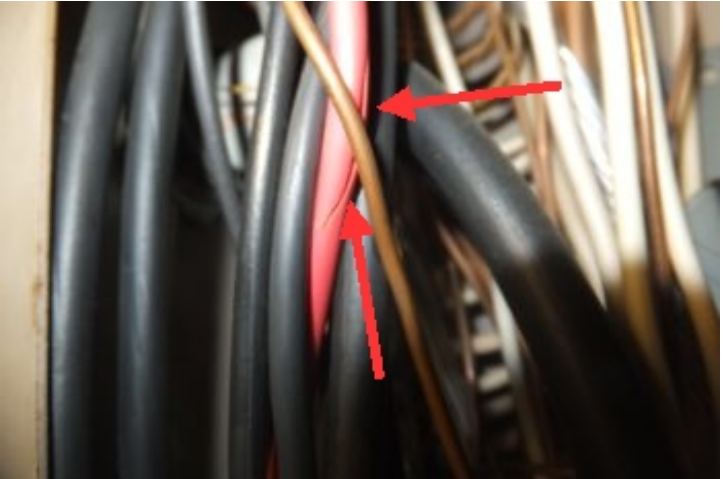
Nicked Insulation

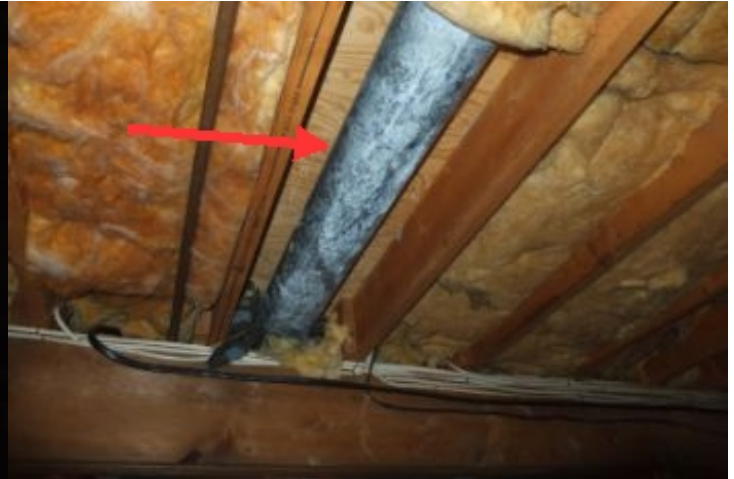
- No major system safety or function concerns noted at time of inspection.
- Installed 2007
- Recommend insulating duct work in unconditioned spaces.

Supply Ducts not insulated

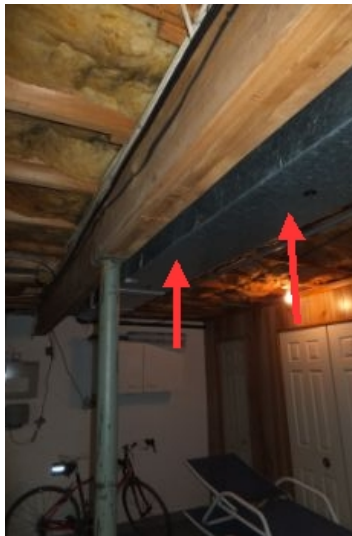
Supply Ducting not insulated

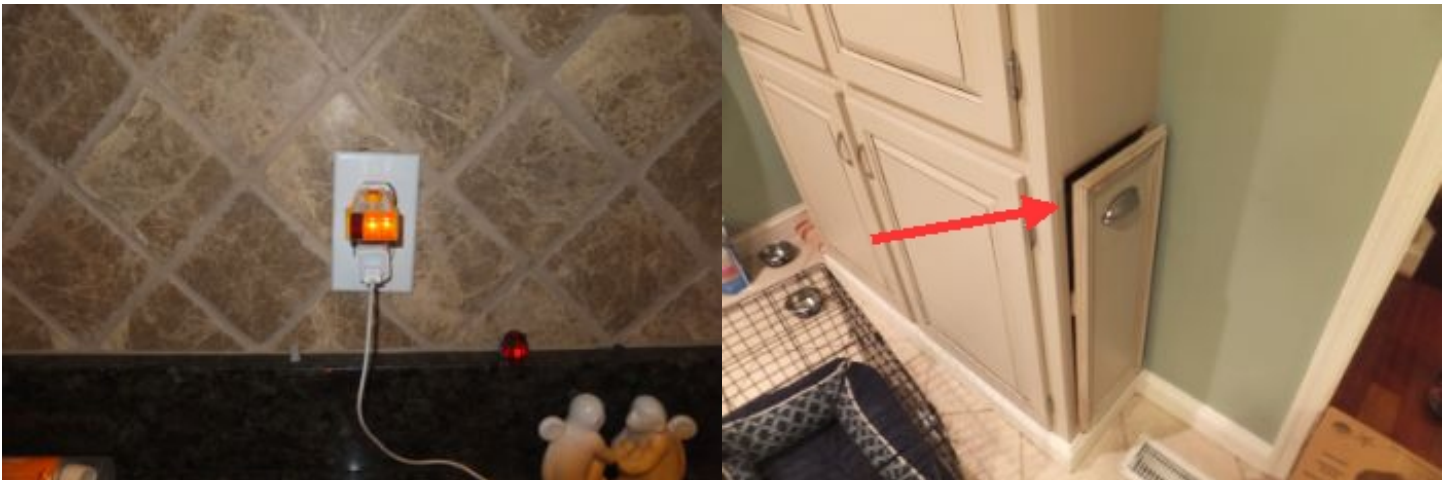
- GFCI trip test failed. It is recommended that all kitchen receptacles be protected by GFCI. A GFCI - Ground Fault Circuit Interrupter device protects us from receiving electric shocks from faults in the electrical devices we use in our home. At the time the house was built GFCI protection was not required in the Kitchen area.
- Cabinet damage. Door/drawer for trash can does not close completely

Kitchen outlet not GFCI protected

Cabinet Door does not close completely

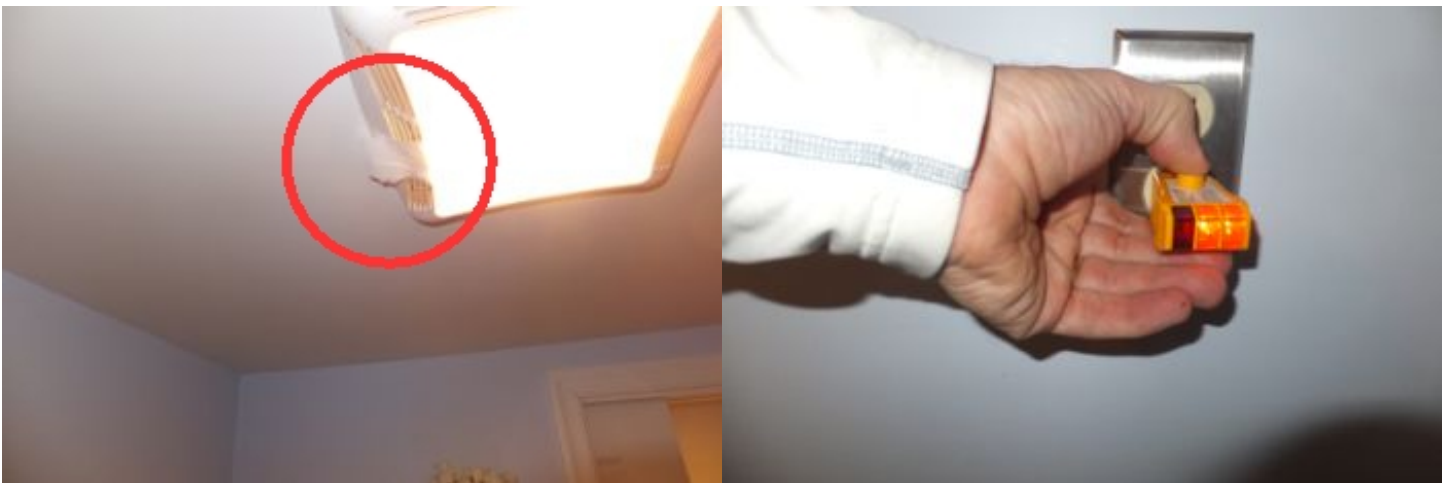
GFI receptacle not working properly

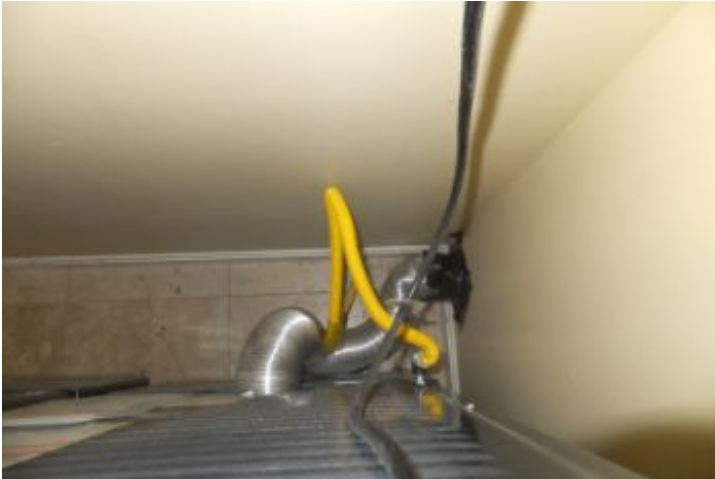
- Dryer venting is loose and should be reconnected to ensure proper air flow.
- Condensation on cold water pipes could be from the excess humidity created by the loose dryer vent. Recommend fixing dryer vent and insulating the pipes with a plastic foam insulation.

Dryer Hook-up - vent is loose

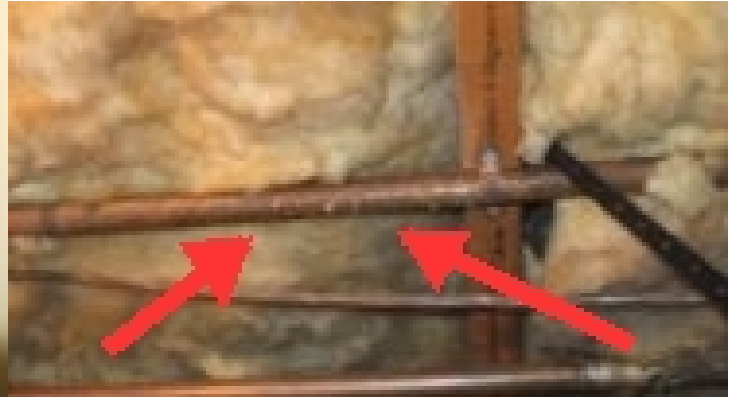
Condensation on Cold Water Pipe

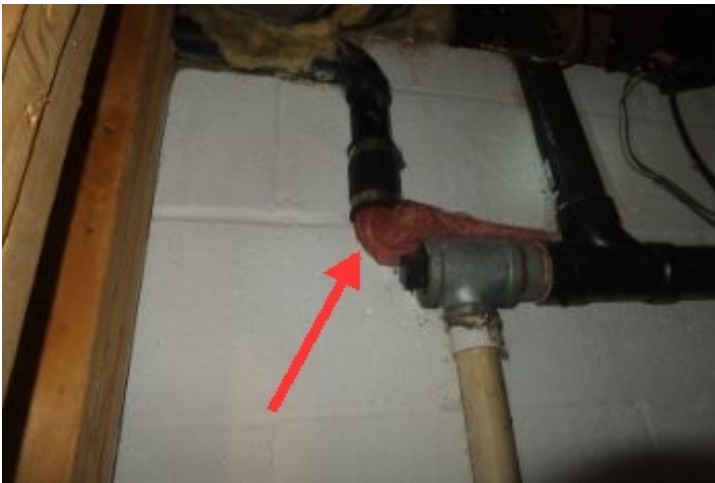
Sump Pump old drain pipe not capped

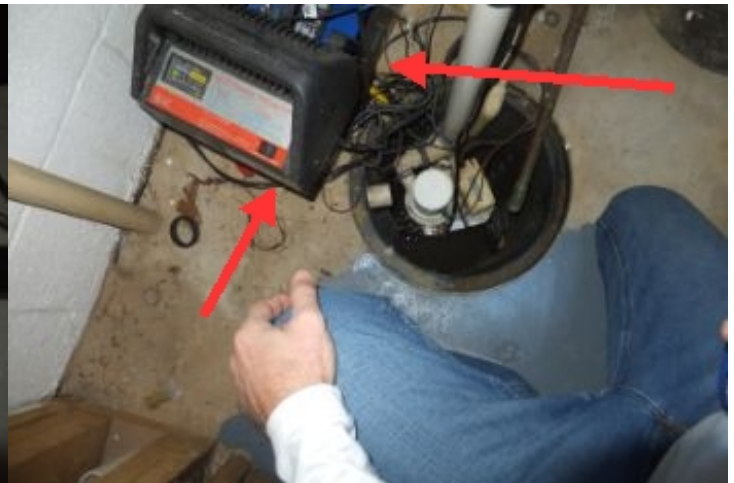
- **Electrical Supply for sump pump should be 4' from floor. Battery back-up for this system is good, but it must be elevated. Recommend an electrician to correct electrical issues.**

Sump Pump wiring with battery back-up should be off floor

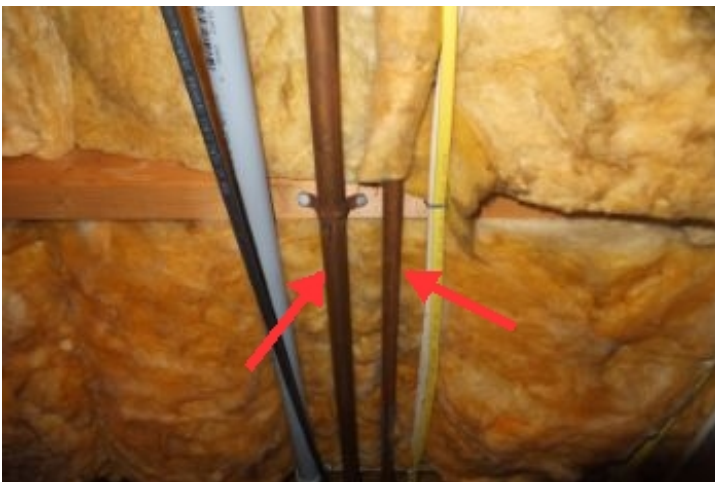
Water pipes too close together

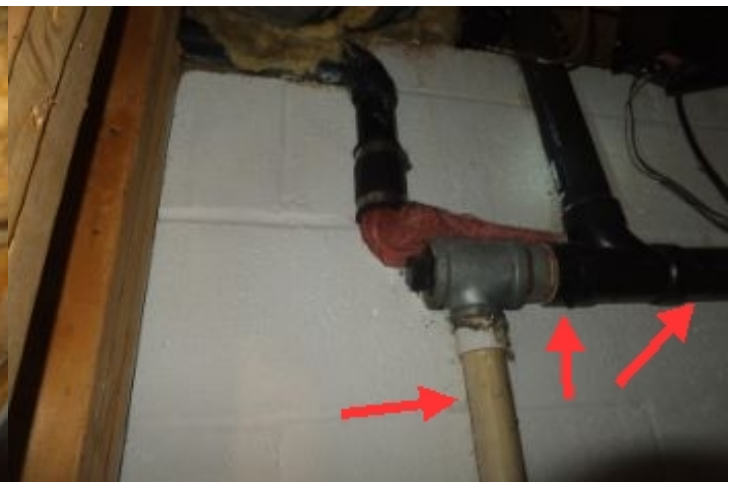
- Old sump drain should be capped off.
- **Sump pump is draining into the public sewer system. When sump pumps are connected to the city sanitary sewer system, their flow is taking up space needed to carry sewage to the treatment plant. These incorrect and illegal connections can cause sewage to back up into your basement or overflow into our rivers and streams.**

Drain to City Sewer

Relocate the sump pump discharges: The sump discharge point may be relocated so that it discharges a minimum of ten feet from the property line adjacent to a street or sidewalk. This distance may enable the water to infiltrate and absorb into the ground before reaching the street or sidewalk. The sump pump discharge may also be relocated to the backyard or side yard of the property. Backyard and side yard discharges should be located a minimum of ten feet from the property line to allow the water to infiltrate and absorb into the ground before reaching the neighbor's property.

Recommend a plumber to relocate sump pump discharge.

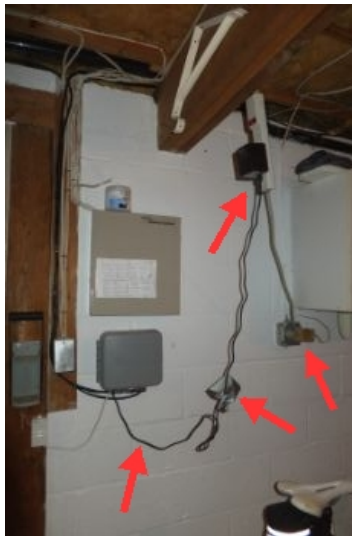
• **Sprinkler system should have an electrical outlet installed within 6 ft so the cord does not have to be extended and strung up on the floor joists.**

Sprinkler System plugged into plug strip

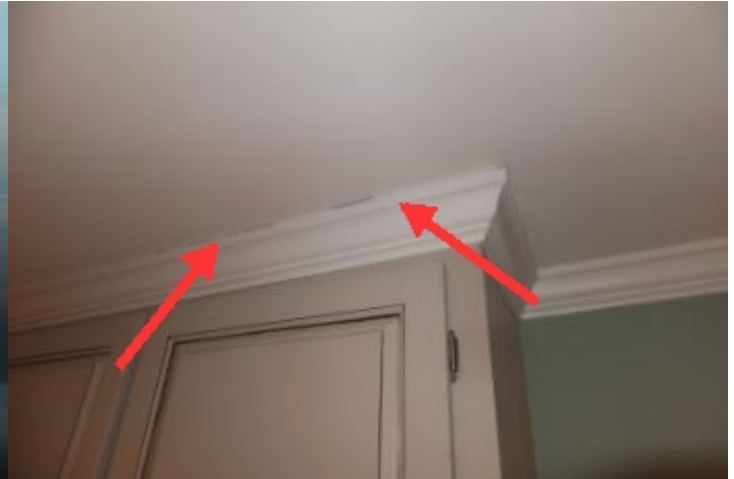
Some caulking needed in Kitchen

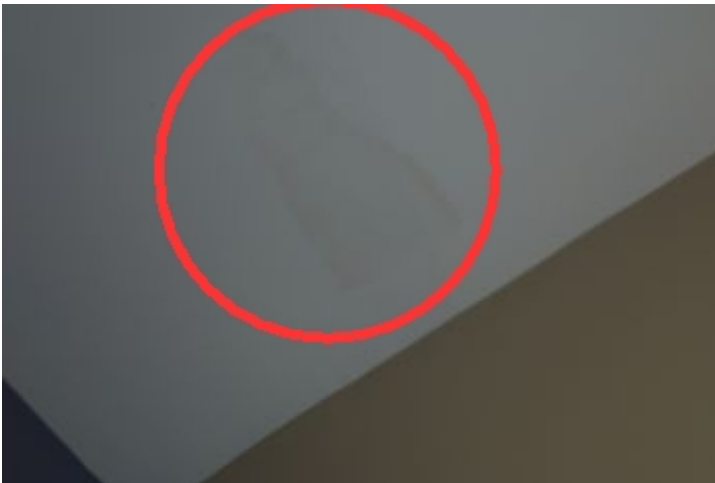
Water Stain on living room ceiling near fireplace

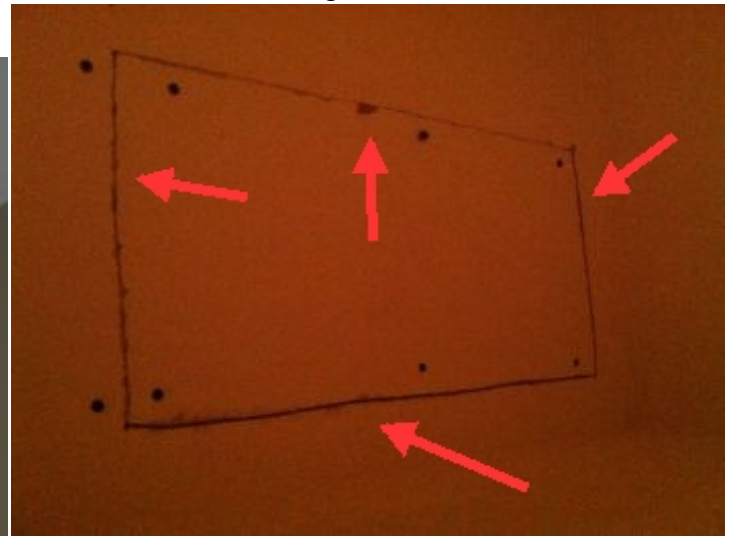
Foyer Closet ceiling patch

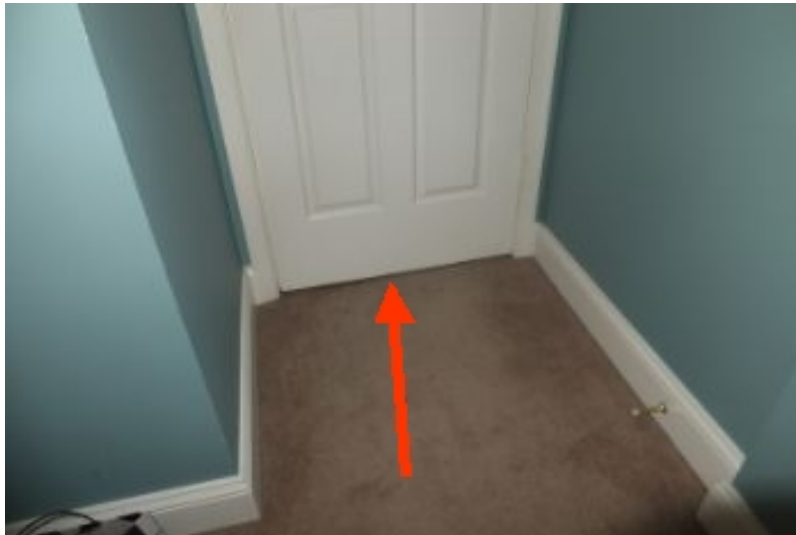
- No major system safety or function concerns noted at time of inspection.
- Air and light entering at entrance door.
- **Bedroom doors too tight to carpeting to allow proper return air flow. Recommend 30 sq in of space between door and carpet. For example is the door is 30 inches than we need a 1 inch gap between the floor and carpet. Currently there is less than 1/2 inch.**

Bedroom doors too tight to floor. Does not allow return air to flow.
