Concrete Preservation Institute

Preservation Field School Alcatraz Island Summer 2015 Project Report

Rehabilitation of the Main Cell House Roof Access Stair and Landing

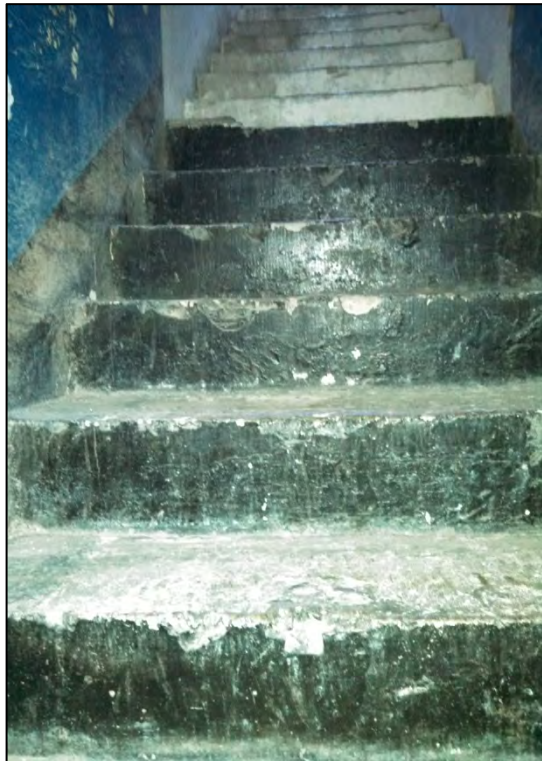
Figure 4: Existing condition of the stairs. The preservation approach was to preserve the treads since they show so much history with their worn appearance. Repairs were done from below. These stairs share the wall with the historically significant graffiti.

Figure 3,, showing the worn concrete steps, shows that the roof access system has been extensively used throughout the Island's history, including serving as .access to the guard tower situated on the roof during the Federal Penitentiary times. Due to external factors such as high concentrations of moisture allowed to enter as a result of deteriorated weatherproofing at the roof access port above the landing, the 100-year-old structure possessed a high degree of deterioration. This condition had progressed to the point that the stability of the stair was concerning. With a preservation-focused approach, the repair plan included preserving the stair treads shown in Figure 3 and repairing/stabilizing the stair system from beneath. This was a difficult approach, but given that they are such a vivid record of history and use (how many pairs of boots walking up and down for over 100 years did it take to wear a pattern into the concrete?), the team decided it was the appropriate approach.

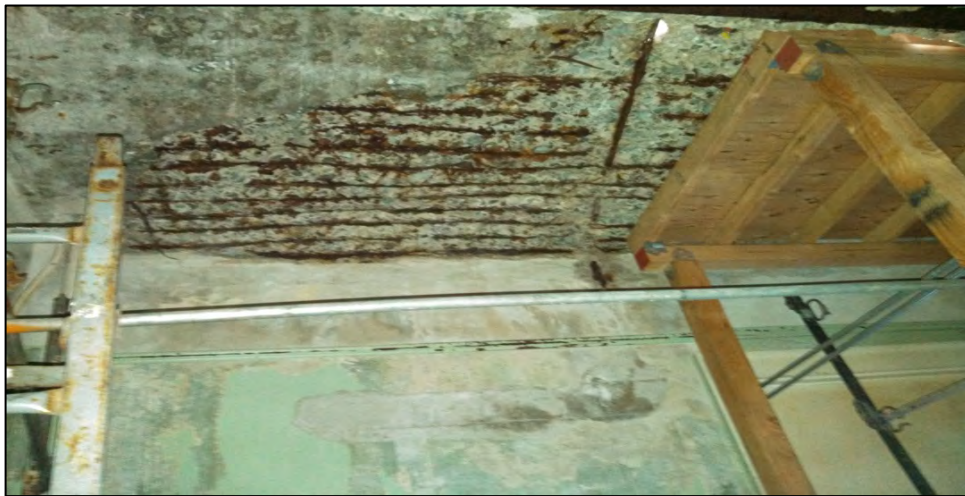
Figure 5: Severe delamination and spalling at the underside of stair landing with approximately 50-60% loss of reinforcement.

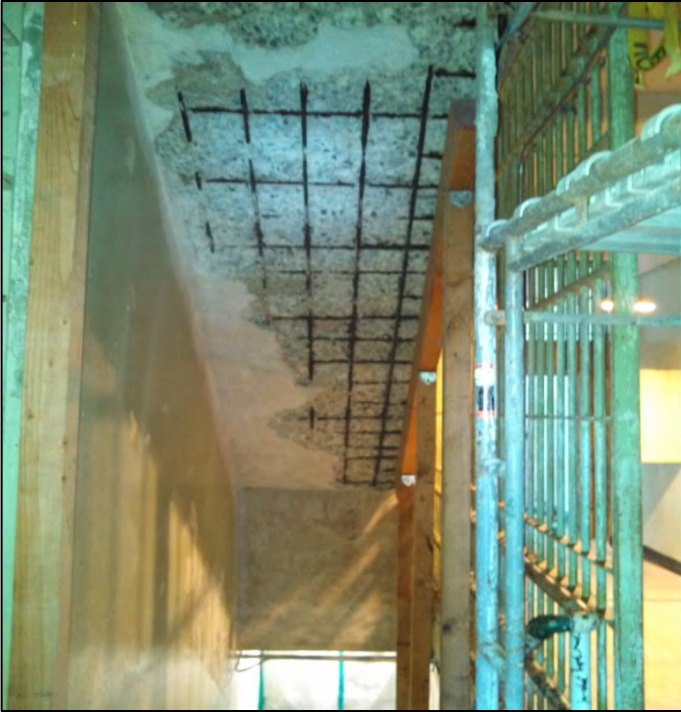
Figure 6: Existing conditions of underside of stairs; extensive delamination due to corrosion of the reinforcing mat.

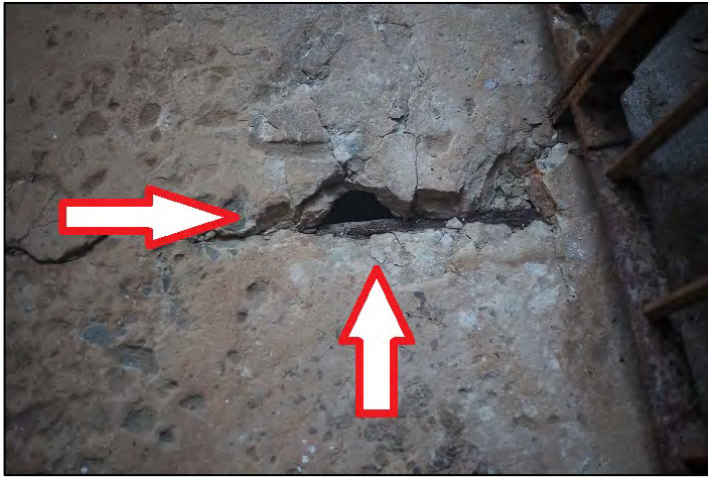
Initial assessment revealed that the stair and landing were badly deteriorated, including reinforcing steel corrosion and spalling as shown in the pictures below. The landing had deteriorated to the point that a visible hole was beginning to form.

Figure 7: Top surface of the landing showing a void approximately 4" x 3"

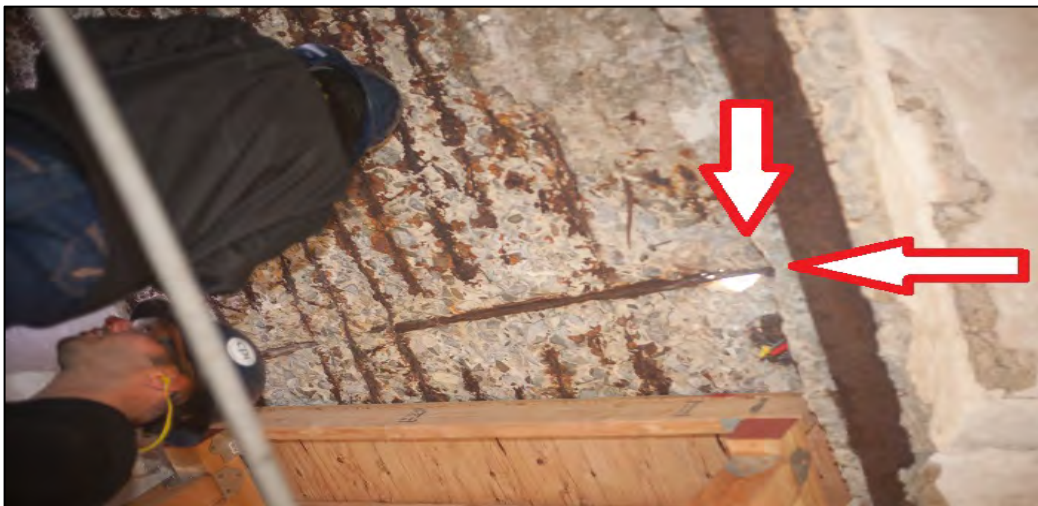
Figure 8: Underside of the landing showing void appearing in Figure 6 as well as general concrete deterioration.

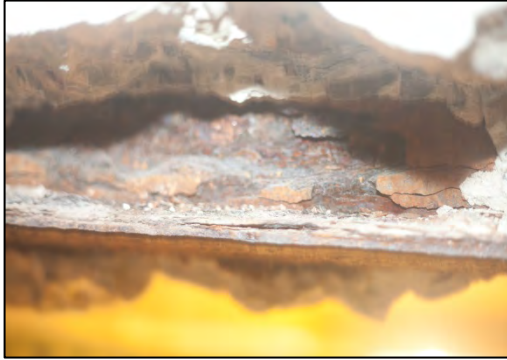
Our team confirmed that expansive corrosion products were forcing movement in the concrete by taking measurements of the beam connected to the landing. A difference of ½ inch on the height to ceiling dimension indicated such forces are acting in an upward direction lifting the

Figure 9: Severe corrosion on the I-beam parallel to the landing.

This difference shows that the south end of the landing was subjected to the dynamic force of corrosion. The following drawings show field verified dimensions substantiating that this dynamic force was being applied within the structure of the landing and I-beam configurations.

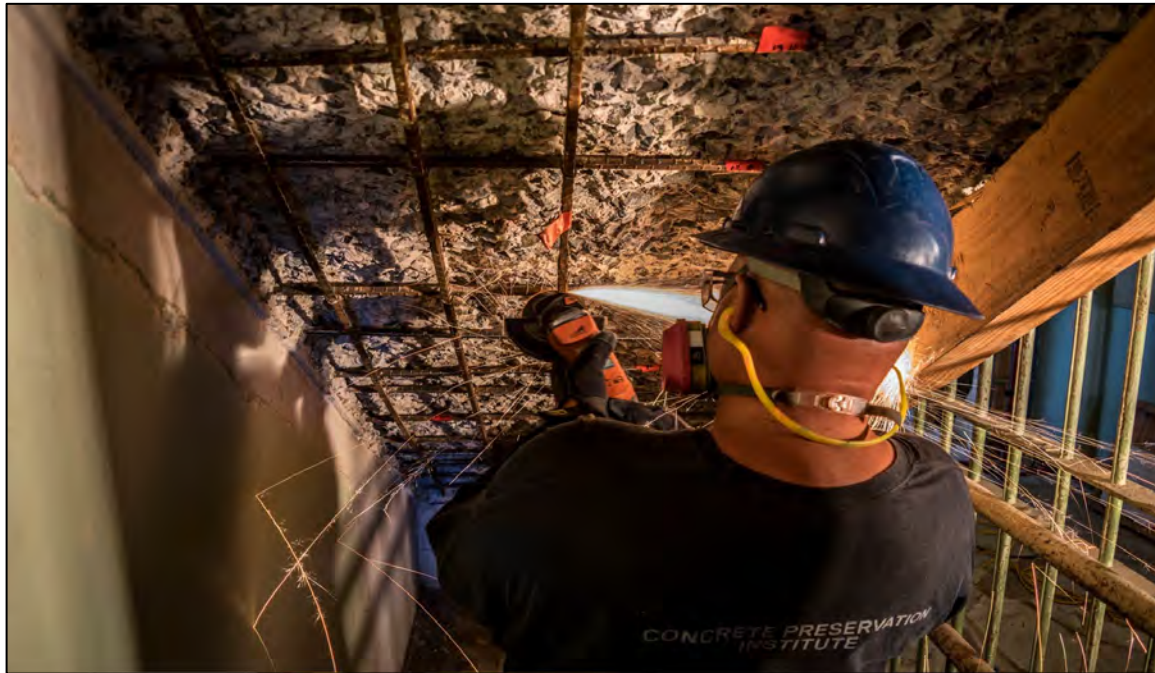
Figure 16: Removal of deteriorated steel reinforcing.

Approximately 40% of the original reinforcement in the stair soffit was reused in this project. Keeping history intact and alive on the Island was the focus day-after-day by the CPI cadre and NPS Historical Architect Jason Hagin.

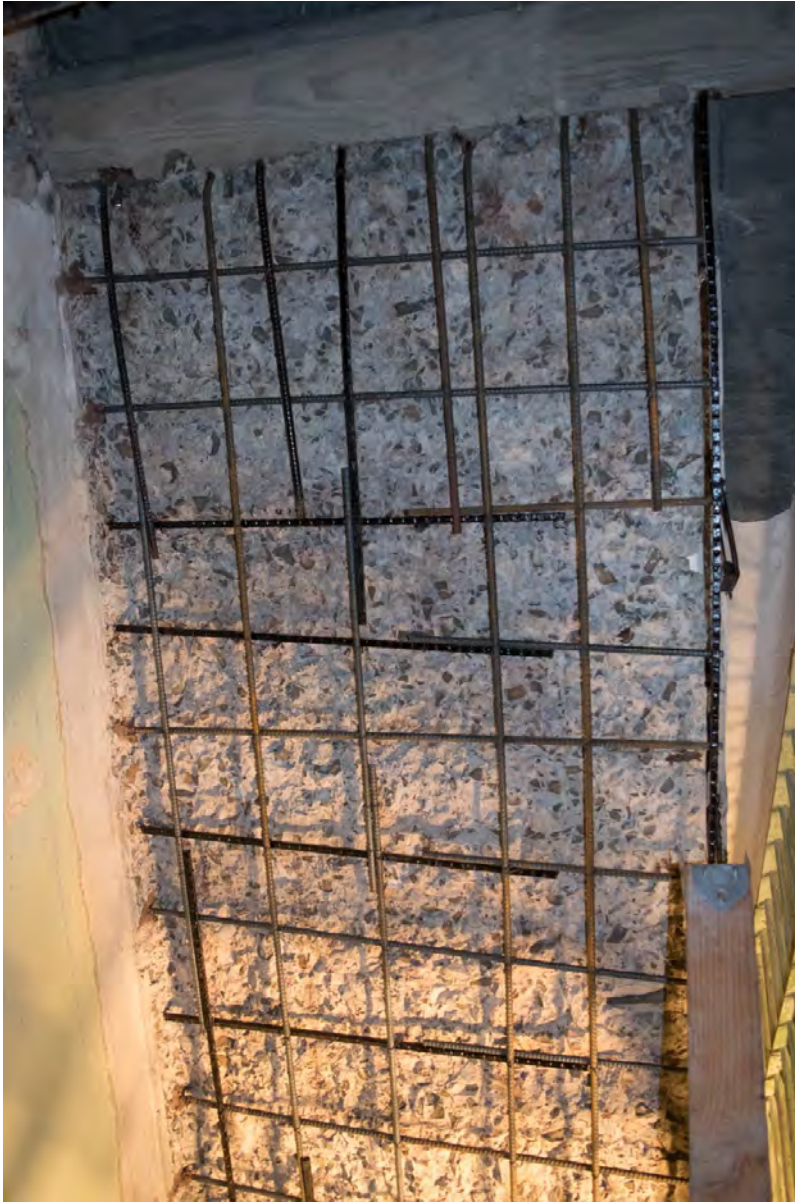
Figure 17: New steel reinforcing spliced onto existing historical reinforcing that was in an adequate condition to be left in place.

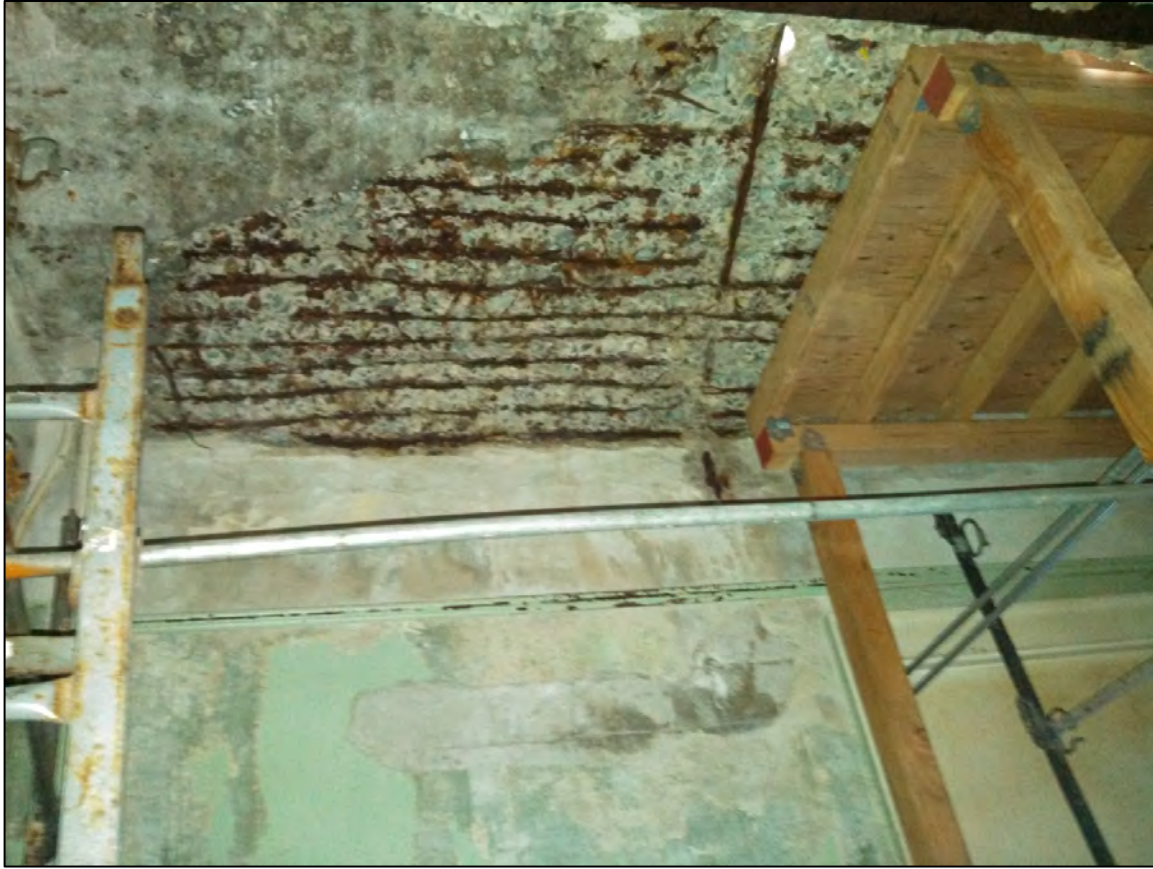
- The reinforcing steel installed during original construction circa 1908-1912 was severely corroded in multiple locations. According to ICRI standards, when 20% section loss of reinforcement has occurred, removal and replacement of the affected steel must be done. New steel reinforcing was spliced onto remaining intact steel with a lap distance of 20 times the diameter of the steel, as per industry standard.

Figure 18: Existing 4" on center, parallel, badly damaged reinforcing steel at landing.

- Upon inspection, we observed that the existing rebar had short spacing of 4" on center. With further inquiry with Sparks Engineering, we were advised that 12" on center spacing and both parallel and perpendicular placement was best. This was placed against the old lateral direction steel (see image below).

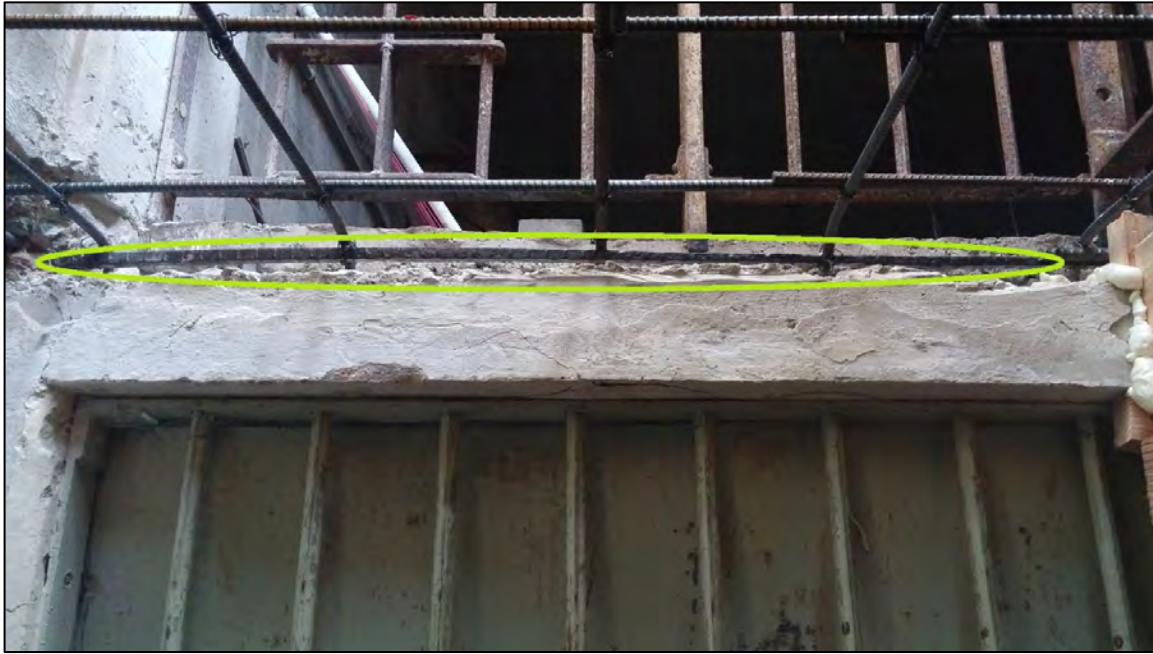
Figure 25: Preserved in situ 5'9" section of steel reinforcing from original construction (circled in yellow).

- The reinforcing bar at the east end of the platform was adequate in size and not corroded. This reinforcement was cleaned using three Hilti grinders. A rust inhibitor was applied to stop any further decay. The rest of the reinforcing steel in the landing was determined inadequate as per ICRI standards. Because of corrosion and the original construction design, after concrete placement it would have less than a 2" coverage. Therefore, it had to be removed. Once it was removed, we installed new reinforcing 1 1/4" lower than the

original design. We mechanically tied it to one 24” piece of #5 reinforcing bar that we dowelled into the existing wall using Hilti HIT-HY 200-A Epoxy.

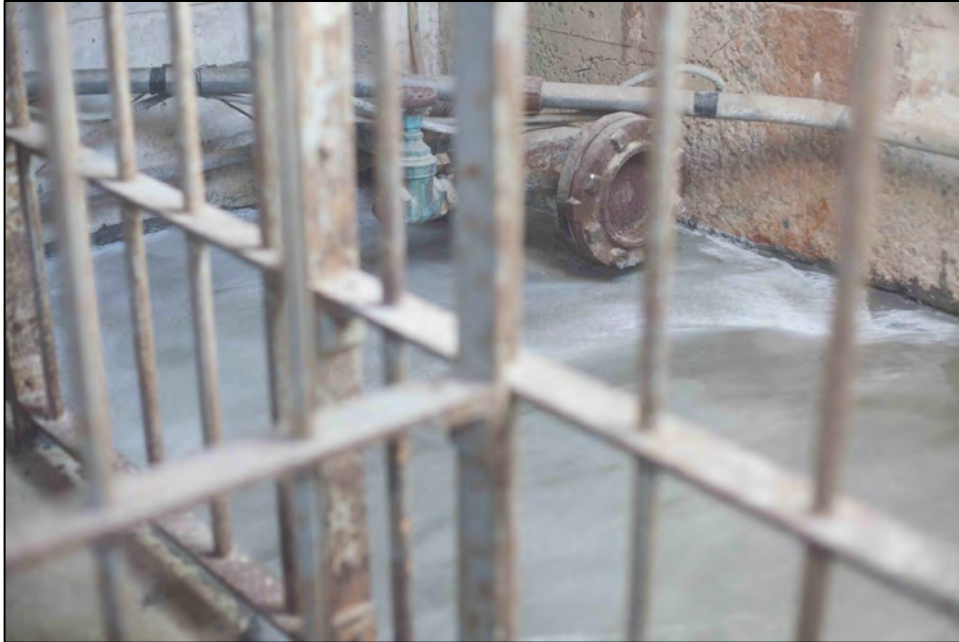
Figure 39: Repair concrete at landing after removal of forms.

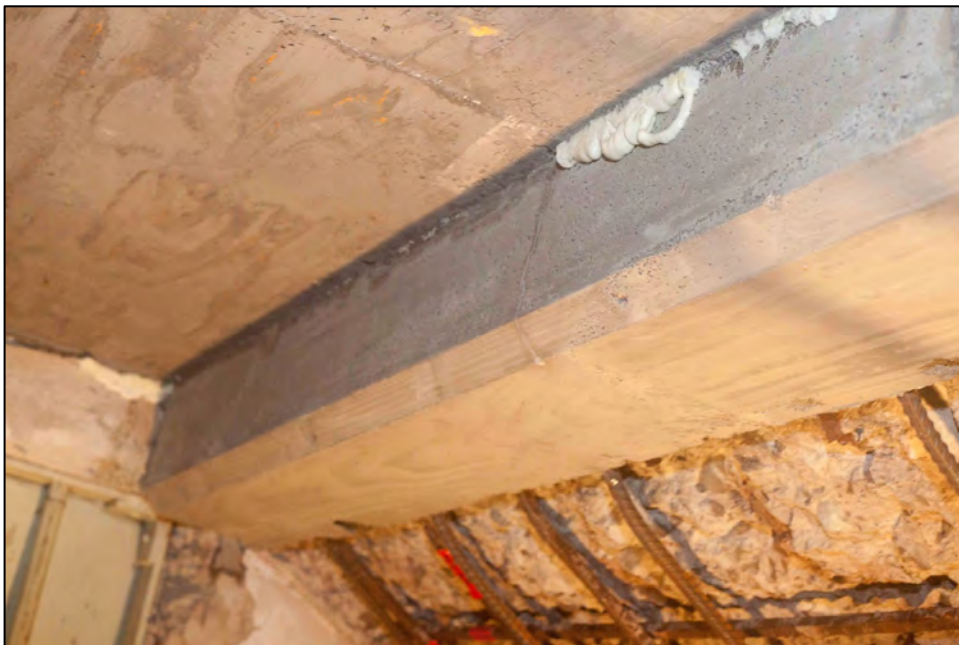
Figure 40: Repaired concrete at landing beam and slab after removal of forms (notice bottom side stairs at below/right/ demolition complete, awaiting formwork and repair).

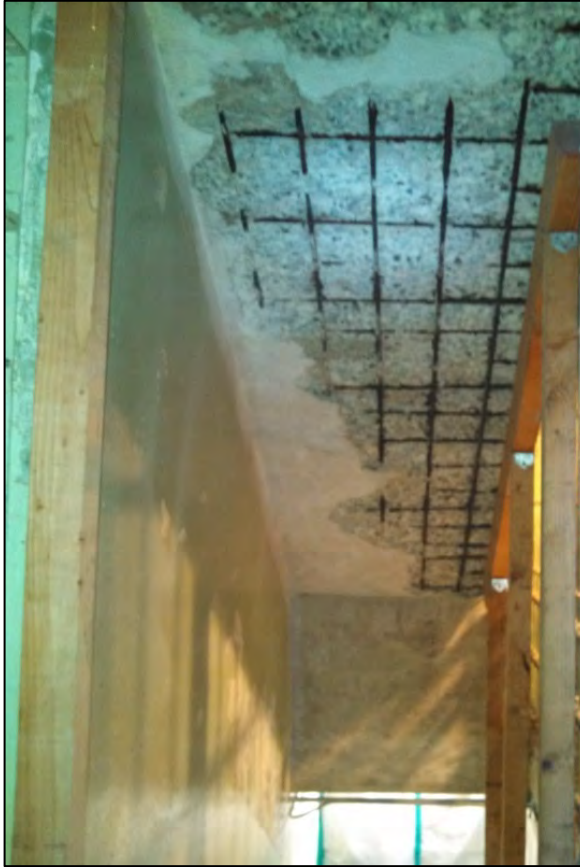
Figure 50: Stair before.

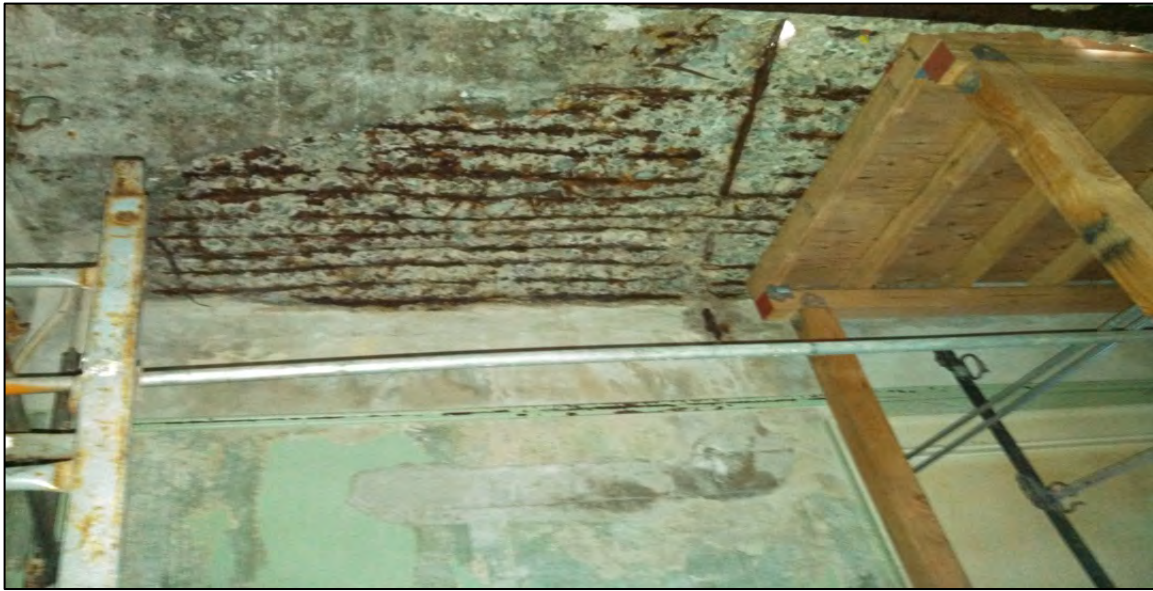
Figure 52: Landing and beams before.
