Home Inspection Report

4 Smith Court, Any-town, NY 12083

Inspection Date:

Thursday, April 12, 2018

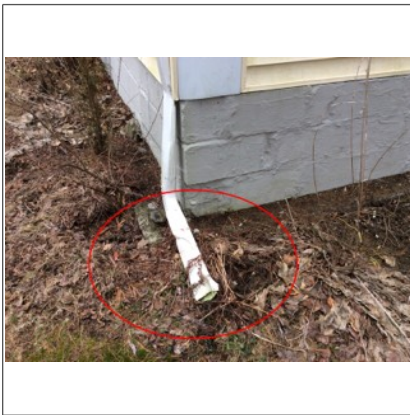
Sloped •Debris should be removed from the roofing to reduce risk of leaks and early roof wear.

Gutters & downspouts •As a preventative measure, it may be wise to direct all downspouts so they discharge at least 5 feet from this house. Storm water should be encouraged to flow away from the building at the point of discharge. Damaged downspouts should also be replaced.

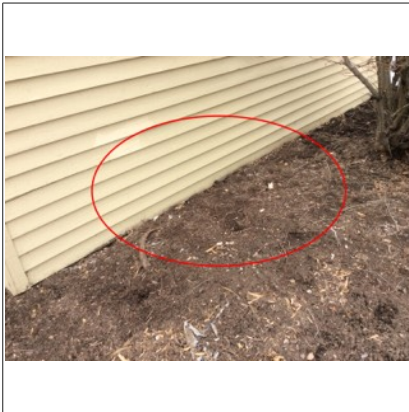
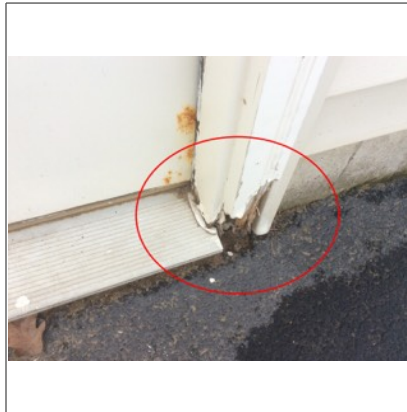
- Ext. walls**
- The openings in the siding, such as the opening where the main service wire passes through the left exterior wall of this home, should be sealed and re-secured to avoid moisture and wind-damage.
 - The wood trim around this home should be painted to preserve the building.
 - Siding to soil contact should be avoided to reduce insect and rot-damage risk.
 - Localized rot was observed in the wood trim of this home. Following repair of the damaged areas (which should be combined with exterior painting/maintenance) proper maintenance of the wood trim and control of water from roof or surface runoff can avoid further damage.

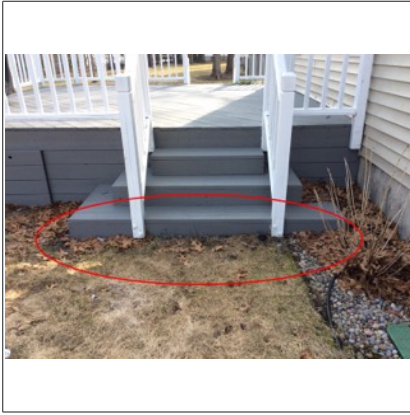
- Windows**
- Damaged windows, such as the broken window located on the right wall of the garage, should be repaired or replaced as necessary. Watch for unsafe loose glass.
- Garage**
- The door between the garage and the interior of the house should be equipped with an auto-closer device, rated to resist fire as per local codes and should be well sealed to prevent automobile fumes from entering the house as discussed.
 - Pronounced floor cracks were noted in the garage. While this amount of cracking is unusual, this slab is not a structural component you should be aware of the trip hazard.
- Deck**
- Wood to soil contact should be avoided on the steps of the deck to reduce insect and rot-damage risk.

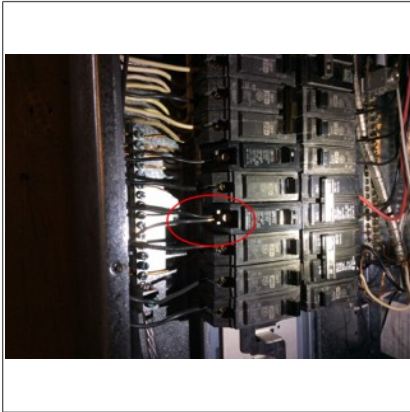
Main panel

- There are two openings in the front of the main electrical panel of this home. Any openings in the main panel should be covered as discussed.
- There is one doubled up circuit labeled in the main electrical distribution panel as serving the basement and exterior of this home. Circuits within the main panel that are doubled up (referred to as "double taps") should be separated as discussed. Each circuit should be ideally served by a separate breaker.

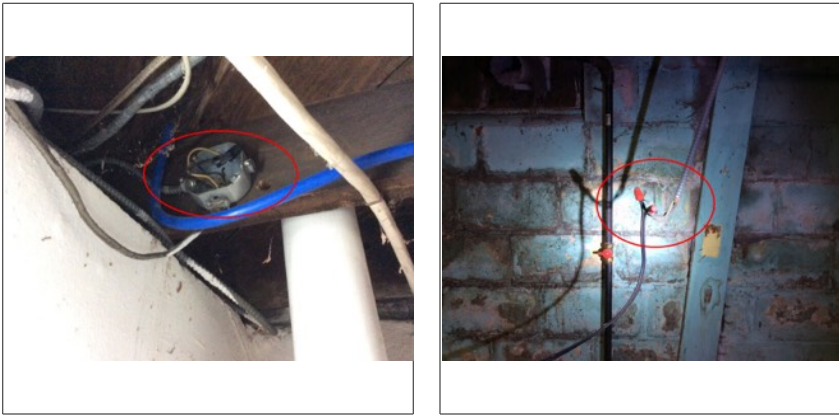
Distribution wires

- Improper electrical connections such as the one found in the basement of this home should be repaired. All electrical connections should be made inside junction boxes fitted with cover plates.
- All junction boxes, such as the open one located in the basement of this home, should be fitted with cover plates, in order to protect the wire connections.

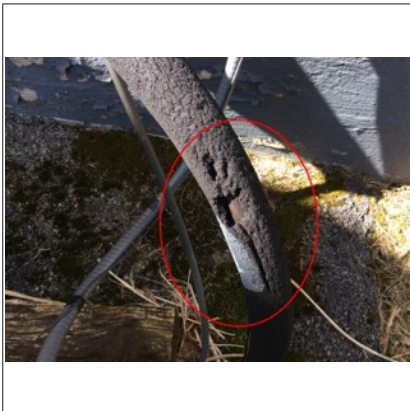
Central air conditioning

- Damaged and or missing insulation on refrigerant lines should be repaired. These outside lines should be insulated all the way to the compressor unit to prevent loss of temperature in the lines.

- The outdoor unit of the air conditioning system is out of level. This should be improved as this condition could cause insufficient lubrication and an off level unit can also add unintended mechanical strain to the fan bearings.

- The outdoor unit of the air conditioning system requires cleaning and service. Servicing should be a regular maintenance item (every two years) to assure efficient and reliable AC. Cleaning your outdoor AC unit should be part of your regular annual exterior maintenance.

- It is recommended that just the top of air conditioning outdoor unit be covered in the months that is is not in use. A top cover can prevent debris from becoming lodged inside the unit. You can use something as simple as a single piece of plywood with a brick or rock to keep it secured. It is important not to cover the sides of the AC unit as it causes trapped moisture. It is important to remember to remove the cover off the top of your AC unit in the spring before use.
