SAGUACHE CREEK DIVERSION INFRASTRUCTURE INVENTORY

Structure Name: GEORGE BALL D

GEORGE BALL DITCH

Saguache Creek Stream
Management Plan

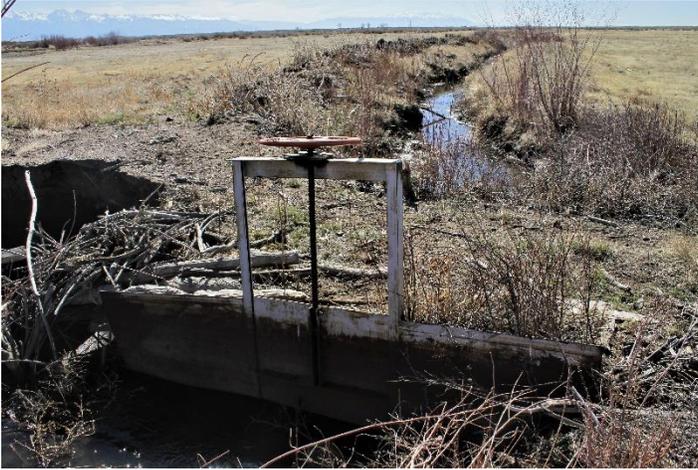
Headgate looking downstream

Repair(s) or Improvement(s) Currently Needed: The leaky headgate needs to be repaired and a new wheel needs to be installed. A new diversion dam should be installed that requires less maintenance and allows debris to pass through the system. Bank stabilization is needed downstream of the diversion dam to prevent channel widening and potential dam and headgate failure. Continued ditch maintenance is required, paying particular attention to ensuring the ditch remains in one channel below the headgate. Fish passage and riparian restoration should be considered as part of any future repairs or improvements.

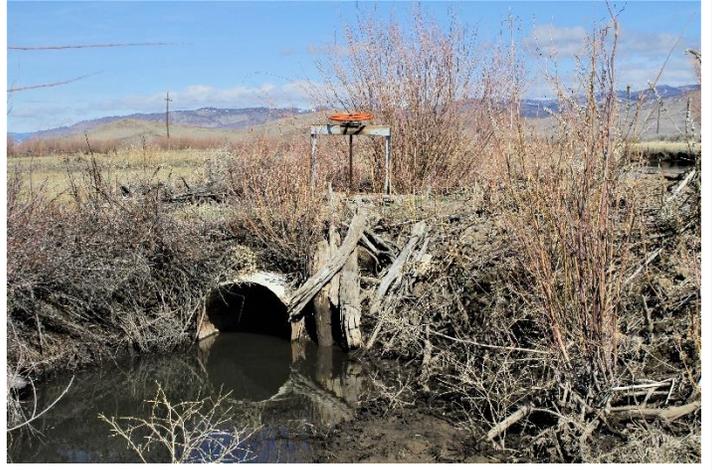
Headgate outlet

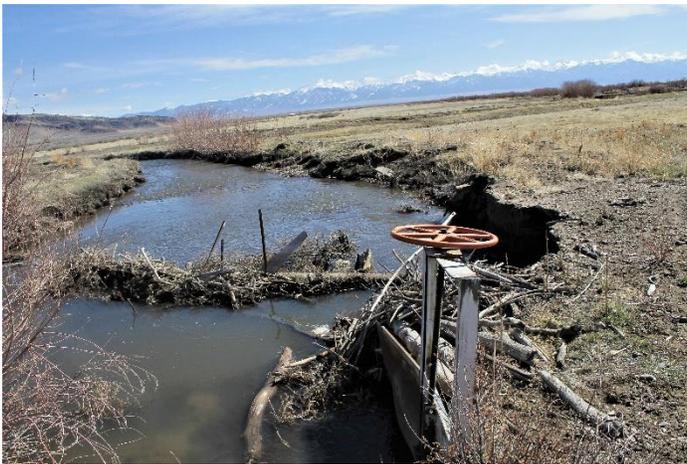
Headgate and diversion dam

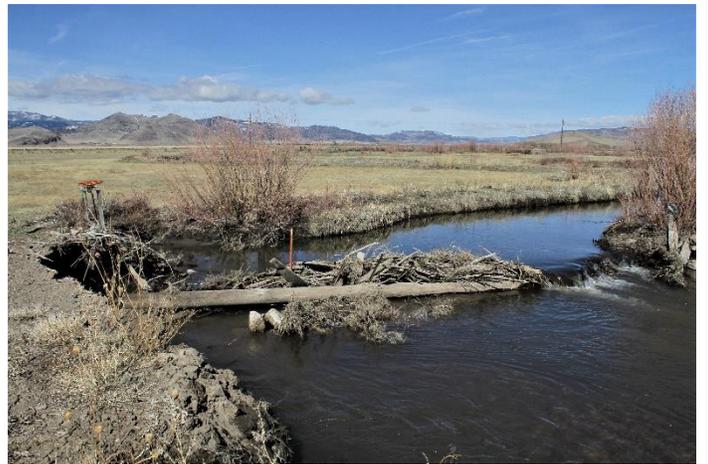
Structure Description: A diversion dam composed of t-posts, a telephone poll, and rocks diverts water to the headgate, which is located on the south bank of the stream. Woody debris accumulates on the dam, making it difficult to adjust head pressure. The streambank downstream of the headgate is eroding and may cause the entire headgate to wash out at high flows. The headgate also leaks significantly. The flume measures accurately but is tilted and severely eroded on its downstream side. During a high flow event, it is possible that the stream could intercept an historic channel beginning just downstream of Quartet Ditch. If this occurs, it would cause the stream to bypass the George Ball Ditch headgate.

Diversion dam

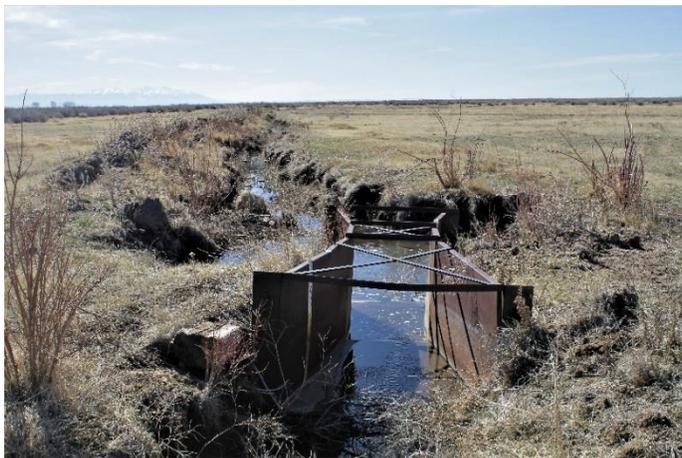
Flume looking downstream

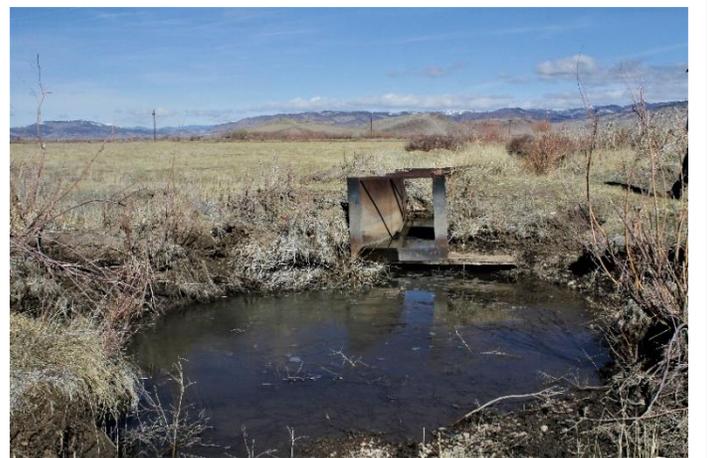
Flume looking upstream
