1623 Carol Street  
Downers Grove, Illinois 60515  
Inspection Report for Property at:

Private Home Inspection for:

## 2 – General Information

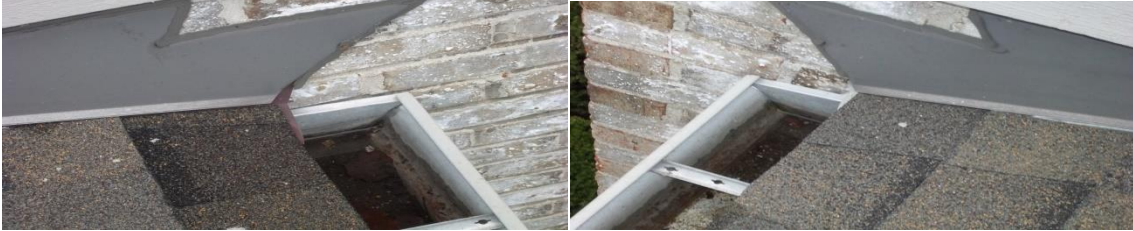
Flashing and Joint material: Galvanized steel/tin or aluminum  
*Comments:* Kick out flashings are missing. These divert runoff to the gutter.

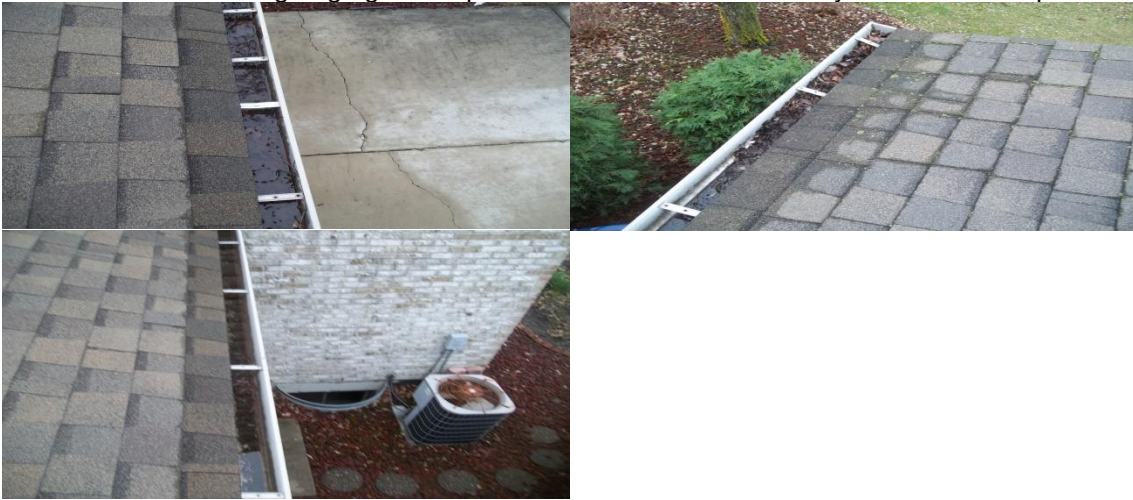
Gutters and Downspouts: Aluminum  
*Comments:* The gutter system appeared to be in serviceable condition at the time of inspection. Keep gutters clean and seams sealed to allow proper control of run-off. Recommend extending downspouts 3-5 feet away from home to improve drainage. The section of rear garage gutter is pitched towards the house away from the downspout.

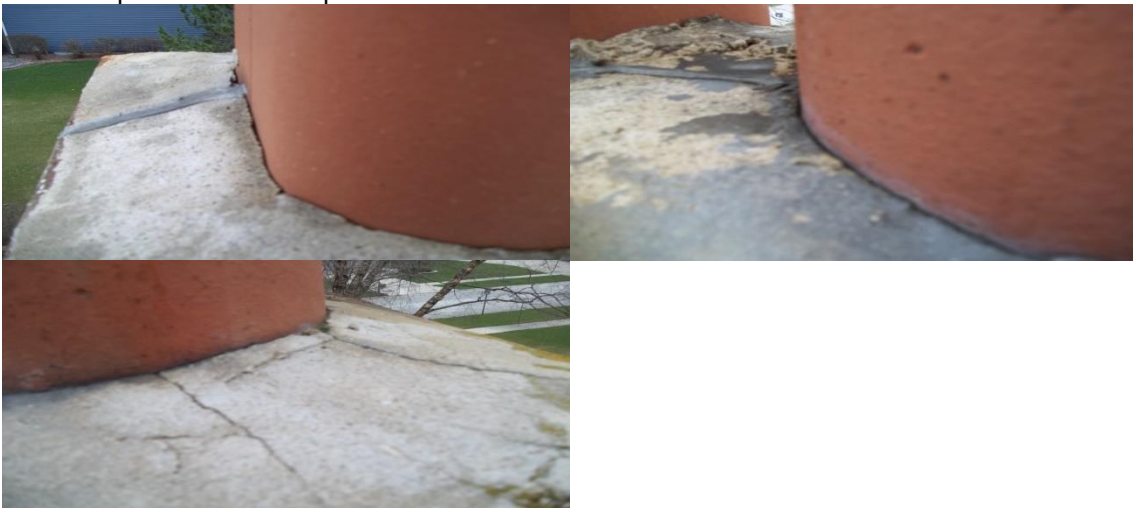
Chimney material: Masonry. Keep the chimney cap well sealed to exclude moisture. There are cracks/gaps in the concrete chimney cap. These are not a structural concern but should be sealed to prevent moisture penetration.

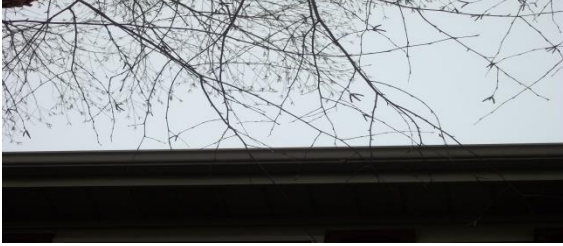
*General roof comments:* Recommend keeping the tree branches trimmed away from roofing to prevent future damage to roofing materials.

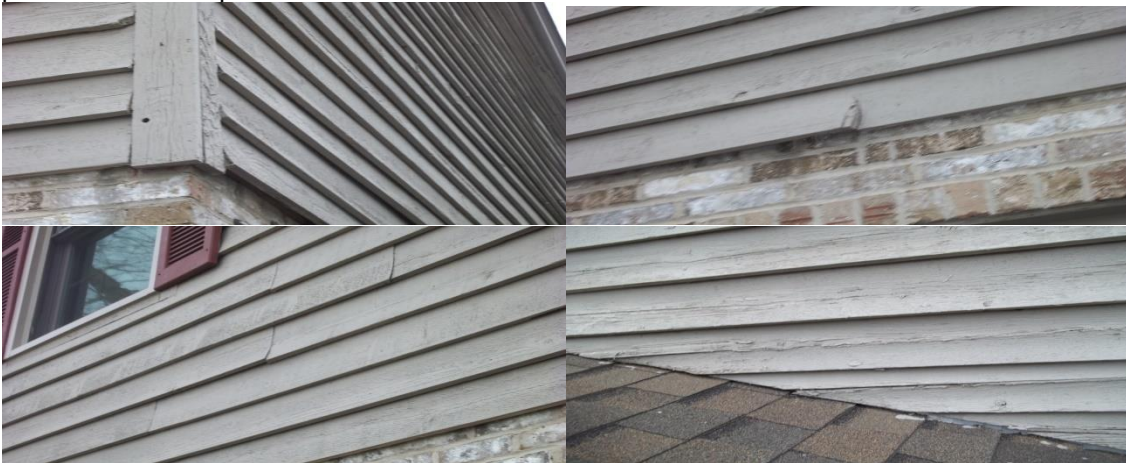
*Comments:* Several sections of the cedar siding cupping & cracking. This creates a potential moisture penetration.

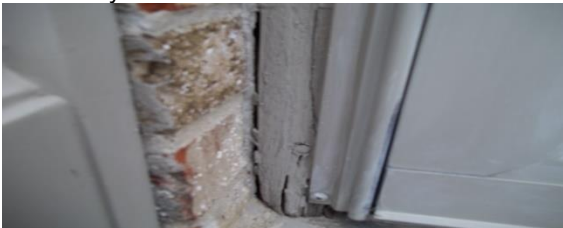
*Comments:* Two 1<sup>st</sup> floor patio doors do not lock properly. Wood rot was detected on the front entry door trim.

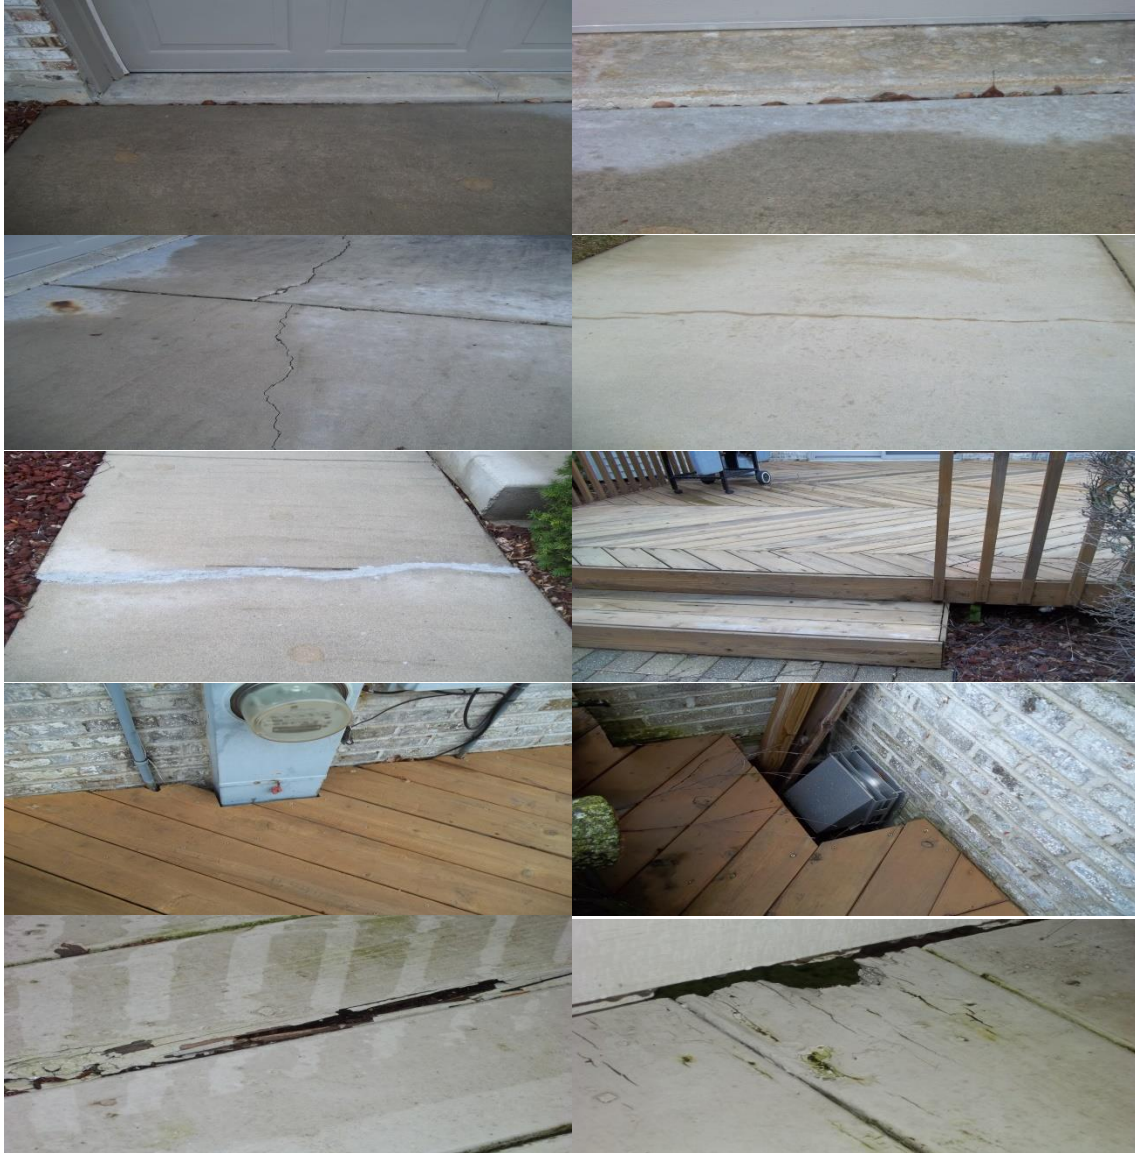
*Comments:* The concrete driveway has settled at the garage. Keep driveway cracks sealed to prevent deterioration. The front walkway is raised creating a trip hazard. Recommend handrails at deck stairs for safety. The deck obstructs removal of the electrical meter access panel. The tankless water heater exhaust requires a minimum two feet clearance from the deck. Wood rot was detected on the master bedroom balcony deck boards.

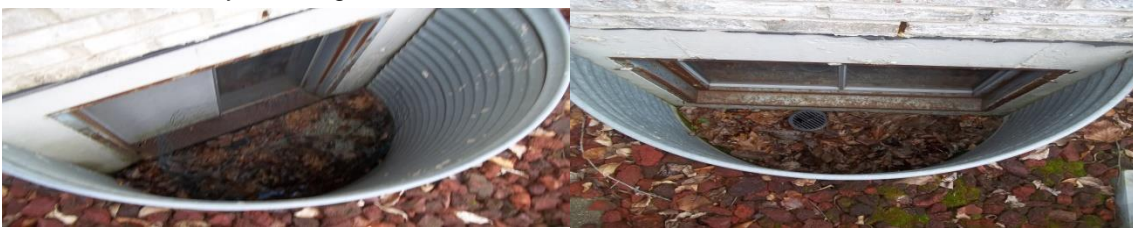
**Basement ventilation System:** Windows. Window wells should be cleaned out and the drains flushed to ensure proper drainage. Keep window wells free of debris to allow proper drainage. This is best done by covering the window wells.

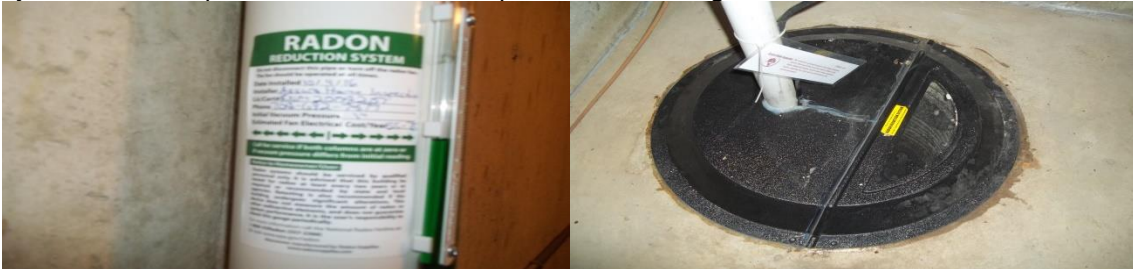
**General Foundation and Structural Notes:** The home is equipped with a radon mitigation vent system. The sump lid has been sealed as part of Radon mitigation.

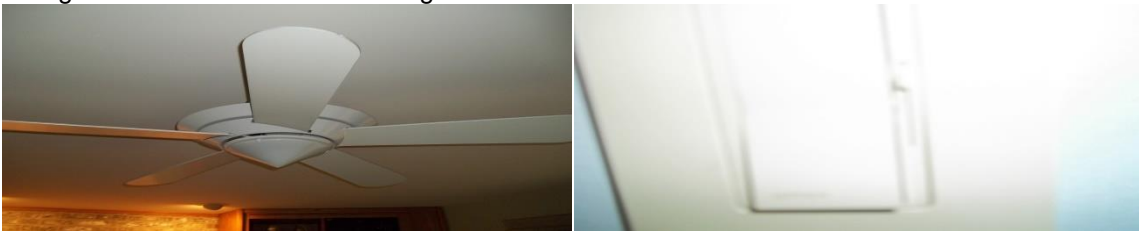
Interior light fixtures: There is no light switch at the bottom of the basement stairs. This may not be in compliance with local electrical ordinances. The family room fan light does not operate. The dining room dimmer switch is damaged.

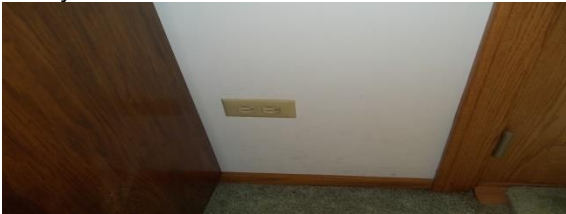
Outlets: The front exterior ground fault outlet did not trip when faulted. Recommend this be corrected for safety. The master bedroom North outlet is damaged. Recommend replacement for safety.

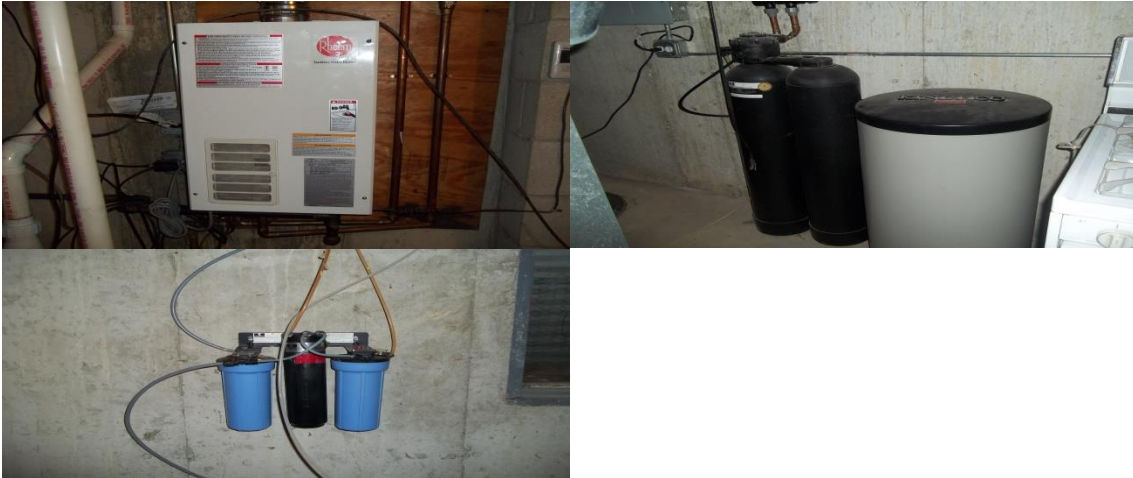
*Comments:* Rheem®. Recommend water softener & water filter be removed if not in use.

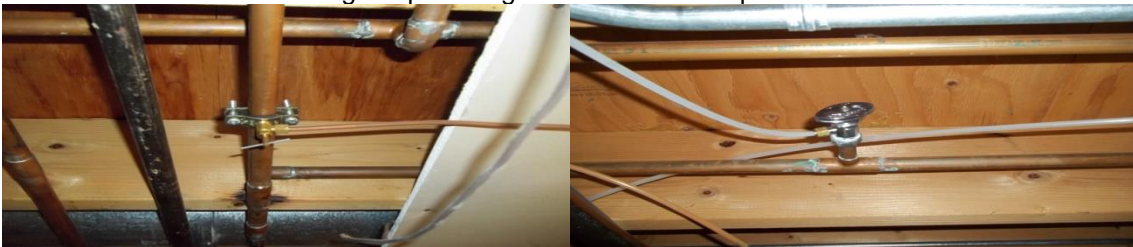
*Comments:* The furnace is a higher efficiency type equipped with induced draft and electronic ignition. Before each winter, clean humidifier and replace element as necessary. Remember to close humidifier damper during summer. The humidifier water supply valve is a pipe clamp type. These are known to fail. A regular plumbing shutoff valve is required.

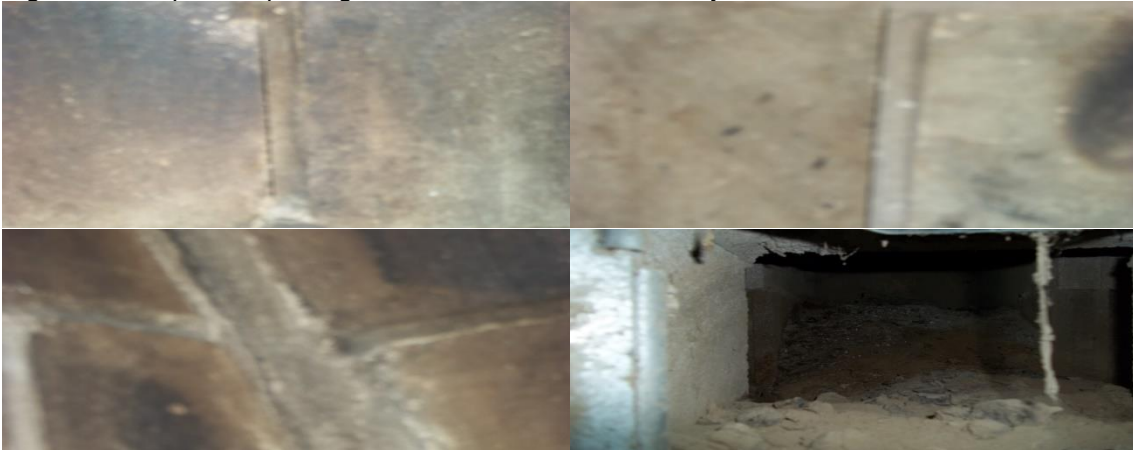
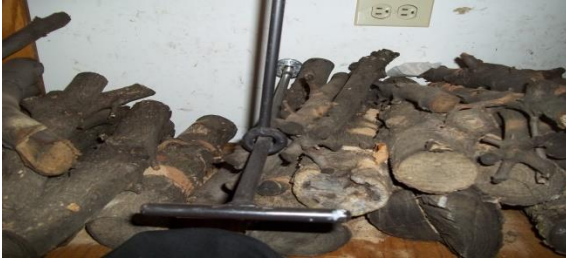
*Comments:* There are several cracks and gaps in mortar joints in walls of firebox. These should be repaired as needed for safe and proper operation. Recommend cleaning ash cleanout in basement. The gas control valve is located inside a cabinet. This does not meet NFPA regulations require fireplace gas valves to be visible & readily accessible.

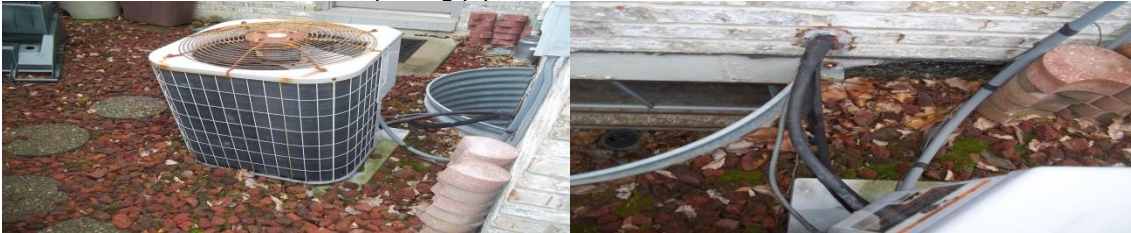
*Comments:* Outside temperature is too cold to safely operate A/C unit. The A/C unit should be operated and checked by a qualified HVAC contractor before closing if possible. The unit is not level. Recommend repairing pipe insulation.

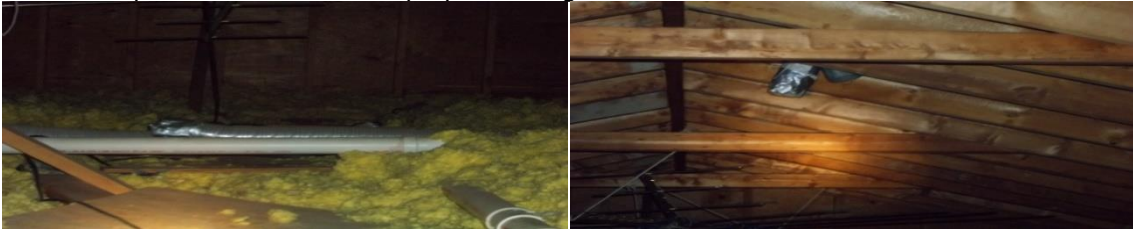
*Comments:* Bathroom vent ducts have come loose in the attic. Recommend they be extended up to roof vent to insure proper venting.

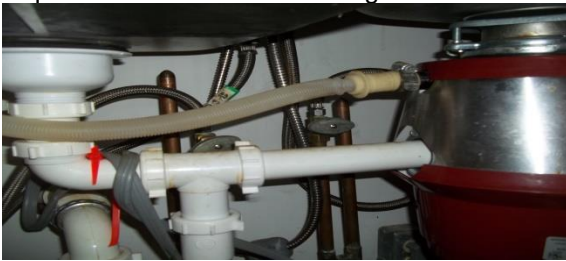
Dishwasher: Bosch®. The drain discharge is configured improperly. Local plumbing ordinances require the dishwasher discharge to be connected to a tailpiece not the waste disposal.

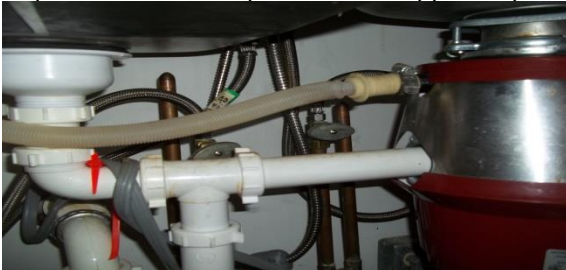
Garbage Disposal: The drain assembly is improperly configured. Local plumbing ordinances require the waste disposal to be trapped separately to the main drain.
