SAGUACHE CREEK DIVERSION INFRASTRUCTURE INVENTORY

Structure Name: MONK D 1

Date: April 4, 2019

Saguache Creek Stream Management Plan

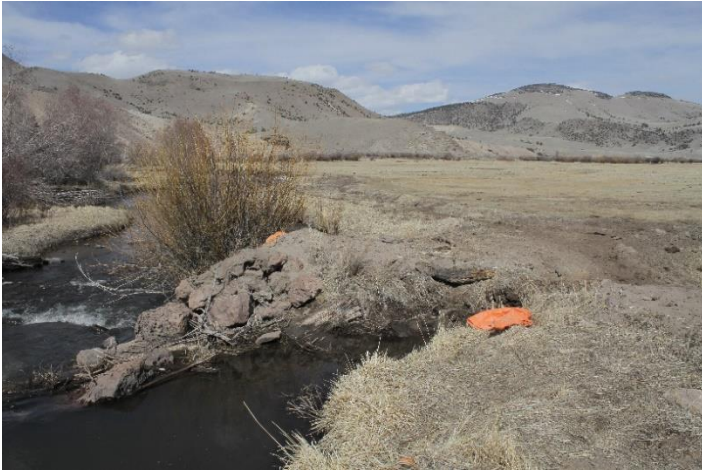
Point of diversion looking downstream

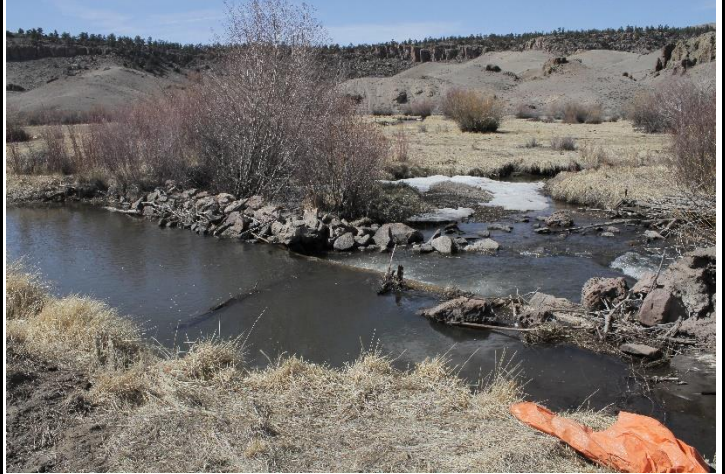
Diversion dam looking downstream

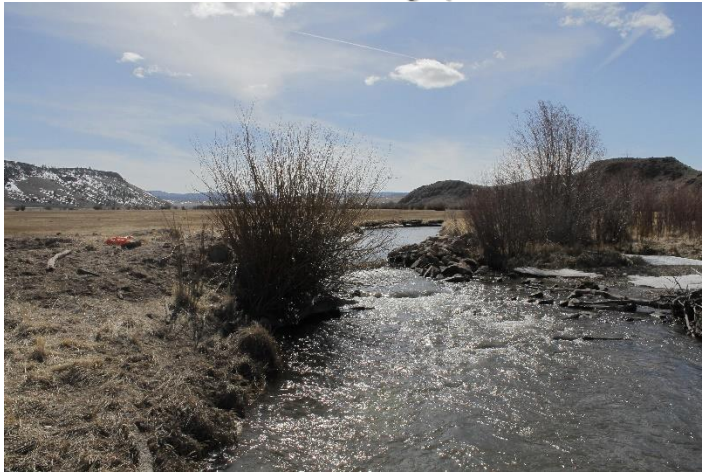
Diversion dam looking upstream

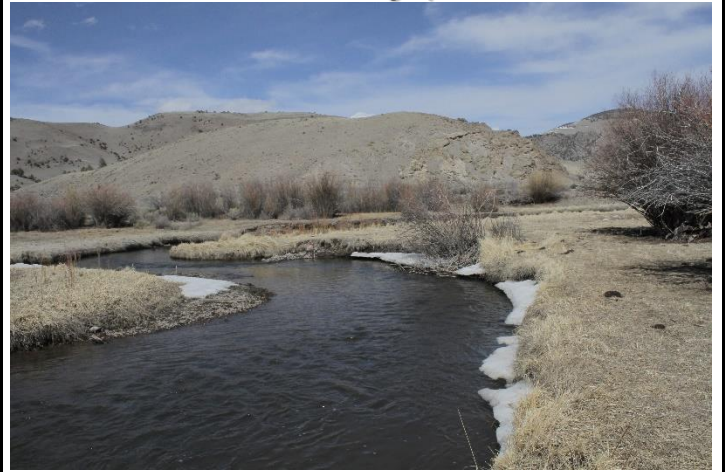
Channel looking upstream

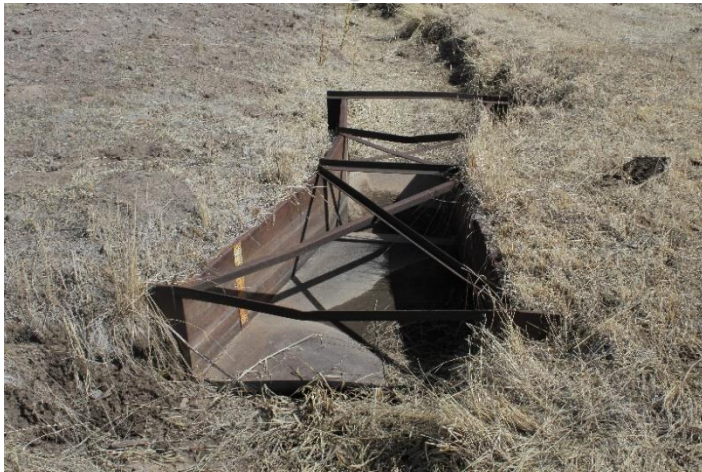
Flume looking downstream

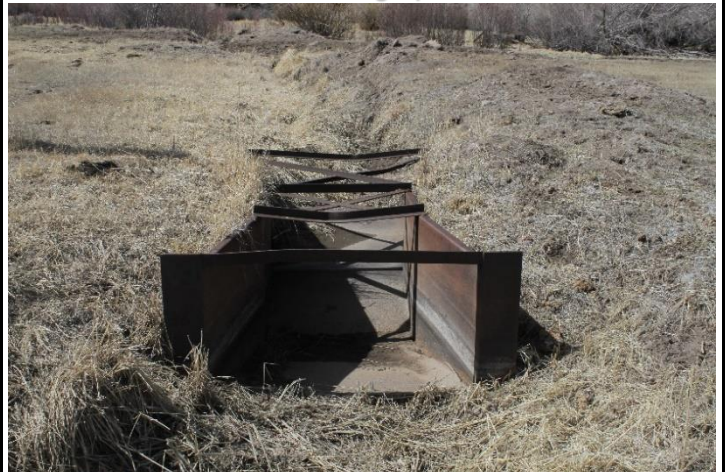
Flume looking upstream
