DIVERSION INFRASTRUCTURE INVENTORY

Structure Name: COSTILLA D (CANAL)

Date: April 10, 2019

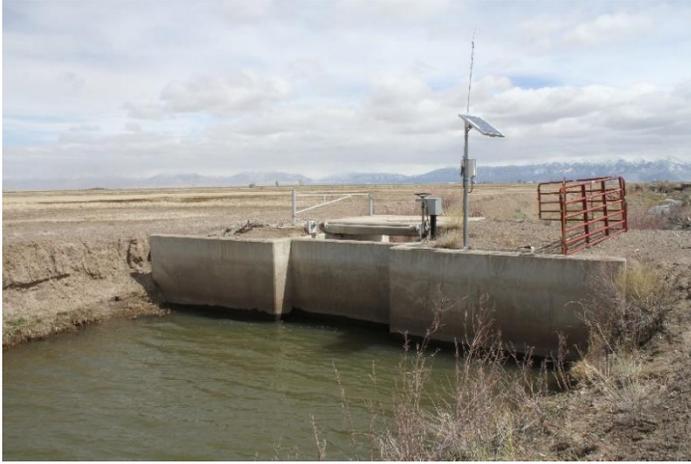
Comments: The headgate is relatively new and functions well. This ditch is a priority 293.

Headgate looking downstream

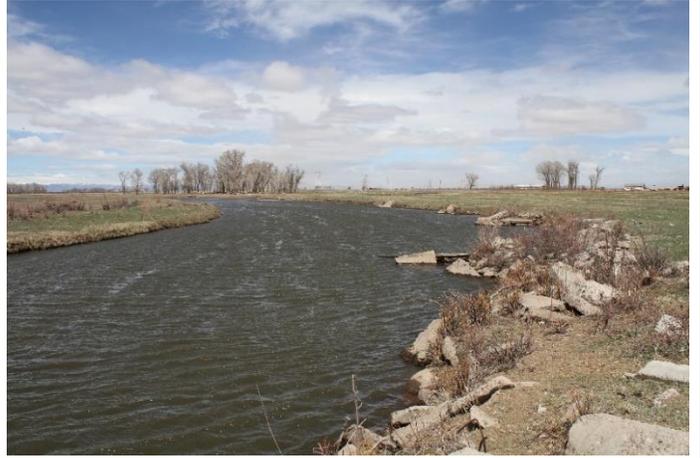
East bank of Rio Grande looking upstream

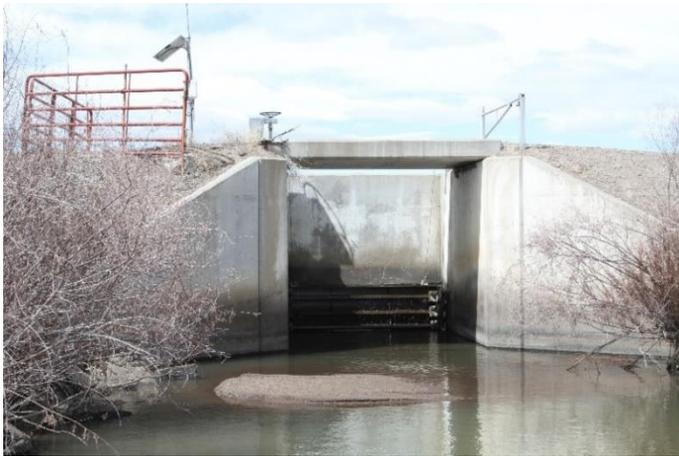
Headgate outlet

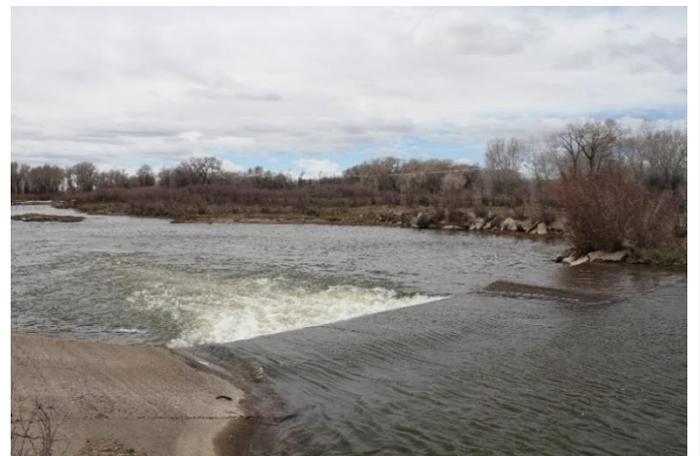
Diversion dam looking downstream

Repair(s) or Improvement(s) Currently Needed: The diversion dam functions well for water users, but reduces channel capacity at this location. If it is reconstructed, its capacity should be increased, thereby improving river function and reducing the likelihood of the river reclaiming an historic channel during a high flow event. The concrete riprap upstream of the diversion could be replaced with boulder structures that are engineered to improve river function and reduce hazards for boaters and livestock. The flume functions moderately well, but its measurement accuracy could be improved. Fish and boat passage as well as riparian restoration should be considered as part of any repairs or improvements.

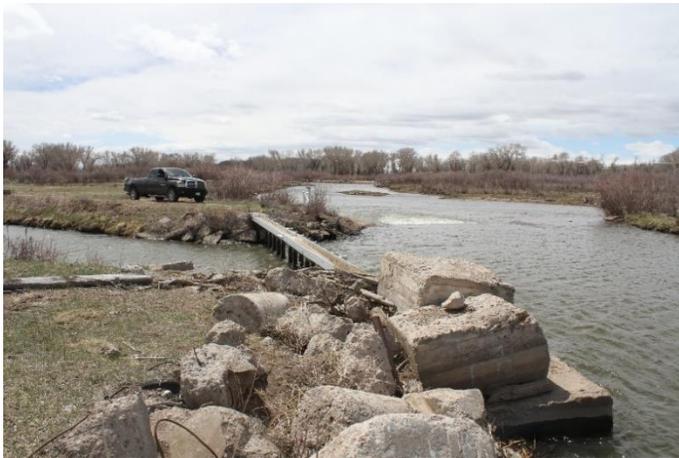
Structure Description: This structure is located on the outside bend of a meander below the apex of the bend. A trapezoidal concrete diversion dam diverts river flow into the feeder channel on the east bank of the river. The feeder channel is ~1,000 ft long and directs river flow to the headgate. There is a steel trash rack at the entrance of the feeder channel. The flow measurement device is a concrete rated section. Channel capacity is limited here, primarily due to the diversion dam. There are several historic channels near the current channel, suggesting channel avulsion was historically prevalent here. For this reason, it is assumed that channel avulsion from the current channel to a historic channel during a flood event is possible. Immediately upstream of the structure, the river has not migrated significantly since the 1960s (see maps below). This is due in part to riprap and concrete rubble that was placed upstream of the diversion on the east bank of the river to stabilize banks. Downstream of the diversion, channel avulsion has occurred historically and there is potential for meander cutoffs. The slope of this ditch is very flat, so it backs up when Excelsior Ditch water is in priority, resulting in a significant issue for water users.

Diversion dam and feeder ditch

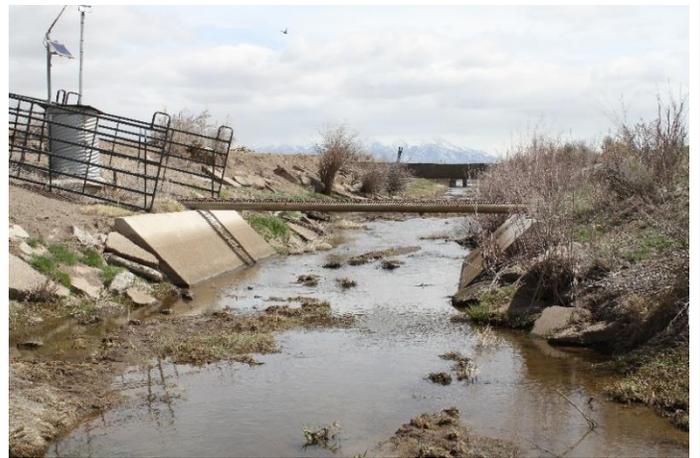
Measurement structure looking downstream

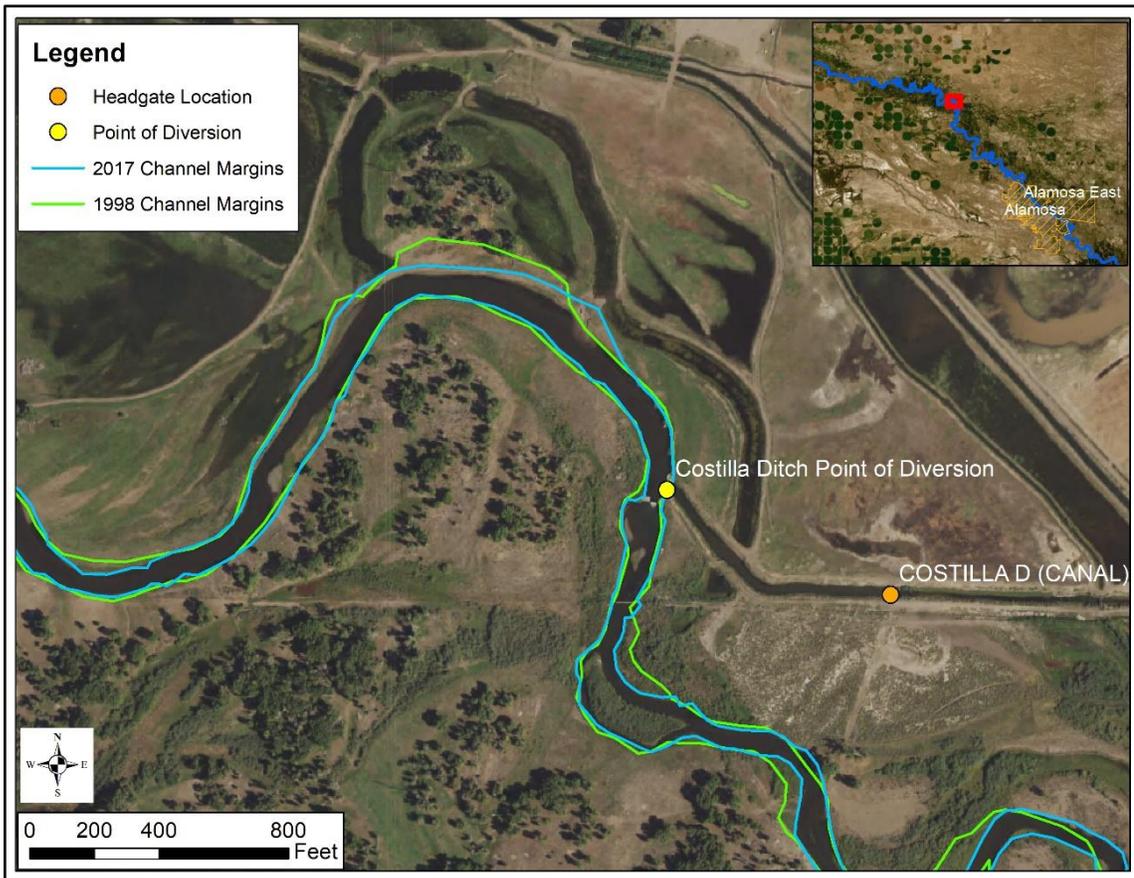
Map showing point of diversion with 1998 and 2017 channel margins overlaid.

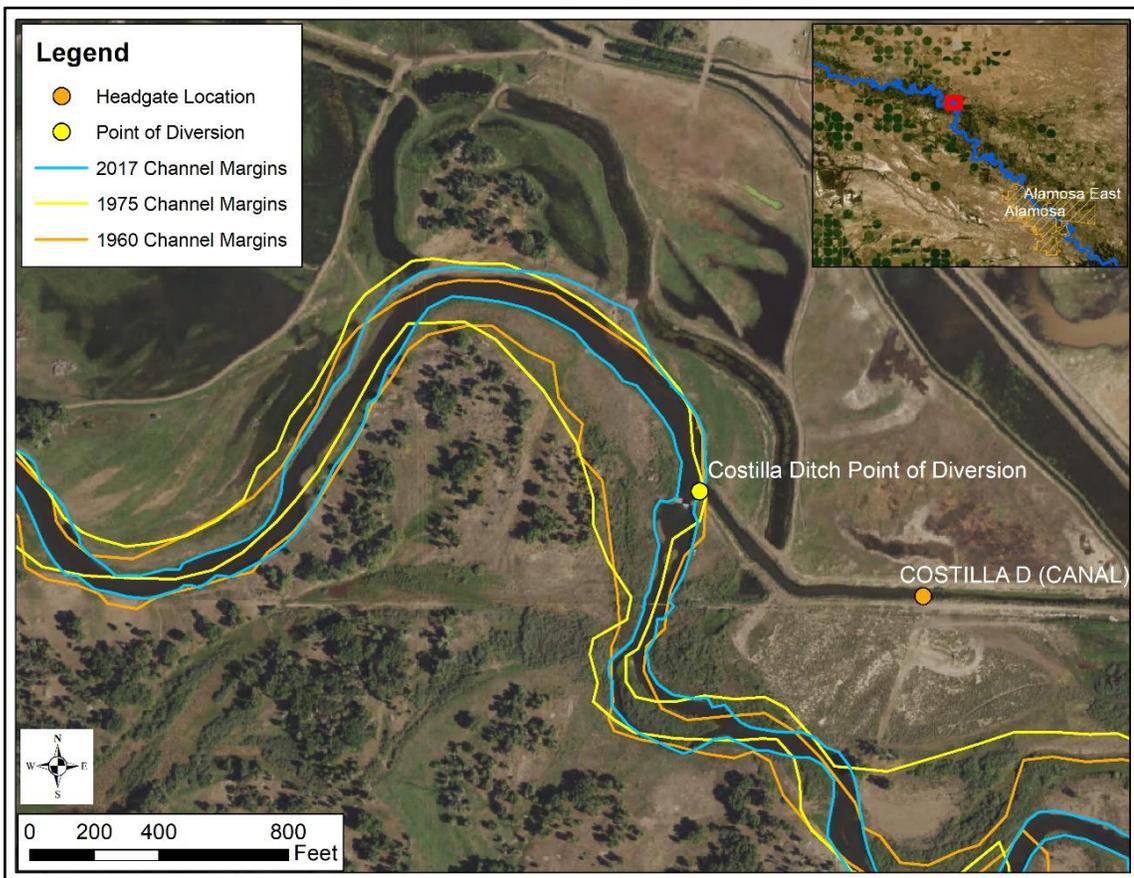
Map showing point of diversion with 1960, 1975, and 2017 channel margins overlaid.
