**VILLAGE OF PARDEEVILLE
JOINT PUBLIC UTILITIES COMMISSION/ VILLAGE BOARD
MEETING AGENDA**

**Village Hall – 114 Lake Street, Pardeeville
Monday, Oct. 3rd, 2022 at 4:30 p.m.**

**VILLAGE OF PARDEEVILLE
PUBLIC UTILITIES COMMISSION MINUTES
Village Hall – 114 Lake Street, Pardeeville
Monday, September 12, 2022 at 4:30 p.m.
DRAFT: Not Approved**

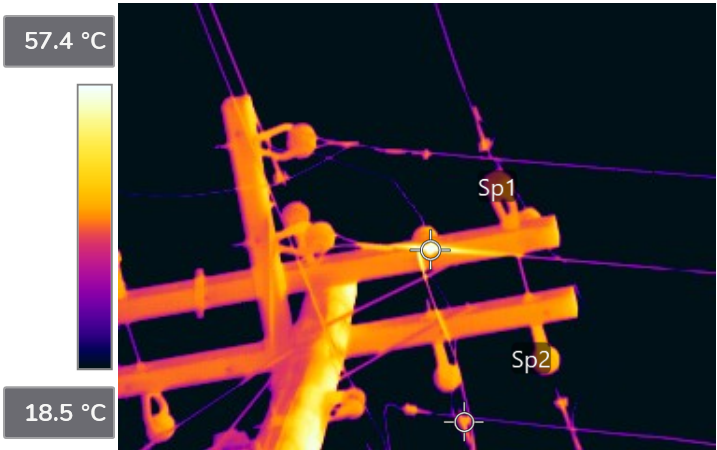
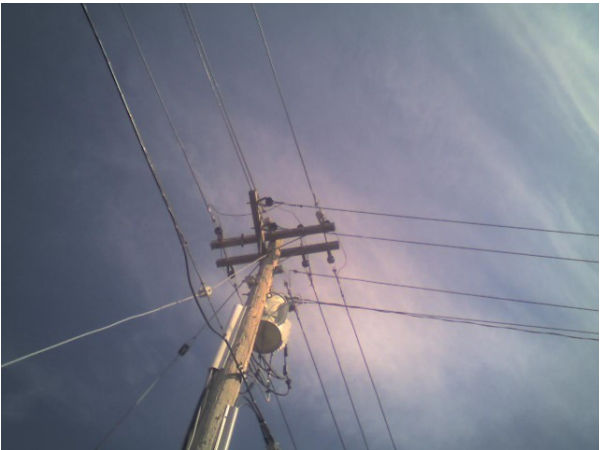
Equipment ID:	<i>Pole feed to grocery store and Mobil</i>
Fault Location:	Center Phase split bolt
Fault Severity:	Severe
Analysis:	Heated connection on split bolt
Recommendation:	Clean and torque connection

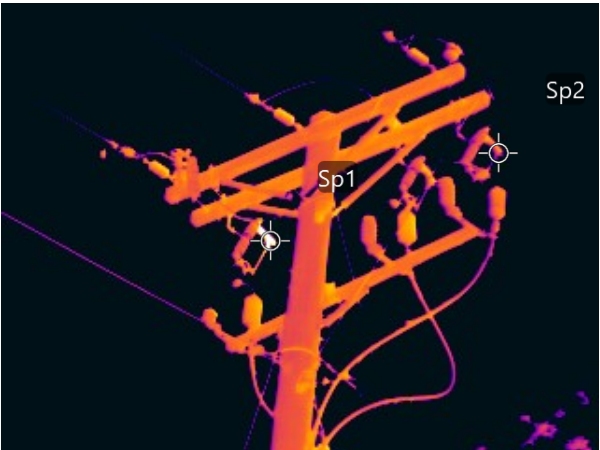
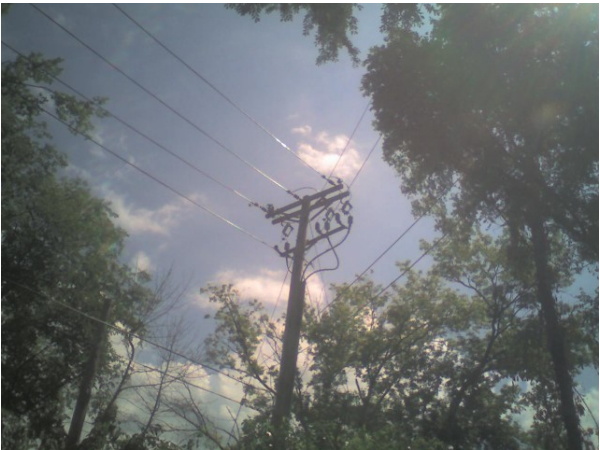
Equipment ID:	Pole behind curling club in alley
Fault Location:	North cutout
Fault Severity:	Severe
Analysis:	Heated upper connection
Recommendation:	Clean connection and measure resistance of connection compared to other phases. Torque or adjust jaw if possible in any way.

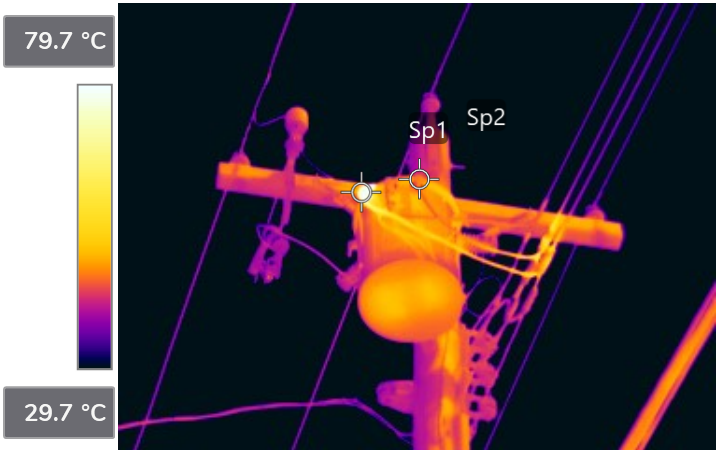
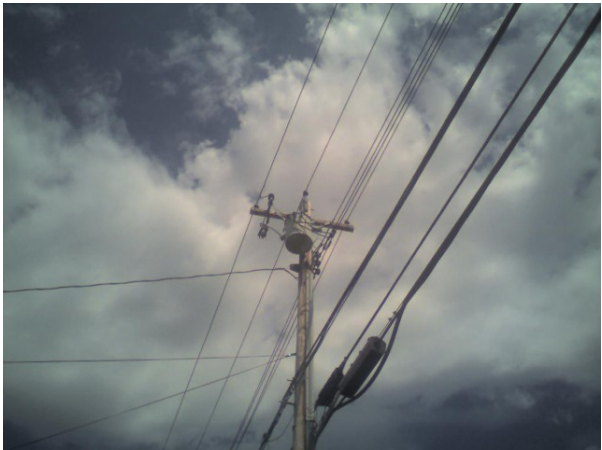
Equipment ID:	NM-38 Pole Transformer
Fault Location:	Secondary connection
Fault Severity:	Critical
Analysis:	Heated secondary connection
Recommendation:	Clean and torque connection on secondary. Corrective action on secondary connection may correct issue at the line. Replace splices or connections at line and clean line at those points if reasonable for reassurance.

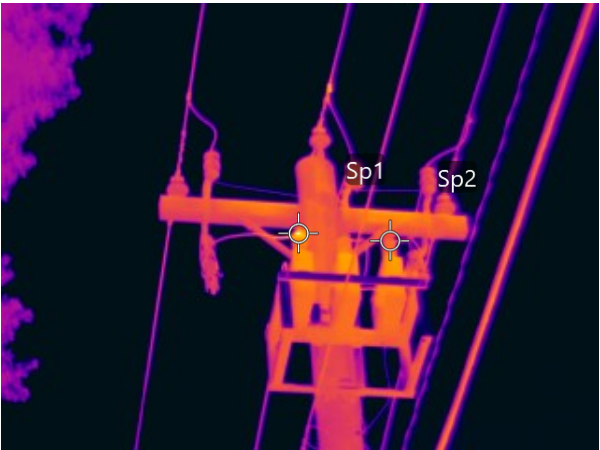
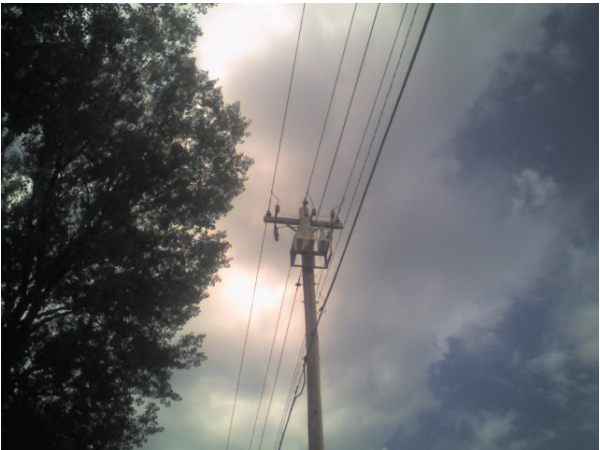
Equipment ID:	LR1/2 Pole
Fault Location:	Capacitor Connection
Fault Severity:	Intermediate
Analysis:	Heated connection on capacitor
Recommendation:	Clean and torque connection

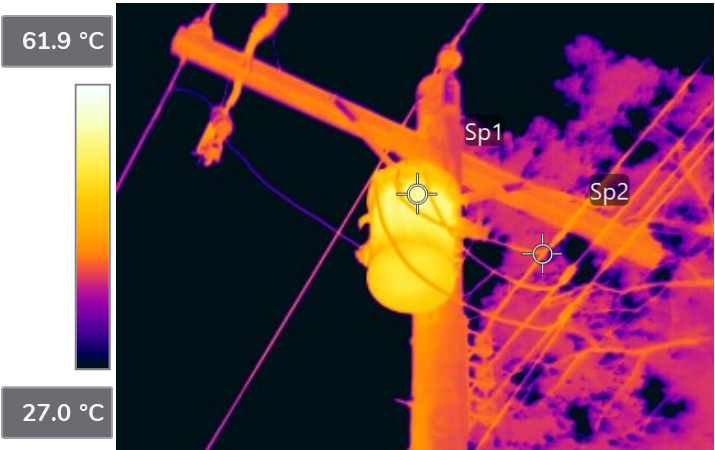
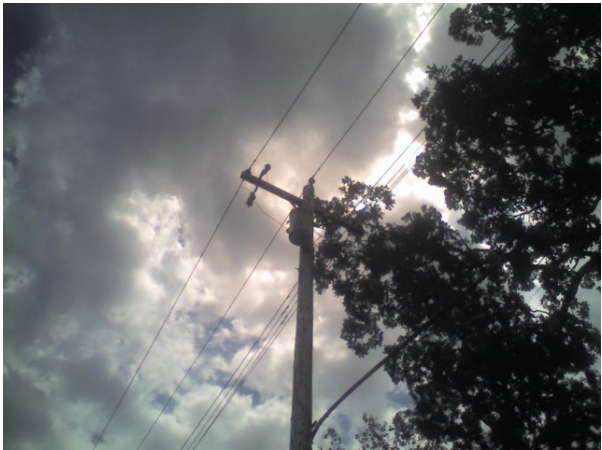
Equipment ID:	LR-8 Pole Transformer
Fault Location:	Transformer tank
Fault Severity:	Intermediate
Analysis:	Tank of transformer 11-20C degrees hotter than similar equipment on same street
Recommendation:	Continue to monitor. Consider what loading is in the area and if it is cause for concern.

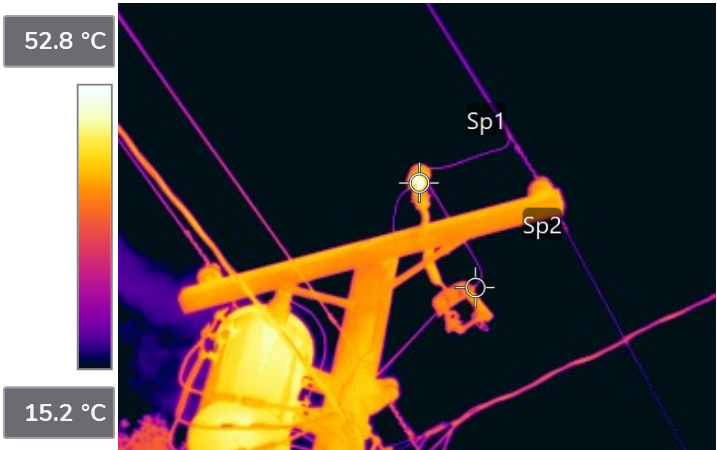
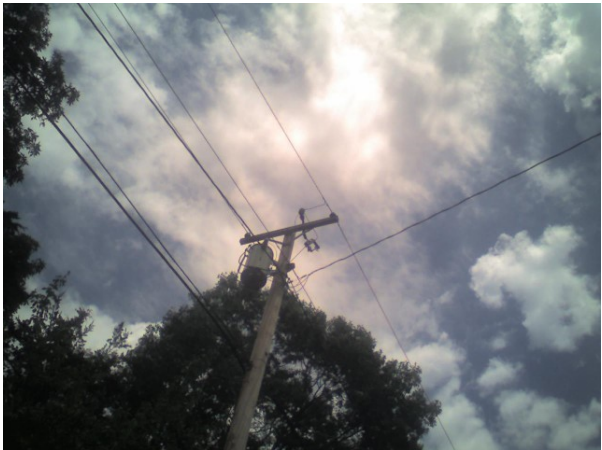
Equipment ID:	RNE-26 Pole
Fault Location:	Arrestor
Fault Severity:	Severe
Analysis:	Heated connection on arrestor
Recommendation:	Clean and torque connection

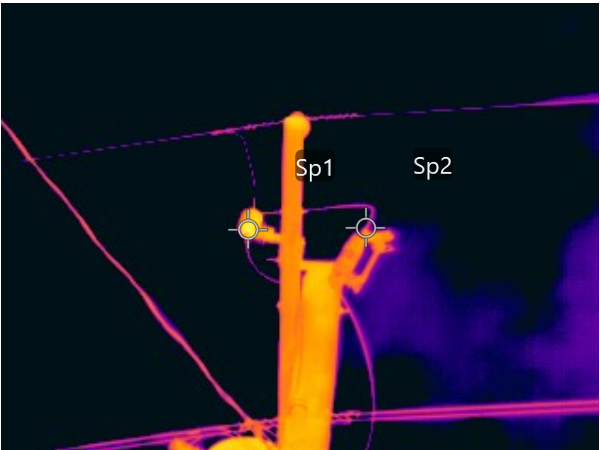
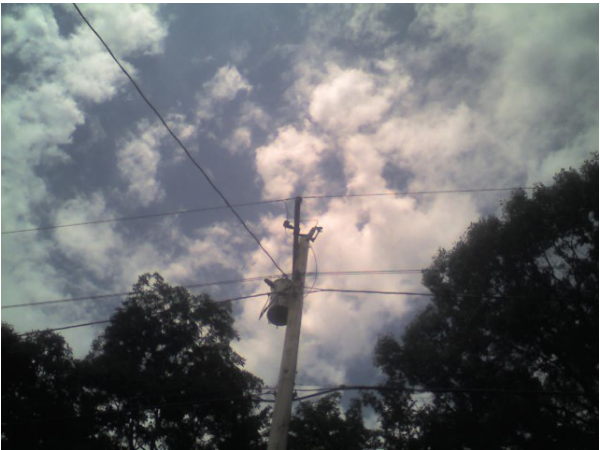
Equipment ID:	NM-48 Pole
Fault Location:	Arrestor
Fault Severity:	Severe
Analysis:	Heated connection on arrestor
Recommendation:	Clean and torque connection

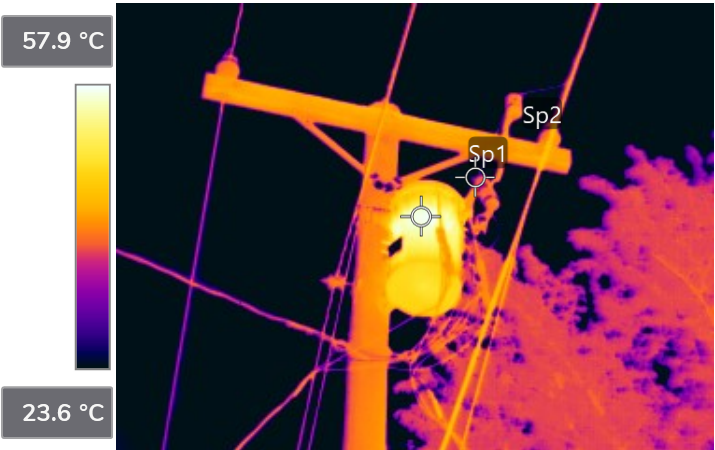
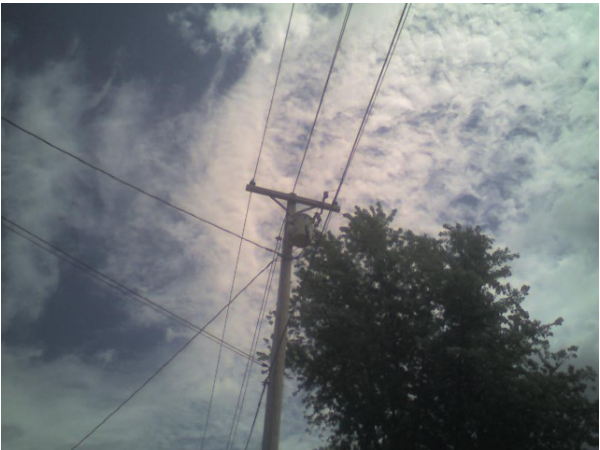
Equipment ID:	EC-40 Pole Transformer
Fault Location:	Transformer tank
Fault Severity:	Intermediate
Analysis:	Transformer tank 11-20C degrees hotter than similar equipment on same street
Recommendation:	Continue to monitor. Consider what loading is in the area and if it is cause for concern.

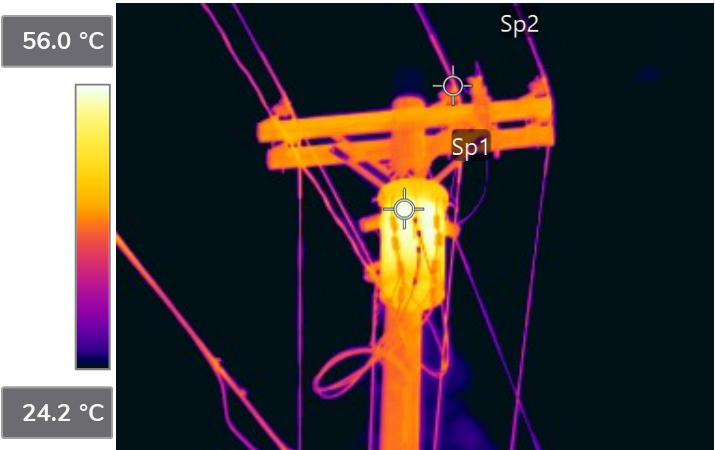
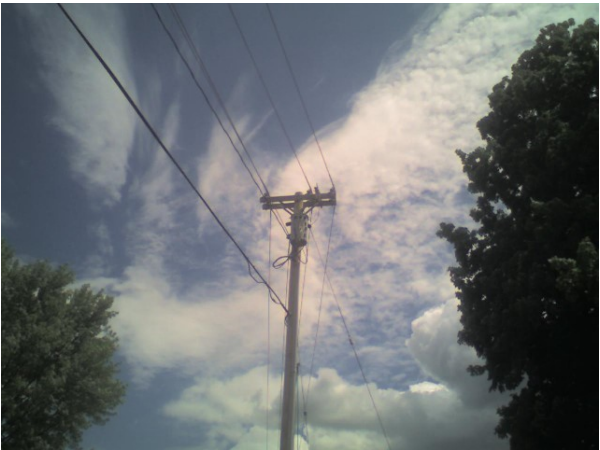
Equipment ID:	EC-58 Pole Transformer
Fault Location:	Transformer Tank
Fault Severity:	Intermediate
Analysis:	Transformer tank 11-20C deg. hotter than similar equipment on same street
Recommendation:	Continue to monitor. Consider what loading is in the area and if it is cause for concern.

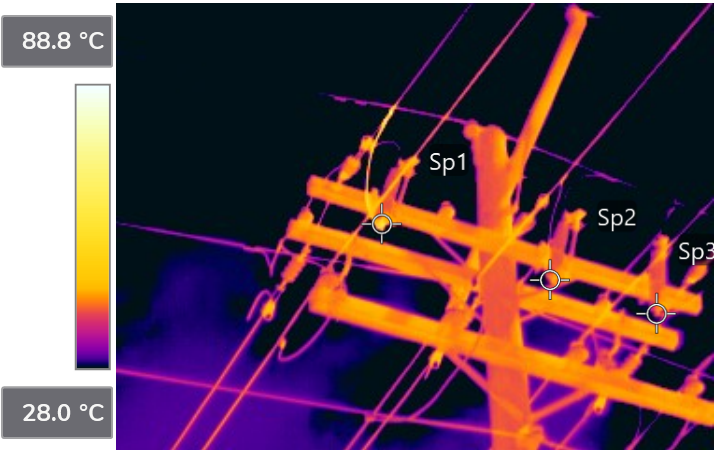
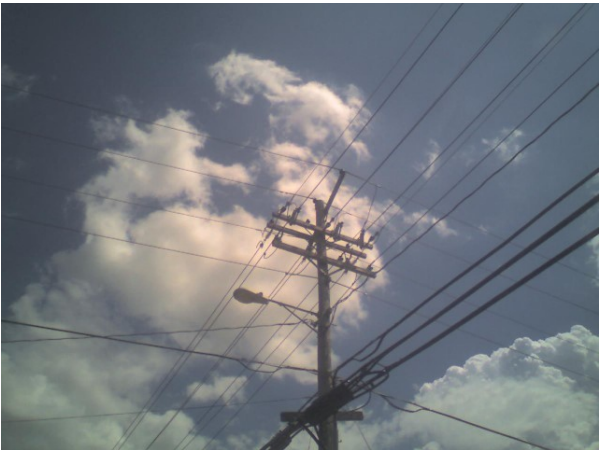
Equipment ID:	WC-6 Pole
Fault Location:	Jumper
Fault Severity:	Severe
Analysis:	Heated jumper connection
Recommendation:	Clean and torque connection

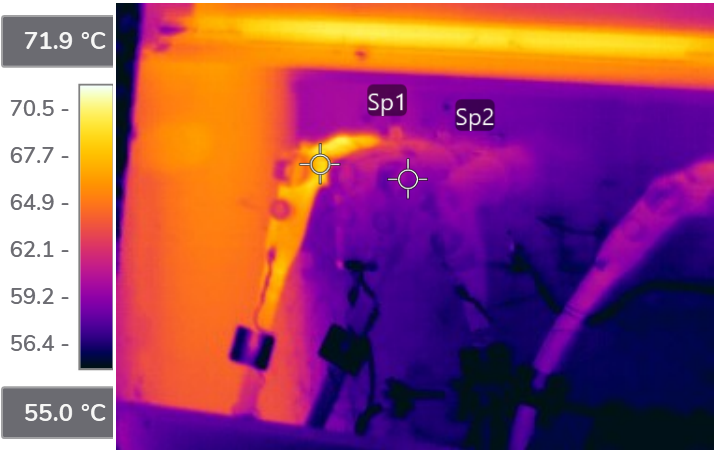
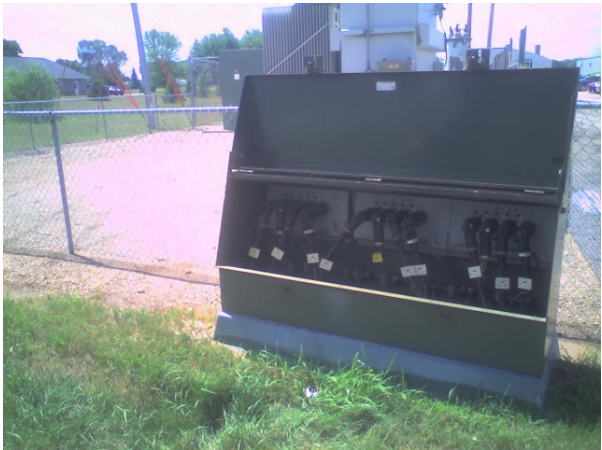
Equipment ID:	Cabinet outside South Main Substation towards road
Fault Location:	Far left elbow
Fault Severity:	Intermediate
Analysis:	Heated connection inside elbow
Recommendation:	Ensure the connection is tight and that nothing is compromised from the elbow to the cabinet.

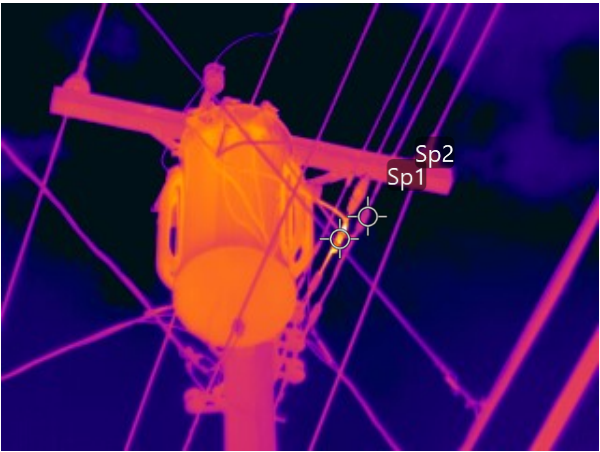
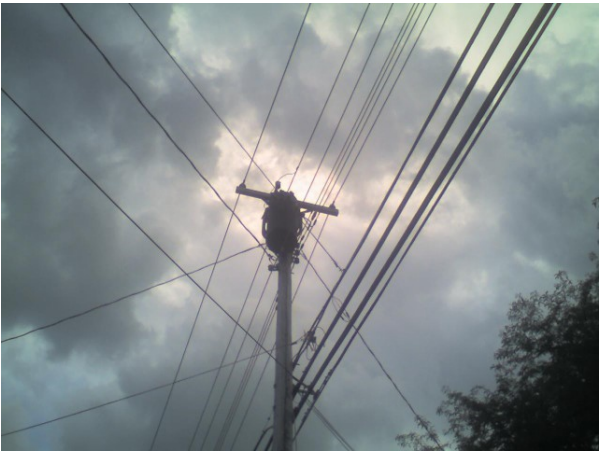
Equipment ID:	SM-34 Pole
Fault Location:	Line splice
Fault Severity:	Severe
Analysis:	Heated connection on line
Recommendation:	Replace splice or connection and clean line at that point.

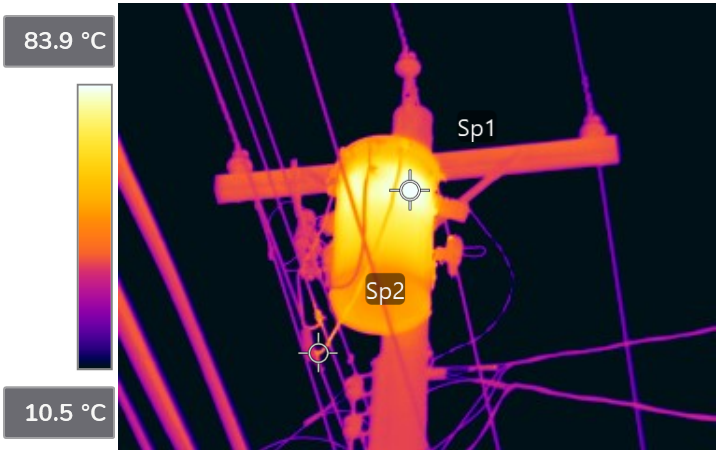
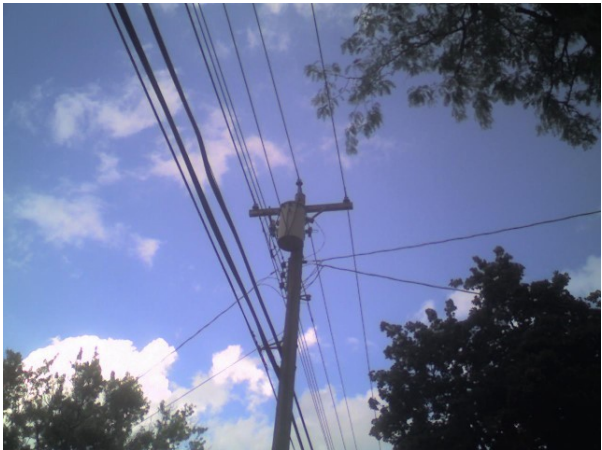
Equipment ID:	SM-26 Pole Transformer
Fault Location:	Transformer Tank
Fault Severity:	Severe
Analysis:	Transformer tank 21-40C degrees hotter than similar equipment on same street
Recommendation:	Continue to monitor. Consider what loading is in the area and if it is cause for concern.

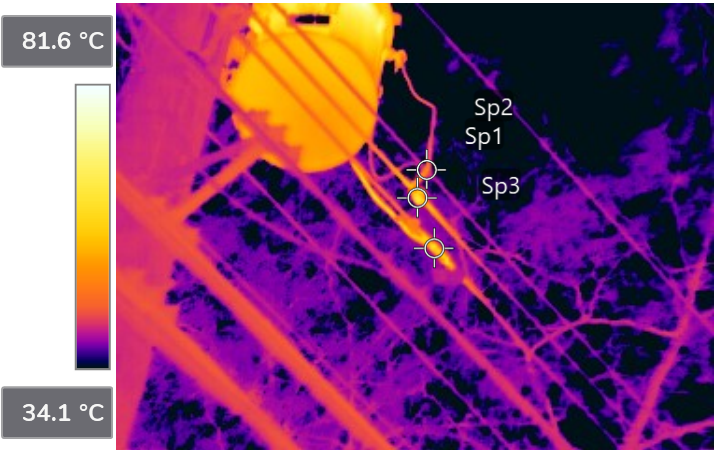
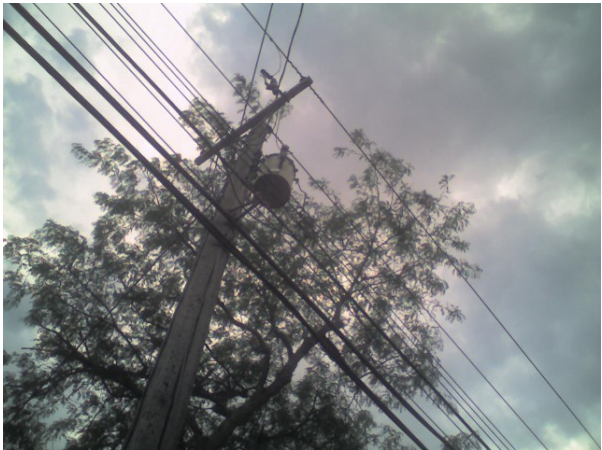
Equipment ID:	SM-26 Pole
Fault Location:	Secondary splices
Fault Severity:	Intermediate
Analysis:	Heated connection at splices
Recommendation:	Replace splices or connections and clean lines at those points.
