**123 Easy Street**  
Piedmont, CA  
March 8, 2018 - 12:00 pm  
Report Number - 180308-123 Easy Street

This Report Prepared for  
**Joe and Jenny Customer**

Inspected by: Star Inspection Group, Eric Meyer  
Member: American Society of Home Inspectors® (ASHI)  
Member: International Code Council (ICC)

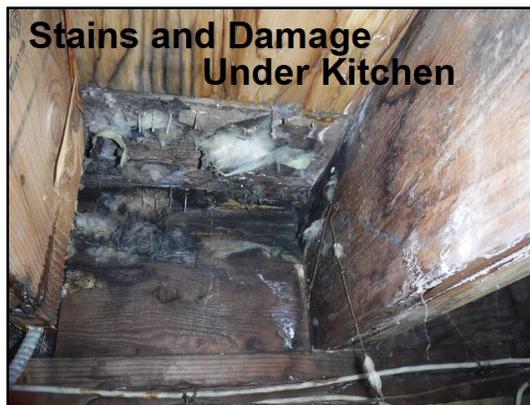
We observed stains on a few portions the subfloor area framing and sheathing, apparently indicating previous water entry or leakage.

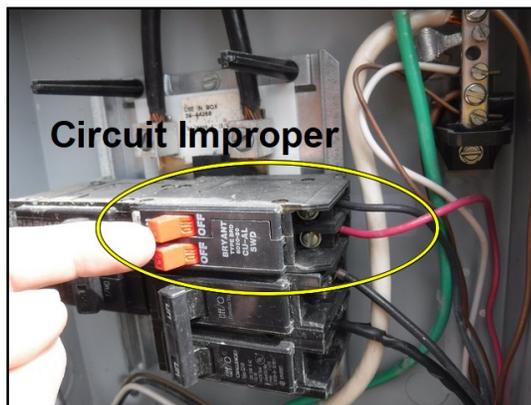
We observed improperly-wired, multi-wire branch circuits. The circuit's hot wires are on the same poles. The circuit lacks proper handle ties. We recommend the improperly installed multi-wire circuitry be corrected by a qualified electrician.

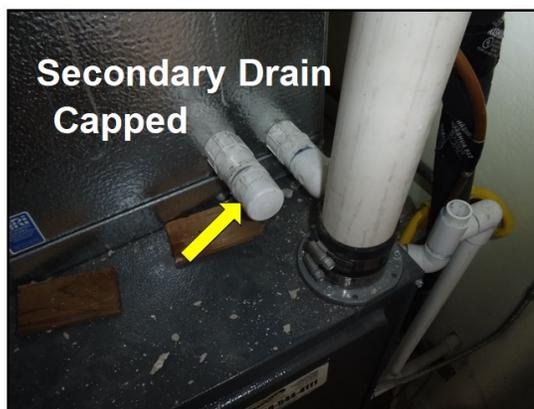
The air-conditioning air handler, located at the furnace, has condensate drain piping. The air handler's secondary drain outlet is capped; we recommend a secondary condensate drain line be installed to prevent damage should the primary drain become clogged.
