## **RESERVE STUDY**

**SPYGLASS LANDING CONDOMINIUM**

**MARSHFIELD, MASSACHUSETTS**

| DATE: | November 2016 |

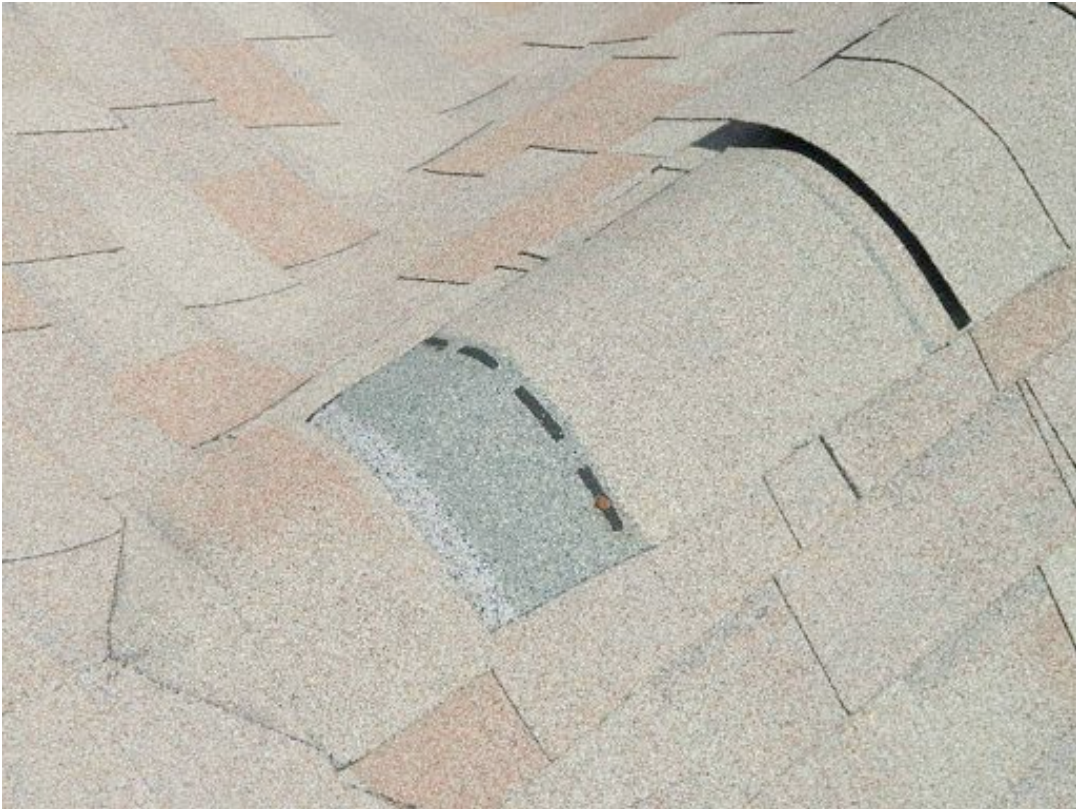
A FEW MISSING RIDGE CAP SHINGLES WERE NOTED (NOT WIDESPREAD)

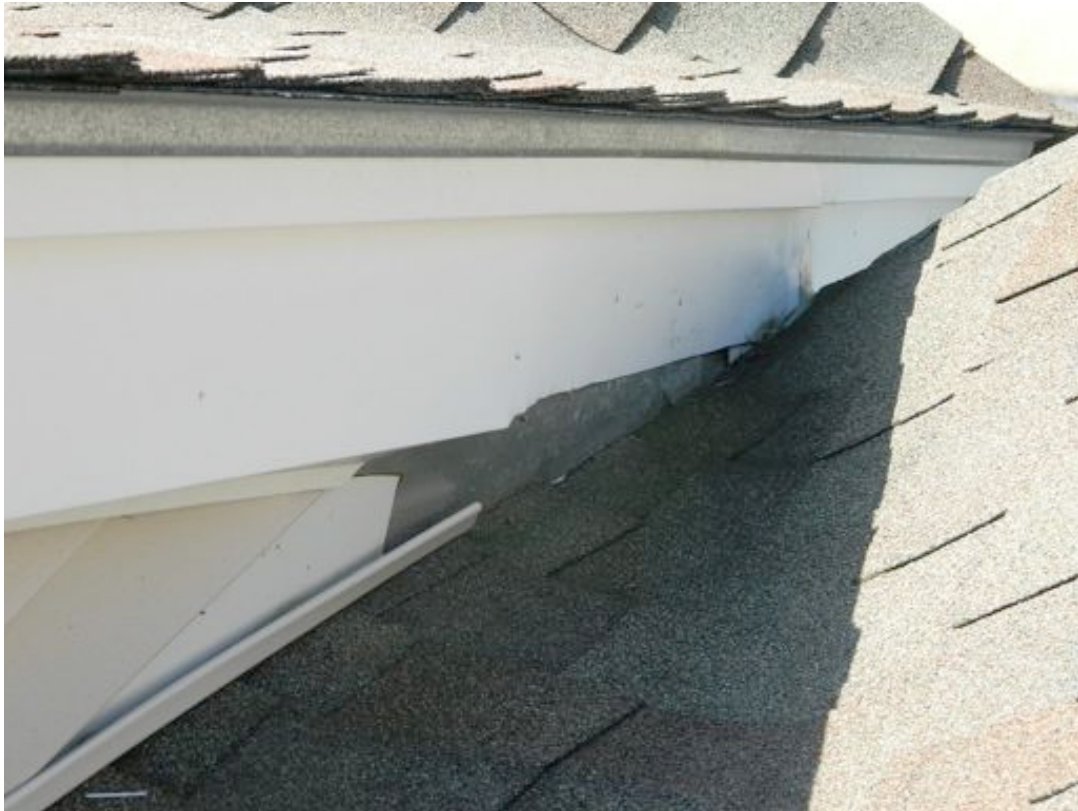
We did note some locations where the units merge that appear potentially vulnerable to leakage. In many cases, the units merge at a step-flashed cheek wall, some of which end against adjacent roofing systems, and appear vulnerable to trapping water, snow or ice (see photos). Without a complete re-design, little can be done about this now, but if any leakage were to occur in the general area, we would suspect a flashing/underlayment deficiency where the units meet.

QUESTIONABLE FLASHING DETAILS WERE FOUND WHERE SOME UNITS MERGE

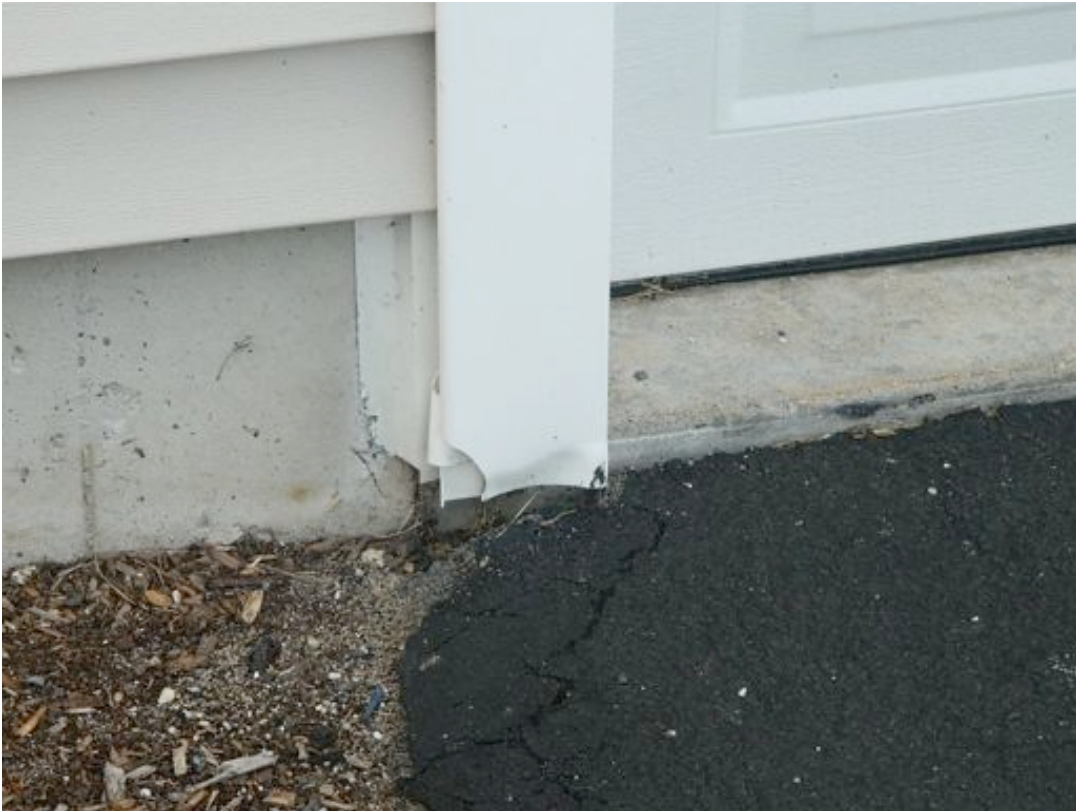
Some minor damage was noted at the base of the walls, again likely caused by landscaping activities. In some instances, the siding is less than 6” from surrounding grade. Although Code allows vinyl siding to be close to grade, the

underlying framing members are required to be at least 8" above grade. The vast majority of the buildings have adequate clearance from grade. The damage at the base of walls is largely an aesthetic issue which will not significantly impact the performance of the siding.

SOME DAMAGED SIDING/TRIM WAS FOUND AT THE BASE OF WALLS (NOT WIDESPREAD)

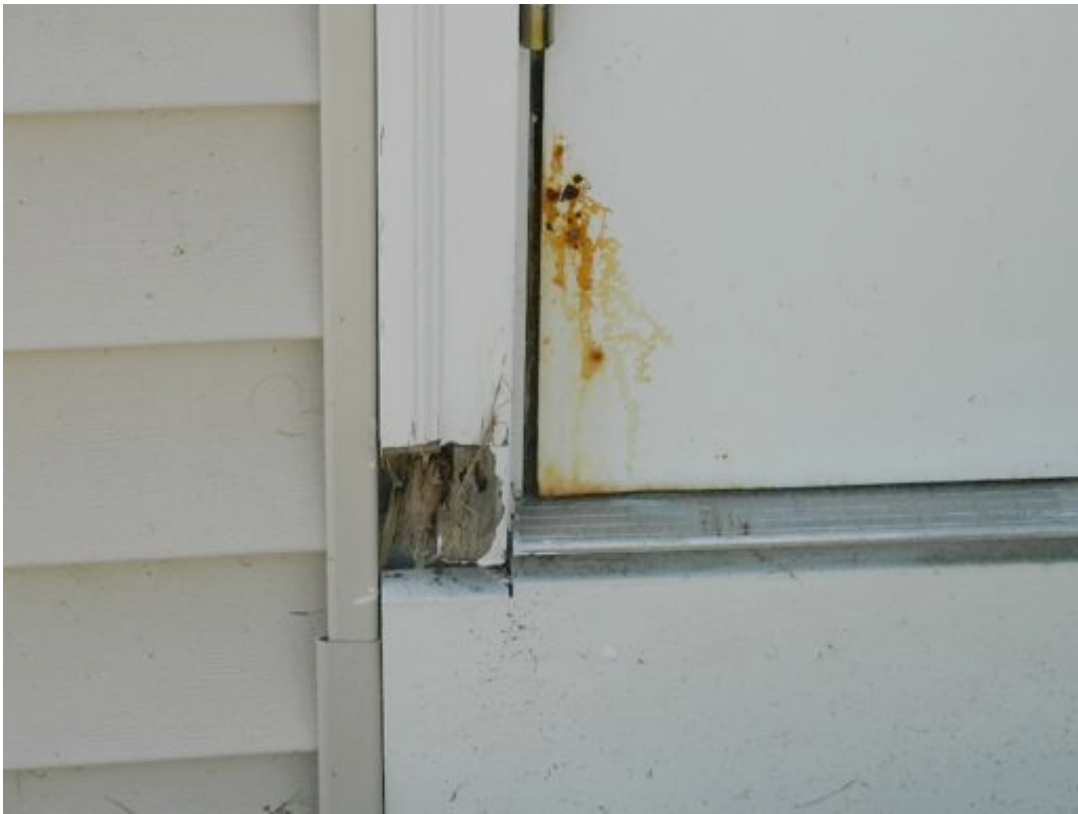
We noted some accelerating trim rot at the exterior doors on the utility rooms (see photos). The doors themselves are pressed-metal units, some of which have also begun to suffer from surface rust. These doors would appear to fall outside of the unit boundaries, and we have included their replacement in approximately 9 more years on the Reserve Schedule (Item #4). The estimated replacement cost reflects removal and replacement with a new equal.

SOME SIDE UTILITY DOORS ARE RUSTING, AND SUFFERING FROM TRIM ROT

FURTHER EXAMPLE OF TRIM ROT ON A UTILITY ROOM DOOR

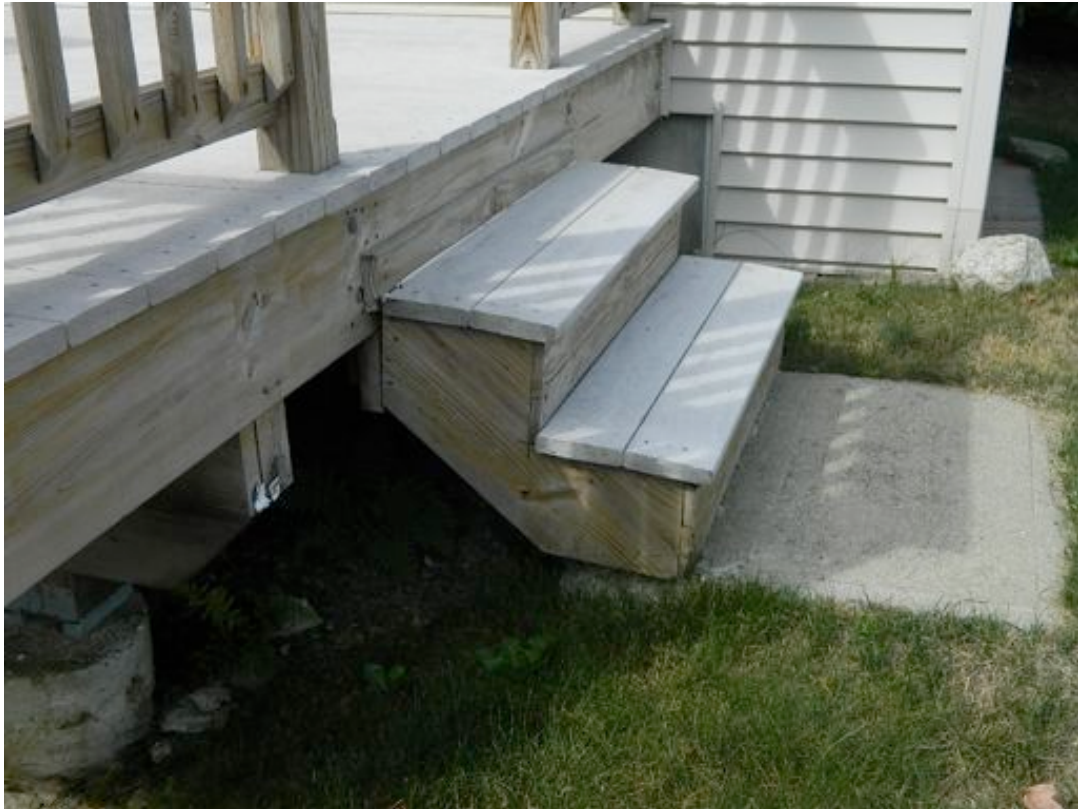
We also noted a few stair stringers that appear to have settled. The most severe such location was found at the rear deck of 22 Schooner, where the steps appear to have settled over 1" (see photos). This appears to be the result of inadequate (or omitted) stringer footings. It seems that many of the steps rest only on the concrete pads at the bottom of the steps.

SOME OF THE STEPS HAVE SETTLED

SETTLING DECK STEPS AT THE REAR DECK OF 22 SCHOONER

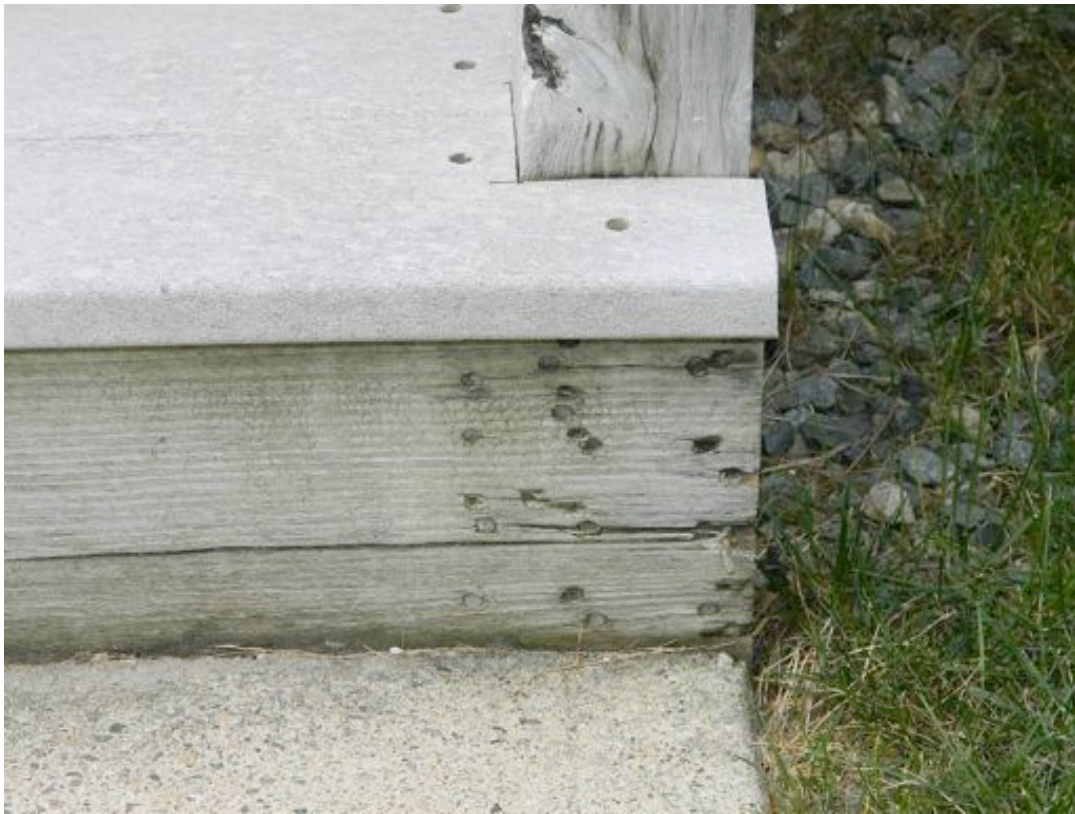
The decks utilize synthetic decking and top railing caps. The railings themselves are also of preservative-treated lumber, with 2 x 4 top and bottom rails, and 2 x 2 balusters installed with nails. Many of the nailed components were found to be suffering from cracking, splitting or other damage (see photos). It appears that some of the nailed connections have been augmented with lag or carriage

bolts. It's unclear if the bolts were a part of original construction, or if they were added after the fact. We suspect that many of the decks will require remedial repairs, in the form of augmenting nailed connections that are failing, in order to achieve the anticipated remaining life of 14 years.

MANY OF THE DECKS ARE “OVERNAILED” WITH INAPPROPRIATE FASTENERS

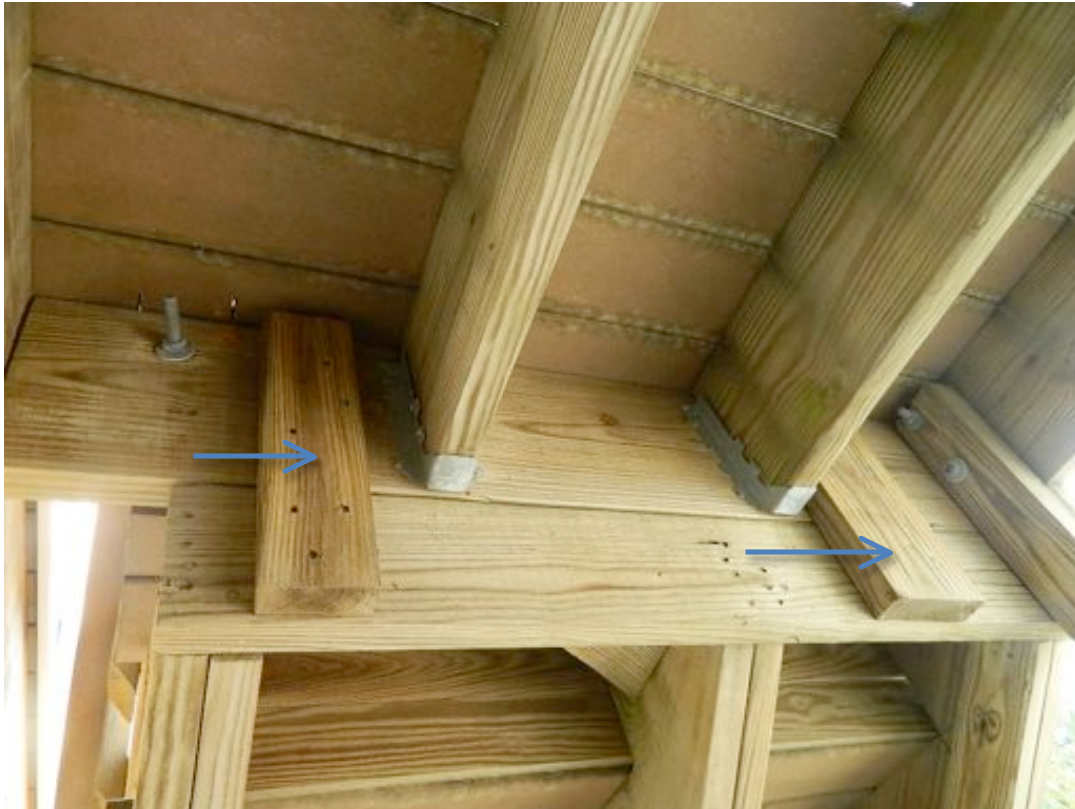
This office has some concern with the way the stair stringers are attached to the main decks. In some of the locations that were directly examined, they are fastened with 2 x 4's nailed to both the deck frame and stringer ledger (see photo). A much better attachment detail would utilize either lag or carriage bolts, or as a minimum, rated screws. We noted some locations where the stringers appear to be pulling away as a result of poor attachment (see photo). This issue is not widespread, but monitoring of the deck stringers should be a regular part of site maintenance/inspection.

OPTIMALLY THE STRINGER BRACKETS SHOULD BE BOLTED (FASTENED WITH NAILS ONLY)

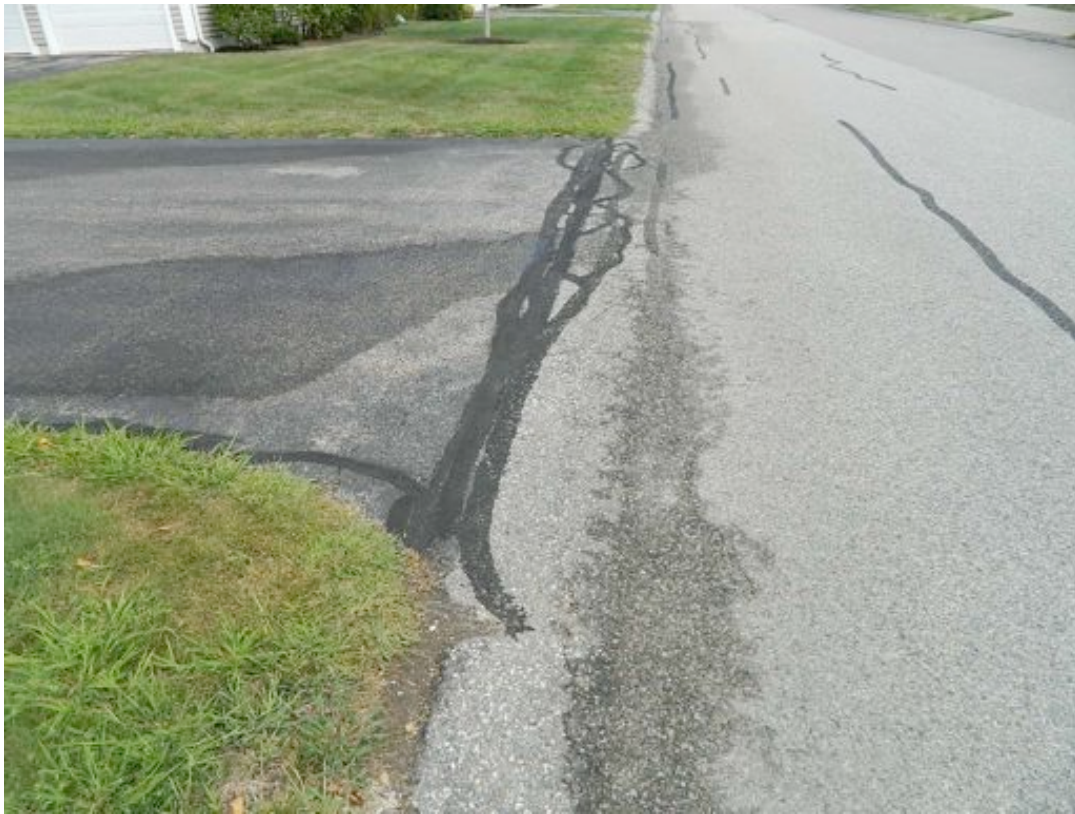
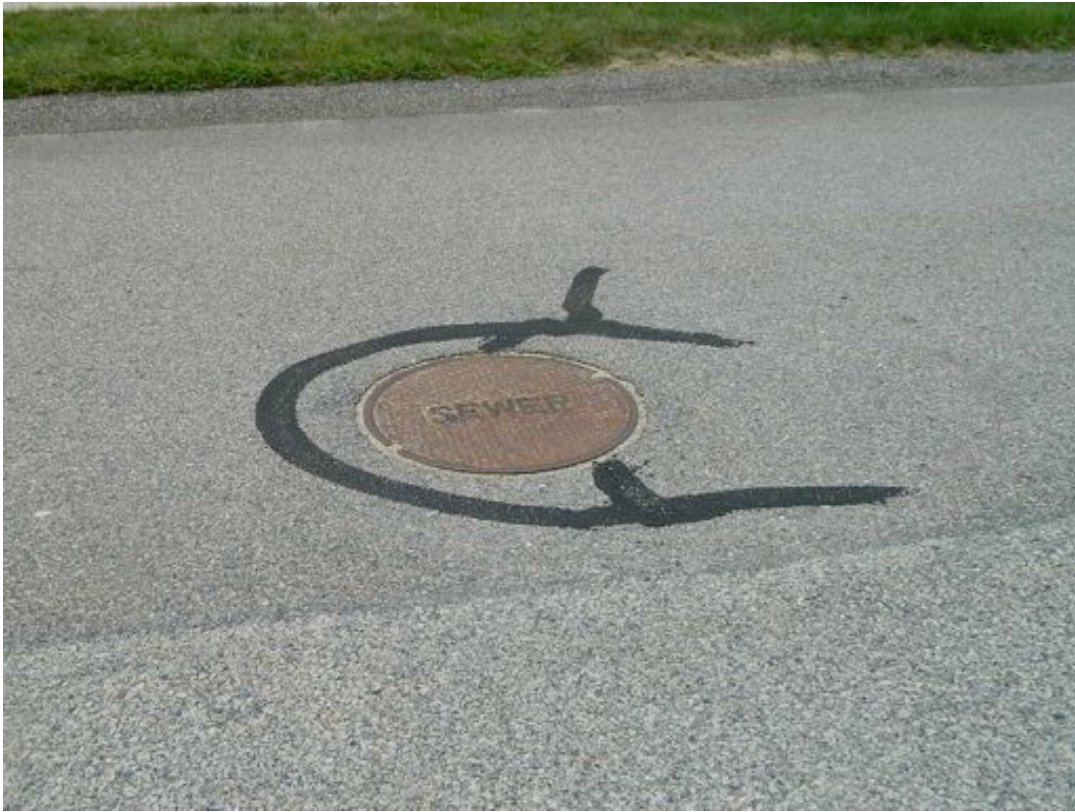
We did note cracking throughout the property, but the vast majority of the cracks have been sealed (see photos). We also noted some apparent “settlement cracks” around catch basin grates and man holes, but not anything excessive.

SEALED CRACKS WERE FOUND AT THE END OF MOST DRIVEWAYS

SOME SEALED CRACKING WAS NOTED AROUND ROADWAYS STRUCTURES

Crack sealing must be a regular part of pavement maintenance, and should be an ongoing process. It is critically important to seal pavement cracks on an annual basis, preferably before every Winter. The cracks most commonly occur at course lines, driveway transitions in the pavement, or at penetrations. When water gets below the pavement, it can cause frost heaves or wash-out of the substrate, which will lead to settlement.

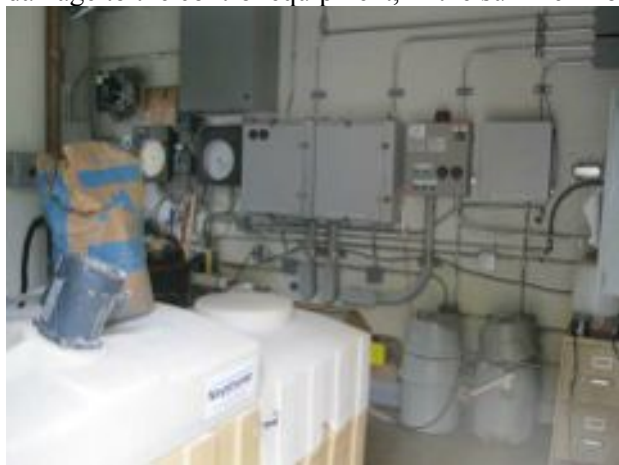
The treatment process is underground, outside the control building. It only houses the electric controls and stores some chemicals. Due to its exposure to sun, an exhaust fan should be on a timer, to prevent heat damage to the control equipment, in the summer months.
