SAGUACHE CREEK DIVERSION INFRASTRUCTURE INVENTORY

Structure Name: BIG MEADOW D

Date: April 11, 2019

Saguache Creek Stream Management Plan

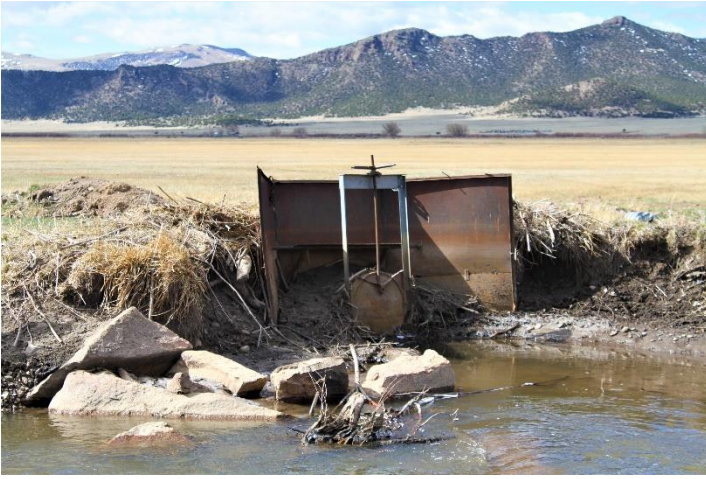
Headgate looking downstream

Structure Description: The ditch is located on the outside of a meander. The diversion dam is a combination of boulders, sheet metal, fencing, and concrete. The diversion constricts the stream and appears to be causing erosion downstream. Woody debris accumulates at the headgate and on the diversion dam. The headgate is tilted and could be reset.
