SAGUACHE CREEK DIVERSION INFRASTRUCTURE INVENTORY

Structure Name: HOUGLAND CREEK D

HOUGLAND CREEK DITCH

Saguache Creek Stream
Management Plan

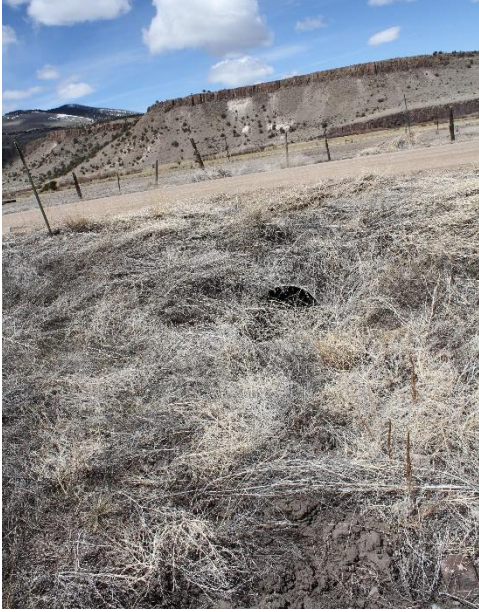
Ditch entrance looking downstream

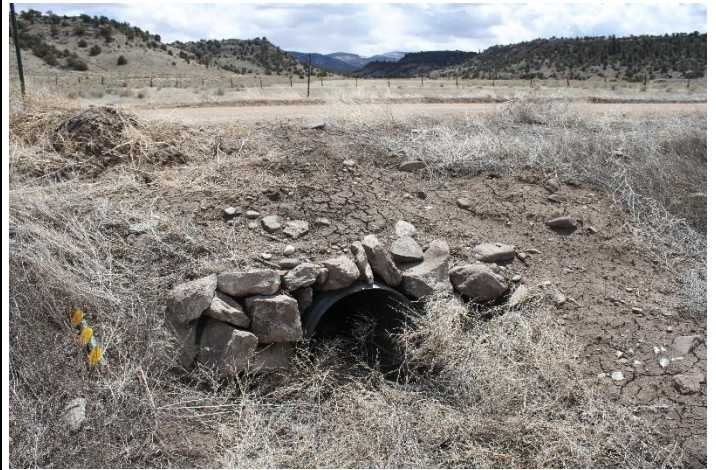
Ditch culvert outlet

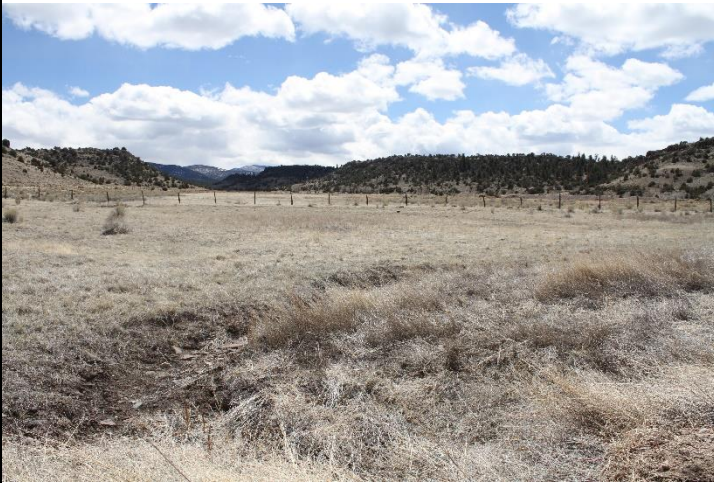
Channel looking upstream of ditch
