All County Home Inspections Swimming Pool/Spa Inspection Report

Inspection Requested By:	Joe and Jill Swimmer
Pool Street Address:	123 Any Street
City:	Anytown
State:	NY
Zip:	14620
Age of Pool/Spa:	2003
Pool/Spa Shape:	Rectangular Shape
Size of Pool/Spa: (Length x Width)	14 x 36
Gallons:	Approximately 19,500
Average Pool Depth:	43 inches
Maximum Depth of Pool/Spa:	66 inches
Shallowest Depth of Pool/Spa:	53.5 inches
Inspection Date:	8/23/2017
Inspection Time:	09:00 AM
Weather:	Partly Sunny
Fee:	\$195.00
Notes:

All County Home Inspections
454 Peart Ave
Rochester NY 14622
Inspected By: Michael Reed

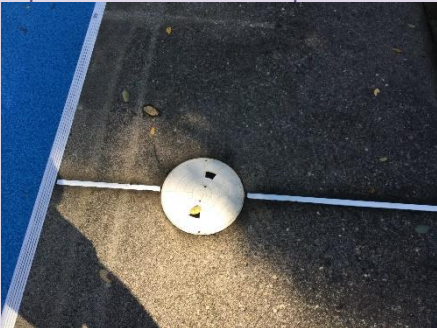
DECK EQUIPMENT	GOOD	FAIR	POOR	NONE	NOTES/COMMENTS/PHOTOS
Skimmer(s); Number: 2	<input type="checkbox"/>	<input checked="" type="checkbox"/>	<input type="checkbox"/>	<input type="checkbox"/>	<p>2 Vinyl deck mounted surface skimmer. Covers are beginning to weaken due to sun exposure. Recommend replacement.</p>

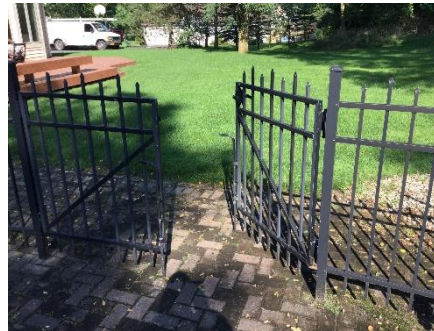
Ropes	<input type="checkbox"/>	<input type="checkbox"/>	<input type="checkbox"/>	<input checked="" type="checkbox"/>	Deep end divider ropes were not installed at the time of inspection. Deep end divider ropes allow for a visual signal a swimmer is nearing water that is deep to stand. Theses should be installed for safety
Diving Board/Water Slide	<input type="checkbox"/>	<input type="checkbox"/>	<input type="checkbox"/>	<input checked="" type="checkbox"/>	
Cover(s); Type: Winterizing	<input type="checkbox"/>	<input type="checkbox"/>	<input type="checkbox"/>	<input checked="" type="checkbox"/>	Winterizing cover was not installed they are in storage.
Fencing; Type: Aluminum/Wood	<input checked="" type="checkbox"/>	<input type="checkbox"/>	<input checked="" type="checkbox"/>	<input type="checkbox"/>	No issues noted at the tim fo inspection
Gate(s)/Doors; Number:1 Aluminum gate/3 Wood doors leading from the house.	<input type="checkbox"/>	<input type="checkbox"/>	<input checked="" type="checkbox"/>	<input type="checkbox"/>	Gate lower peg is binding causing self closing mechanics to not work. Also the three doors leading from the house to the pool should be alarmed preventing unauthorized access to the pool area.

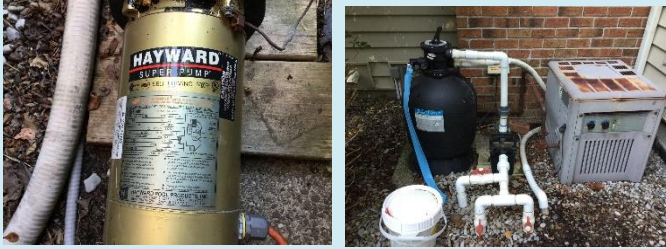
No Issues noted

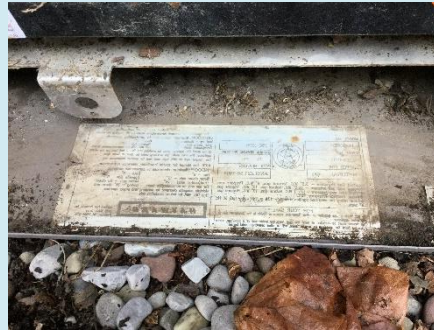
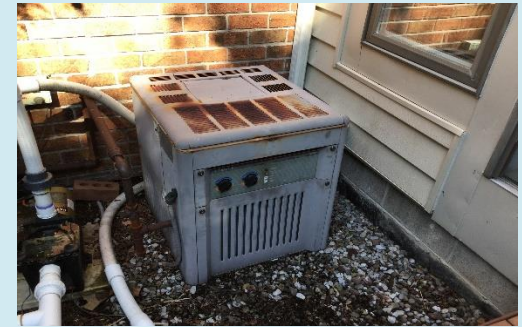
Heater; Type: Natural Gas

Heater not responding to thermostatic controls at time of inspection. Appears past its serviceable life. Manufacturer date 1994.
