TALON
Home Inspections

Inspection Report

Property Address:
4100 Mangini Street
Lexington KY 40509

Date: 9/15/2017	Time: 10:00 AM till 02:30 PM	Report ID: 170915BISHOP
Property: 4100 Mangini Street Lexington KY 40509	Customer: Ms. Amy Bishop	Real Estate Professional:

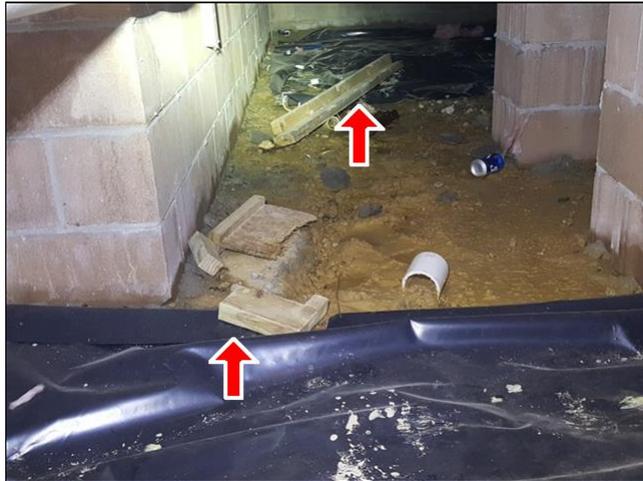
1.2 Item 1(Picture)

1.2 (1) All wood, cardboard, insulation and unused building materials should be removed from the crawlspace floor. The insulation will hold moisture creating condensation and possible mold growth on the wooden structure in the crawlspace. Wood debris risks rotting and can attract wood eating insects into the crawlspace which can lead to more costly repairs later. Recommend all types of debris resting on the crawlspace floor be removed to prevent damage to the wood structure of the home.

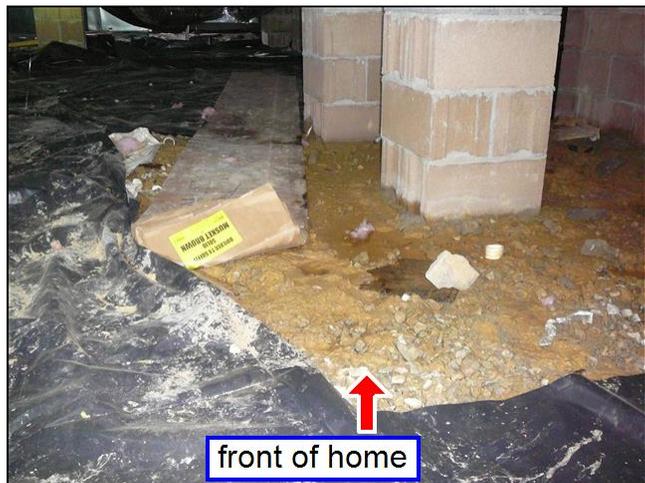
1.2 Item 6(Picture)

1.2 (2) There are some gaps in the coverage of the crawl space floor. A plastic vapour barrier should be installed in the missing areas and needs to be a minimum of 9mil thick in Kentucky (recommend using 15 or 20 mil) Recommend adding additional vapour barrier cover where needed to cover entire crawlspace floor to prevent excessive moisture entering which can lead to mold and deterioration of the floor structure and insulation in the crawl space. Recommend correcting and replacement using a qualified contractor.

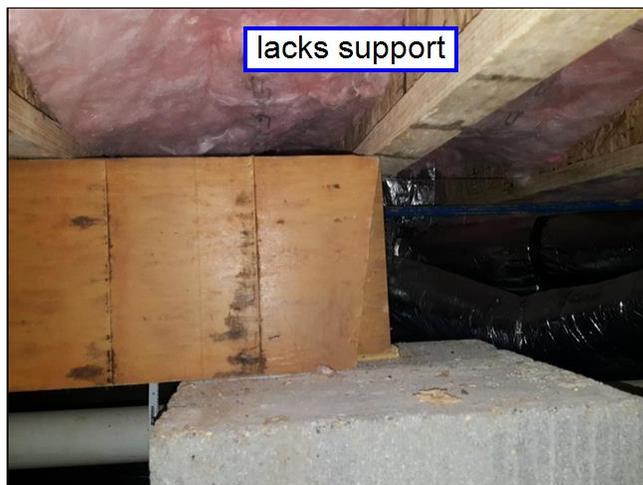
1.4 Item 1(Picture)

1.4 The wood beam in the middle of the crawlspace under the entry foyer area has insufficient end bearing to support the floor joist above. Additional support maybe needed to reduce risk of structural movement and damage to floor and wall above. Strongly recommend a qualified contractor or structural engineer be consulted to further evaluate and improve support for the wood joist and correct as needed.

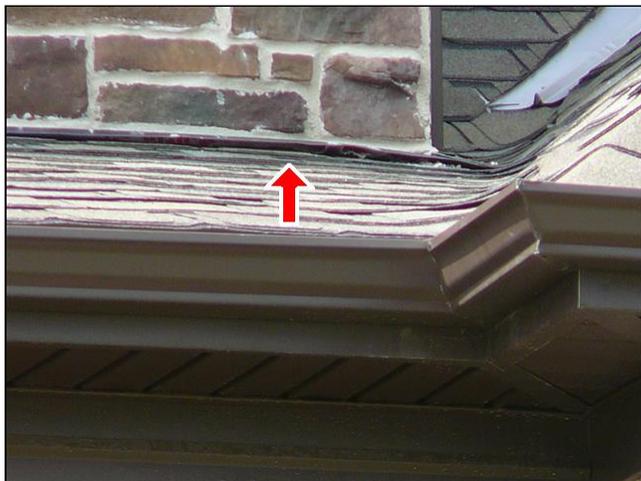
2.1 Item 1(Picture)

2.1 The flashing at the front of home has lifted between the wall and the front porch roof. Recommend the flashing be re-secured and flattened by a qualified contractor to prevent water entering underneath flashing and to allow ease of water runoff to reduce the risk of roof/wall leaks.

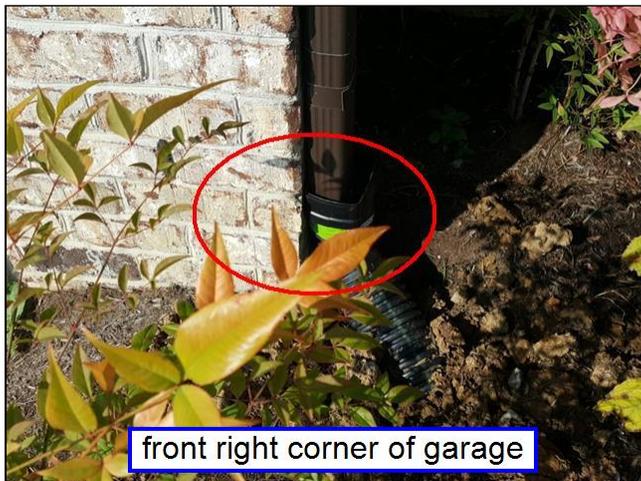
2.3 Item 1(Picture)

2.3 (1) Downspouts that discharge below grade level should be monitored. If they are ever suspected to be clogged or disconnected below grade, they should be redirected to discharge at least 10 feet from the building or into a storm sewer system. Foundation leakage adjacent to a downspout is an indication of a problem below grade.

Note: Could not locate exit port.

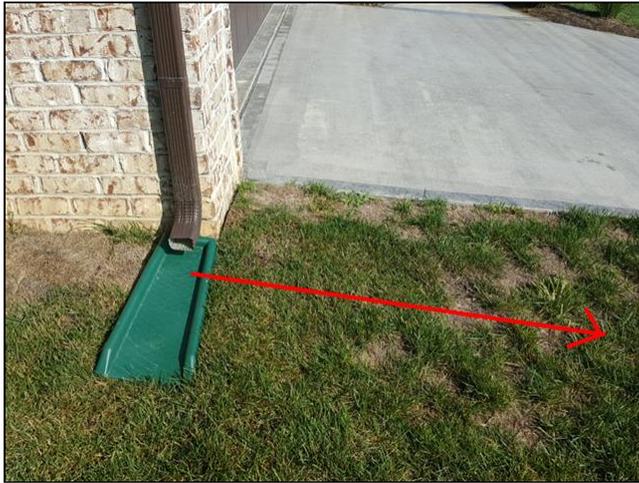
2.3 Item 2(Picture)

2.3 (2) Recommend the downspout(s) at the front left corner of the garage where indicated in the photo(s) be re-directed and extended at least 5 feet and flow onto splashblocks so water flows away from the foundation perimeter. This will ensure water is kept away from the foundation perimeter, soil erosion does not occur and water cannot leak into/under the concrete slab. Also this will prevent settlement from occurring around the foundation perimeter. Recommend repair and replacement as needed.

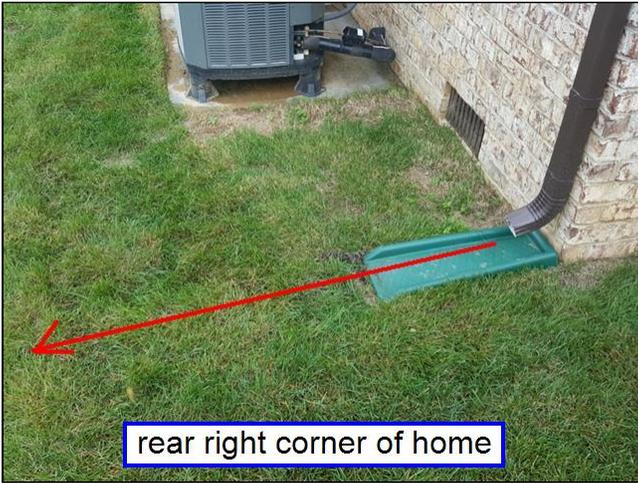
2.3 Item 3(Picture)

2.3 (3) Recommend the downspout(s) around the perimeter of the home be extended at least 5 feet and flow onto splashblocks. This will ensure water is kept away from the foundation perimeter, soil erosion does not occur and water cannot leak into the crawlspace area via the vent which may cause settlement of the foundation.

Note: You may wish to consider burying the extension to prevent a tripping hazard. See photos for example.

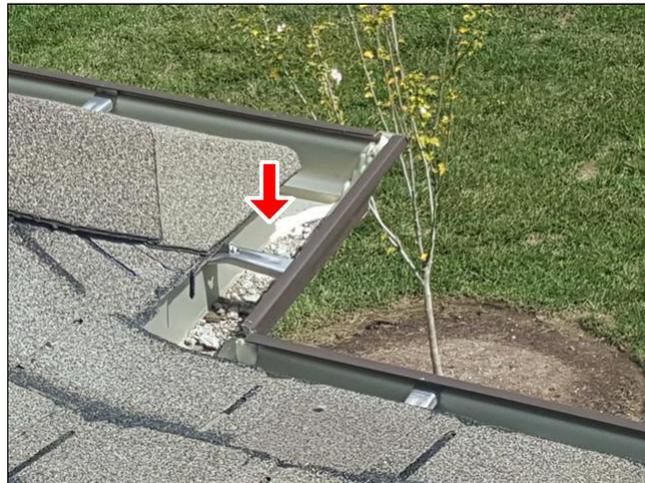
2.3 Item 6(Picture)

2.3 (4) The gutter(s) at the front of the home where indicated in the photos, especially where they drain into the downspouts, are full of debris and need to be cleaned. Gutters require cleaning to avoid spilling roof runoff around the building - a potential source of water entry or water damage. Recommend cleaning the gutters as needed.

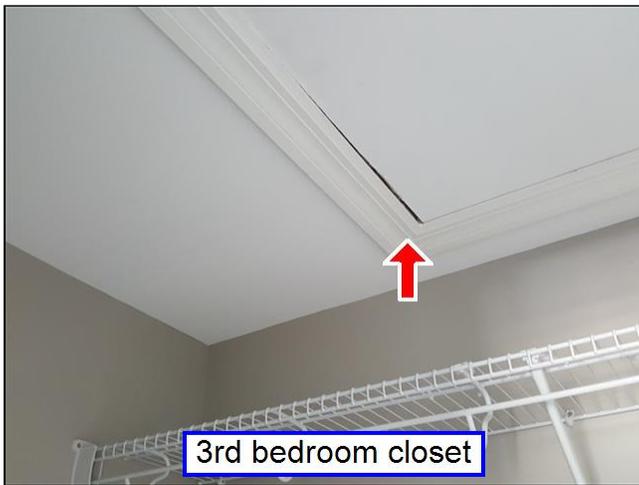
2.4 Item 3(Picture)

2.4 (2) The attic access in the 3rd bedroom door(s) does not fit the opening properly. This can cause some heat loss in winter and loss of cool air in summer if not corrected. Recommend replacement as needed.

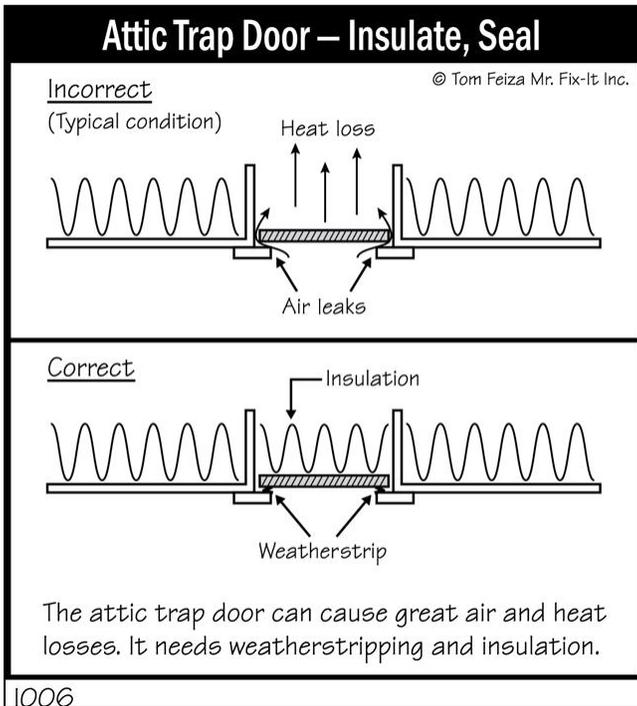
2.4 Item 4(Picture)

2.4 (3) Recommend the attic access hatch be insulated to prevent air and heat loss for energy conservation.

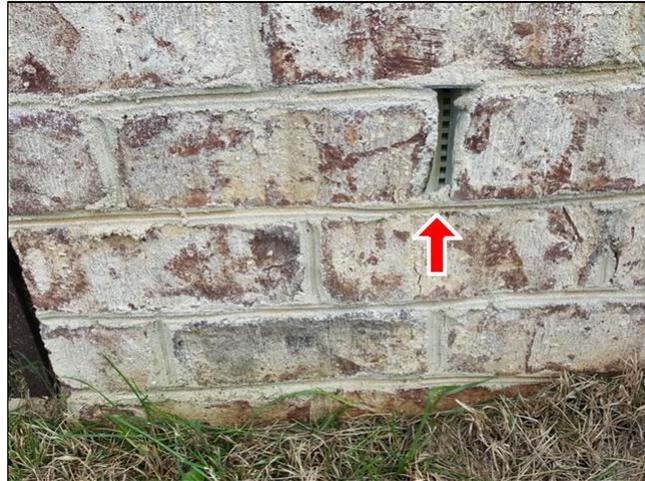
3.0 Item 1(Picture)

3.0 Missing mortar in these areas of the brick siding are known as weep holes. They allow moisture to escape from behind the wall siding. They should not be filled in. This is for your information.

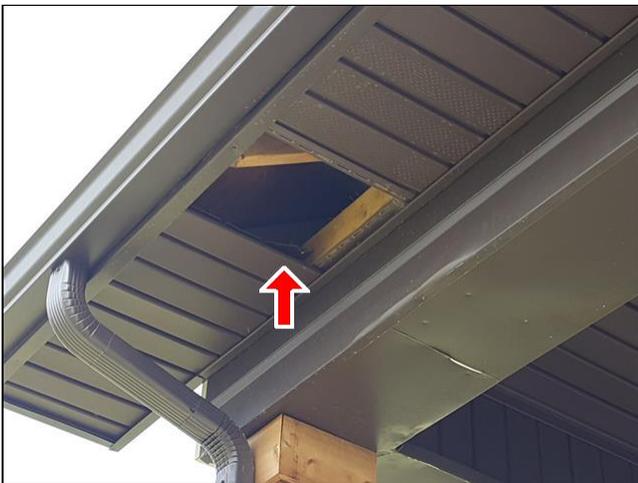
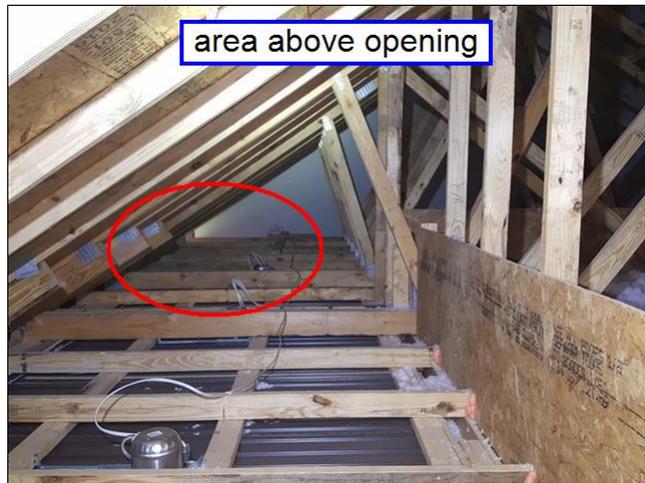
3.1 Item 1(Picture)

3.1 The soffit at the rear left corner of the home has a opening. These openings should be sealed to prevent entry of weather,rodents and insects. These openings can allow bees or wasps to enter which can lead to nests being formed in the attic. Also if water enters it can lead to deterioration of the roof structure and possible mold forming. Recommend a qualified contractor replace missing soffit.

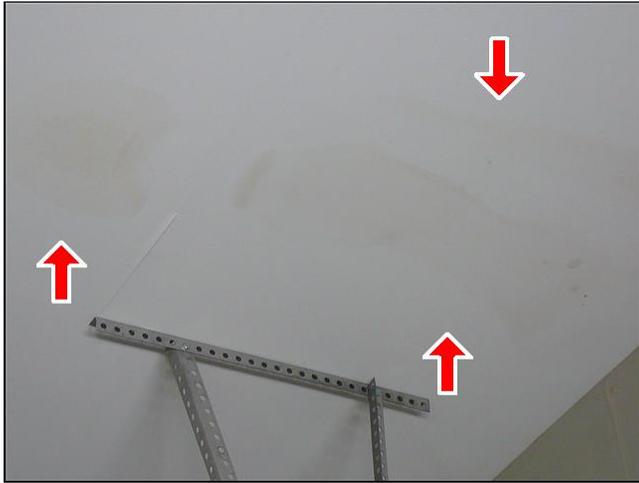
4.0 Item 1(Picture)

4.0 The drywall at the ceiling in the garage has a previous water stain. This area was dry at the time of inspection. However I do believe water leakage will be experienced in this area, especially when heavy rainfall is expected. See note 4.1. Inspections are limited and destructive inspections are excluded. The extent of damage cannot be realized until the covering is removed.

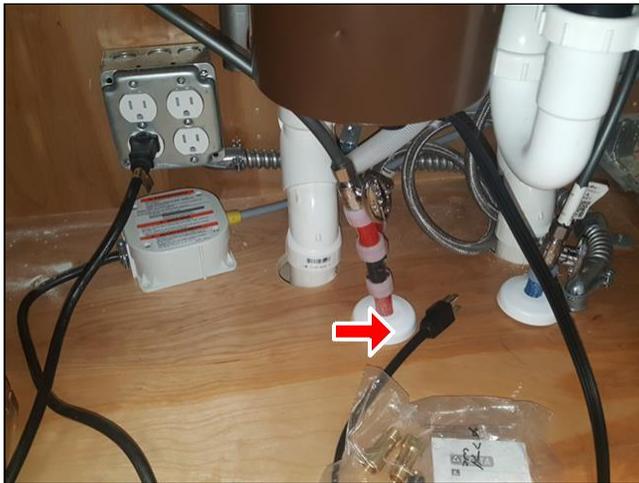
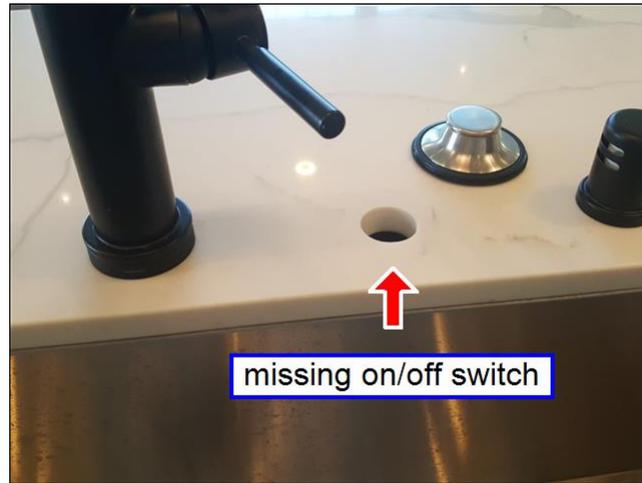
5.3 Item 1(Picture)

5.3 The disposer was not inspected for operation due to it was not connected to power at time of inspection. Also the on/off switch is missing. The disposer cannot be operated even if connected due to missing switch. Recommend a qualified appliance contractor install missing switch and verify disposal is operational prior to closing.

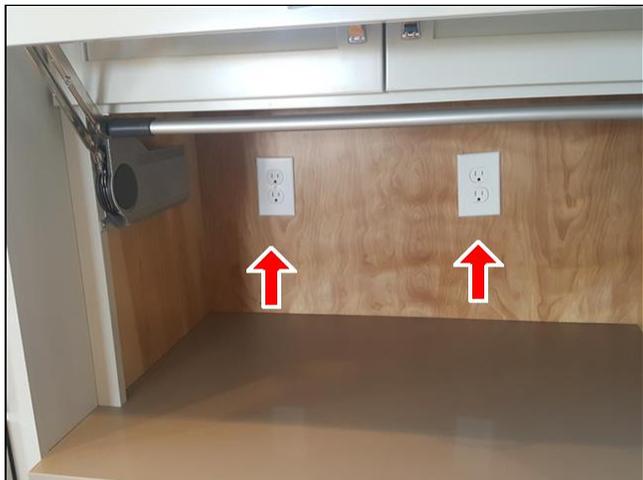
5.10 Item 1(Picture)

5.10 (3) The outlet(s) in the kitchen where indicated in the photo(s) are loose in the wall. Electrical issues are considered a hazard until repaired. This is a safety issue that needs to be corrected due to an electric shock or fire from loose connections could occur if not repaired. Recommend a qualified licensed electrical contractor correct as needed.

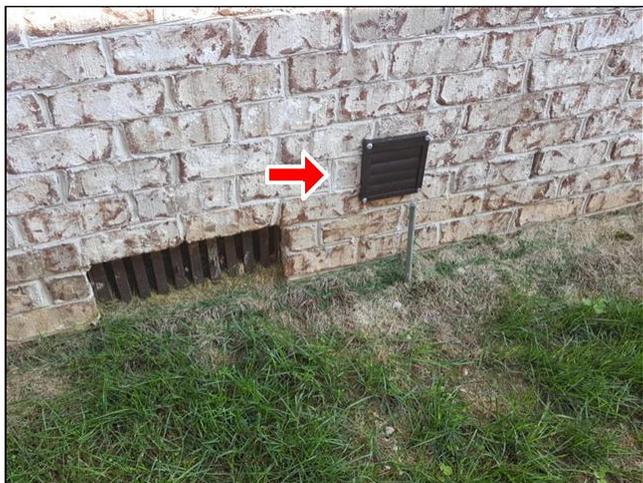
5.11 Item 1(Picture)

5.11 (1) The exterior port for the dryer vent pipe is located on the left side of the home. (see photo for location) This is for your information.

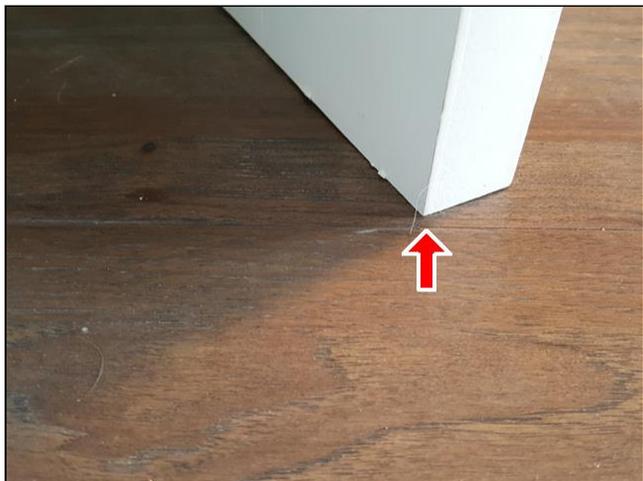
6.4 Item 1(Picture)

6.4 (1) The door between the main entry and the 2nd bathroom on the ground floor needs to be trimmed at the bottom. The door is difficult to operate and rubs the floor when opened which can damage the floor covering. Recommend a general contractor repair as needed.

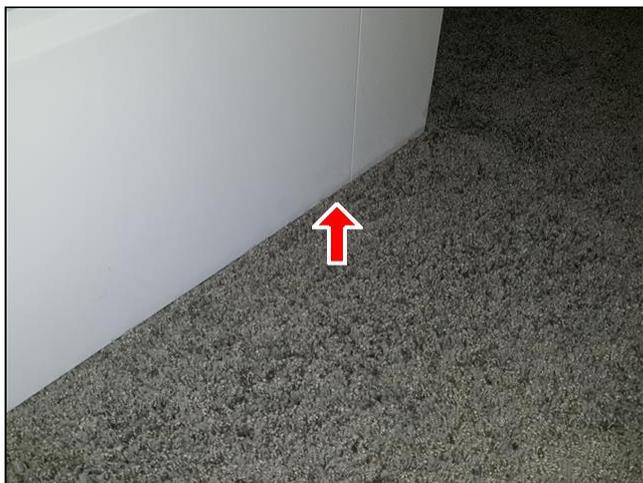
6.4 Item 2(Picture)

6.4 (2) The door in the 2nd Bedroom closet rubs on the carpet when opened and closed. The bottom of the door needs to be trimmed to prevent wearing the carpet. Recommend a general contractor repair as needed.

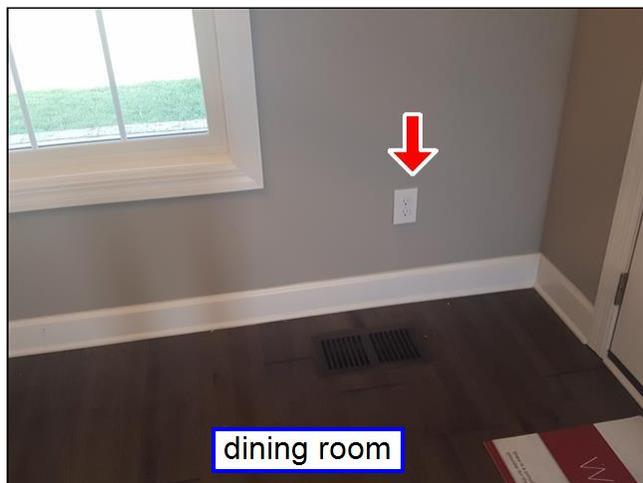
6.7 Item 1(Picture)

6.7 (1) The outlet(s) where indicated in the photo(s) are loose in the wall. Electrical issues are considered a hazard until repaired. This is a safety issue that needs to be corrected due to an electric shock or fire from loose connections could occur if not repaired. Recommend a qualified licensed electrical contractor correct as needed.

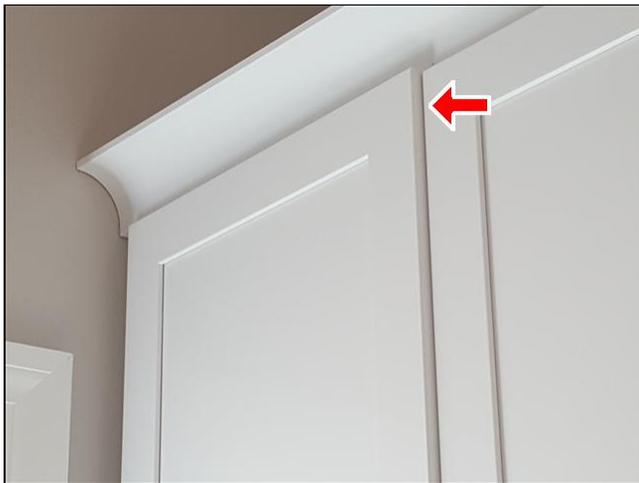
7.1 Item 1(Picture)

7.1 The cabinet door in the master bathroom near the window does not seal flush with the cabinet when closed. An adjustment of the hinge maybe required. Recommend repair or replace as necessary.

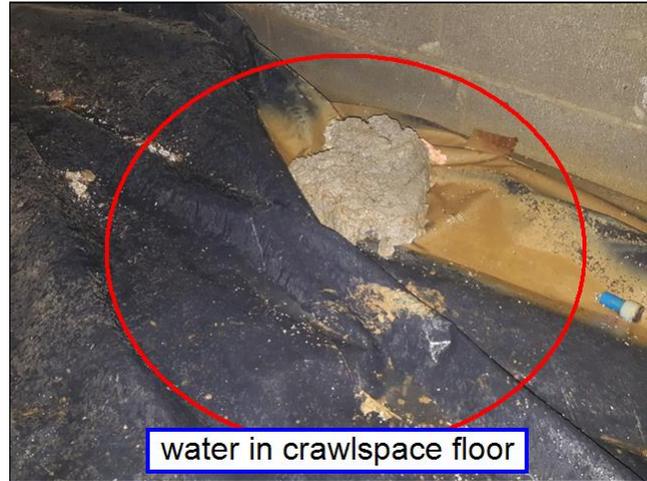
8.0 Item 2(Picture)

8.0 (2) The drain line in the crawlspace below the shower and tub in the 2nd bathroom area has a major water leak. Water leakage was experienced when faucet was turn on, drain plug sealed, and when water was drained in the tub. Cannot determine cause or how water is leaking. It maybe due to drain plug not sealing and there is a leak at the drain line. Water in a crawlspace can lead to mold or damage to the floor structure if not repaired. Recommend a qualified plumber further investigate, repair leaks prior to closing to prevent costly repairs in the future.

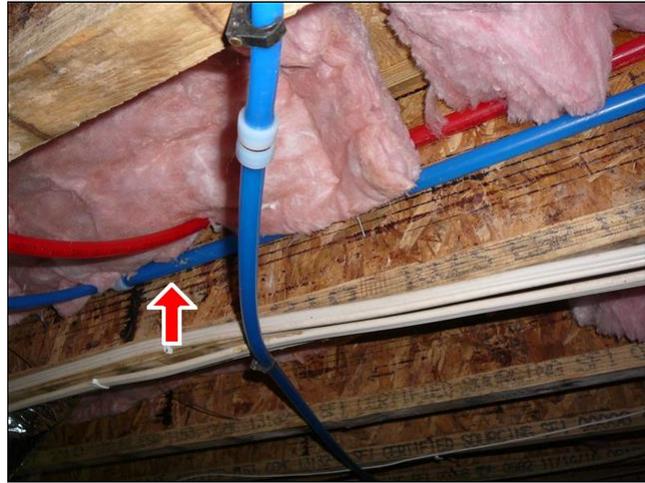
8.1 Item 1(Picture)

8.1 (2) Recommend insulating the water supply pipes underneath in the crawlspace (hot and cold) to ensure pipes do not freeze in winter which may cause a serious plumbing leak in the crawlspace, and to prevent heat loss of water when hot water is flowing into home. This will improve efficiency. This is for your information.

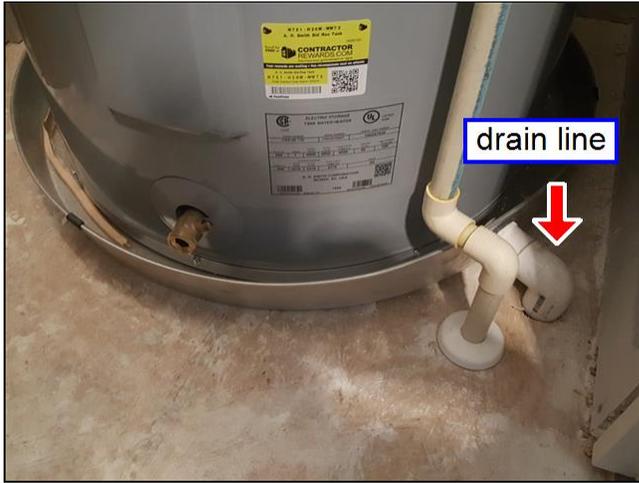
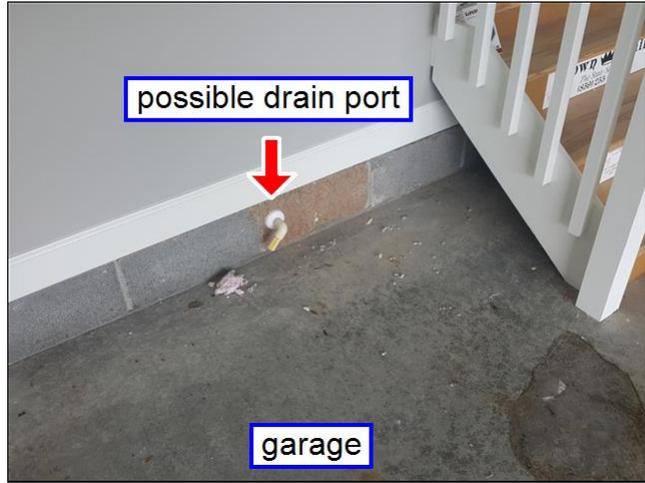
8.2 Item 1(Picture)

8.2 (3) The drain pan installed under the water heater under the stair case does have a drain line, however could not determine where the drain line exits too. It should drain to the exterior of the home. Recommend asking the owner of the home for location prior to closing. It may drain directly into the drainage system or in the garage. If the owner is unaware then recommend consulting a licensed plumber to determine location. This is for your information.

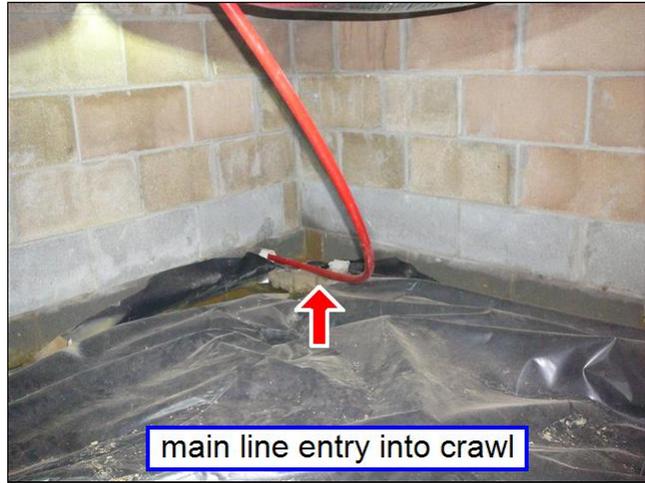
8.4 Item 1(Picture)

8.4 (1) The main shut off is the red lever located above the water heater underneath the staircase. You may wish to consider relocating main shut closer to the entry point in the crawlspace. Before the main shut off the supply line will always have water flowing regardless if water has been shut to the interior of the home. If a leak occurs in the supply line before the main water shut off water will leak and possibly flood the crawlspace floor area which will lead to costly repairs. This is for your information. A qualified licensed plumber will be able to relocate main shut off if desired. Best alternative to shutting water to the home will be at street meter and a water key will be required. This is for your information.

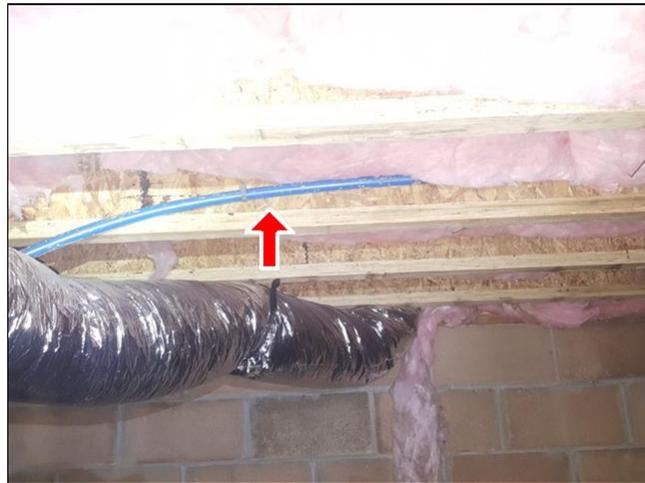
8.4 Item 3(Picture)

8.4 (2) Recommend insulating the main water supply line pipe in the crawlspace due to the pipe is located in an unconditioned area. This will ensure that the pipe does not freeze in winter which may cause a serious plumbing leak and prevent costly damage to the home. This is for your information.

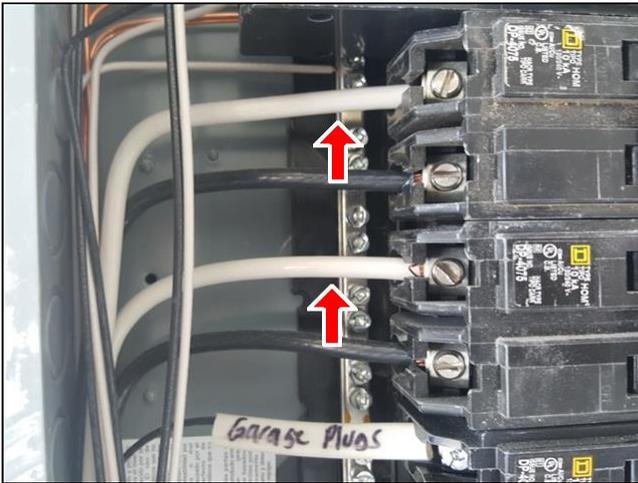
9.3 Item 1(Picture)

9.3 The white wire(s) that are connected to the circuit breaker(s) should be marked black to indicate that they are live (hot wires) and are being used for the flow of electricity to travel. Recommend an electrician correct due to safety.

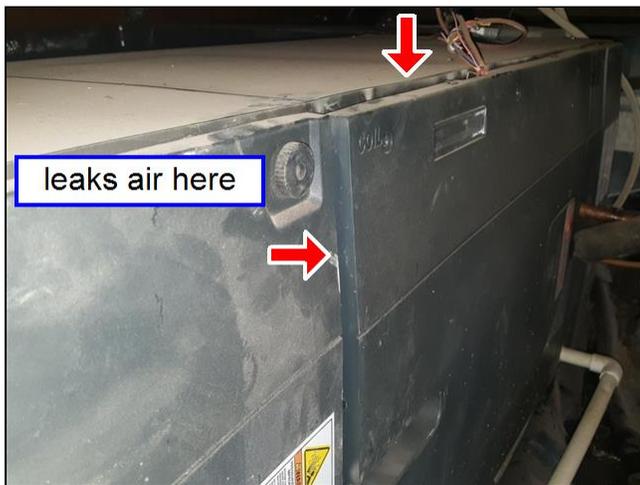
10.0.A Item 1(Picture)

10.0.A (2) The cover is not secured correctly at the air handler in the crawlspace and leaks air. Besides inefficiency of cooling and heating the home the air escaping into the crawl can lead to mildew or condensation to form in the crawlspace. Though this wasn't evident at the time of the inspection, for efficiency would recommend a qualified licensed HVAC contractor correct and repair as needed.

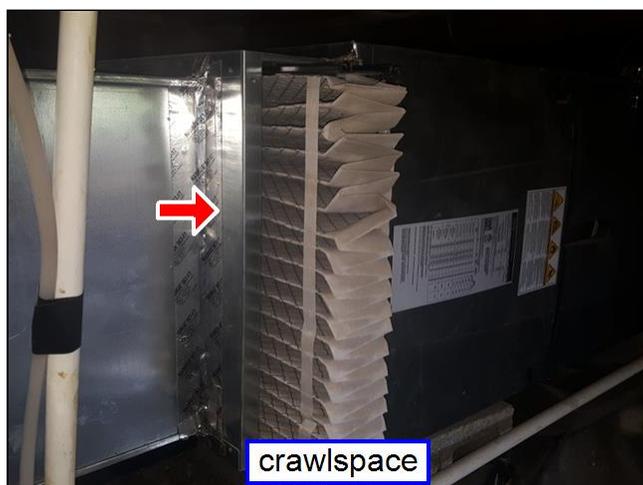
10.1.A Item 1(Picture)

10.1.A Filter location (see photo). The arrow on the filter should always point towards the blower.

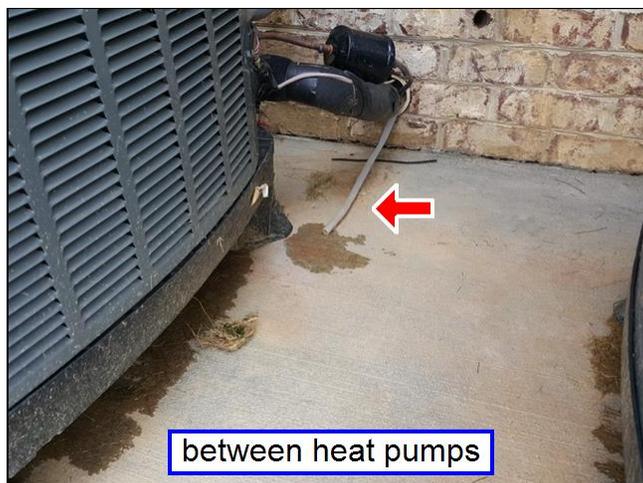
10.3.A Item 1(Picture)

10.3.A (1) Location of the condensate drain line to exterior. (see photo)

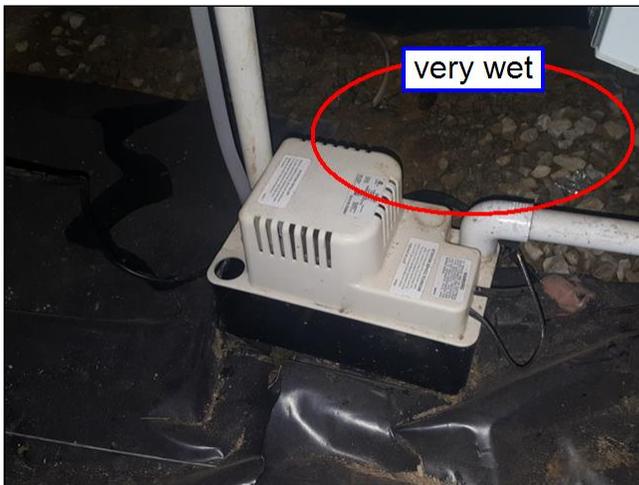
10.3.A Item 2(Picture)

10.3.A (2) The condensate pump did not appear to be functioning at the time of the inspection. Water was leaking at the pump onto the crawlspace floor. The unit was full of water. Water in a crawlspace can lead to mildew or mold to form. Recommend a qualified HVAC contractor further investigate and repair or replace as needed.

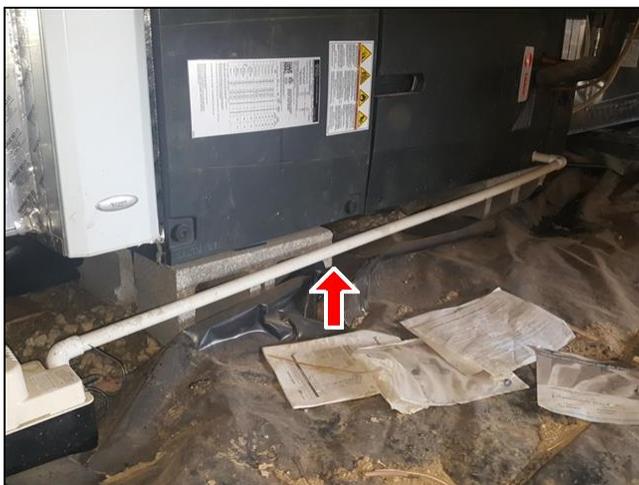
10.3.A Item 4(Picture)

10.3.A (3) There was no visible condensate trap installed at the condensate drain line for the Air Handler in the crawlspace. It is recommended by the manufacturer to have one. The purpose of the trap is to allow the water to drain freely, with out it air flowing in the drain line can cause the water to not flow (drain to the exterior). Recommend a qualified HVAC contractor correct as needed.

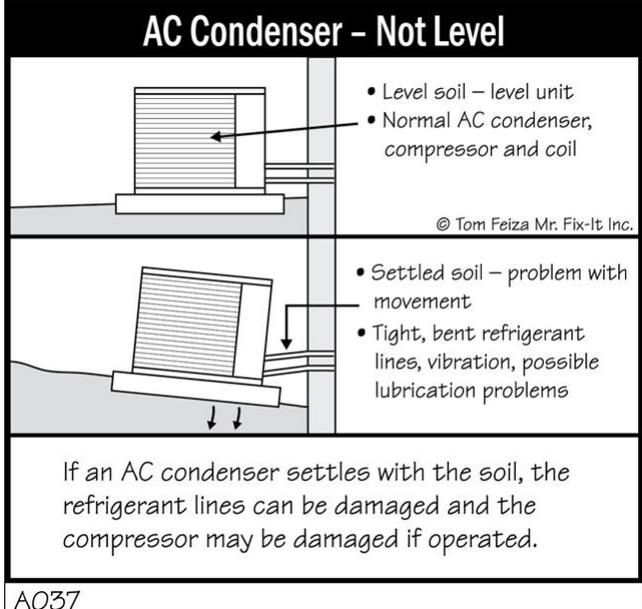
10.3.A Item 6(Picture)

10.3.A (4) Recommend the discharge for the condensate drain line be improved via extending the drain line at the rear right side of the home. This will prevent water pooling near the foundation which could cause settlement of the foundation wall and water leakage into the crawlspace. Also to prevent possible settling of the platform for the Heat Pumps. A qualified HVAC contractor is recommended for these repairs.

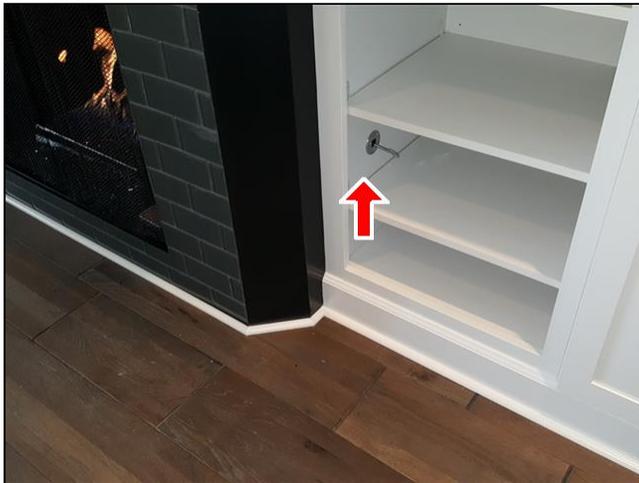
10.8.A Item 2(Picture)

10.8.A (2) The gas shut off for the gas log fireplace. (see photo) This is for your information.

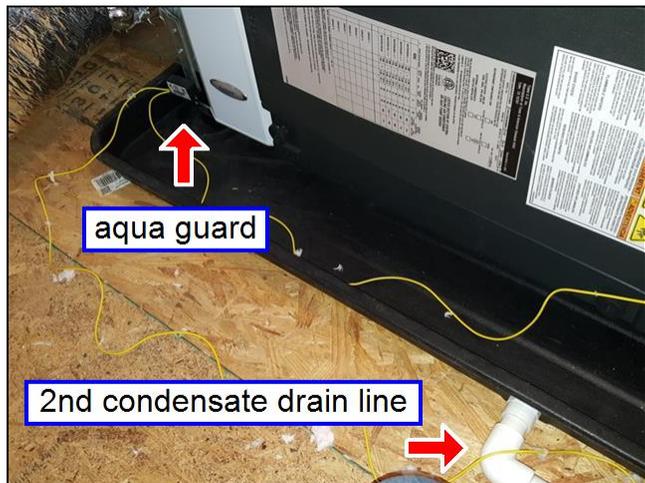
10.0.B Item 1(Picture)

10.0.B (3) The Air Handler in the attic has a condensate drip tray under the unit. In the event that condensate drain line malfunctions or water overflows into the tray the additional condensate line will drain the water to the outside from the drain pan. In the event that the 2nd condensate malfunctions the float switch will sense there is excess water in the tray and will shut down the system. This may be inconvenient in hot weather, but the installer or owner have chosen to protect the building against a potentially costly mold or water damage to the attic. This is for your information.

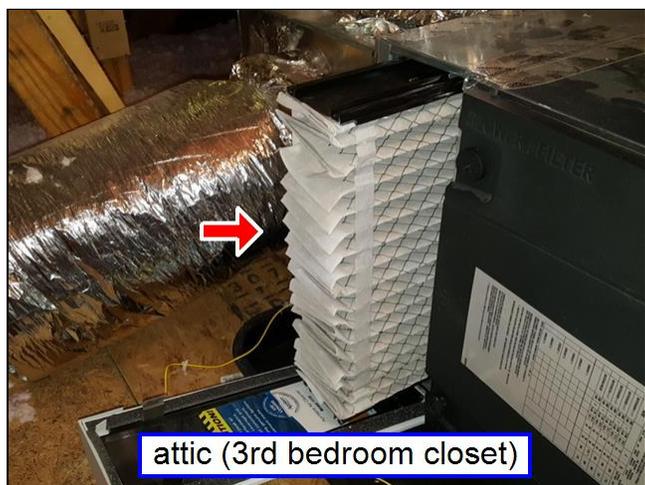
10.1.B Item 1(Picture)

10.1.B Filter location (see photo). The arrow on the filter should always point towards the blower.

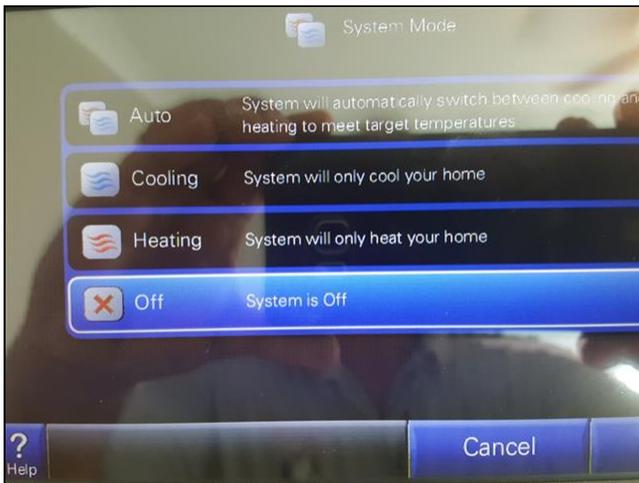
10.6.B Item 1(Picture)

10.6.B The thermostat does not have the emergency heat mode to suit the heat pump. Recommend replace as needed by a qualified HVAC contractor in order to operate the emergency heat at the heat pump when needed.

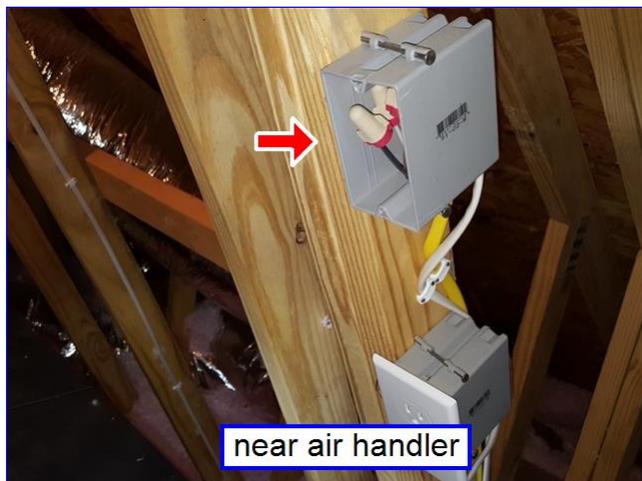
2.8 Item 1(Picture)

The junction box near the air handler in the attic (3rd bedroom closet area) should have a cover installed to prevent tampering, protect the wire connections, and for personal protection. This is a safety issue that needs to be corrected. Recommend a qualified licensed electrician correct as needed.
