Evaluation of Publicly Maintained Bioretention Facilities

Does good maintenance guarantee optimum performance?

Phase I and II studies

A Fairfax County, VA, publication
April, 2017

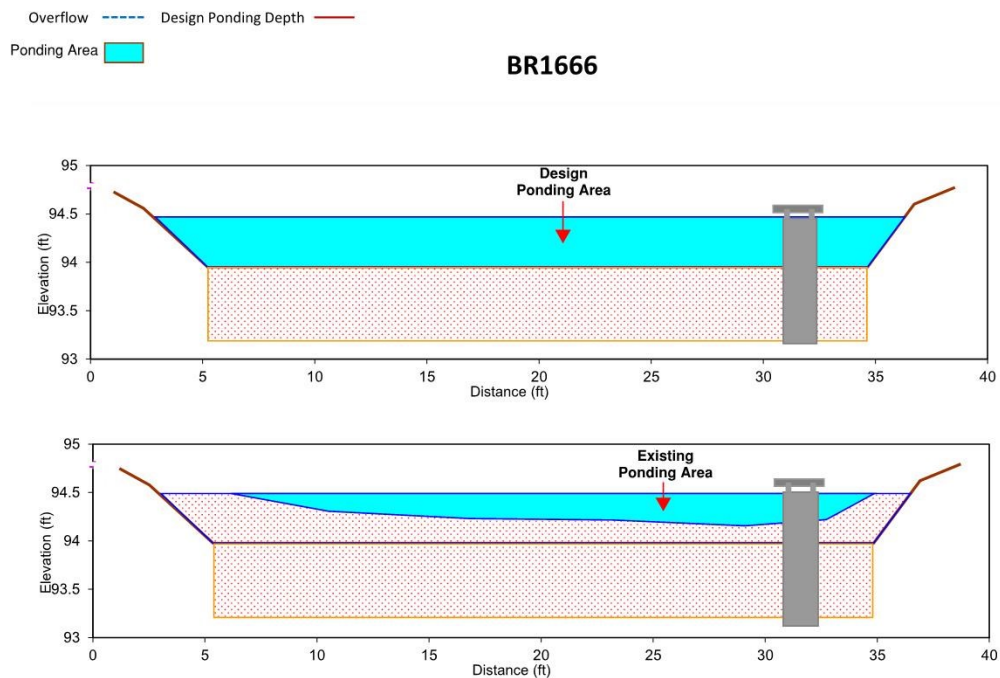
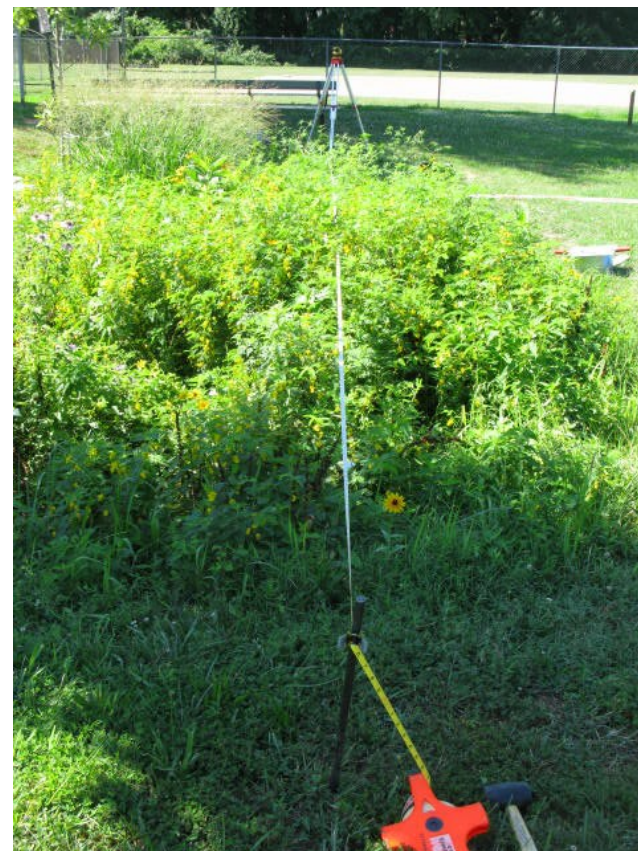
Topographic survey of the ponding area

Top of the berm seems to serve as the overflow

Overflow (ft.) = 94.21

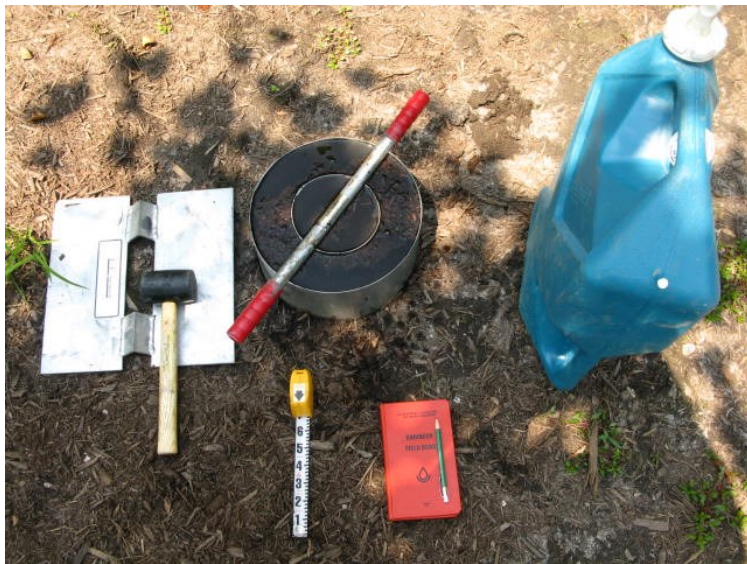
Soil media infiltration rate

Date: 07/20/2014				
Number of Measurements		4		
#	Time (min)	intervals (min)	Readings (ft)	Rate (in/hour)
1	0	5	0.44	0
2	5	5	0.42	2.88
3	10	5	0.38	5.76
4	15	5	0.32	8.64
		I Rate (in/hour)		5.76
% sand	82			
% silt	12			
% clay	6			
%org. matter	2.4			
Textural Class	loamy sand

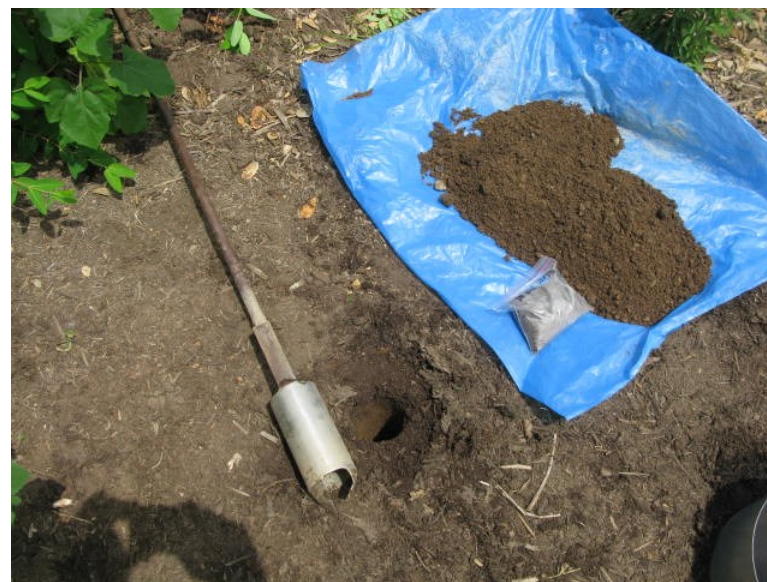
Soil media depth & particle size

% sand	82
% silt	12
% clay	6
%org. matter	2.4
Textural Class	loamy sand

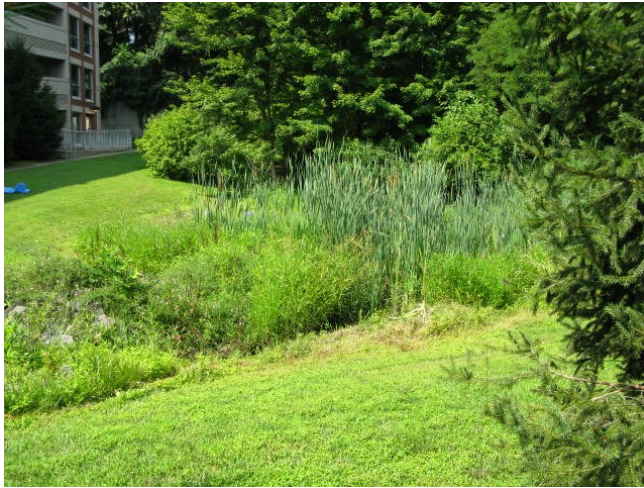
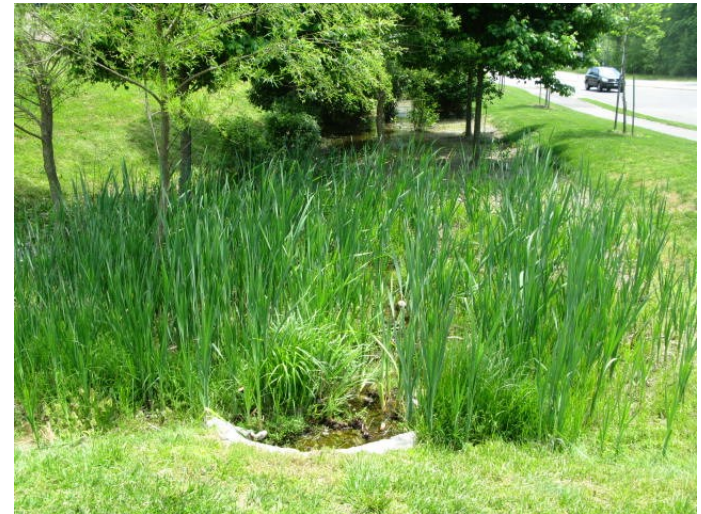
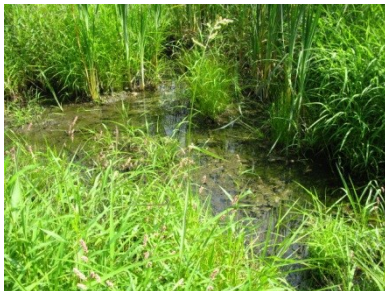
Seepage or continuous base flow into bioretention facility might develop localized wetlands.

- *Eliminate or divert continuous base flow into the bioretention.*
- *Although filter fabric did not have a negative impact on vertical flow, 6.0" of pea gravel is a preferred option.*
- *Within 6 months after construction is complete, survey/evaluate the facility using the SOP developed during this study, and at least every 5 years thereafter.*
- *Share the results with other DPWES divisions, private industry, other jurisdictions.*

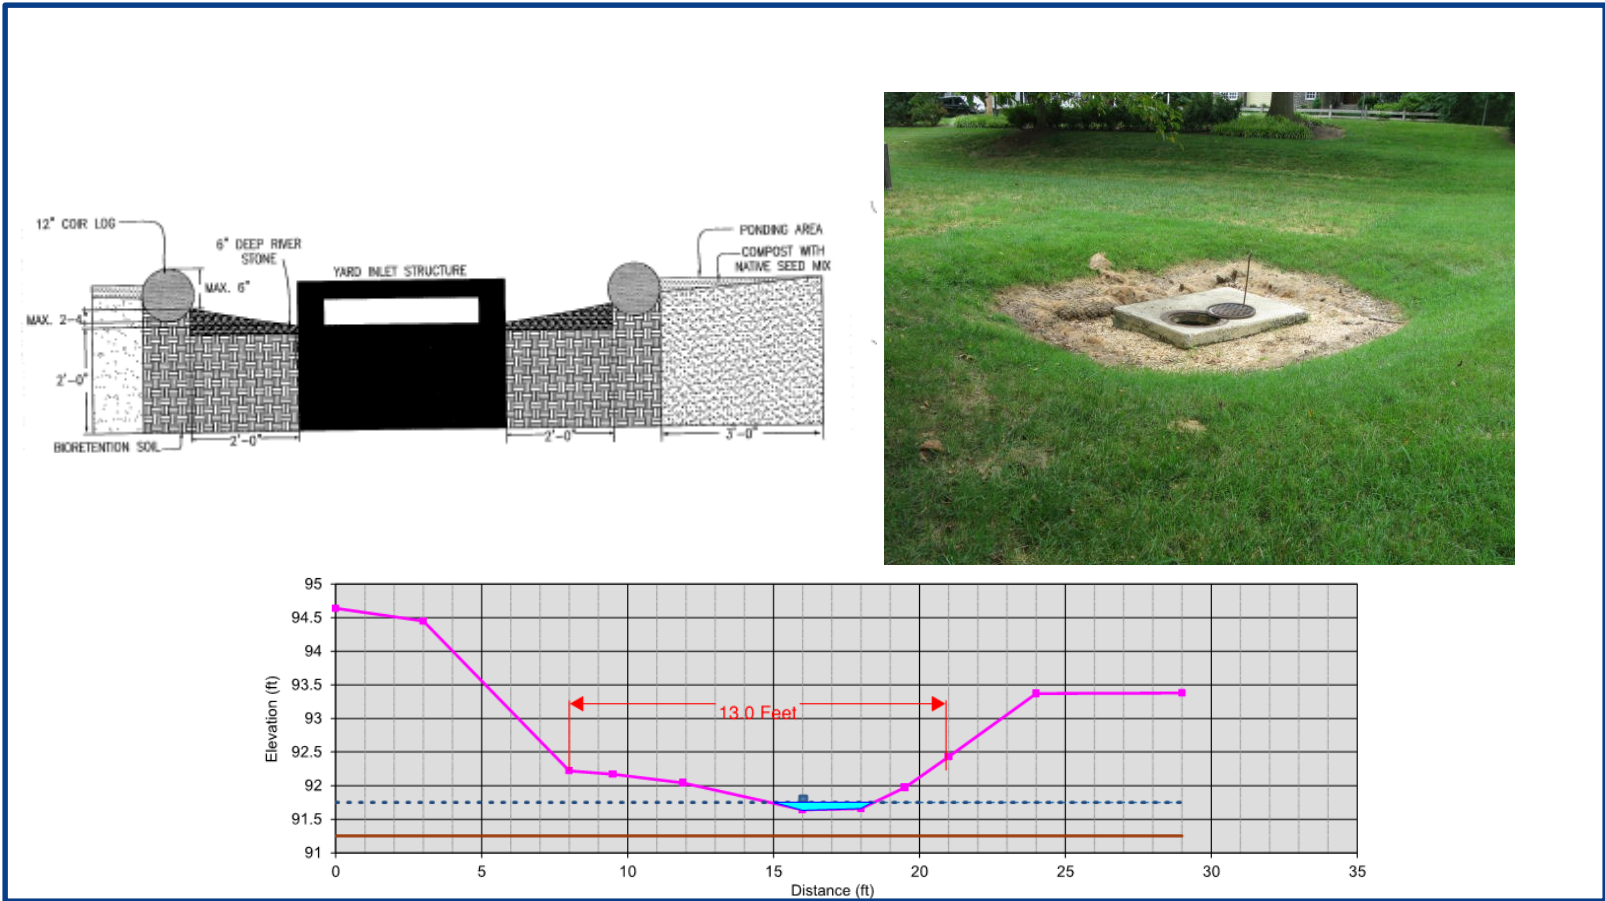
Facilities that might not qualify as bioretention

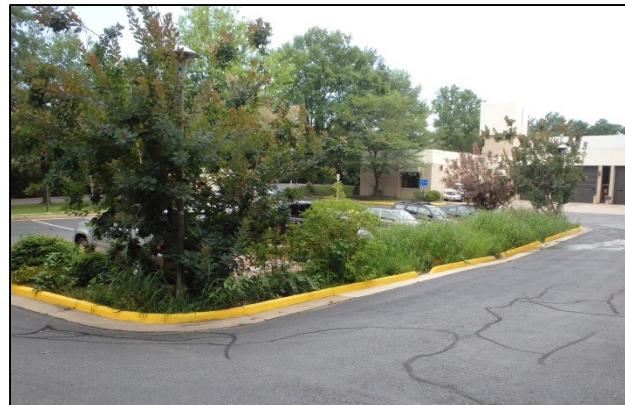
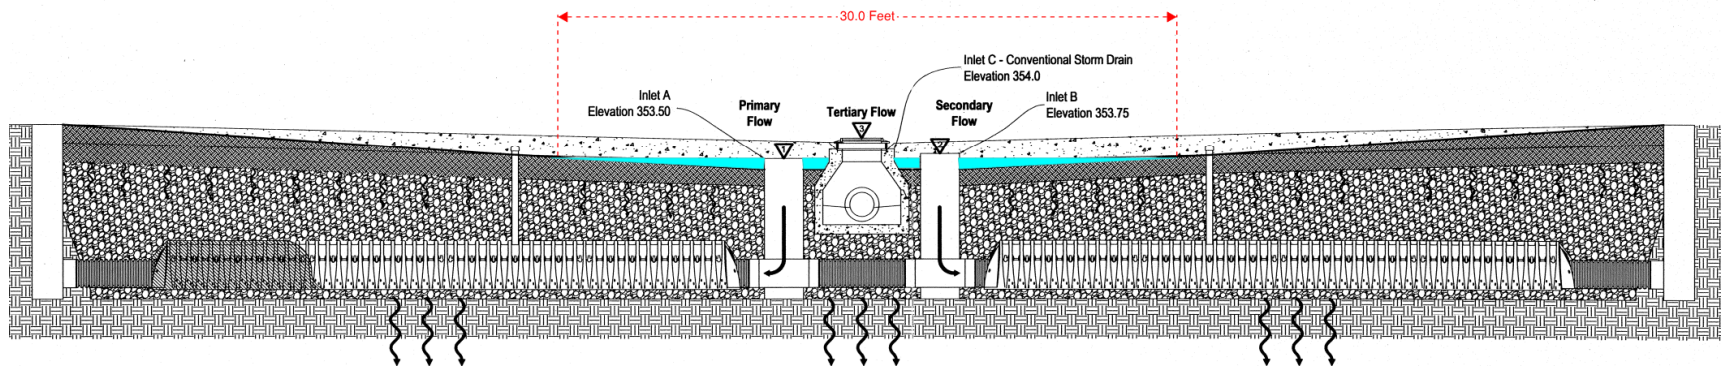
Facilities that might not qualify as bioretention
