3871 Piedmont Avenue, #15, Oakland, CA 94611 www.stargroup.com Office – 510.482.8016
Residential and Commercial Building Inspections Since 1979

123 Easy Street
Oakland, CA
July 7, 2017 - 12:00 pm
Report Number 170707Customer

This Report Prepared for
Mr. Customer

We inspected the three-level, commercial building at 123 Easy Street in Oakland, California on July 7, 2017.

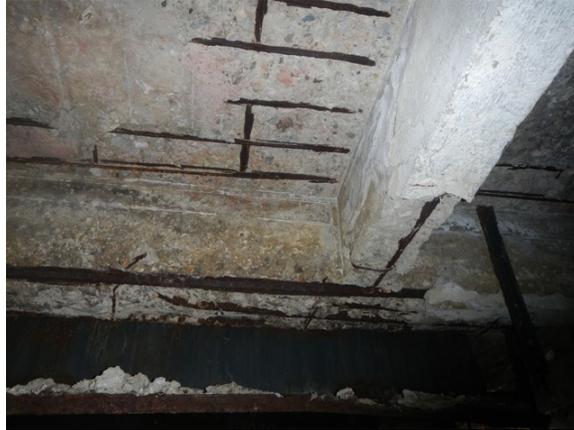
A surface drain at the sidewalk empties into an area below the sidewalk adjacent to the building's out-of-use freight elevator. There does not appear to be any provision for removing whatever water may enter through the surface drain, and it is unclear who is responsible for maintaining this area. We recommend review of whatever agreements, leases, or other arrangements with the authority having jurisdiction in this area may exist and that appropriate action be taken to address the water entry in this area.

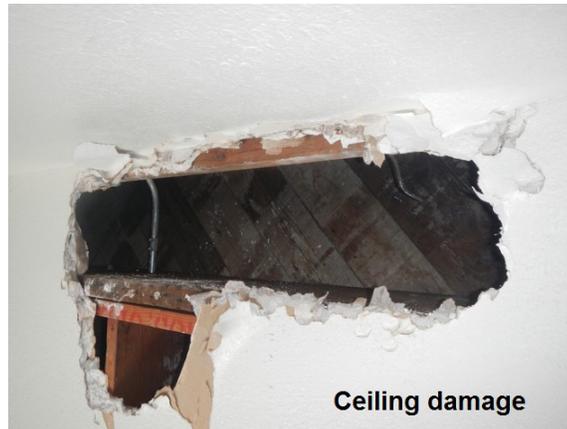
A few of the ceilings show moisture related damage; we recommend they be repaired by a qualified contractor for appearance once the source of the moisture is identified and properly addressed.
