Thursday, May 28, 2015

IM Buyer  
1 Seller Lane  
Anywhere, NY 11563

### **REPORT SUMMARY**

# GENERAL INFORMATION

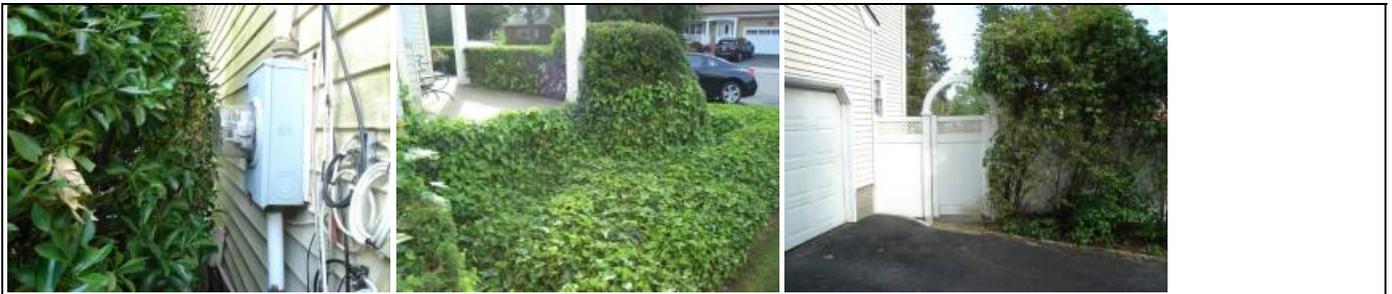
### 2.6 Bushes and Shrubs Condition:

Bushes and shrubs need to be trimmed away from the structure at least 2 inches. This space is needed to prevent direct access to the structure by insects and to keep the bushes from damaging the siding.

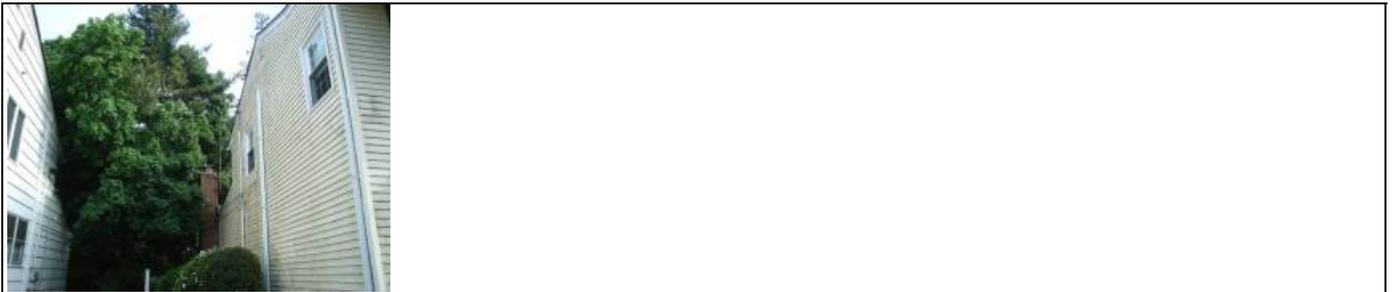
### 2.7 Trees Condition:

Trees overhanging the structure need to be trimmed so that limbs, leaves, and rain will not drop off the tree onto the roof covering and clog the gutters, damage the roof, or promote moss growth. Trees that rub against the roof can cause severe damage and can drastically reduce the life of the roofing material. Trees that have power lines passing through them can cause a power outage. Also, tree limbs can break off due to wind or ice. The owner may be responsible for repair expenses.

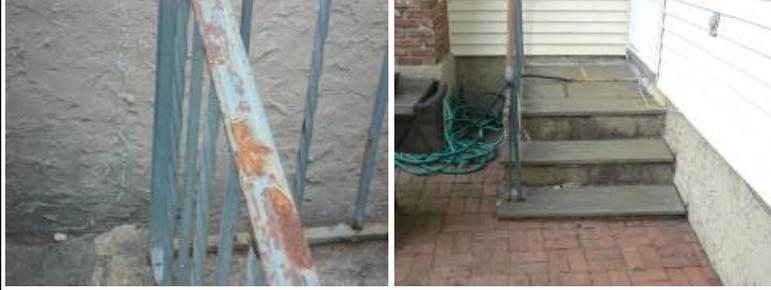
**3.19 Staircase Condition:**

There are handrails solidly attached and in useable condition. The staircase to the basement level appears functional. Hand rails are heavily weathered and should be maintained to prevent further deterioration. Rear entry steps appears functional; Support post is weathered and should be maintained to prevent further deterioration.

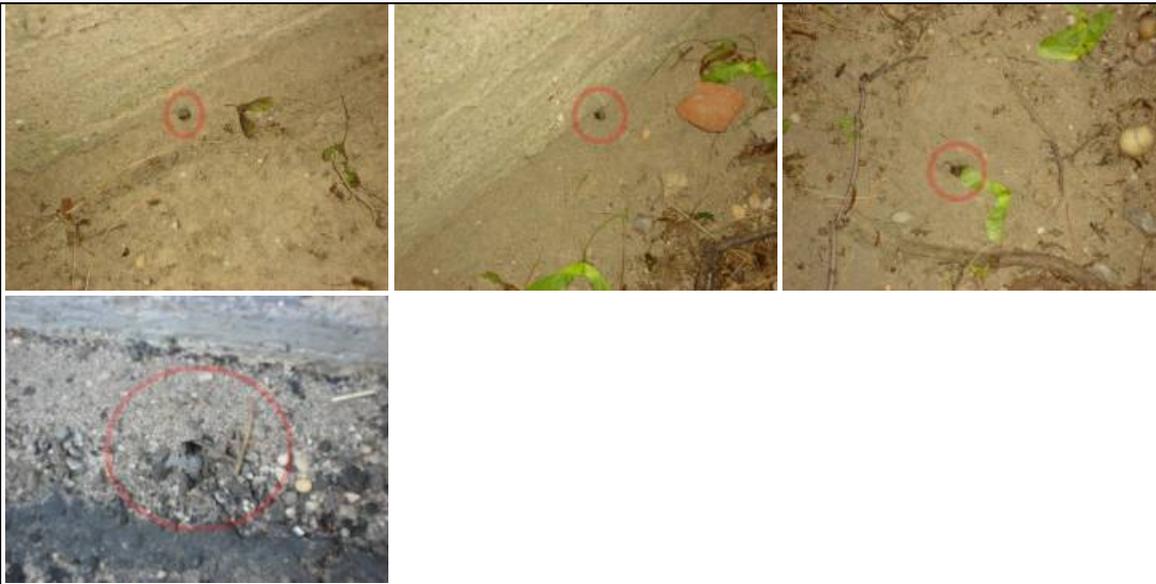
Possible - There was no visible evidence of insect infestation on the lower level. Boring holes are visible along exterior perimeter on the side and rear of residence. Recommend further evaluation by a licensed pest control technician.

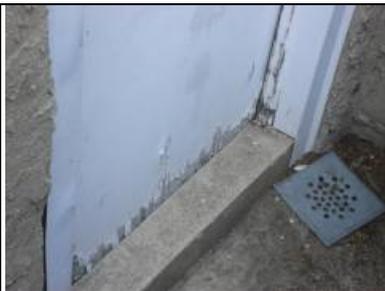
There is a wood walkout door installed. **Attention Needed** - The outside entry door to the walkout basement needs some minor adjustment or repair.

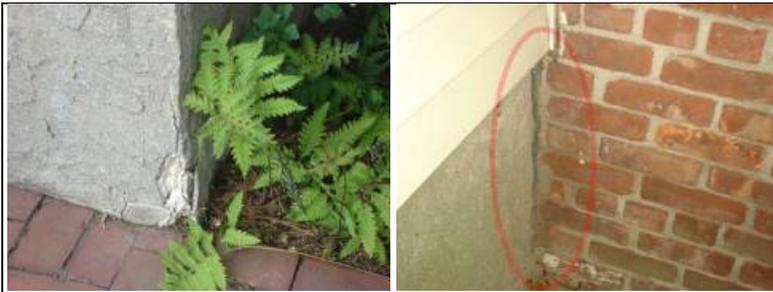
**3.31 Repairs In Exterior Walls Noted:**

There is some form of repairs made to some portion of the walls. The inspector was unable to determine the age of the repairs or the effectiveness of the repairs made. The repairs are described, but the inspector accepts no liability for the repairs or their effectiveness. It is strongly recommended that you investigate the source of the repairs made with the current owner prior to closing. If possible, determine who made the repairs and what warranty if any remains.

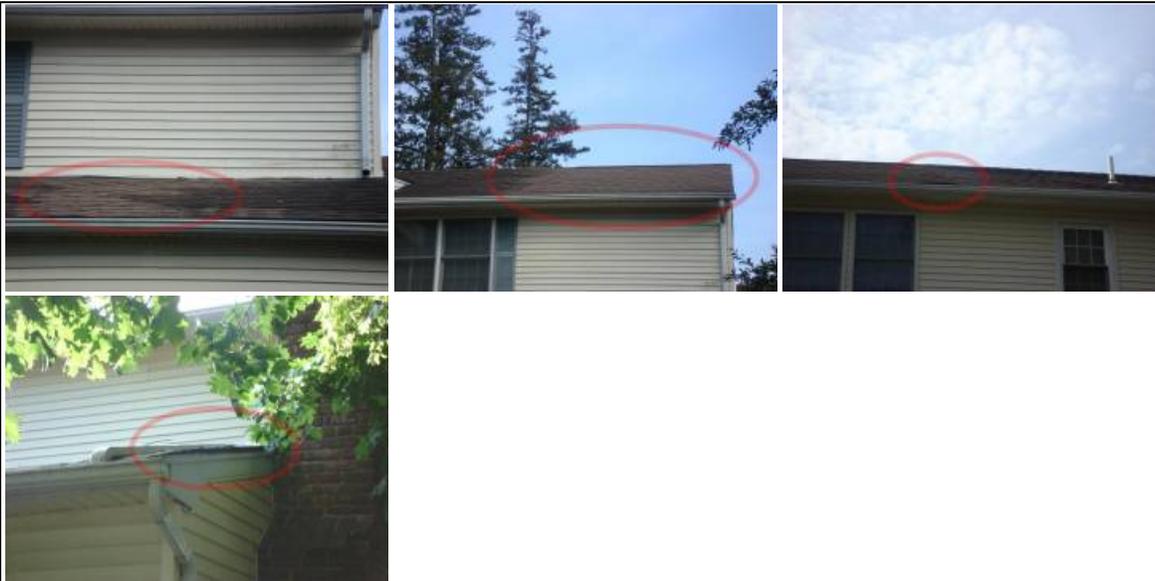
#### 4.5 Condition of Roof Covering Material:

The roof covering material is in a condition that is consistent with its age and method of installation, showing no deficiency or cause for immediate concern in older areas. No age can be determined however roof should be monitored for future issues; Repairs are evident and may have been made due to leaks. Water stains and mold are visible in garage area. This was more likely than not caused by previous damage to roof.

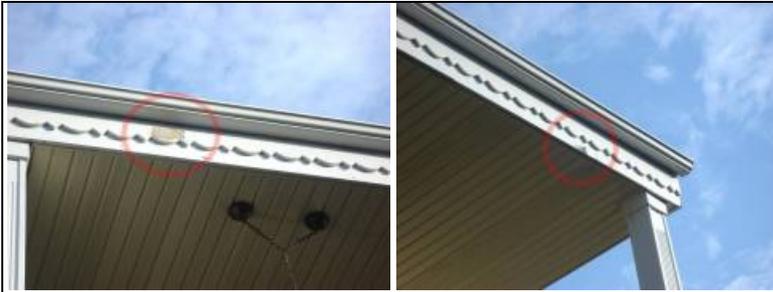
Weathering on fascia is noted; Should be properly maintained to prevent further deterioration.

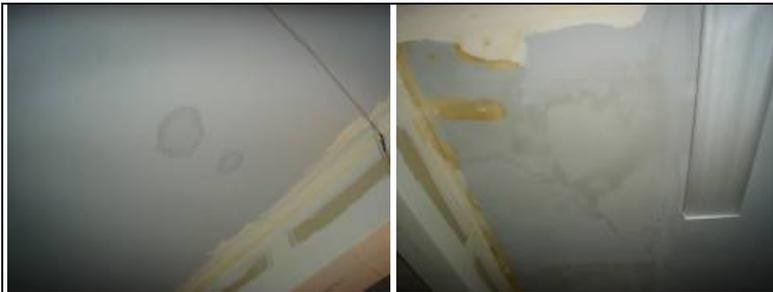
**4.12 Evidence of Leakage:**

Yes - Repairs are evident and may have been made due to leaks in roof. Water stains visible in garage area. This was more likely than not caused by previous damage due to water intrusion.

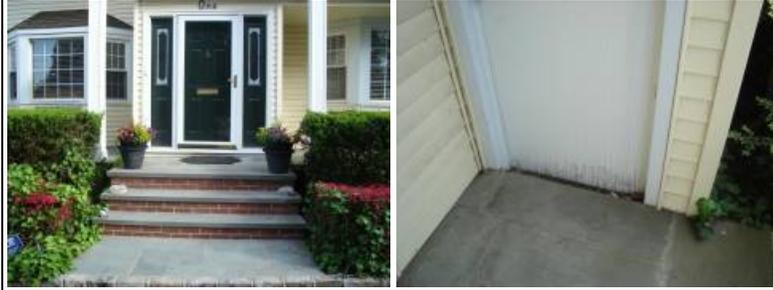
Good - The outside entry door is of insulated glass. The outside entry door(s) is functional as noted from the exterior. **Attention Needed** - The outside entry door needs some minor adjustment or repair. Side and rear entry doors are made of hollow wood core and are heavily weathered at the bottoms. Solid doors of wood/metal/composite is highly recommended.

Note: Fire rated steel door is recommended for basement leading to boiler room.

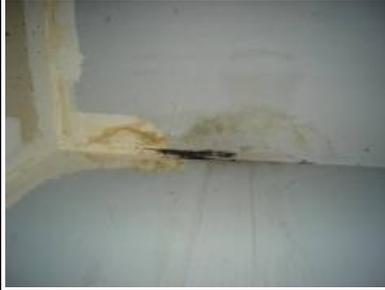
**5.22 Evidence of Mold Noted:**

Yes. There is a mold or fungus noted on the ceiling in at least one location in garage area. This inspection does not include testing for mold type or toxicity. Further testing is recommended and needed to determine the type and the toxicity levels. A serious health hazard may exist from what appears as a simple mold. Testing for airborne mold is also excluded from this inspection.

Please consider having testing completed to protect your investment and your family's health.

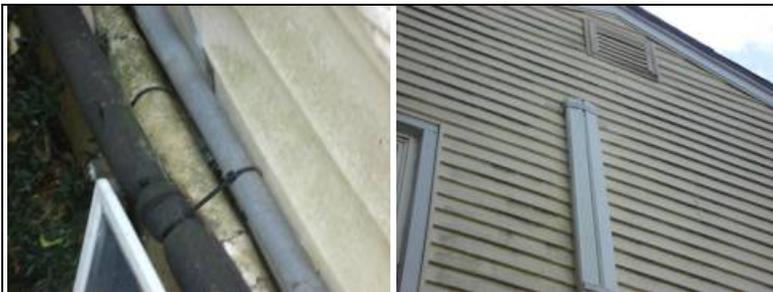
**Attention Needed** - The insulation wrap on the suction line to the condenser/compressor is in need of attention due to deteriorated or missing insulation.

Note: aluminum drainage pipe used in place of PVC. Not a deficiency however PVC is preferable.

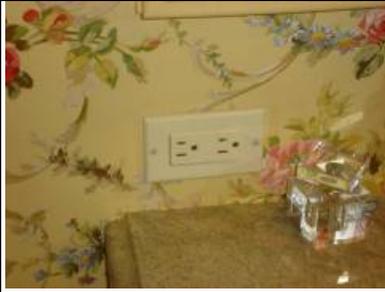
Recommend - This bathroom does not have a Ground Fault Circuit Interrupt outlet installed. The age of the structure may predate the required installation. However, for safety considerations, it is strongly recommended that one be installed at any location within 6 feet of a water source.

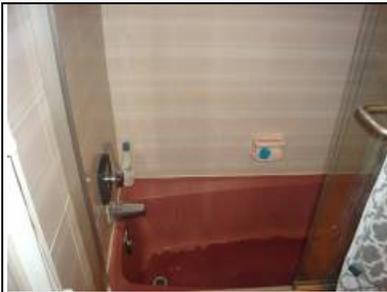
Tub in functional condition. **Action Necessary** - The finish on the bathtub is damaged. Repair of the damaged area can delay further deterioration.
