RIO GRANDE DIVERSION INFRASTRUCTURE INVENTORY

Structure Name: JOHN ANDERSON D

Date: April 1, 2019

JOHN ANDERSON DITCH

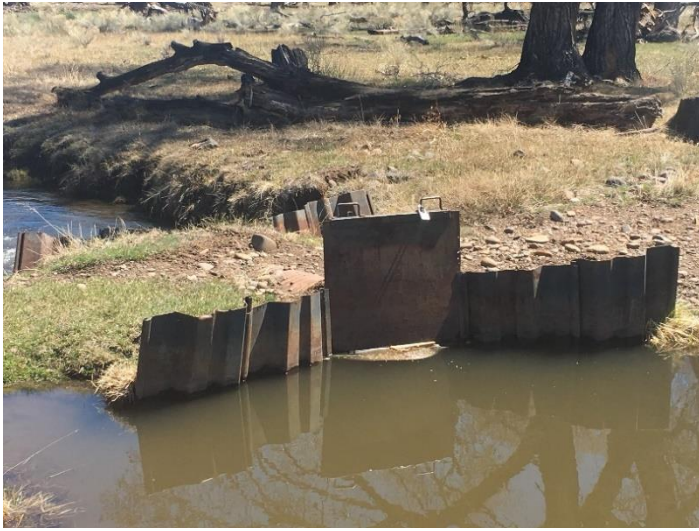
Repair(s) or Improvement(s) Currently Needed: The headgate does not function well and needs to be replaced. The flume could not be located at the time of inspection but the water commissioners confirmed that it measures accurately.

Headgate looking downstream

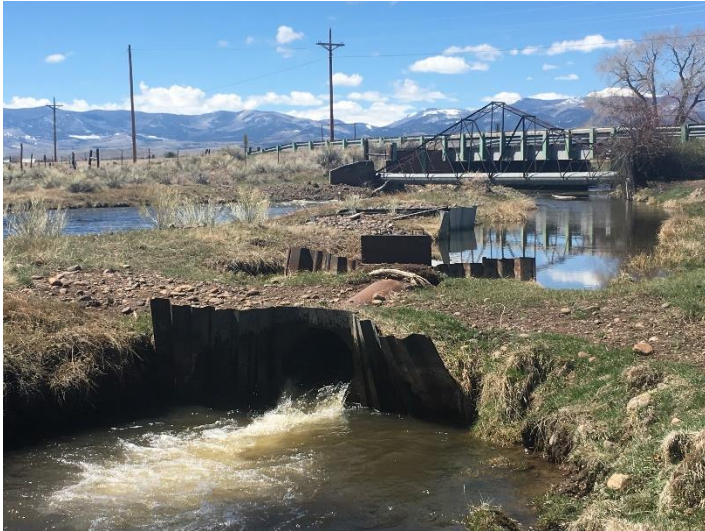
Headgate outlet

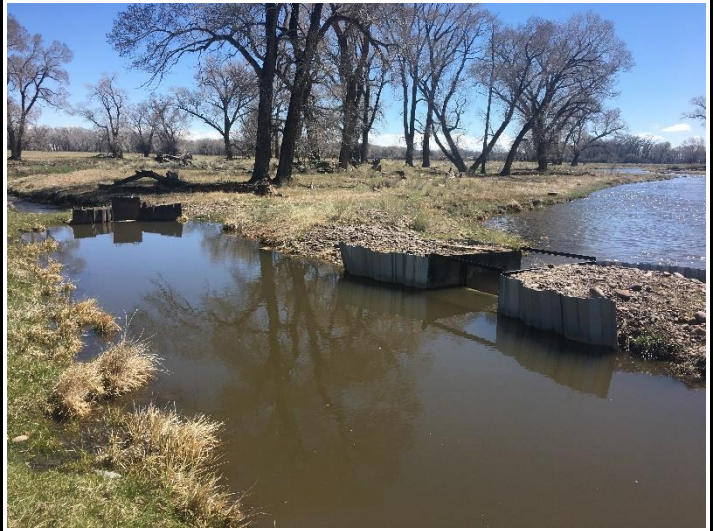
Diversion dam

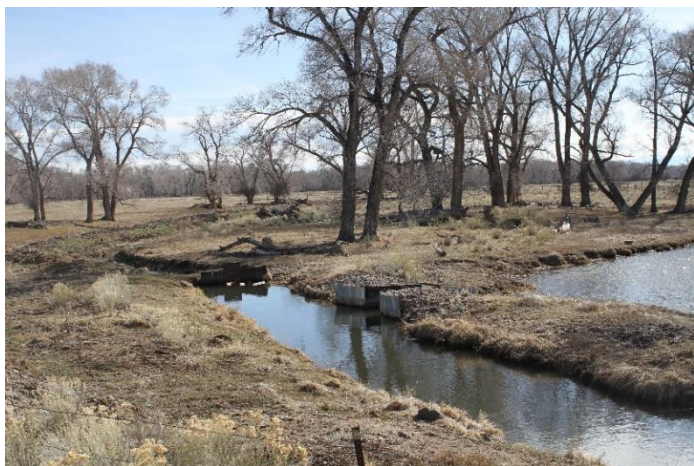
Flume looking downstream
