Home Inspection Report

123 Main Street, Anytown, NY 12205

Inspection Date:

Friday, January 17, 2025

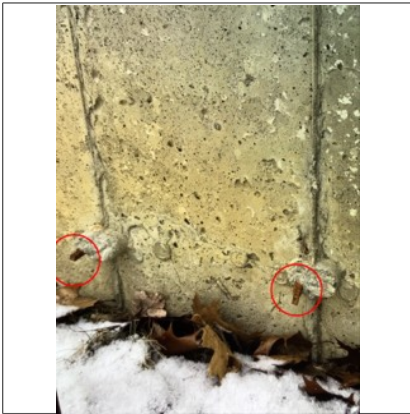
Foundations •Foundations are completed, form ties are left protruding from inside and outside of the walls. They should be snapped off to prevent injuries. There is a tool made to snap these off. However, without the tool, there are two ways to simulate; a qualified tradesman could use an open end wrench that fits the tie at the break point snugly and use it to twist. Or, he or she could use a pair of vice grip pliers to lock on and twist the ties off.

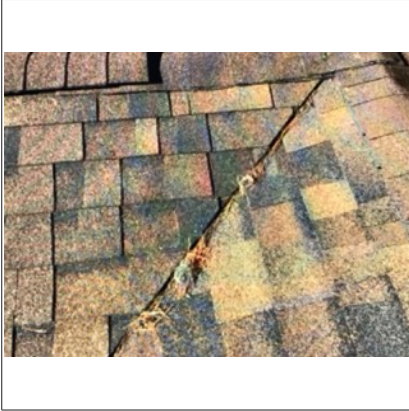
Sloped •Improve: Debris should be removed from the roofing to reduce risk of leaks and early roof wear.

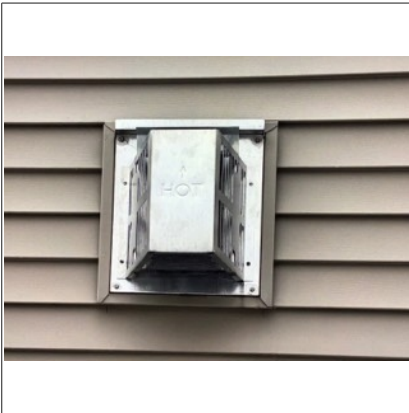
Chimney •Repair: The metal chimney should be cleaned to help assure safe and functional operation.

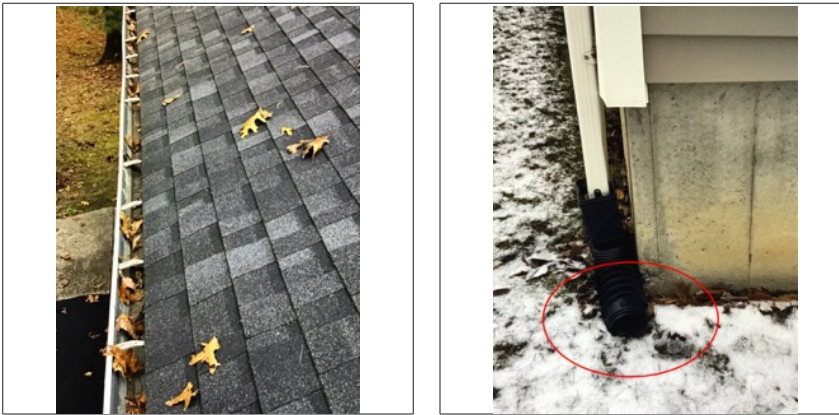
Gutters & downspouts •The gutters require cleaning to avoid spilling roof runoff around the building - a potential source of water entry or water damage.
•Repair: The downspout(s) should discharge water at least five (5) feet from the house. Storm water should be encouraged to flow away from the building at the point of discharge.

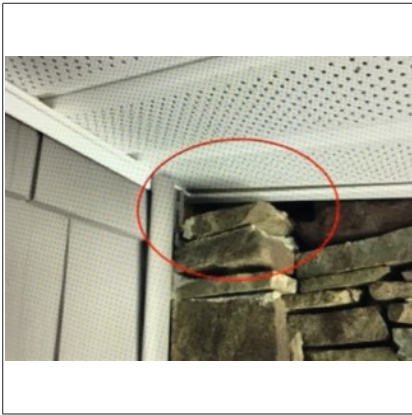
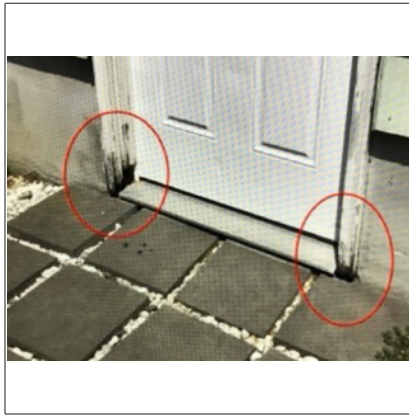
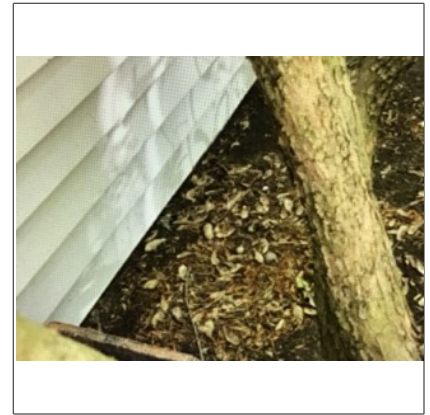
- Ext. walls**
- Repair: The exterior brickwork should be re-pointed (replacement of the mortar between the bricks) to prevent further deterioration.
 - Siding to soil contact should be avoided to help prevent moisture and or insect activity.
 - The openings in the siding should be sealed and secured as needed to avoid moisture, insect and or wind damage.
 - Localized rot was observed in the wood trim. Following repair of the damaged areas (which should be combined with exterior painting/maintenance) proper maintenance of the trim and control of water from roof or surface runoff can avoid further damage.
 - Repair: The wood trim should be painted to preserve the building.

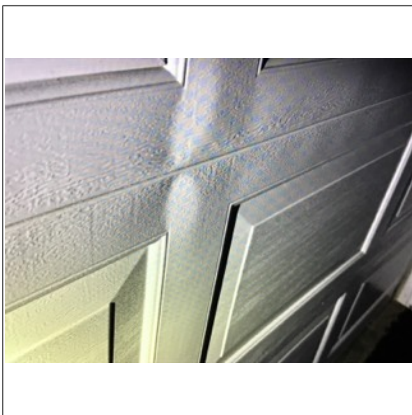
Garage

- Improve: The doors between the basement, house and garage should be, fire rated, weather-stripped and fitted with an automatic closer. This will reduce the potential of toxic automobile gases entering the house.
- Repair: Proper fire separation between the garage and house proper is recommended.
- The left side overhead garage doors is dented. This condition does not prevent the door from operating.

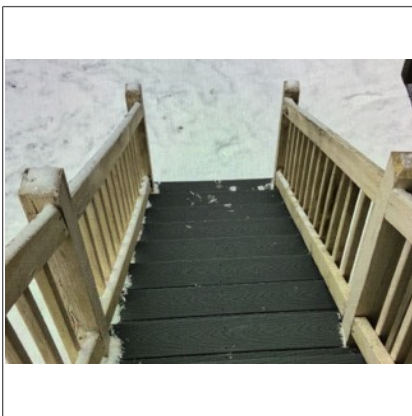
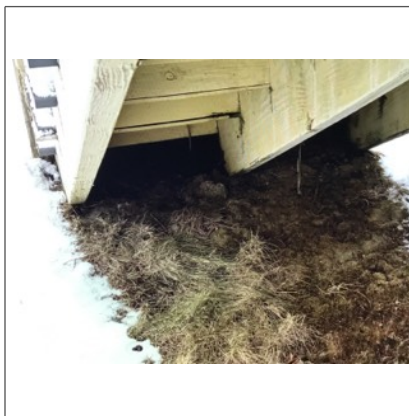
Porch/Deck

- Repair: As there is a danger of falling, a graspable hand railing, should be provided for all stairs and steps.
- Soil contact should be avoided on the stairs of the deck.

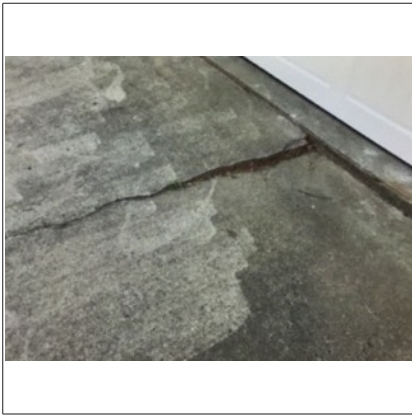
Driveway

- The driveway shows evidence of cracking and heaving. Re-surfacing of the driveway would be a logical improvement.

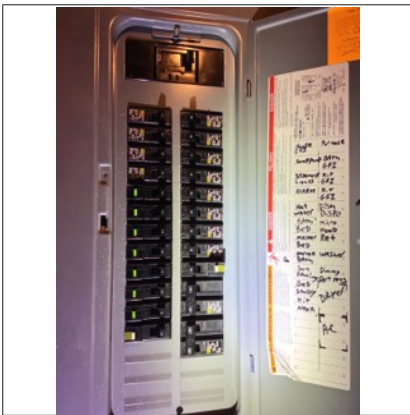
Main panel

Service / entrance •Repairs: The grounding of the electrical service is ineffective. The grounding of the electrical service should be grounded to water supply, gas piping and also ideally securely connected to two driven ground rods located not closer than six feet apart.

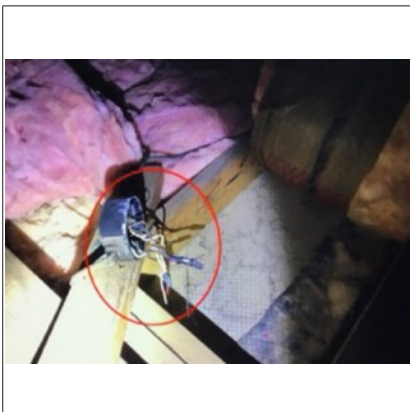
Distribution wires •Repair: Extension cords (in the garage serving the opener) should not be used as permanent wiring. This wiring should be replaced as needed.
•Repair: Improper electrical connections should be repaired. All electrical connections should be made inside junction boxes. All junction boxes should be fitted with cover plates, in order to protect the wire connections.

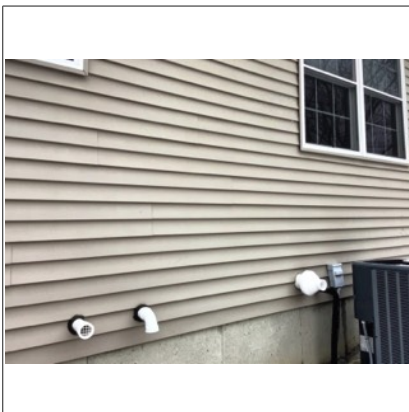
Combustion / exhaust • High efficiency exhaust should ideally not be located within four feet of an openable window. Maintain this condition. Labeling the window(s) near the exhaust is recommended.

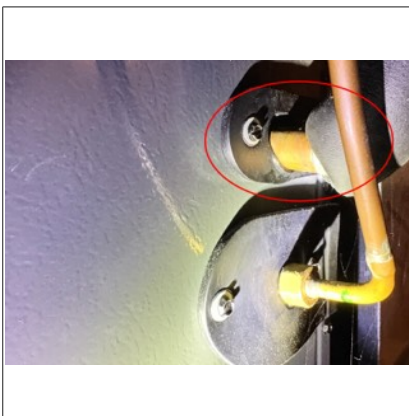
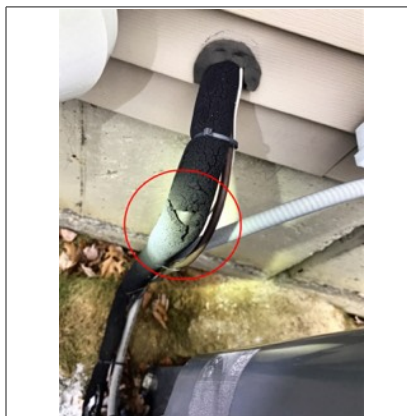
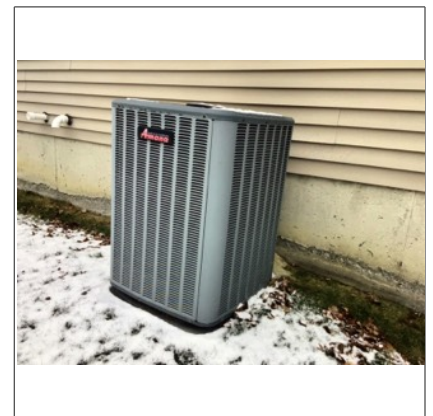
- Central air conditioning**
- Damaged and or missing insulation on refrigerant lines should be repaired. These lines should be insulated from the evaporator case all the way to the compressor unit to prevent condensation moisture damage and possibly a loss of temperature in the lines.

- Repair: The outdoor unit of the air conditioning system is out of level. This should be improved.
- AC Maintenance**
- The air conditioning system requires servicing frequently. This should be a regular maintenance item ideally performed in spring months to ensure efficient and reliable AC.

- The outdoor unit of the air conditioning system should remain level. This should be improved as needed, when and if needed.
 - The outdoor unit of the air conditioning systems requires cleaning on a frequent basis.

- It is recommended that just the top of the air conditioning outdoor unit be covered in the months that it is not in use. A top cover can prevent debris from becoming lodged inside the unit. You can use something as simple as a single piece of plywood that is properly secured. It is important not to cover the sides of the AC unit as it may cause trapped moisture that can decay the fins and encourage nesting of rodents, insects or the like. It is important to remember to remove the cover in the spring before use.

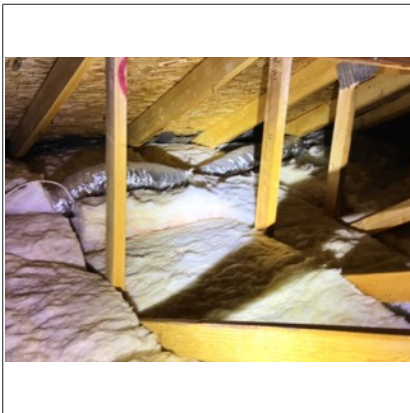
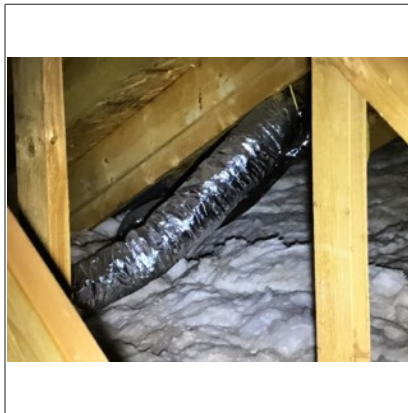
- Attic / roof** •Repair: The exhaust vent pipes from the bathrooms should be vented to the building exterior, ideally via roof (can) vents, installed directly above the fans.
- The level of ventilation should be improved. It is generally recommended that one (1) square foot of free vent area be provided for every one hundred and fifty (150) square feet of ceiling area. Proper ventilation will help to keep the house cooler during warm weather and extend the life of roofing materials. In cold climates, it will help reduce the potential for ice dams on the roof and condensation within the attic. The soffit vents and ridge vent are congested. A wider and improved ridge vent should be installed working with generously opened soffit vents is recommended.

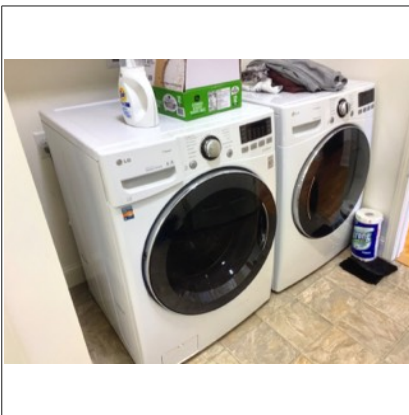
- Discretionary improvements** •The use of an overflow pan and the installation of burst free hoses is recommended on the washing machine of this home to protect against overflow or hose failures.
 •The discharge of the dehumidifier into the sump pit should be improved, for a host of reasons. Primarily, it may provide the basement leakage measurements a false level of moisture.
 •It may also be prudent to consider a back up style pump (sump jet) that will still work in the event of a power interruption.

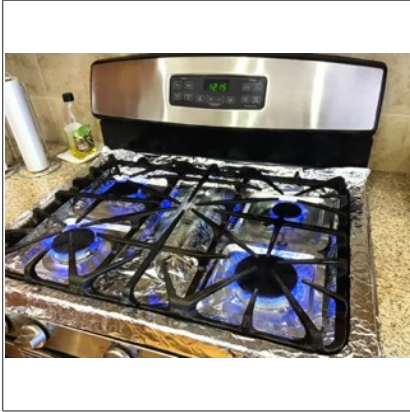
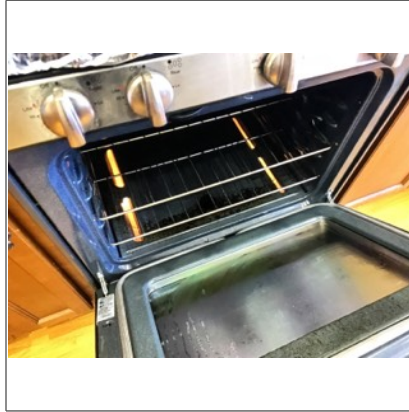
Gas range unit •The proper installation of an anti-tip bracket is recommended to safely secure an oven to the floor to provide extra protection when excess force is applied to an open oven door.

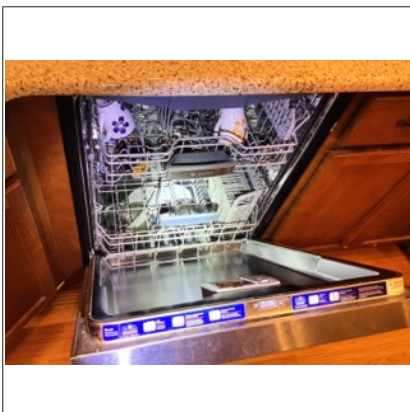
Dishwasher unit •Repair: The dishwasher should be better secured to the counter top or cabinets.

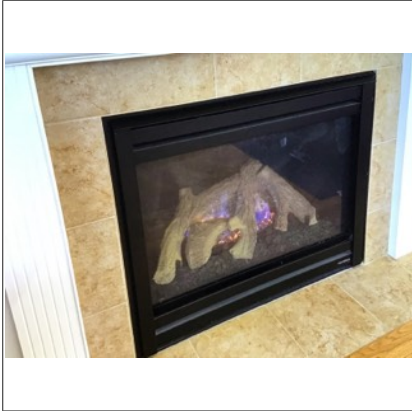
Fireplace •Repair: The fireplace chimney should be inspected and cleaned prior to operation.
