Report: 3732

Confidential Inspection Report

February 14, 2025

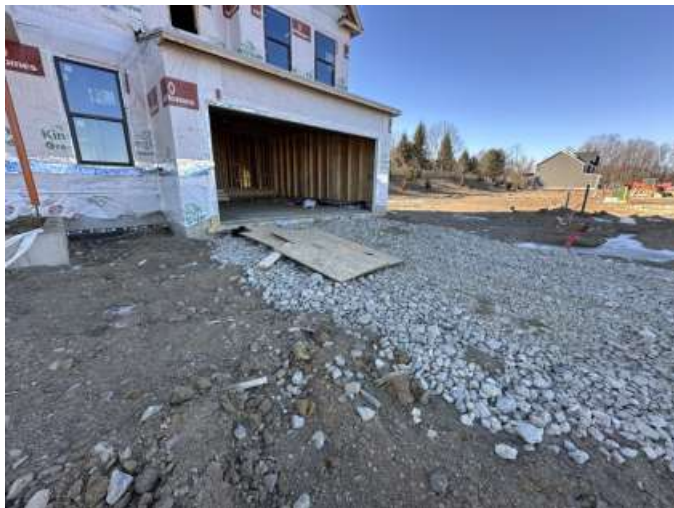
Driveway was not yet completed. This is typically occur later in the construction phase. Consult with builder for timing.

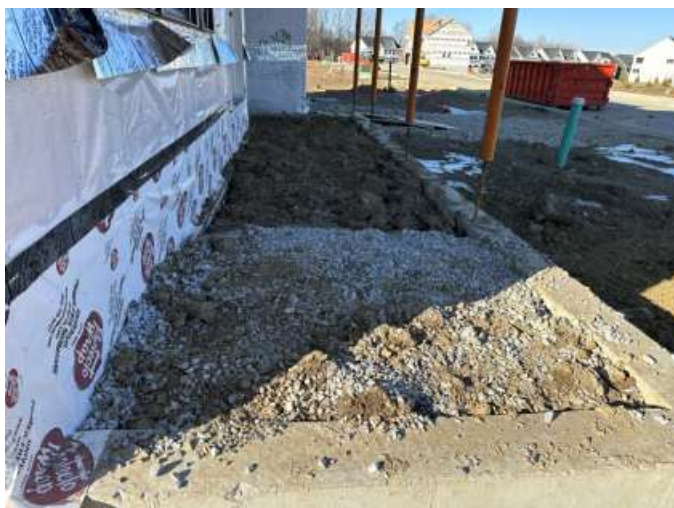
The front porch has not yet been fully installed with only some components in place. Consult builder for timing and materials intended to complete the porch.

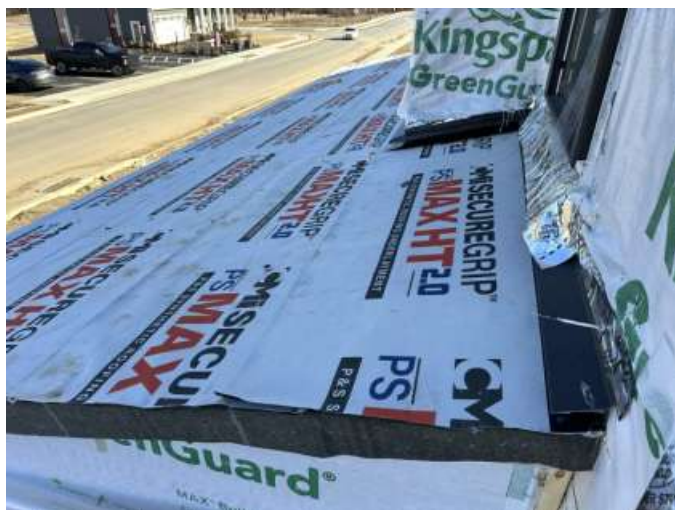
Incomplete roof installation. Metal has not yet been installed. Consult builder

for install date.

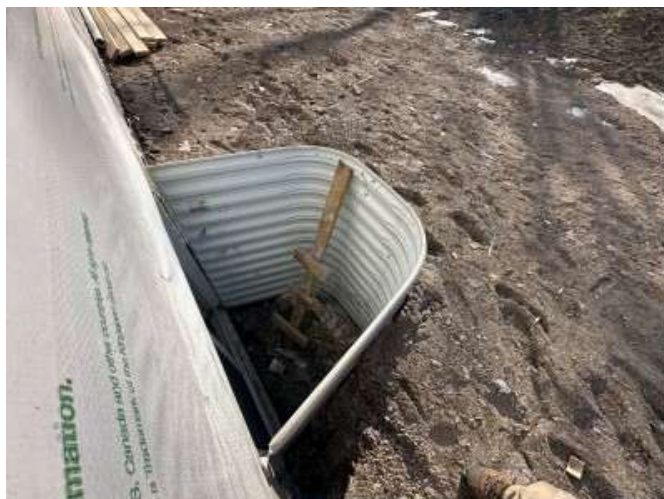
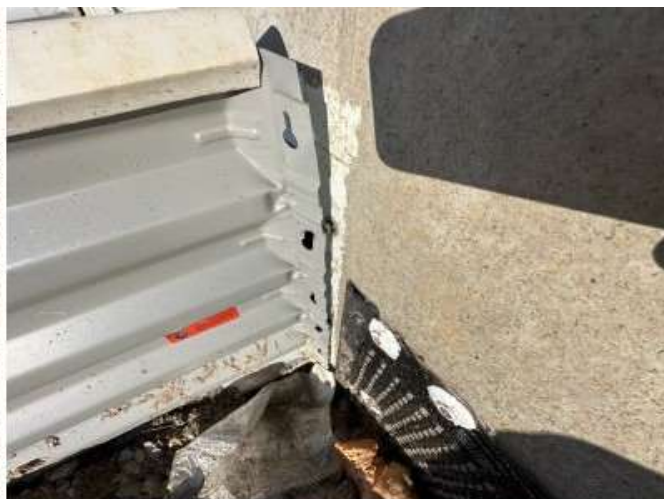
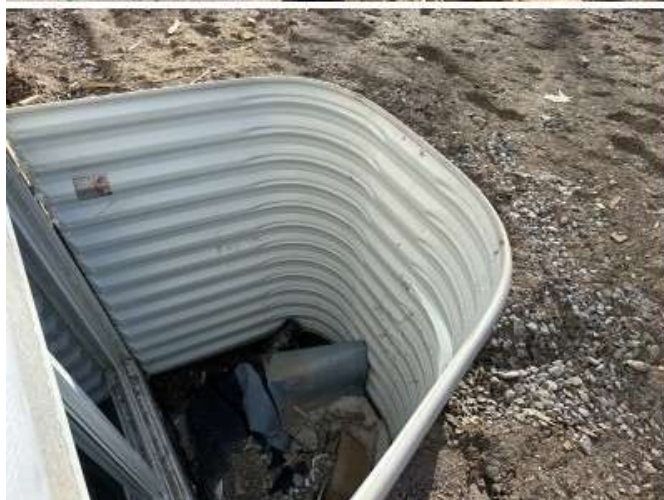
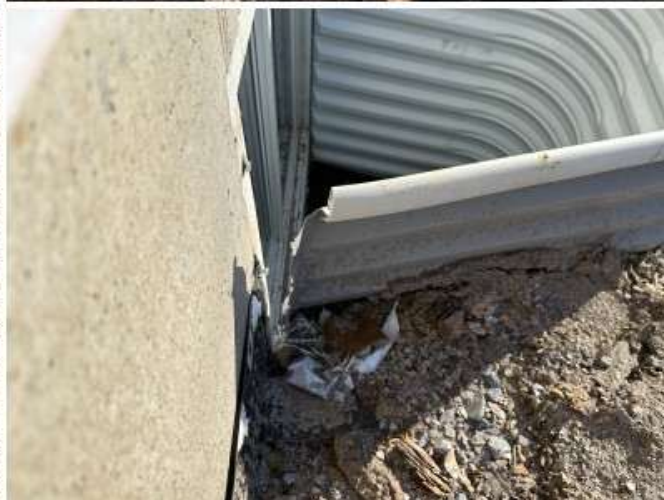
Uncovered. Installing rain covers can improve drainage and protect foundation. Egress ladders and or steps are required on window wells deeper than 44" and must be permanently attached. An egress ladder or step may encroach into well up to 6". Steps and/or distance between rungs of the ladder can't exceed 18". Window well(s) have become detached from the foundation at the side bolts. Recommend reattaching and sealing to prevent dirt and moisture from entering the well.

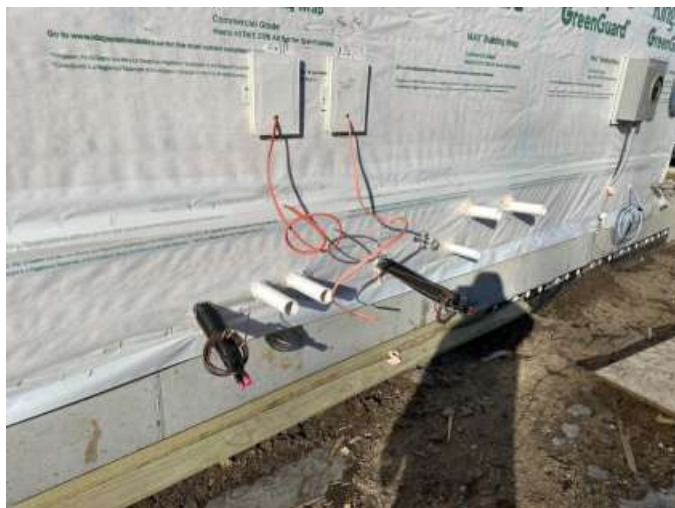
Ensure all exterior penetrations are sealed to prevent moisture, insect, or rodent entry.

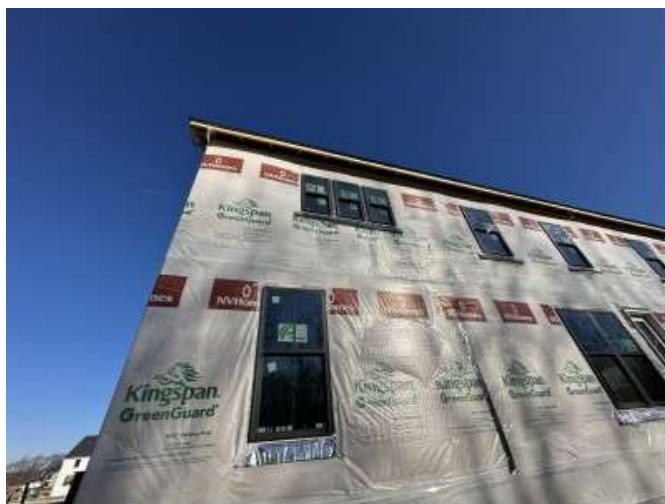
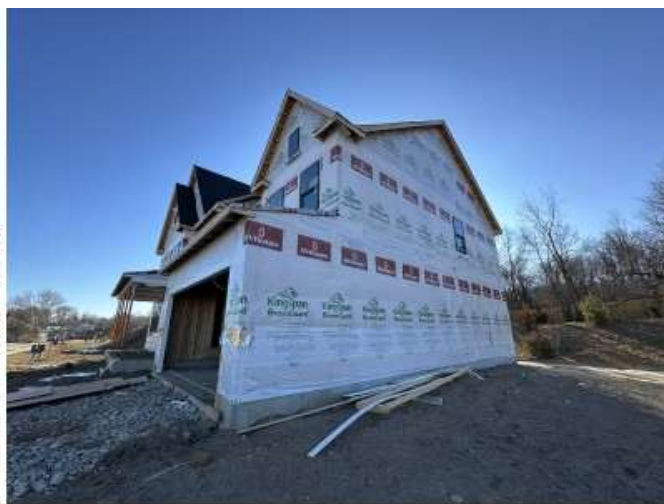
General house wrap, seal tape, drip edges, and flashing appear proper for the current stage of construction.

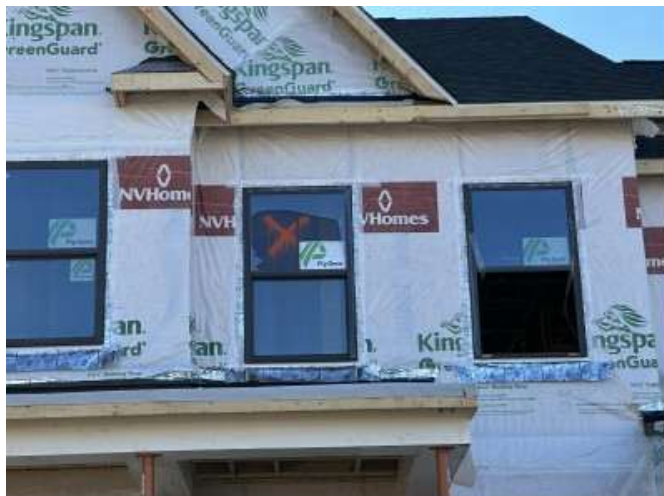
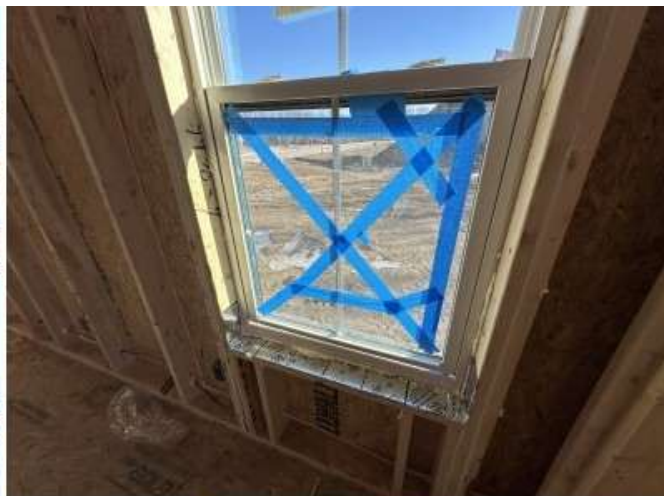
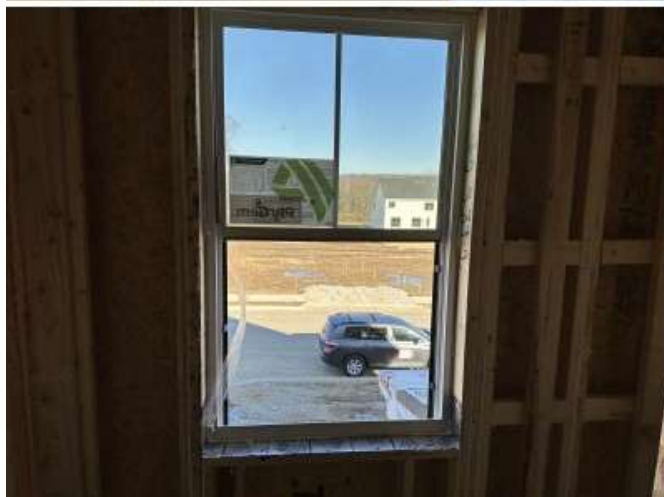
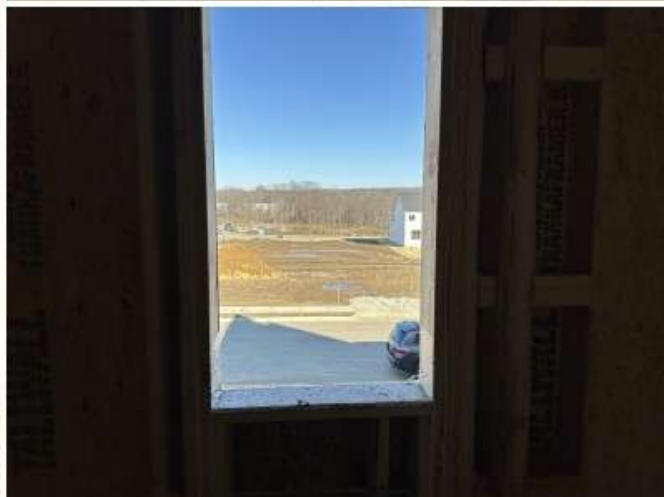
Broken glass noted in one 2nd floor front window and one 2nd floor side window. Missing lower sash and damaged window noted in one 2nd floor front window. Missing window entirely noted in one front 2nd floor window. Consult builder concerning replacement windows.

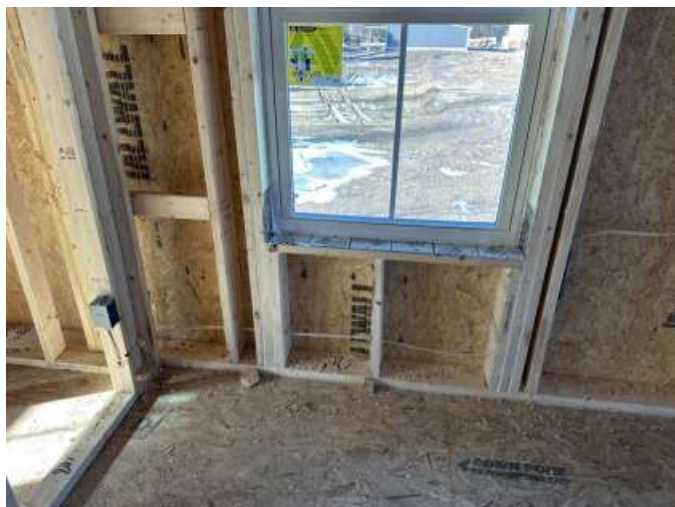
Proper sill seal tape is noted in all the windows to mitigate moisture entry.

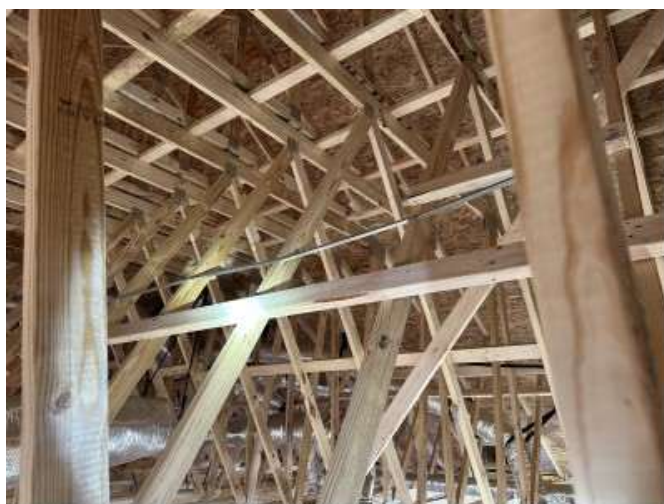
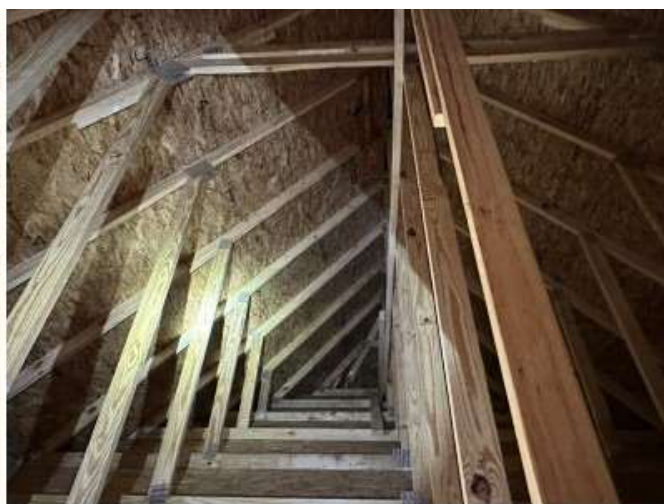
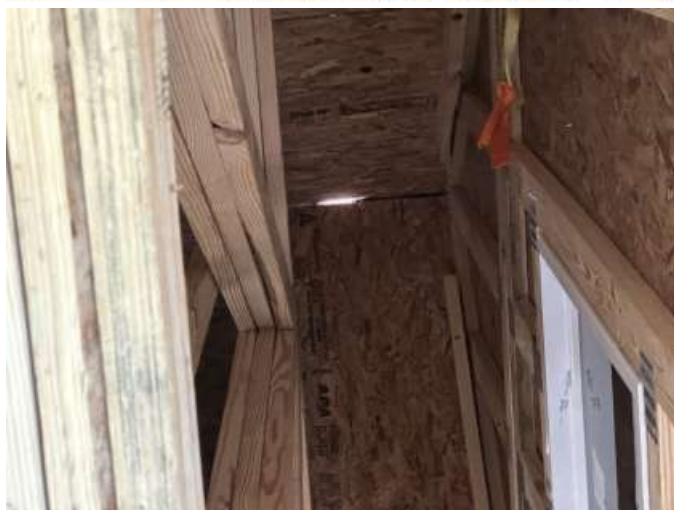
Light noted at peak of front dormer. It could not be determined if this was missing shingles, loose ridge vents, neither or otherwise. Recommend review by the builder to determine if this is a leak risk and if repairs are necessary.

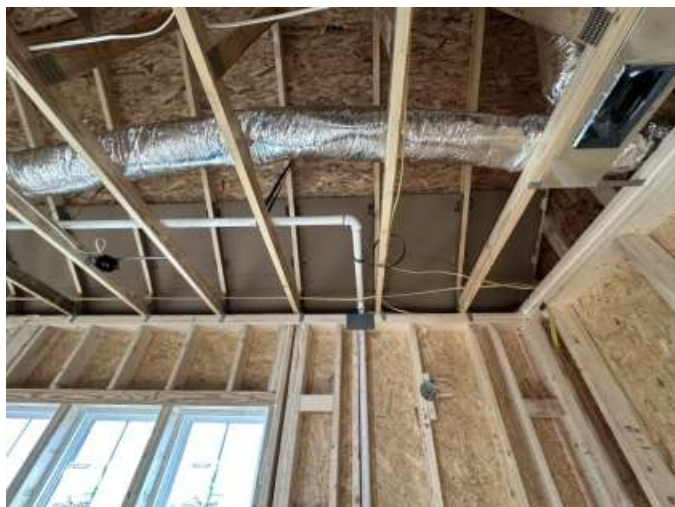
There are soffit vents installed. Proper baffles were noted in the soffit bays to prevent insulation from blocking the vent air flow.

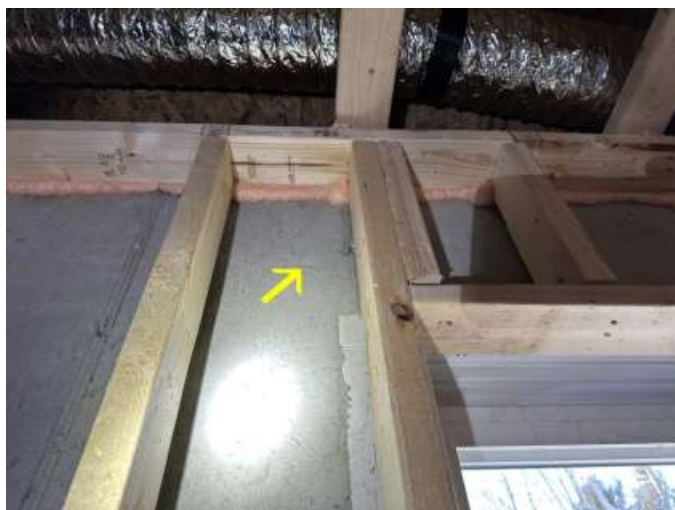
Foundation Walls: Poured concrete. Minor shrinkage cracks noted where visible. Cracks noted at poured concrete foundation. Cracks are less than 1/4 inch, and no further movement or displacement noted indicating this is not a structural issue. Suggest evaluation for epoxy or urethane foam repair by qualified contractor to prevent water entry.

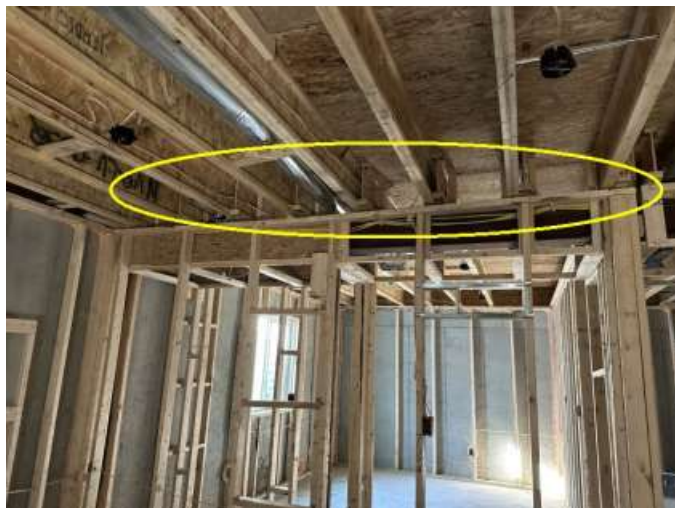
Beams: Steel. Proper squash blocks noted at load bearing TJI joists above the steel I-beam.

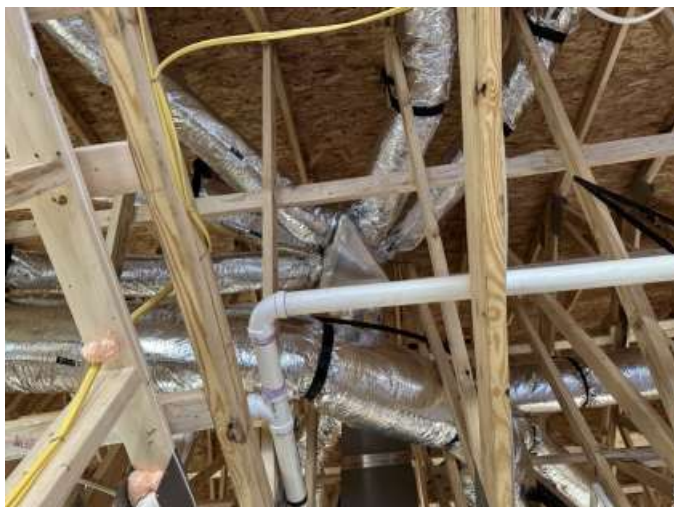
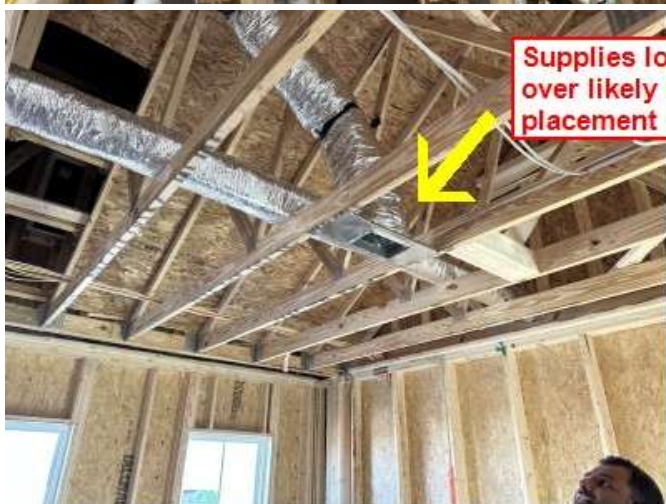
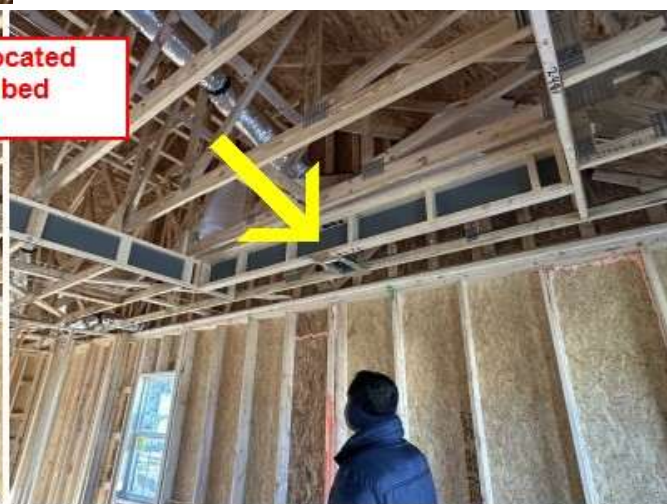
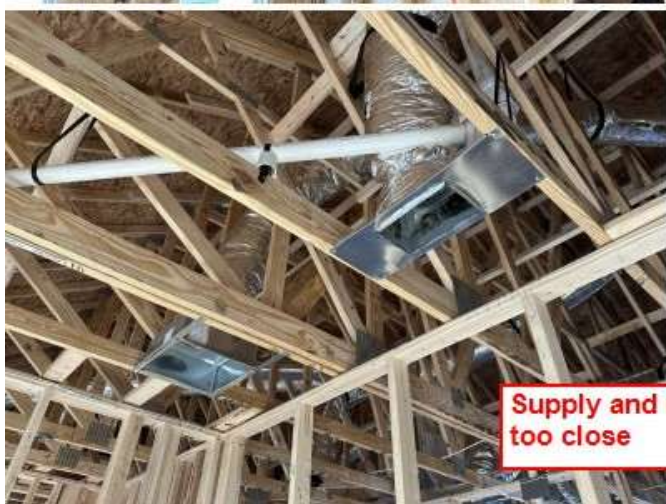
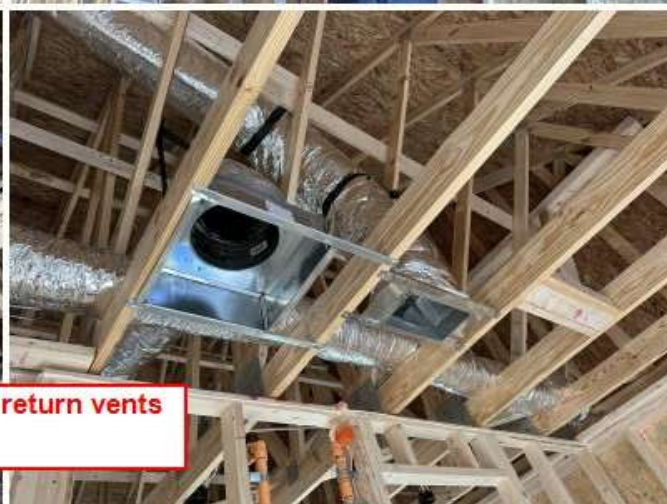
<i>Ducts / Pipes:</i>	Proper ducting support and soft angles noted. The supply and return vents are noted installed too close to each other in all 2nd floor bedrooms. A recommended 10 feet or more of distance provides proper air flow for efficiency. Consult with the builder for improvements. Additionally, the supply vents for the front corner bedroom and the master bedroom are mounted in or close to the centers of the room. It is customary to have supply vents at the exterior walls of a room and not directly over where beds will most likely be placed. Consult the builder for improvements.
-----------------------	--

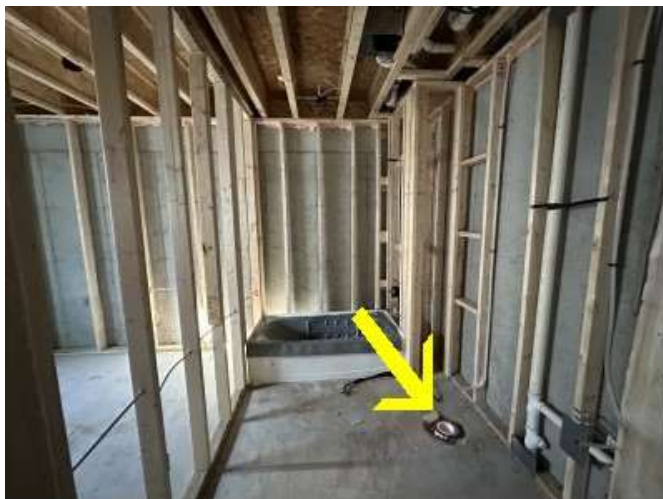
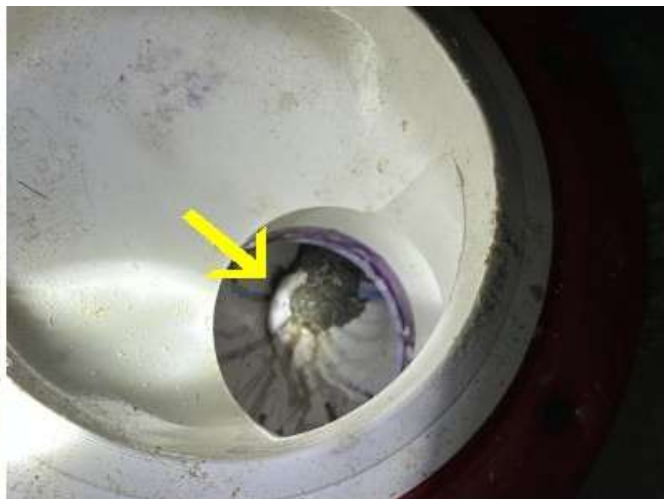
Plastic. Debris is noted in the toilet drain in the basement bathroom. This construction debris could potentially clog or damage the grinder pump once running. A proper cap should have been placed over this drain to prevent debris from entering. Recommend vacuuming out the debris prior to installation of toilet.

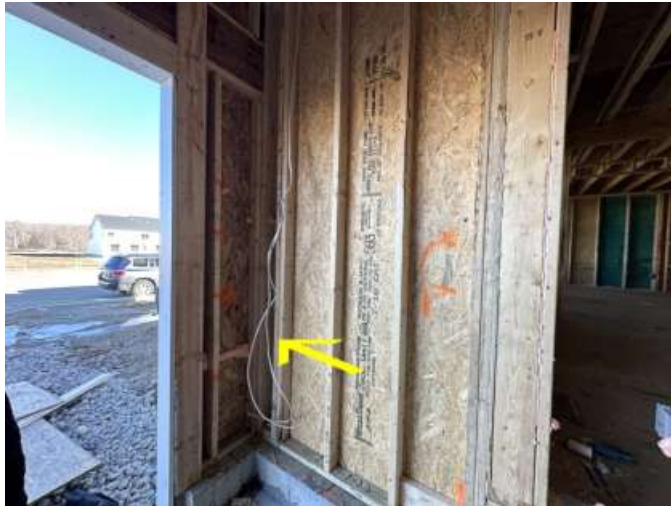
Unsecured wiring is noted at the front wall of the garage. All wiring must be secured every 4 feet by a qualified electrician.

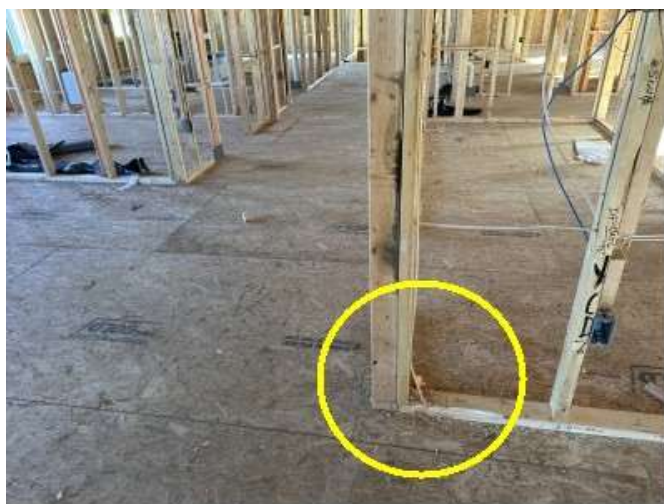
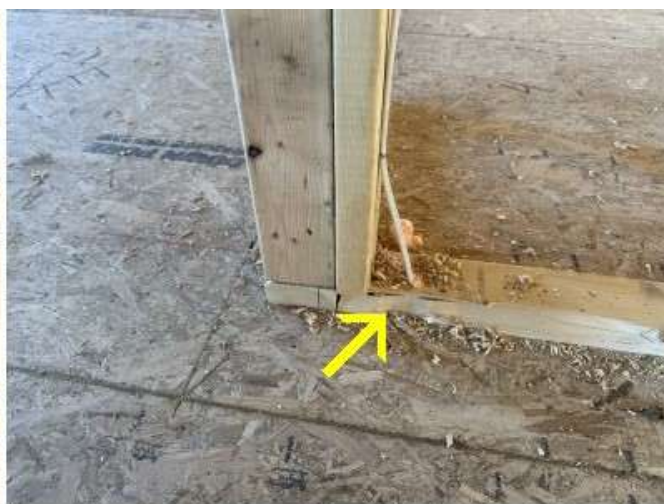
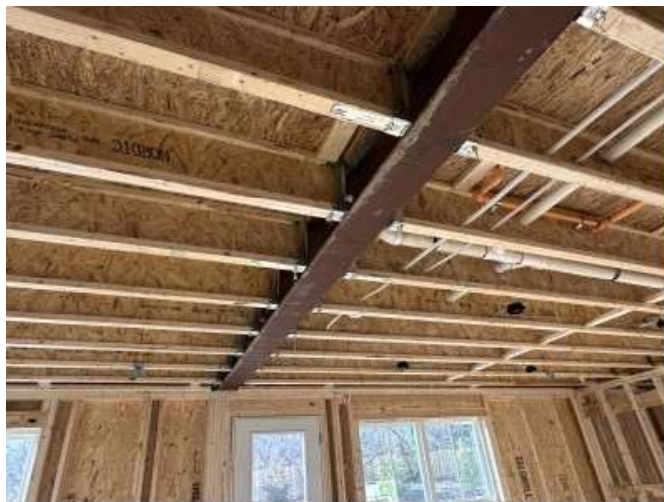
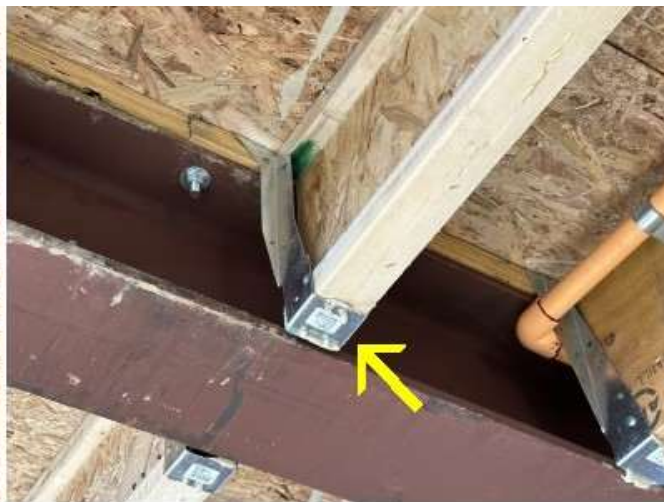
Missing nail plate noted at base of corner of front master bedroom closet. Recommend installation of the nail plate to protect wiring at this location.

TJI joists were noted connected to the main center support steel I-Beam on the first floor. A wooden bolted top nailer is noted at the top of the steel beam. Because top-mount joist hangers won't resist twisting as well as face-mount hangers, it may be necessary to use strapping below or blocking between the joists. Consult with builder for consideration of this improvement.
