Report: 1058

Confidential Inspection Report

**██████████
Philadelphia, PA 19145**

September 29, 2015

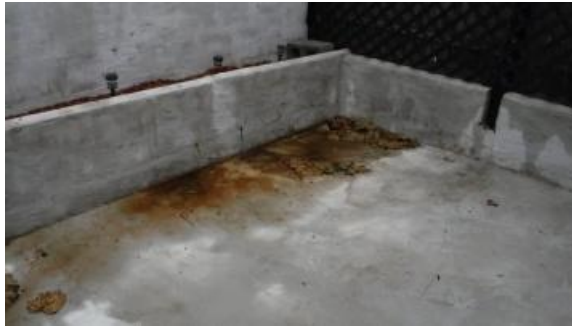
- Masonry:*
 - Concrete. Water noted puddling in the rear corner of the patio again rear wall with moderately small amount of rain. Consider improvement by installed drainage at this location.

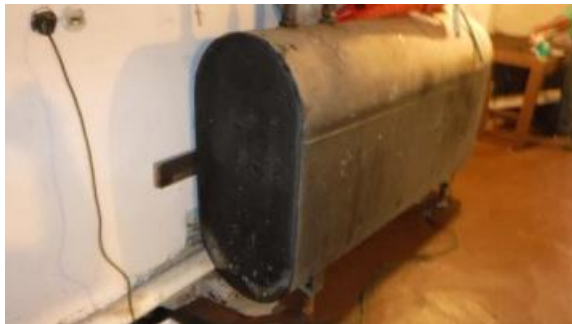
- Oil Tank:*
 - An abandoned oil tank was noted at basement. Recommend removal by qualified contractor. Note: Removing unused fuel from a tank is more expensive than filling it. Verify that oil fill and vent pipes and connection have been removed.

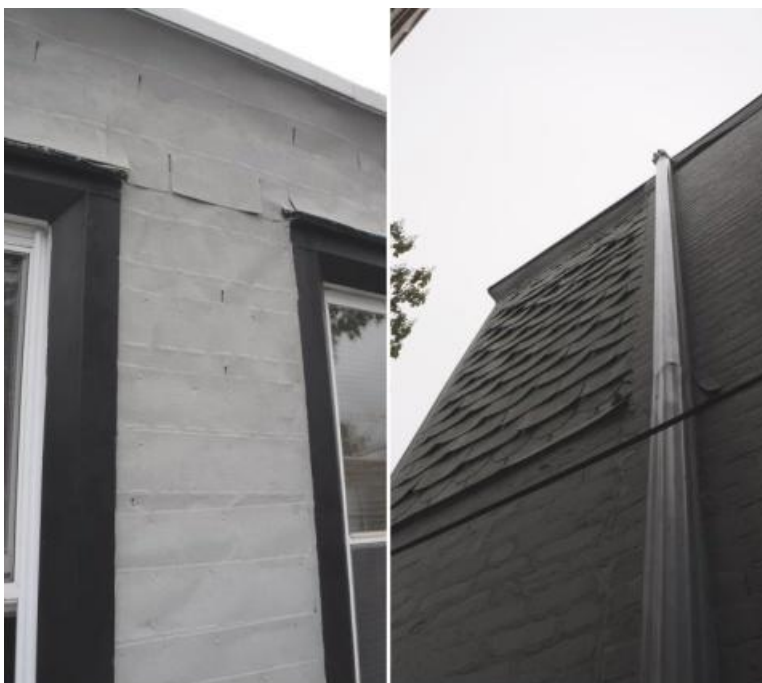
Brick. Second floor rear has been sided improperly with asphalt shingles. The shingles on the back of the home were installed with the top edge revealed and top nailed. This will eventually fail and draw water towards the structure. The shingles mounted on the side rear second floor are losing adhesion and curling. Recommend removal of all shingles from side walls and installation of proper siding by a qualified contractor.

- Brick. Second floor rear has been sided improperly with asphalt shingles. The shingles on the back of the home were installed with the top edge revealed and top nailed. This will eventually fail and draw water towards the structure. The shingles mounted on the side rear second floor are losing adhesion and curling. Recommend removal of all shingles from side walls and installation of proper siding by a qualified contractor.

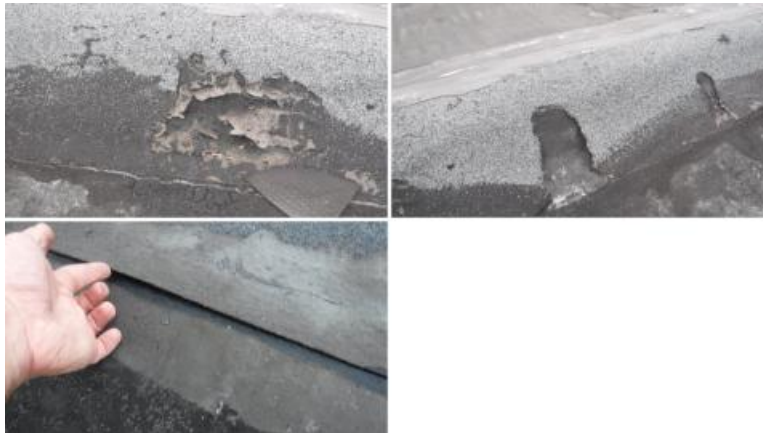
Roofing material appears to be in fair condition for its age and nature. Age related wear noted. Many patches have previously been made. Monitor for future leakage. Budget to replace in the coming future. Cracks at seams noted at rear repair patch and along party wall to neighbor's roof. Entire roof requires a general coating of tar or silver aluminized paint for a solid seal end to end. Recommend repair by a qualified roofer to prevent leaks into the home.

Roofing material appears to be in fair condition for its age and nature. Age related wear noted. Many patches have previously been make Monitor for future leakage. Budget to replace in the coming future. Cracks at seams noted at rear repair patch and along party wall to neighbor's roof. Entire roof requires a general coating of tar or silver aluminized paint for a solid seal end to end. Recommend repair by a qualified roofer to prevent leaks into the home.

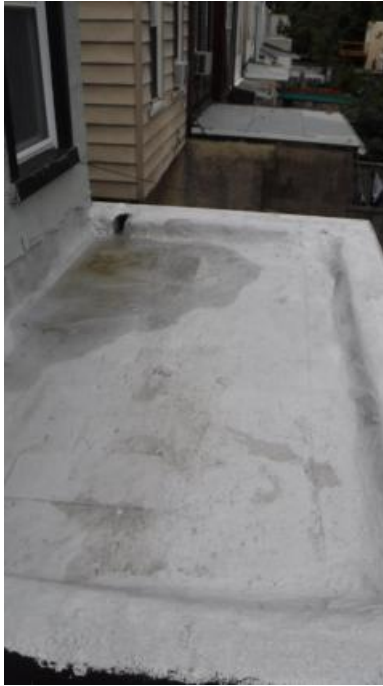
Roof #2: Lower Rear Roof

Modified bituminous membrane, often referred to as rubber roofing noted. Recommend recoat with silver aluminized coating every 2 to 4 years to prolong life.

Roofing material appears to be in good condition for its age and nature. Monitor for

future wear and leakage.

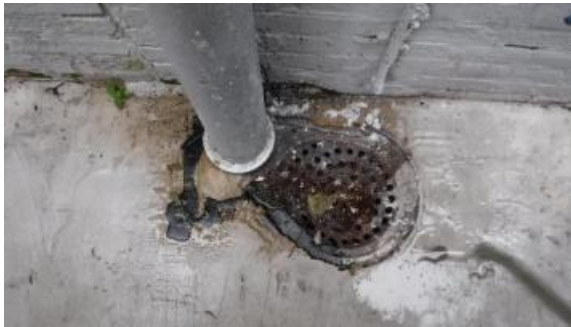
- Aluminum, Subsurface downspout drains noted. Verify proper flow and maintain seasonally.

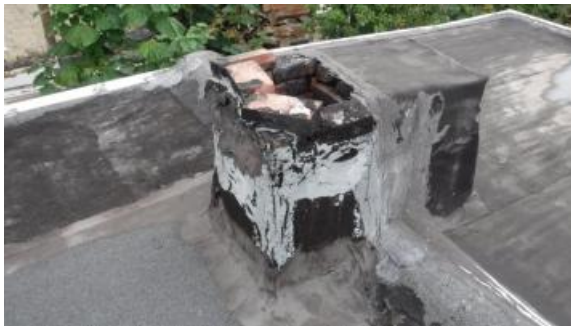
- Brick. Loose bricks noted at chimney top. Recommend evaluation for repair as needed by qualified chimney mason.

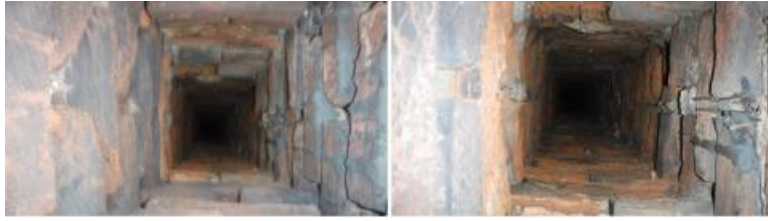
There is no chimney rain cap installed. Installation of a chimney rain cap is recommended to prevent water from entering the chimney flue and causing damage. Also will prevent bird and critter entry. Unlined flue chimney flue

noted. Though this was typical for the time of construction, a chimney liner is now required for health and safety reasons. Recommend evaluation by qualified chimney professional for liner installation as needed for safety.

- ⊙ There is no chimney rain cap installed. Installation of a rain cap is recommended to prevent water from entering the chimney, which can cause damage. Also will prevent bird and critter entry. Unlined chimneys are not recommended. Though this was typical for the time of construction, a chimney liner is recommended for health and safety reasons. Recommend evaluation and repair.

professional for liner installation as needed for safety.

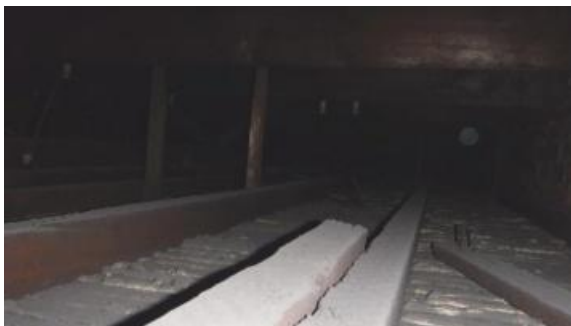
- No insulation noted in visible areas. Proper installation of insulation to increase the energy efficiency of the house is recommended. Address ventilation improvements as well.

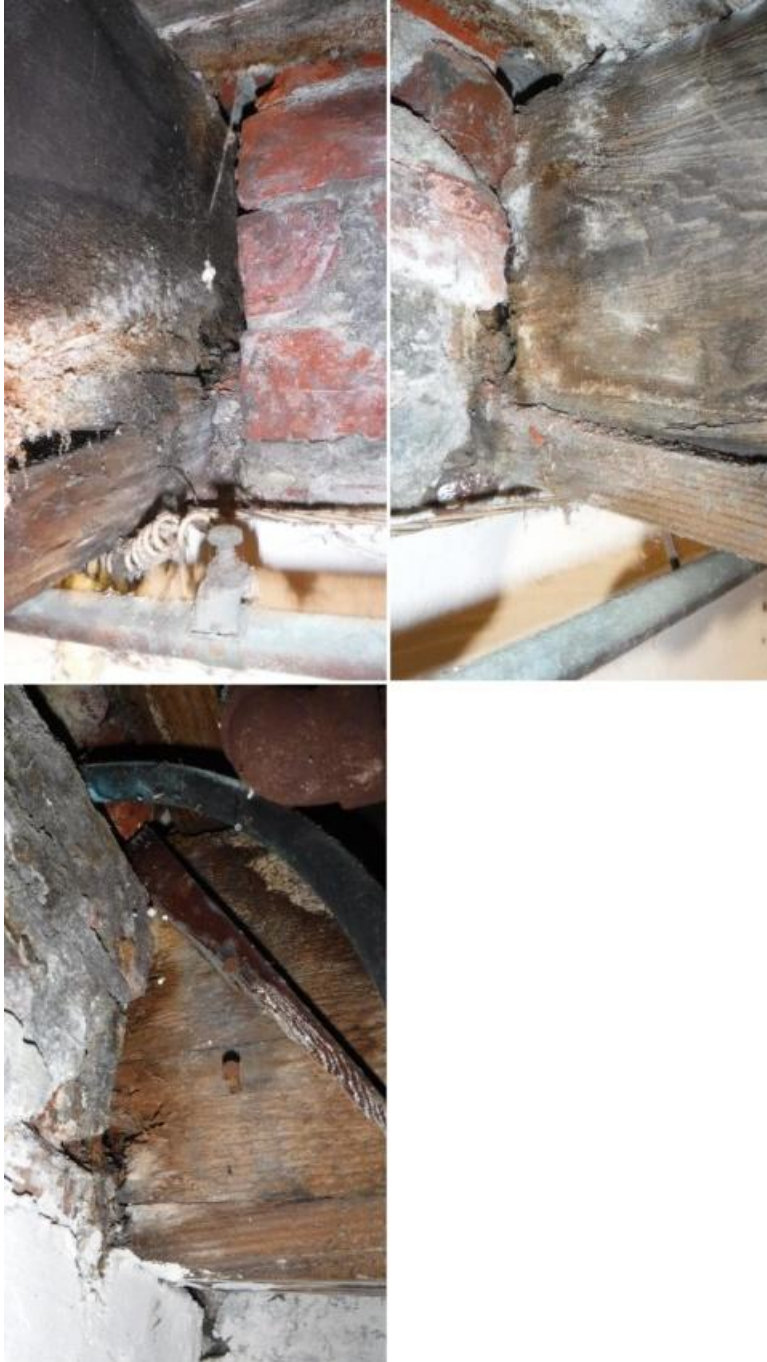
Dimensional wood joists, Rotted end bearing and moisture noted at joists visible at rear left corner. Recommend evaluation for repair as needed by qualified contractor to provide proper structural support.

⊙ Dimensional wood joists, Rotted end bearing and moisture noted at joists visible at rear left corner. Recommend evaluation for repair as needed by qualified contractor to provide proper structural support.

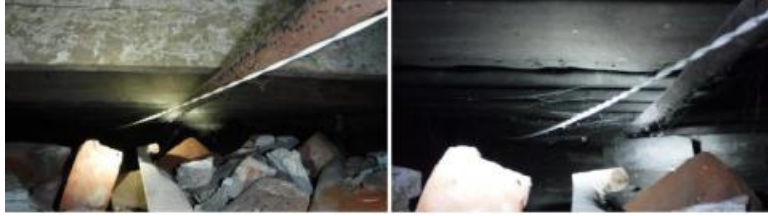
Crawlspace was not accessible due to size of opening. Recommend gaining access for inspection prior to settlement. Most jurisdictions require crawlspaces to be accessible.

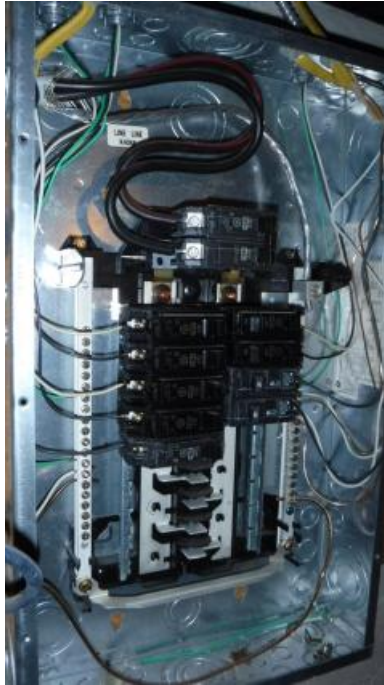
Multiple over fused circuits noted at main service panel. This can allow a wire to burn when breaker should trip. Recommend evaluation by qualified electrician to repair the over fused condition for safety.

Main Panel Observations: Multiple over fused circuits noted at main service panel. This can allow a wire to burn when breaker should trip. Recommend evaluation by qualified electrician to repair the over fused condition for safety.

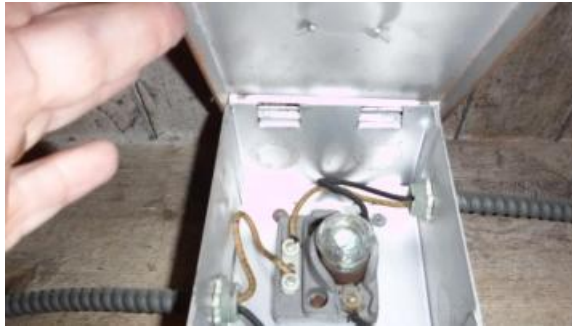
Improper bonding noted at sub-panel. Ground and neutral wires not properly isolated or wired. Recommend evaluation for repair as needed by qualified electrician to prevent fire and shock risk.

Electrical system appears outdated by today's standards. Fuses are no longer typically accepted as insurable. Recommend evaluation for upgrade to modern equipment by qualified electrician.

Sub Panel Bonding: ⊙ Improper bonding noted at sub-panel. Ground and neutral wires not properly isolated or wired. Recommend evaluation for repair as needed by qualified electrician to prevent fire and shock risk.

Sub Panel Observations: ⊙ Electrical system appears outdated by today's standards. Fuses are no longer typically accepted as insurable. Recommend evaluation for upgrade to modern equipment by qualified electrician.

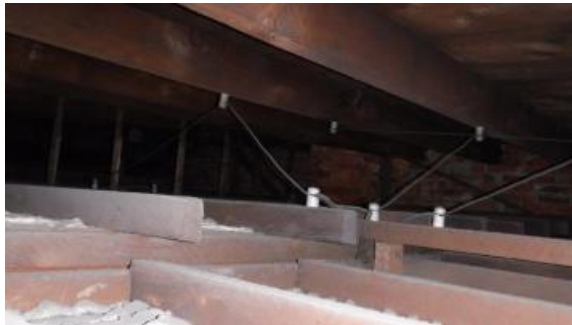
Knob and tube wiring noted in use, visible in the attic. KnT style wiring dates back to the earliest days of electrical wiring and is considered antiquated by today's standards. Recently, a majority of insurance companies have rejected the insurability of knob and tube wiring and are calling for complete upgrade of all KnT wiring in houses they insure. Recommend evaluation by qualified electrician for rewiring as needed for safety and insurability.

- ⊙ Knob and tube wiring noted in use, visible in the attic. KnT style wiring dates back to the earliest days of electrical wiring and is considered antiquated by today's standards. Recently, a majority of insurance companies have rejected the insurability of knob and tube wiring and are calling for complete upgrade of all KnT wiring in houses they insure. Recommend evaluation by qualified electrician for rewiring as needed for safety and insurability.

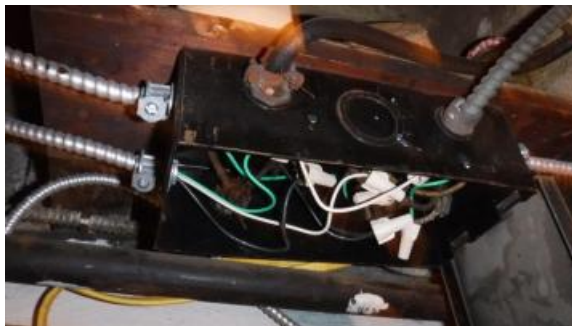
Openable former fuse box used as a junction box. This is not allowed. Recommend upgrade to proper junction boxes by a qualified electrician for safety.

- ⊙ Openable former fuse box used as a junction box. This is not allowed. Recommend upgrade to proper junction boxes by a qualified electrician for safety.

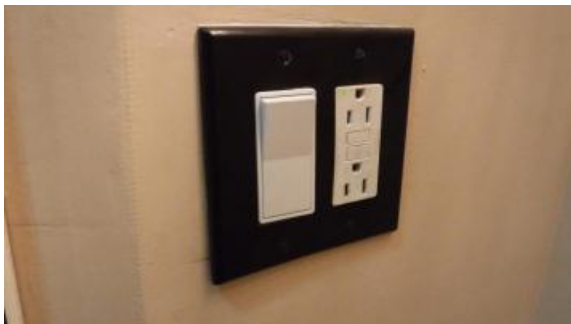
Ground Fault Circuit Interrupter (GFCI) protection is required at all bathroom outlets. Recommend evaluation for installation or repair as needed by qualified electrician for safety.

- Aluminum, 110/220 Volt, Circuit breakers. Overhead.
- ⊙ Ground Fault Circuit Interrupter (GFCI) protection is required at all bathroom outlets. Recommend evaluation for installation or repair as needed by qualified electrician for safety.

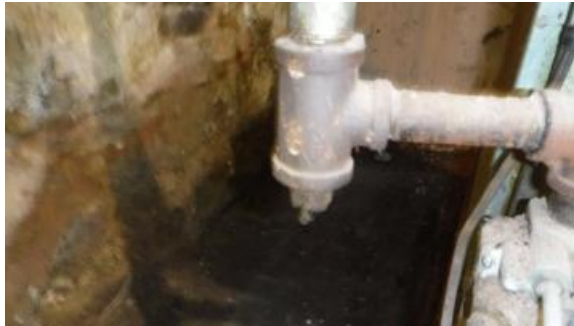
- Natural Gas. Missing drip leg noted at gas supply to furnace. Gas supply is required to come to the unit from a vertical direction and enter the unit at a "T" with a proper drip leg. Recommend evaluation for repair/installation as needed by qualified technician.

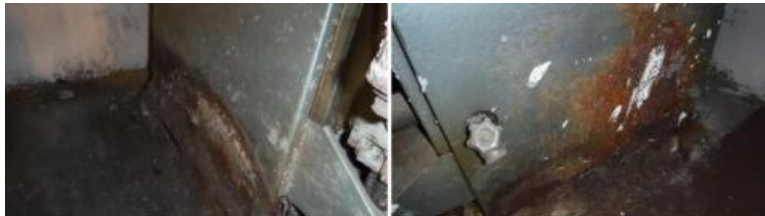
Heating system did not respond to controls. Recommend evaluation for service or repair as needed by qualified technician. Unit is heavily corroded.

⊙ Heating system did not respond to controls. Recommend evaluation for service or repair as needed by qualified technician. Unit is heavily corroded.

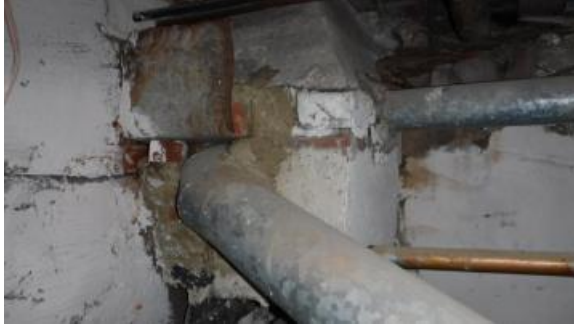
The flue connector pipe is metal and enters a masonry flue. Unlined masonry chimney noted. This was typical in the days of construction but is no longer considered safe for use. Recommend evaluation for liner installation as needed by qualified chimney professional.

⊙ The flue connector pipe is metal and enters a masonry flue. Unlined masonry chimney noted. This was typical in the days of construction but is no longer considered safe for use. Recommend evaluation for liner installation as needed by qualified chimney professional.

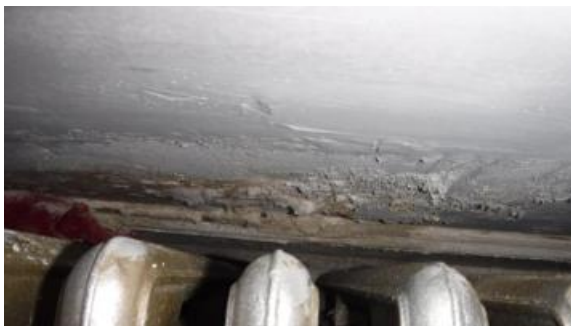
Plaster. Water stains noted at dining room behind radiator. Moisture was detected at this location with efflorescence. These stains appear to be from an active leak. Further investigation is needed to determine repair needed.

- Plaster.
 - ⊙ Plaster. Water stains noted at dining room behind radiator. Moisture was detected at this location with efflorescence. These stains appears to be from an active leak. Further investigation is needed to determine repair needed.

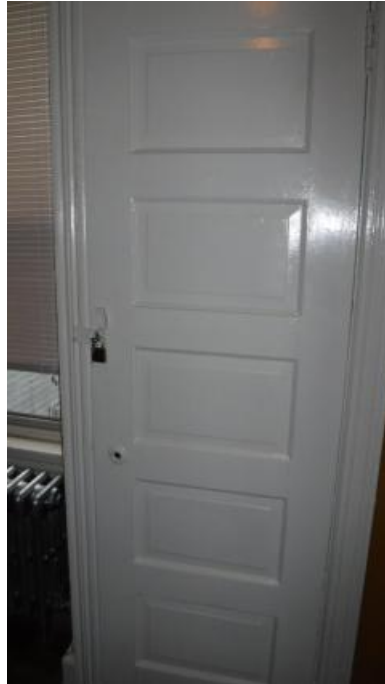
- Closet in middle bedroom was padlocked closed and not inspected.
