# SAGUACHE CREEK DIVERSION INFRASTRUCTURE INVENTORY

**Structure Name:** HEARN D

HEARN DITCH

Saguache Creek Stream Management Plan

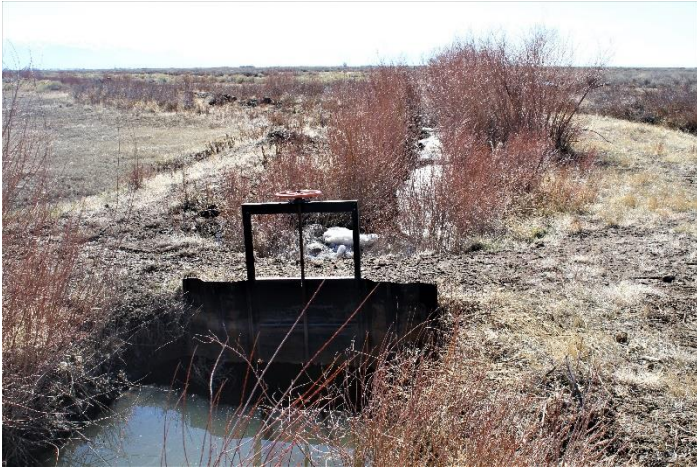
Headgate looking downstream

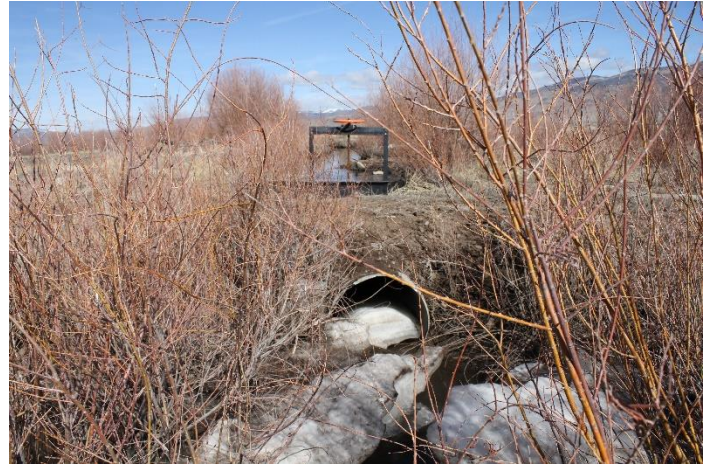
Headgate outlet

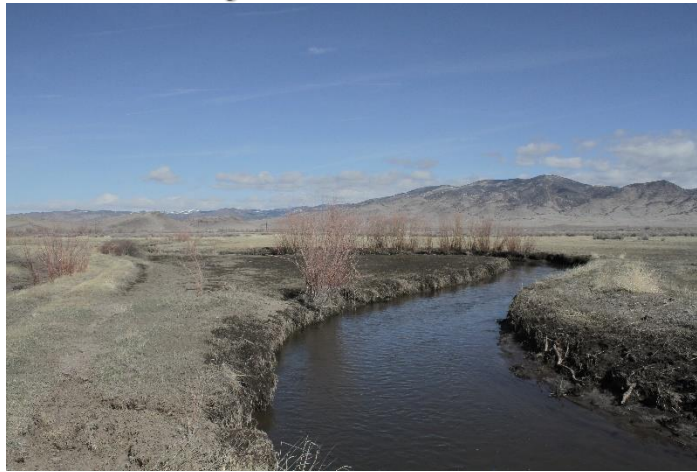
Headgate and diversion dam

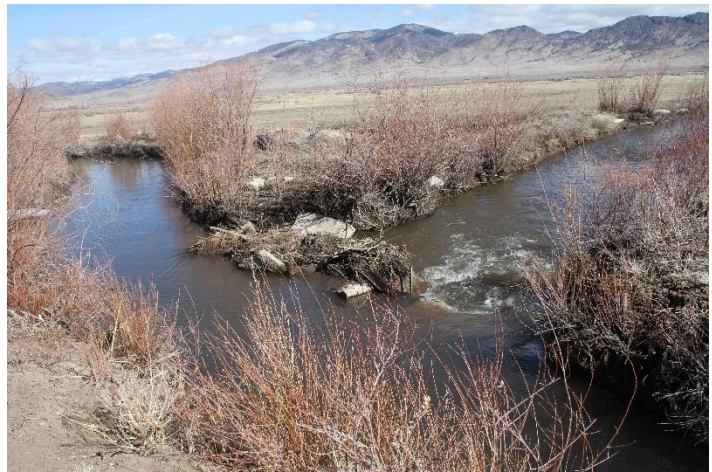
**Structure Description:** This ditch is located at the apex of a meander in the stream. A diversion dam made of t-posts, boulders, and concrete directs flow to a short, ~30 ft feeder ditch on the south bank of the stream and to the headgate. The headgate functions very well. The flume is housed inside a small structure to prevent freezing. It measures accurately. No significant channel or bank erosion was identified at this structure.

Diversion dam

**Repair(s) or Improvement(s) Currently Needed:** The diversion dam should be replaced with a lower maintenance structure that promotes sediment transport and stream function. Fish passage and riparian restoration should be considered as part of any future repairs or improvements.

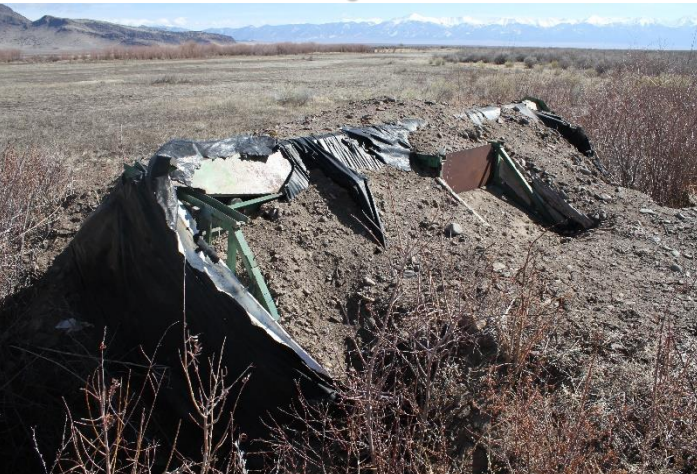
Flume looking downstream

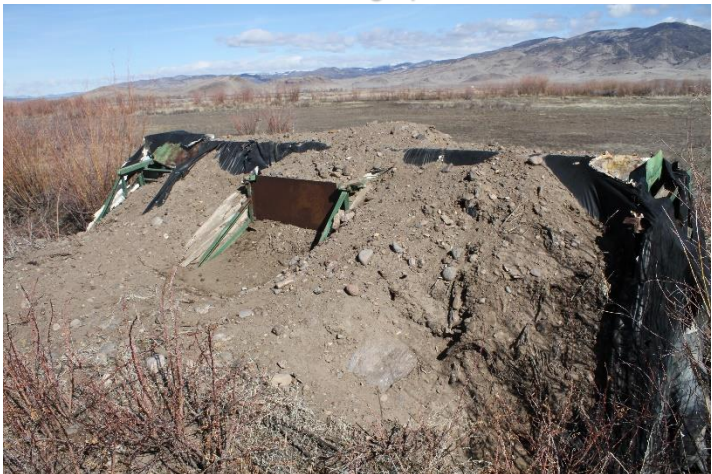
Flume looking upstream
