# SAGUACHE CREEK DIVERSION INFRASTRUCTURE INVENTORY

**Structure Name:** FULLERTON D 1

**Date:** July 3, 2019

Saguache Creek Stream Management Plan

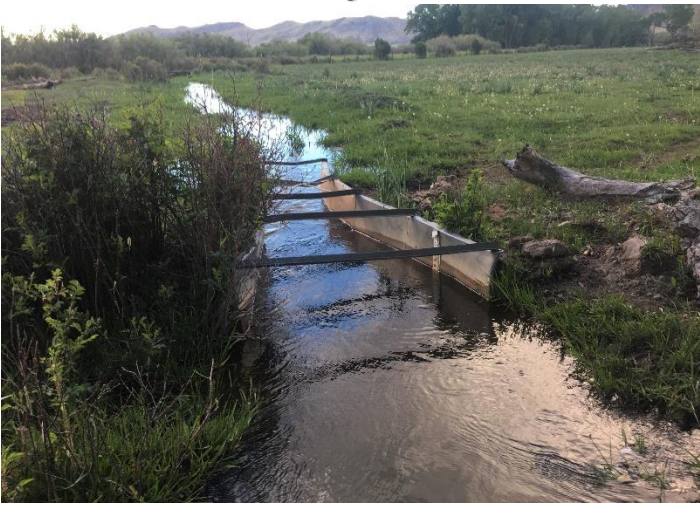
Flume looking downstream

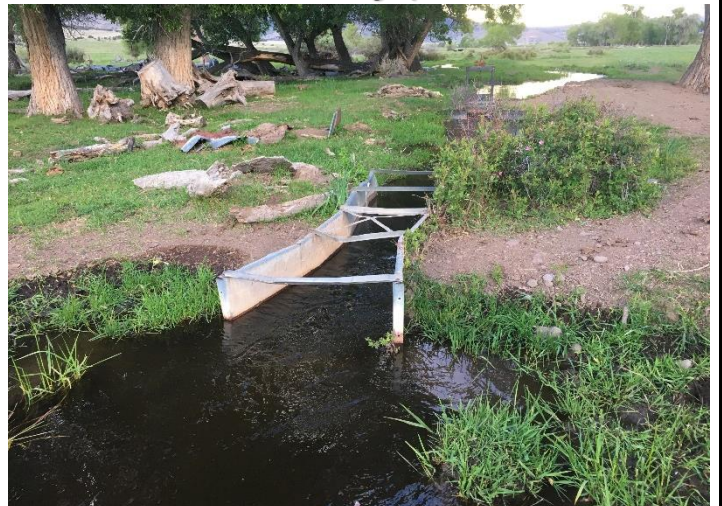
Flume looking upstream
