# SAGUACHE CREEK DIVERSION INFRASTRUCTURE INVENTORY

**Structure Name:** PROFFIT COMPANY D

**Date:** April 3, 2019

PROFFIT COMPANY DITCH

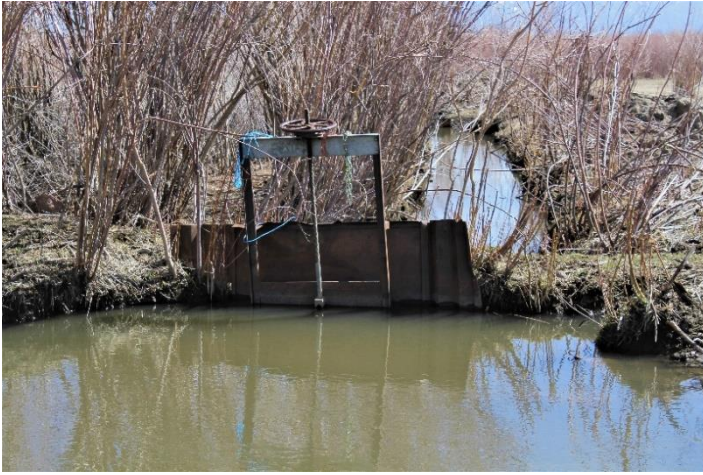
Headgate looking downstream

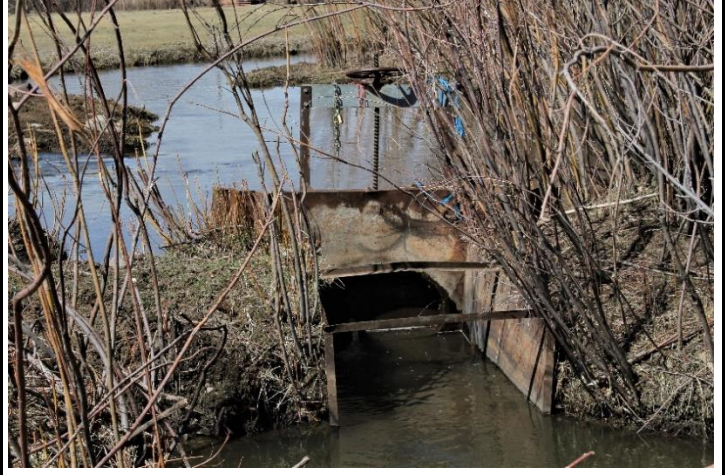
Headgate outlet

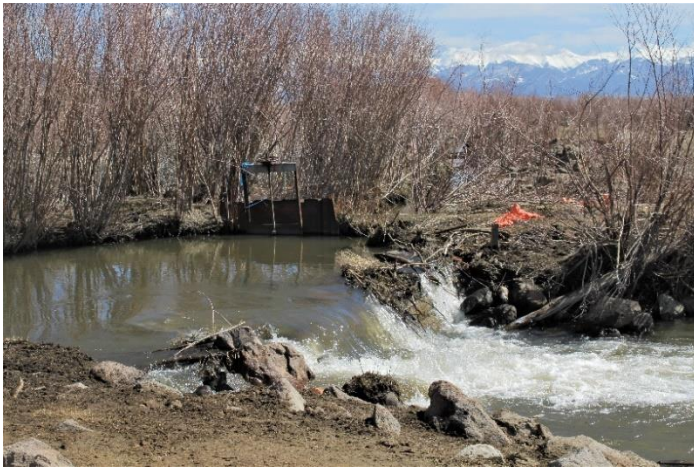
Headgate and diversion dam

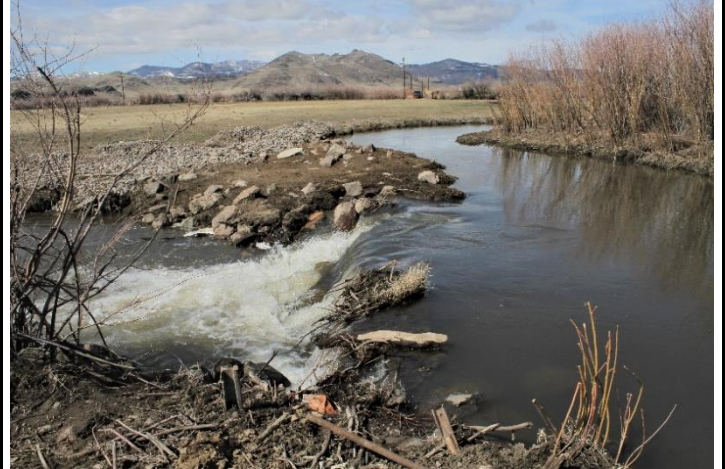
Diversion dam

**Repair(s) or Improvement(s) Currently Needed:** Additional bank stabilization could be installed downstream of the diversion to mitigate erosion of the bank and diversion dam. Fish passage and riparian restoration should be considered as part of any future repairs or improvements.

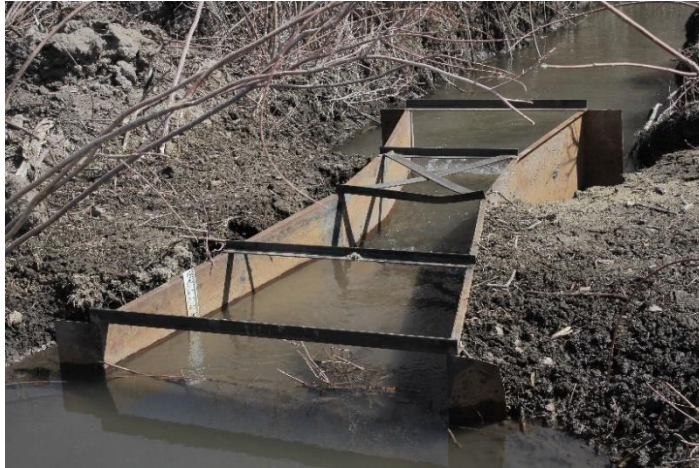
Flume looking downstream

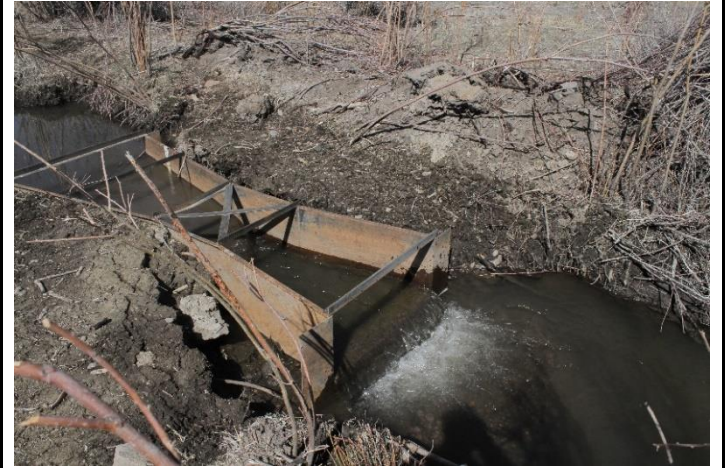
Flume looking upstream
