SAGUACHE CREEK DIVERSION INFRASTRUCTURE INVENTORY

Structure Name: JEEP SCANDRETT D

JEEP SCANDRETT DITCH

Saguache Creek Stream Management Plan

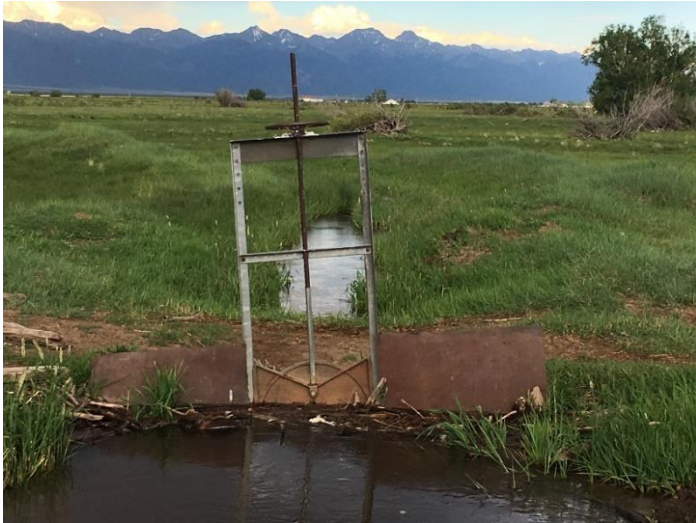
Headgate looking downstream

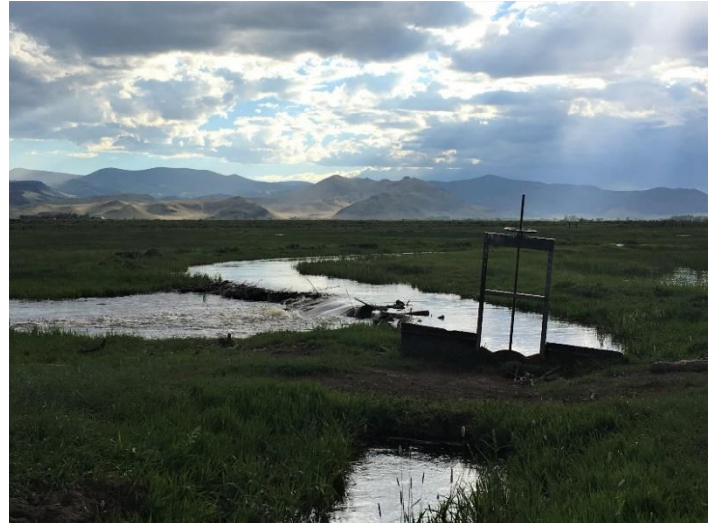
Headgate outlet

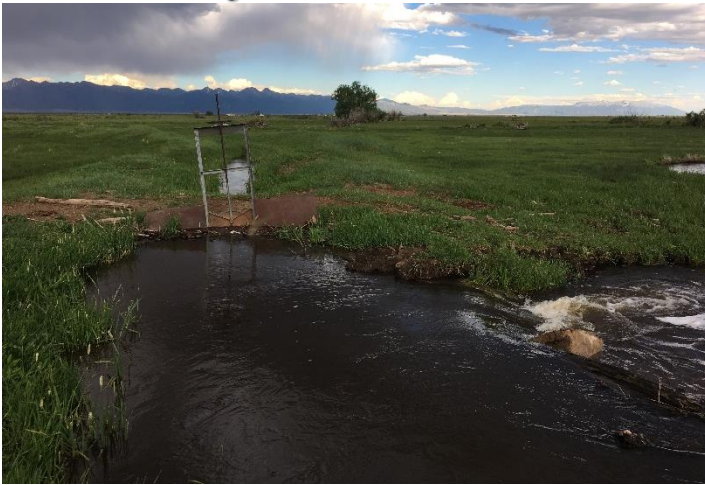
Structure Description: A diversion dam of boulders and woody debris directs water to the headgate, located on the north bank of the stream. The diversion is located on the outside of a tight meander. The diversion dam functions poorly in low flow conditions, collects debris, and does not have adequate sediment transport capacity.

Headgate and diversion dam

Repair(s) or Improvement(s) Currently Needed: The diversion dam should be improved to more effectively divert water and to improve sediment transport. Relocating the diversion dam downstream may improve its function and sediment transport capacity. Fish passage and riparian restoration should be considered as part of any future repairs or improvements.

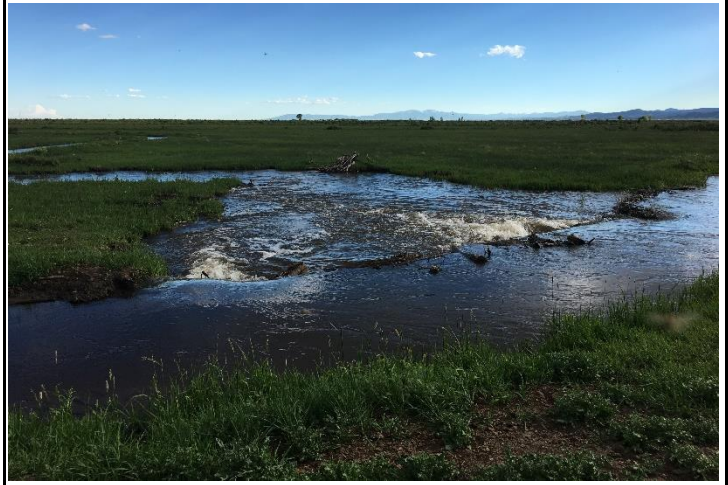
Diversion dam

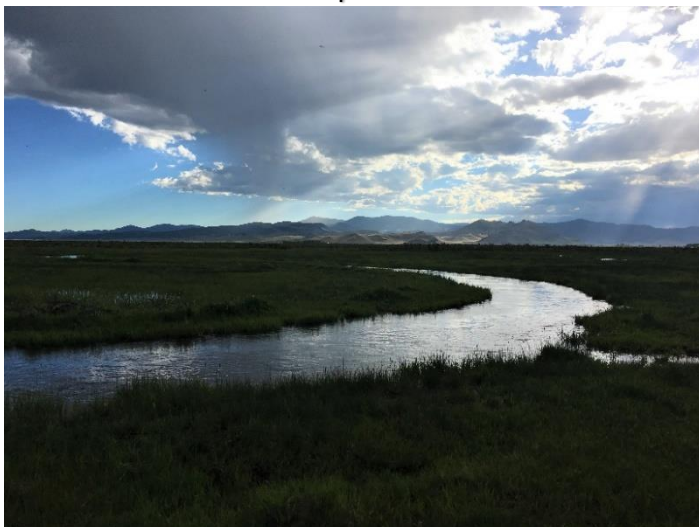
Stream channel upstream of diversion

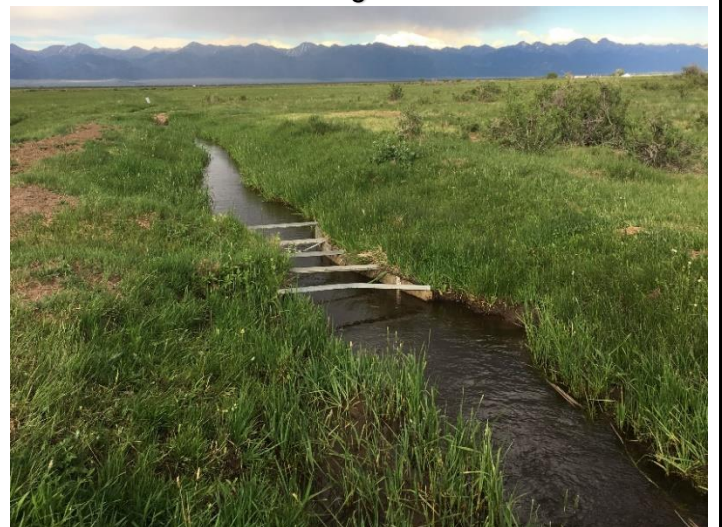
Flume looking downstream
