# Inspection Report

CLARO HOME INSPECTIONS LLC

## Property Address:

Los Angeles, CA 90044

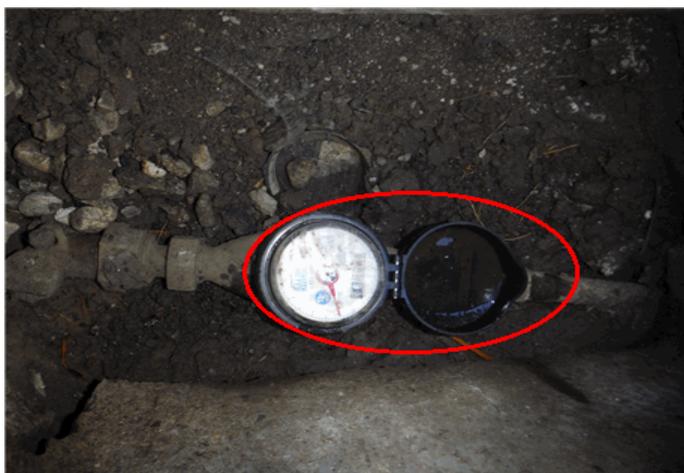
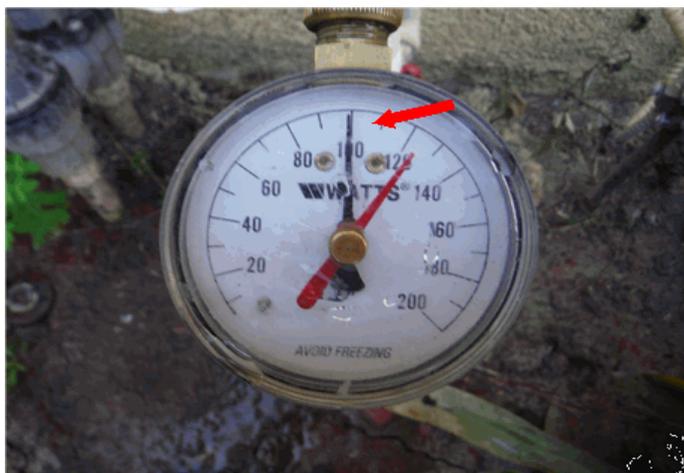
#### 1) Water Utility

Water service was provided to the home via public utility. Water service was established for the inspection. **Water pressure was high on the day of inspection.** Client should consult with a licensed plumber for further evaluation and resolution. A minor amount of moisture was observed at the meter dial and pipe, origins are unknown, further evaluation recommended.

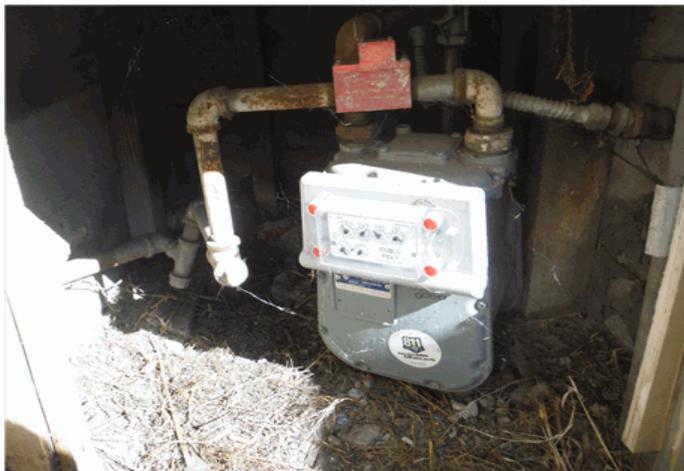
#### 2) Gas Utility

Natural gas service was provided to the home via public utility. Gas was on at time of inspection. There were no gas leaks detected on the day of inspection.

A meter wrench could not be located in the vicinity of the gas meter, it is recommended in areas subject to seismic activity. A proper wrench should be chained to the meter to provide a convenient means to shutoff the gas valve in case of emergencies. Consult your local gas authority.

The meter was equipped with an automatic seismic shutoff valve. We recommend client consult the local gas authority provider for requirements.

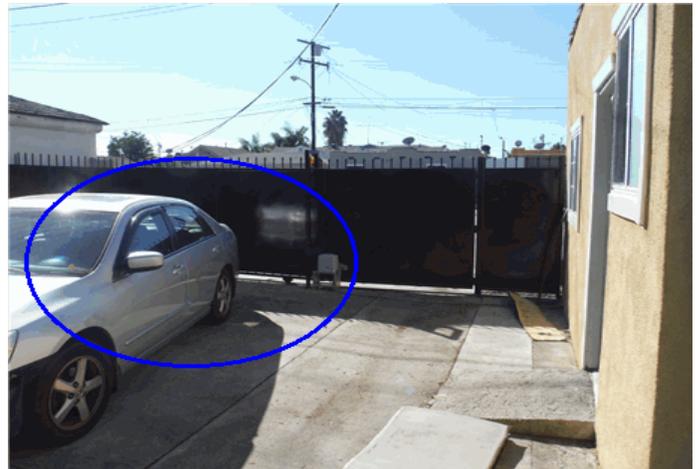
6) Driveway Conditions

The driveway appeared to be in serviceable condition at the time of the inspection. Common cracks were observed in the driveway. Recommend maintenance as needed. Areas covered by parked car, could not be inspected.

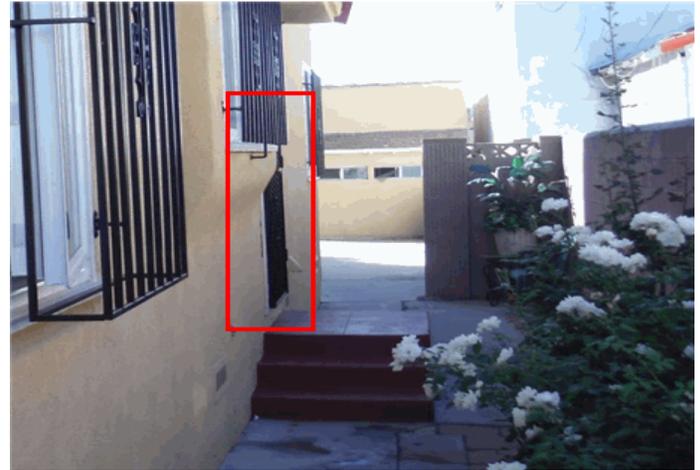
7) Sidewalk Conditions

The visible areas of the sidewalk appeared to be in serviceable condition at the time of the inspection. Minor hairline cracks were observed that are part of normal curing and settling of the concrete itself. [Hand rails recommended for safety.](#)

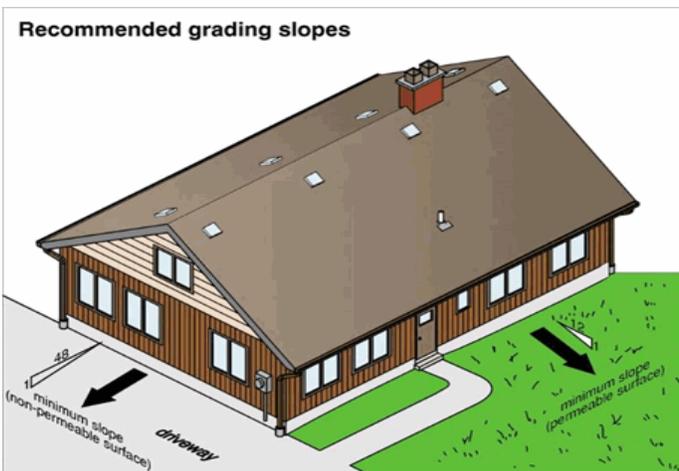
8) Grading Conditions

Overall grade of the property is flat or nearly flat. A 5% grade away from the homes foundation is considered ideal.

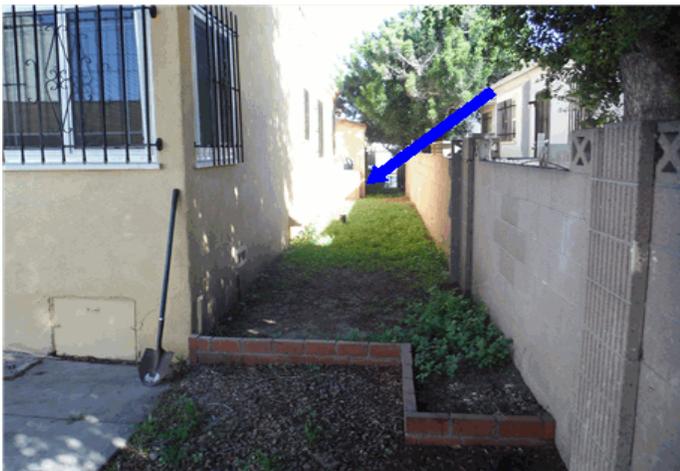
Satisfactory drainage was noted at west side yard. Reverse drainage was noted at the east side yard. Client should consult with a landscape contractor for further evaluation and resolution.

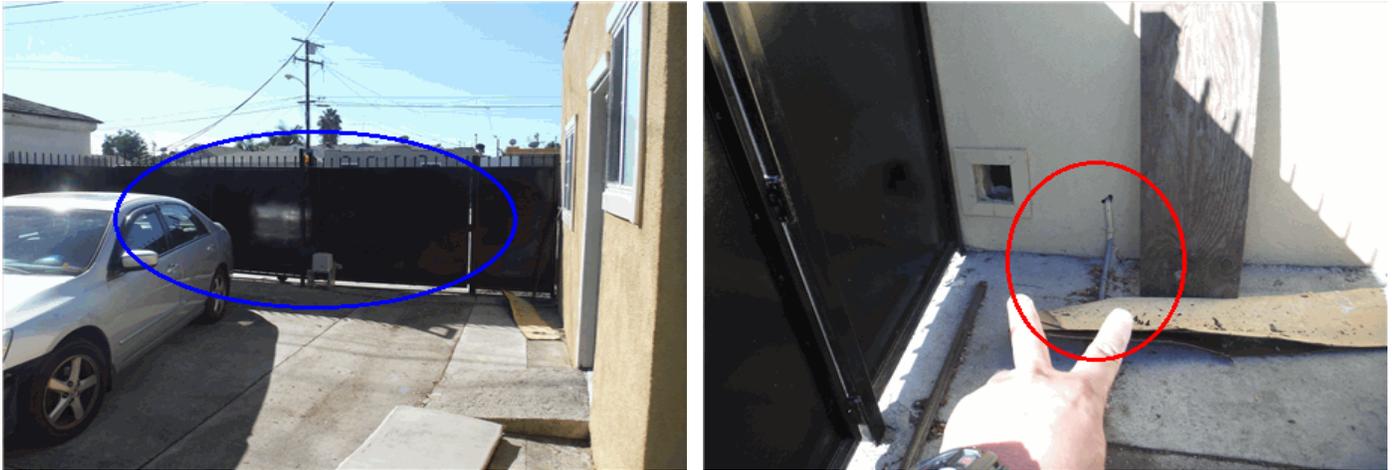
13) Property Wall & Fencing Conditions

The visible and accessible portions of the block walls appeared to be in serviceable condition at the time of the inspection, **However settling, step cracks and missing blocks were noted. Monitor cracks and make repairs as needed.**

Means of testing the electric driveway gate were not provided, not inspected for functionality. Electrical conduit subject to damage, not installed according to manufacturer's guidelines.

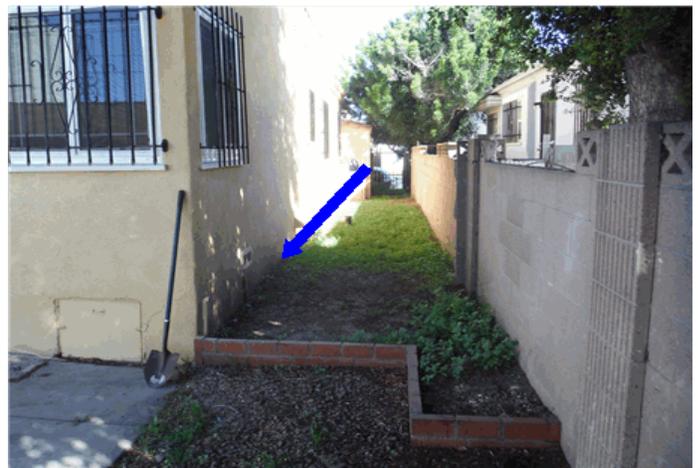
The stucco was in satisfactory condition. Common cracks were found in the exterior walls. Recommend sealing to reduce the possibility of water penetration. It should be noted that the building stucco siding terminated below or at finished grade of the perimeter walls and foundation (no weep screed). This condition is no longer considered acceptable by modern construction standards and practices. Condition is conducive to moisture migration to the wood framing supporting members. Subject to moisture damage. It is suggested that a positive finish grade slope away from the buildings perimeter be maintained to prevent future moisture damage.

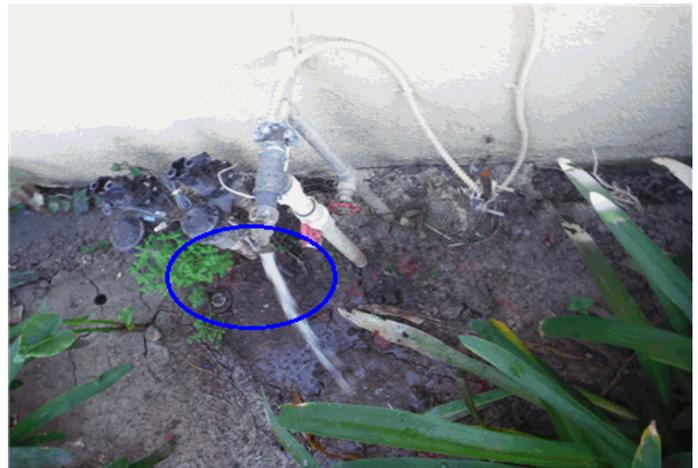
Back-flow preventers should be installed at all hose bibs to prevent back-flow contamination to the home's drinking water. Maintenance, such as tightening of the packing nut, or replacements may be needed to prevent leaks while hoses are in use.

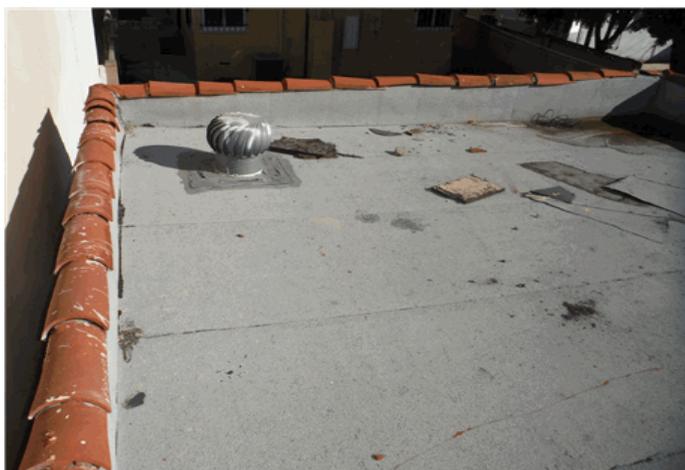
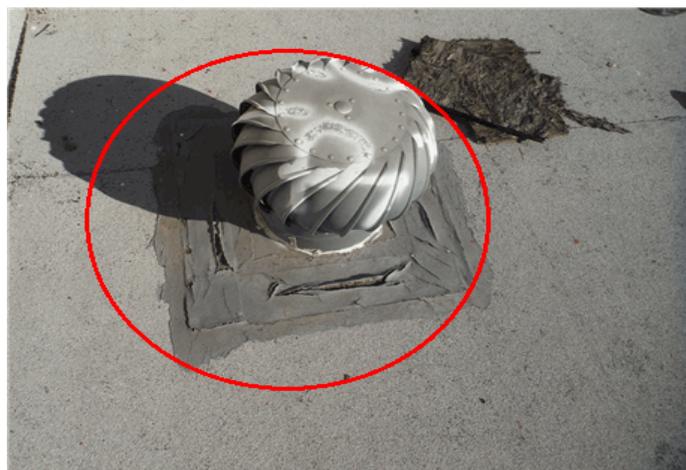
29) Penetrations-Flashings Condition

The exposed roof penetrations and flashings appeared to be in serviceable condition at the time of inspection. There were no apparent signs of water infiltration. Roof penetrations should be resealed every 3 to 5 years as part of a regular home maintenance plan.

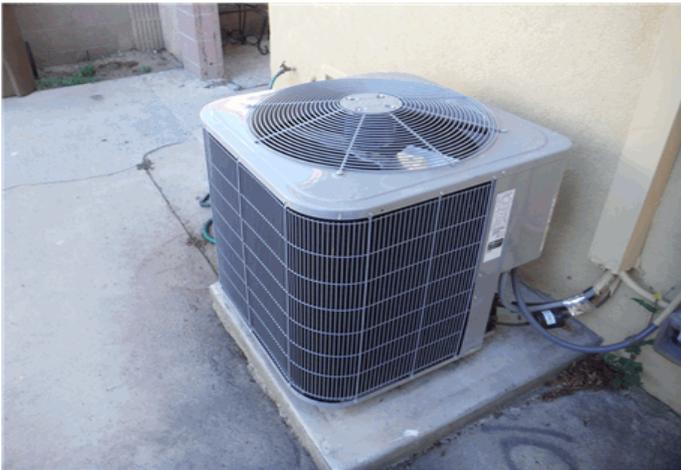
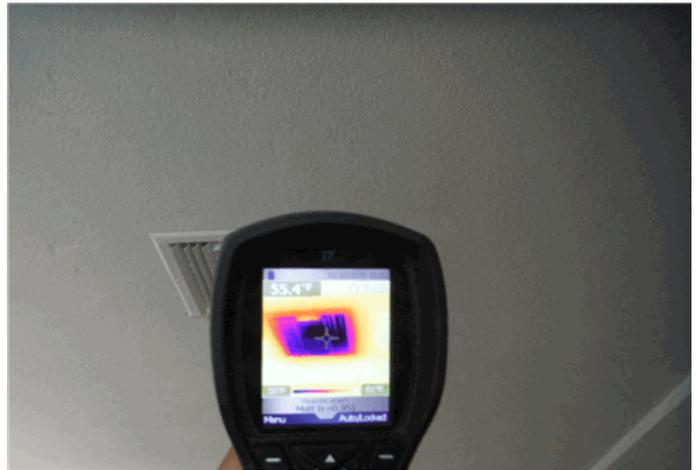
A/C condenser responded normally to testing. Air-conditioning output temperatures were satisfactory. Cooling output temperature was measured at 55.4°.

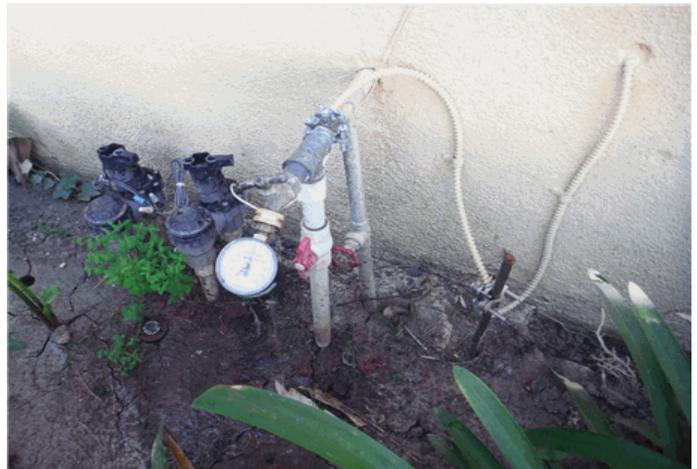
The main shutoff valve was tested and found to be functional on the day of inspection. **Water pressure was high on the day of inspection.** Client should consult with a licensed plumber for further evaluation and resolution.

Water pressure regulators are recommended for all residential homes. This will help prevent over pressurizing the system and connected appliances such as dishwashers and washing machines.

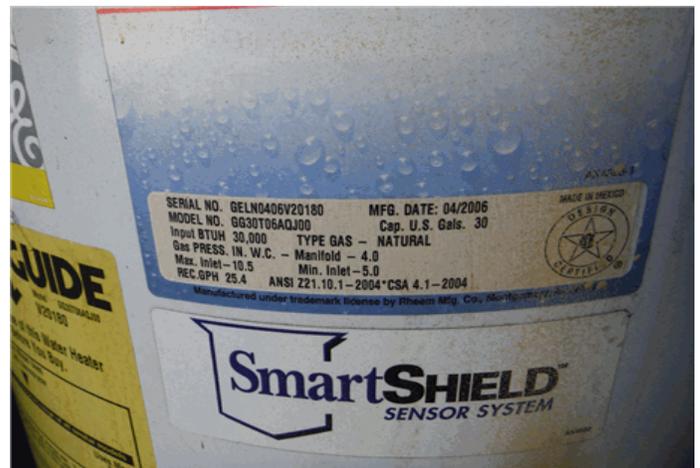
The hot water heater is functioning beyond manufacturers life expectancy. Client should consider the cost of upgrades. Consult with a licensed plumber for cost of replacement. Hot water heater temperature was measure at 133°. A desirable temperature between 110° and 120° it's recommended for safety.

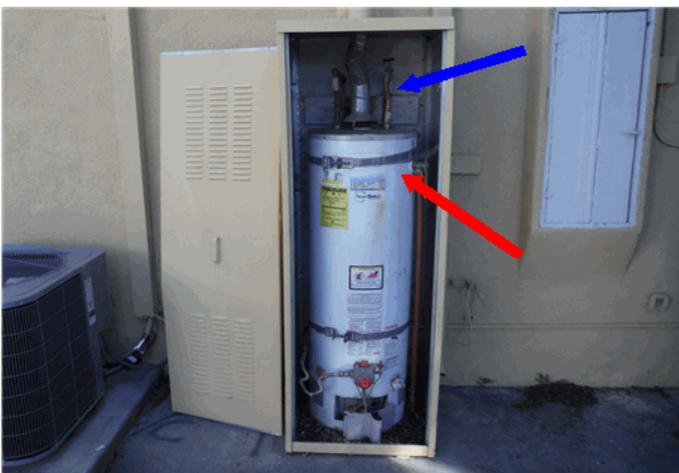
Plumbing	45	<p>Hot water heater supply lines were in functional condition. The water heater cold water shutoff valve appeared in functional condition. (minor rust and corrosion)</p> <p>Insulation is recommended at supply lines. This will help prevent condensation calcium and corrosion.</p>

Hot water heater supply lines were in functional condition. The water heater cold water shutoff valve appeared in functional condition. (minor rust and corrosion) Insulation is recommended at supply lines. This will help prevent condensation calcium and corrosion.

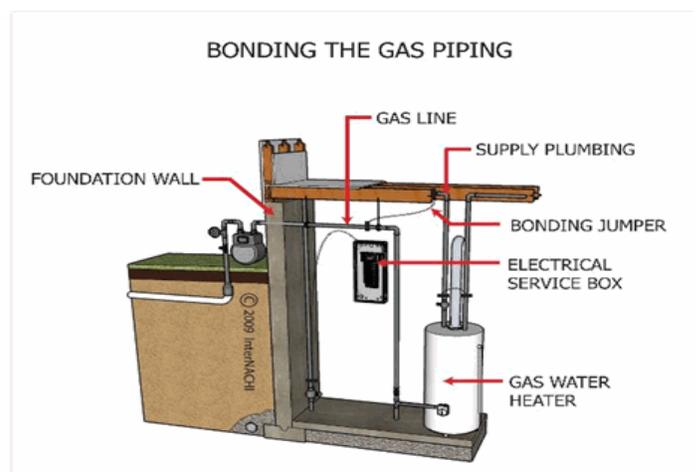
There were no apparent gas leaks at gas appliance connections. A drip leg (sediment trap) at the gas line connection was missing, it is recommended client consult their local utility provider/license plumber for local installation requirements. Pipe bonding between water supply line and gas line was not vincible. Ideally, current standards require a simple jumper wire across.

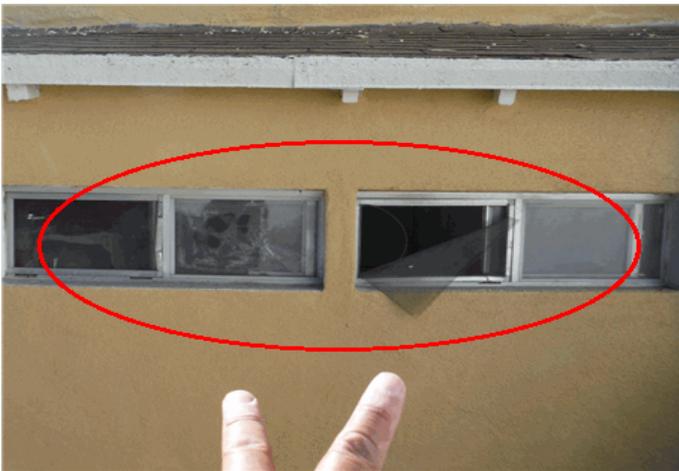
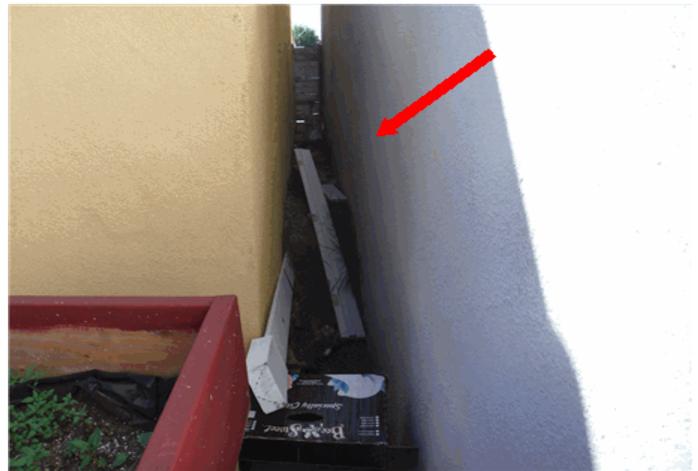
The garage was in average condition. Personal items and storage obstructed a complete visual assessment of the garage area.

Damaged and broken windows observed.

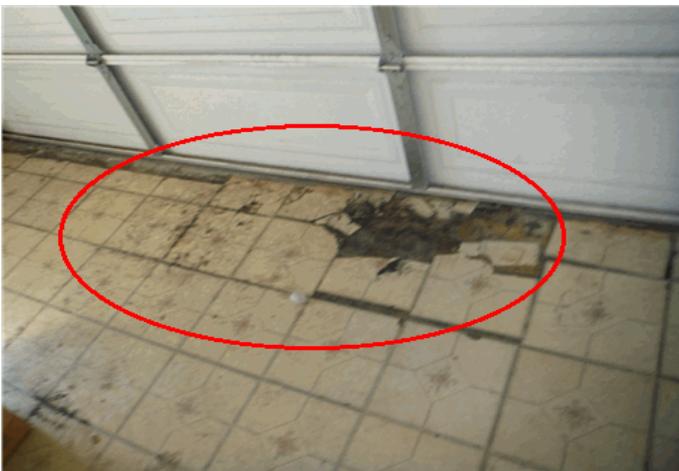
55) Slab

The garage slab was in functional condition. A resilient tile floor was installed above the slab, flooring was in poor condition in some areas, recommend repair.

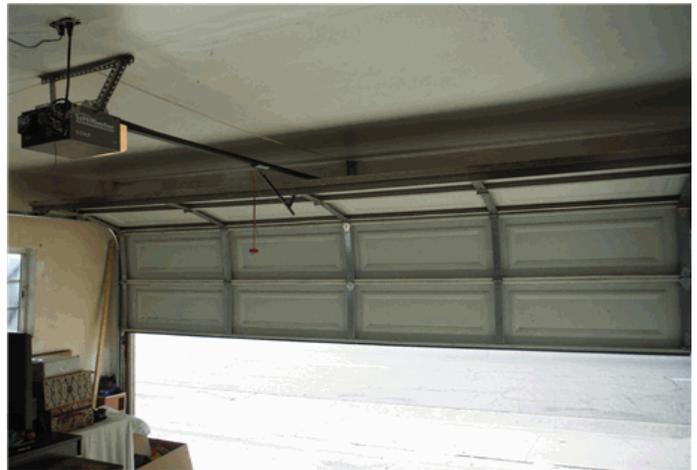
Garage door opener and safety sensors were tested and found to be functional.

All garage door safety sensor should be installed within 6" of the slab for safety. Safety sensors installed above this height pose additional risk for pets and personal items for potential injury or damage.

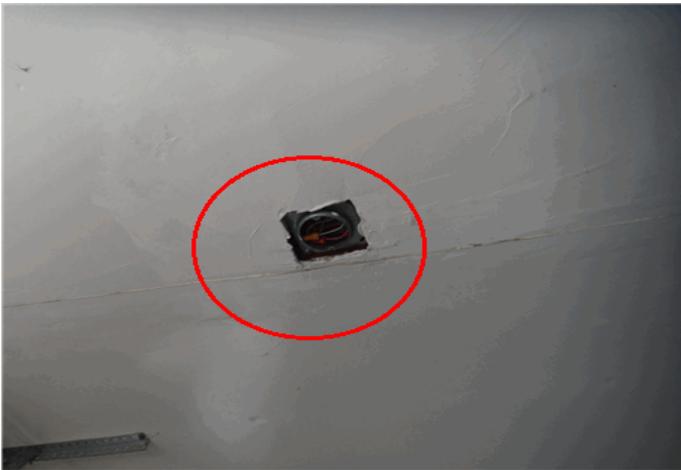
Lighting that was tested was found to be functional.  
Missing junction box cover. It is suggested that a "Licensed Electrical Contractor" be contacted for further evaluation and repair.

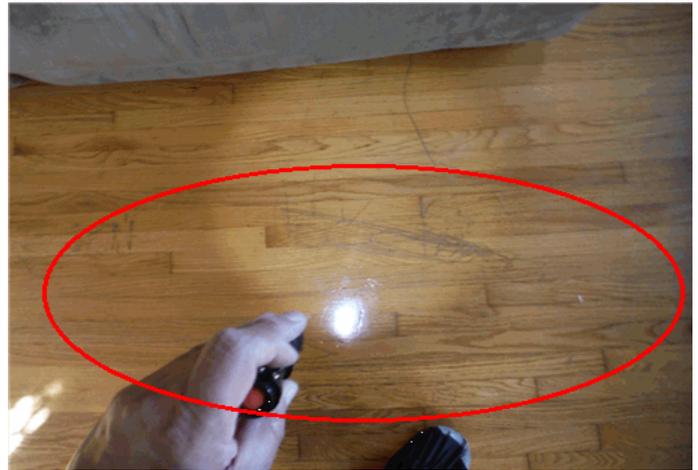
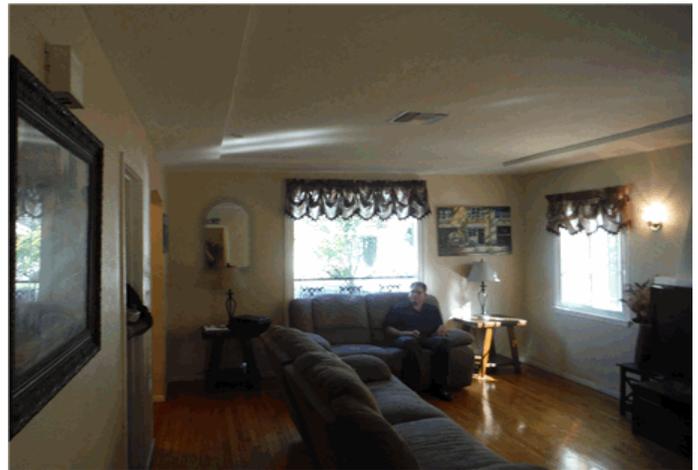
Flooring was found to be in satisfactory condition. Harwood floors are showing signs of scratches from common traffic patterns. It is recommended client consult with a flooring contractor for evaluation and costs of repair/maintenance.

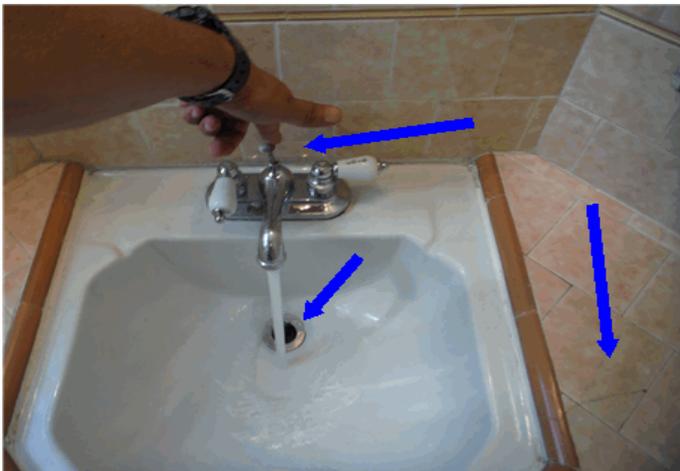
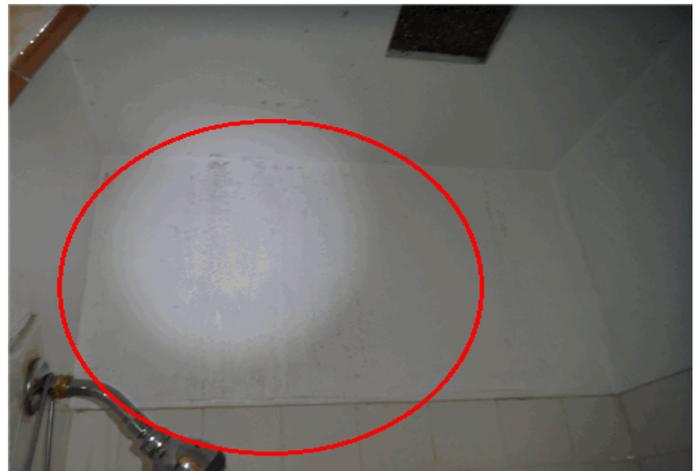
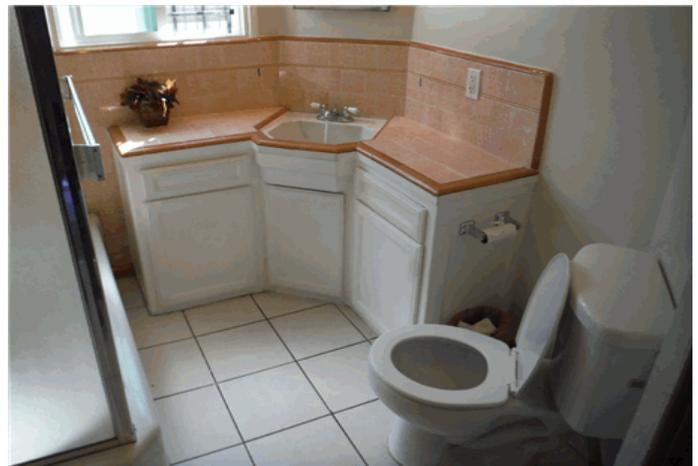
Sink was operational showing signs of average daily use. Faucet was functional. Hot and cold running water was present. Drain assemblies were functional with no signs of active leaks. Stoppers were not present or functional. Stoppers prevent accidental intrusion of foreign objects into the plumbing system. Replacement recommended. Cracked tiles were observed, consult a tile setter for repair.

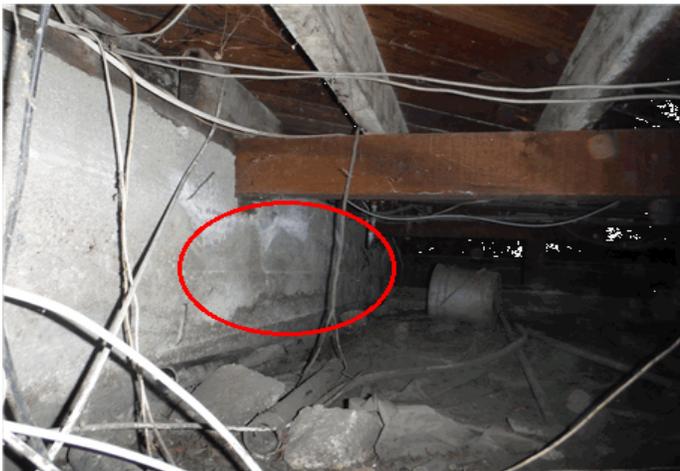
The foundation walls were found to be in serviceable condition. There were no abnormal cracks or settling noted for the age of the home. Small hairline cracks caused by curing of the concrete and seismic activity were observed. Recommend drainage be addressed. Significant signs of efflorescence and minor concrete deterioration was observed at the foundation walls. This is likely a result of poor drainage and/or moisture migrating in and out of the foundation walls. Condition may also be caused by plumbing leaks.

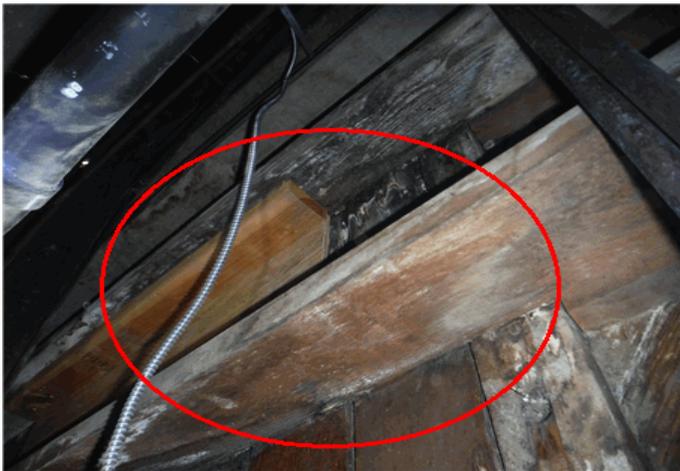
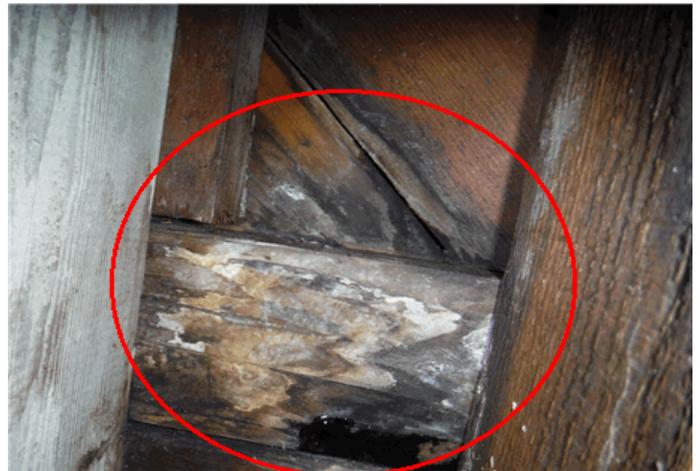
Sub floor rot and decay observed in areas of bathroom, previous repairs also observed. It is suggested that a "Licensed General Contractor" be contacted for further evaluation and repair.  
Construction debris observed, consult a qualified professional for removal.

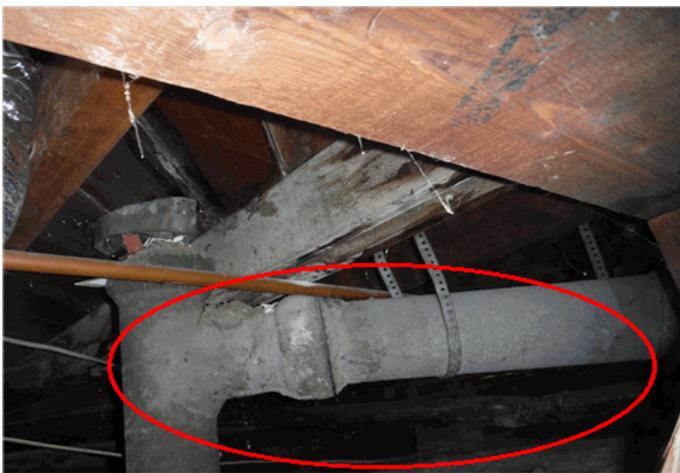
No insulation was observed in the crawl space. Although this may have been typical at the time of construction, clients should consider insulation to increase energy efficiency. Abandoned asbestos type furnace transite pipe observed, consult a qualified professional for removal.
