MINIMUM INSPECTION PROCEDURAL GUIDELINES
FOR BUILDING ELECTRICAL RECERTIFICATION

INSPECTION MADE BY: FLORIN FLOREA P.E.

a. Name on Title: Village at Dadeland Condominiums (J)

b. Street Address: 7600 SW 82nd St. Miami, Florida 33143

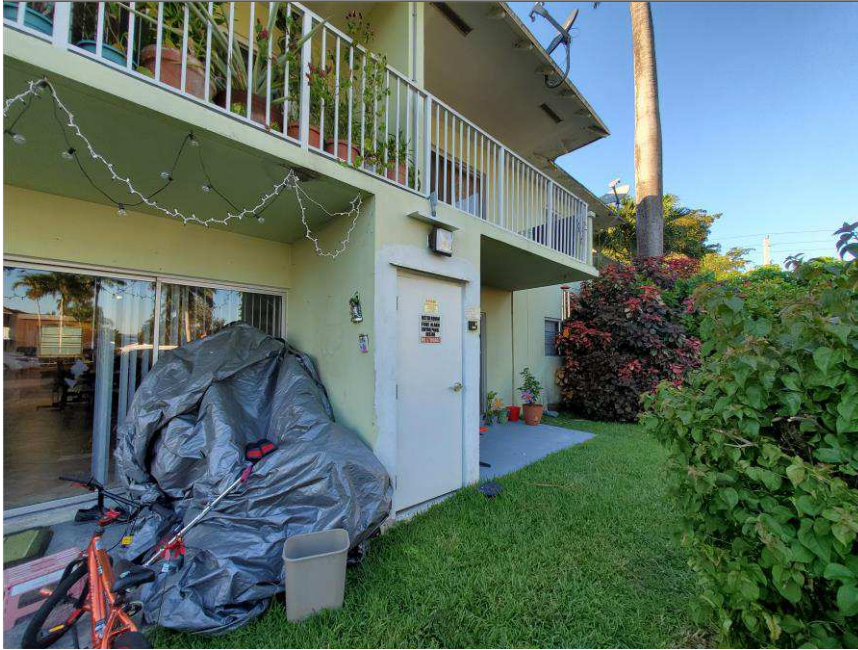
Photo 1 – Village of Dadeland Condominium Association

Existing Electrical Room - 1st FL
Provide sign with Building
Number

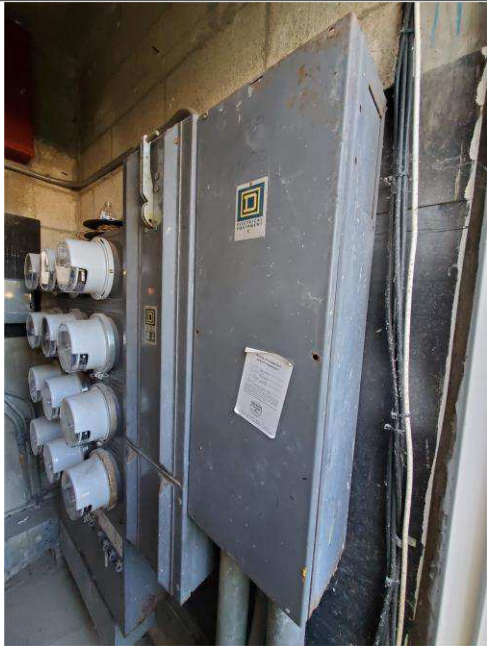
Photo 3 – Village of Dadeland Condominium Association

Existing Electrical Room - 1st FL
Building Main Disconnect is
corroded.
50 year old electrical
component.

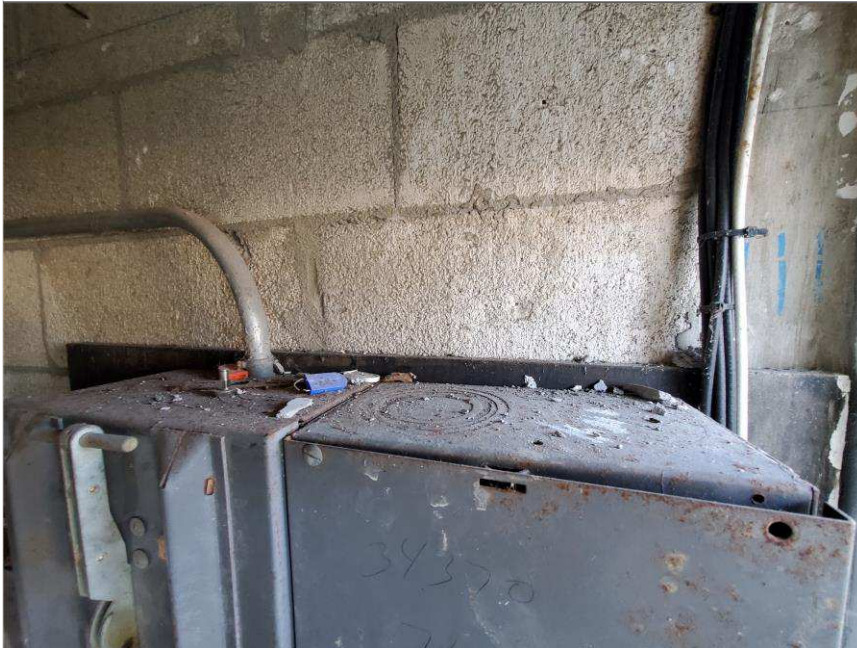
Photo 4 – Village of Dadeland Condominium Association

Existing Electrical Room - 1st FL
Building Main Disconnect is
corroded.
50 year old electrical
component.
Missing screws

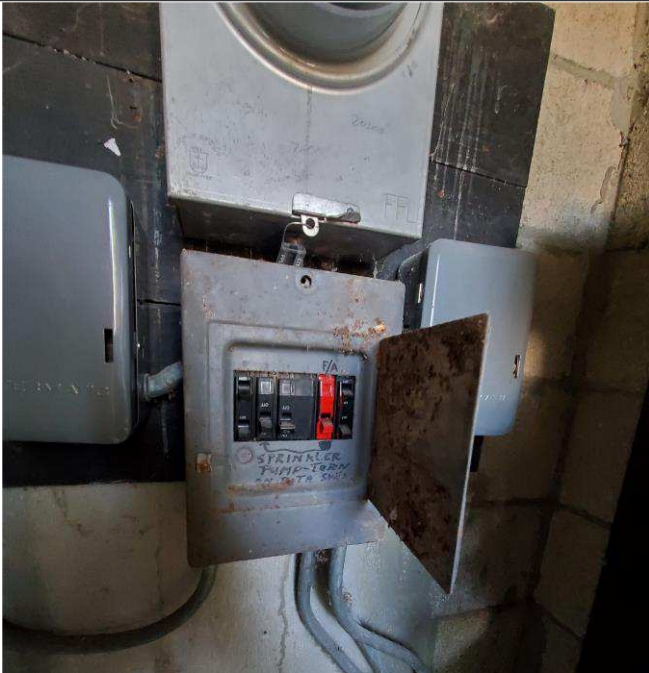
Photo 6 – Village of Dadeland Condominium Association

Existing Electrical Room - 1st FL
House Panel Board and
breakers.

Panel nameplate missing.

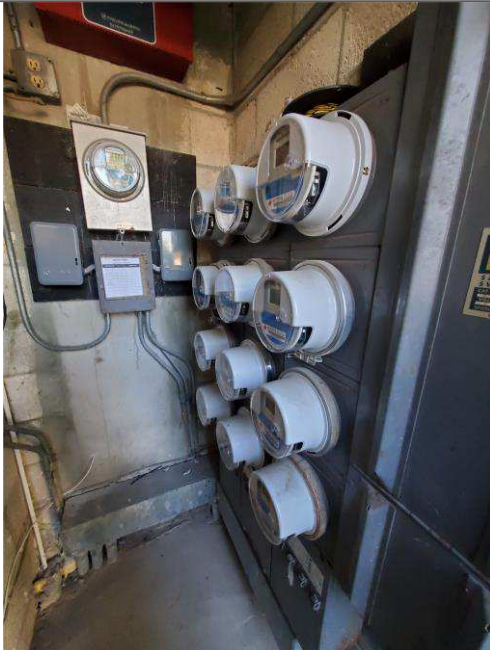
Photo 7 – Village of Dadeland Condominium Association

Existing Electrical Room - 1st FL
Main Switches for Apartments,
Meters, and Gutter.

Old and oxidized meter stacks.

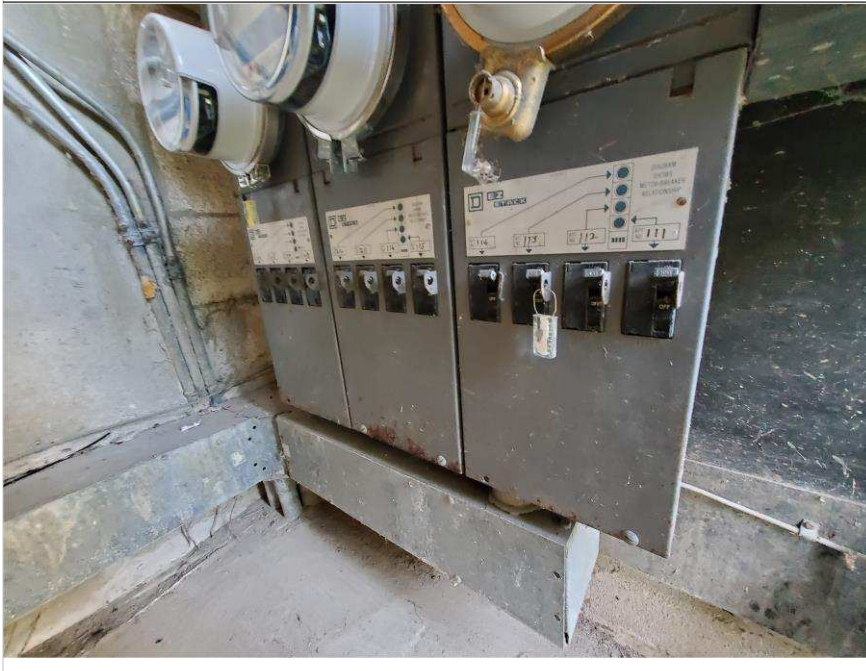
Photo 9 – Village of Dadeland Condominium Association

Existing Electrical Room - 1st FL
Main Switches for Apartments,
Meters, and Gutter.

Old and oxidized meter stacks.

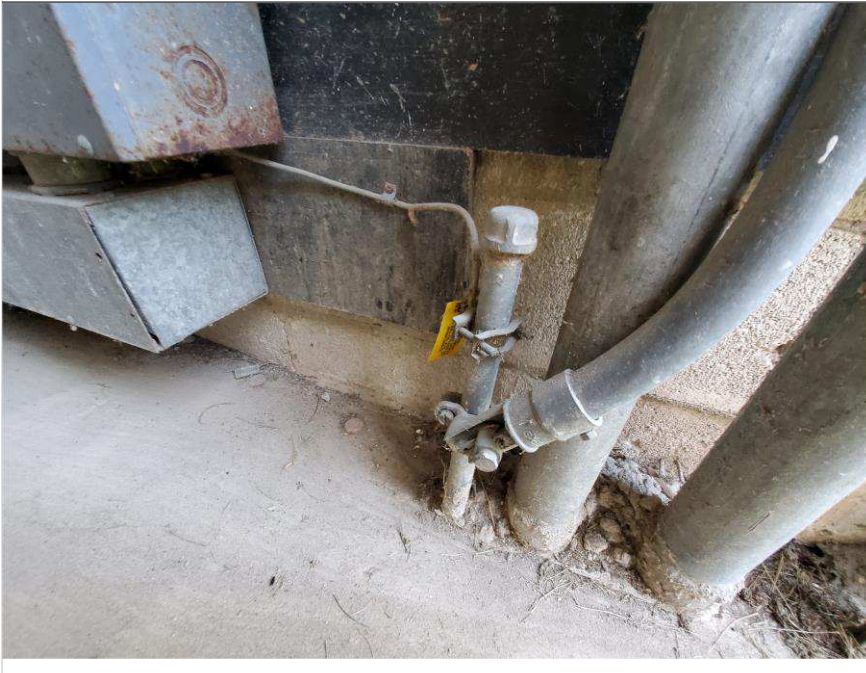
Photo 11 – Village of Dadeland Condominium Association

Existing Electrical Room - 1st FL
Main Service - Grounding

Grounding resistance to be tested to determine if repairs and/or maintenance are required.

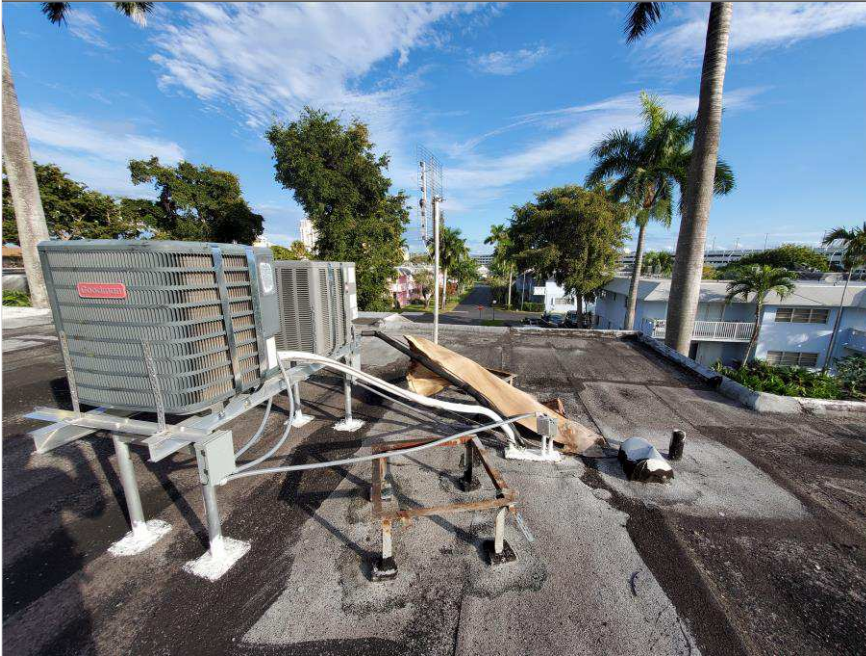
Photo 12 – Village of Dadeland Condominium Association

Rooftop
Rooftop Condenser Units

Junction boxes not properly supported.

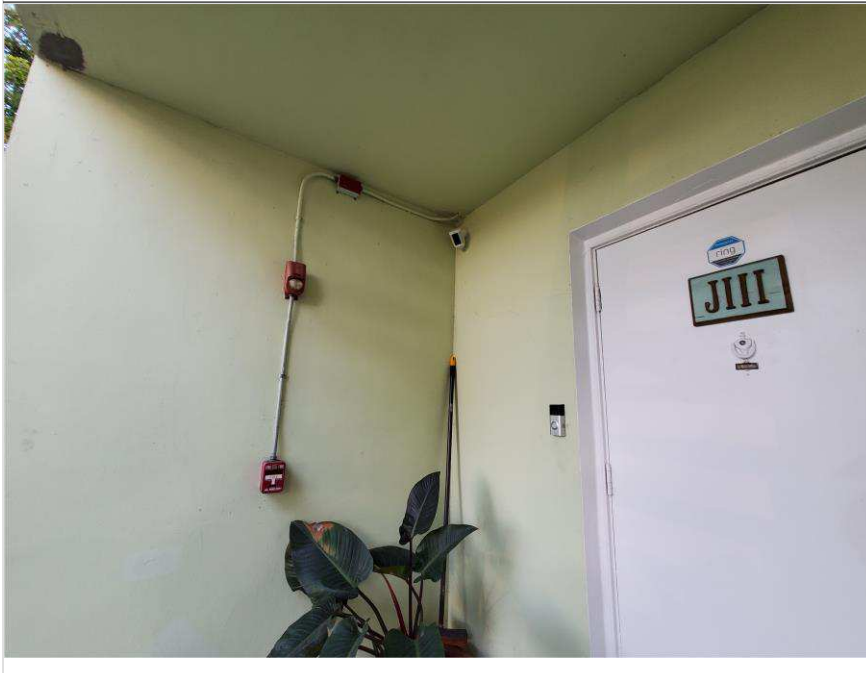
Photo 15 – Village of Dadeland Condominium Association

Level 1

Fire Alarm - Old and Weathered
Fire Alarm Devices and Control
Center

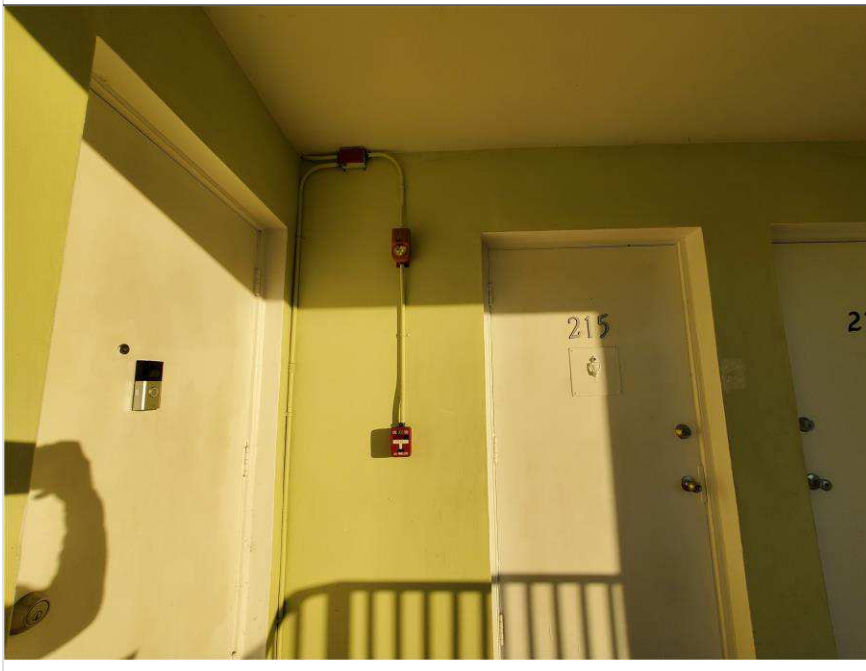
Photo 16 – Village of Dadeland Condominium Association

Level 2

Fire Alarm - Old and Weathered
Fire Alarm Devices and Control
Center

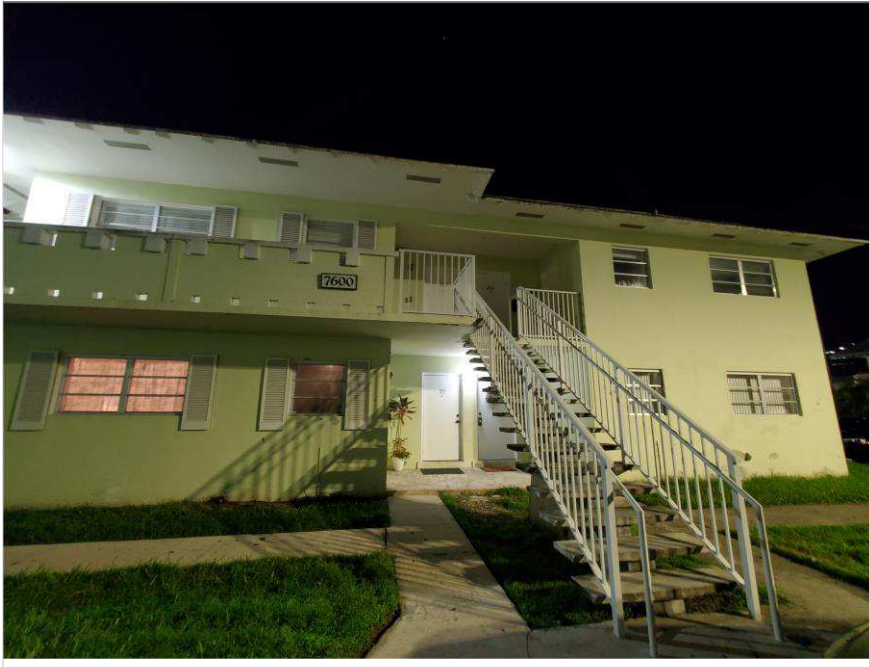
Photo 17 – Village of Dadeland Condominium Association

Points of Egress
Insufficient illumination at
Building Points of Egress,
catwalks, and sidewalks.
Exterior lights not functional.

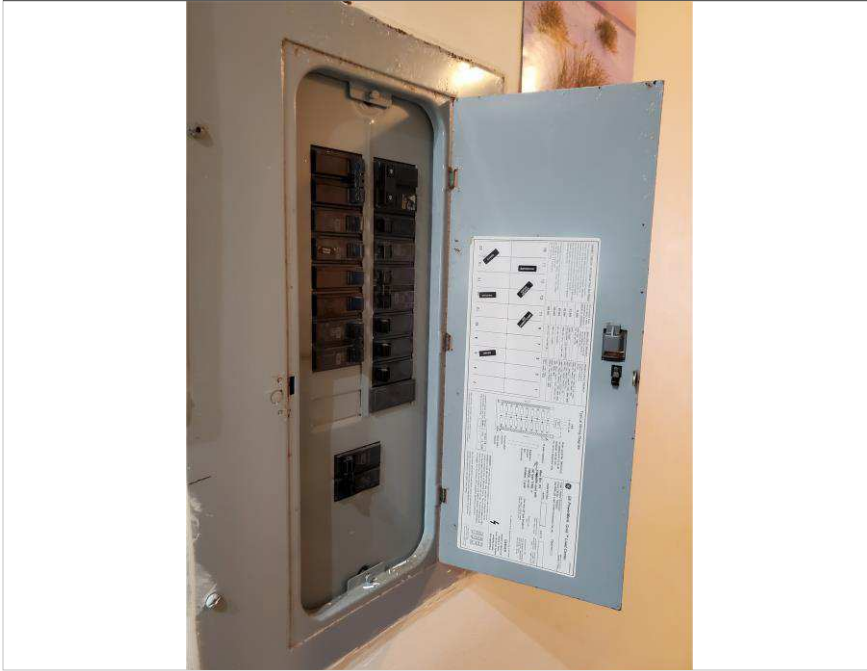
Photo 19 – Village of Dadeland Condominium Association

Apartments - Old Electrical Panels

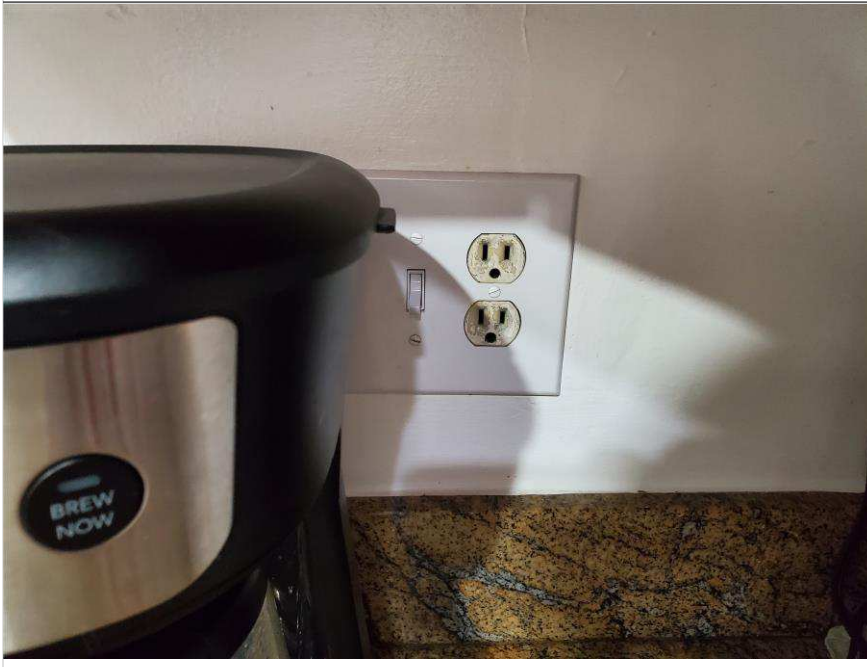
Photo 20 – Village of Dadeland Condominium Association

Apartments - Kitchen outlets not GFCI type.

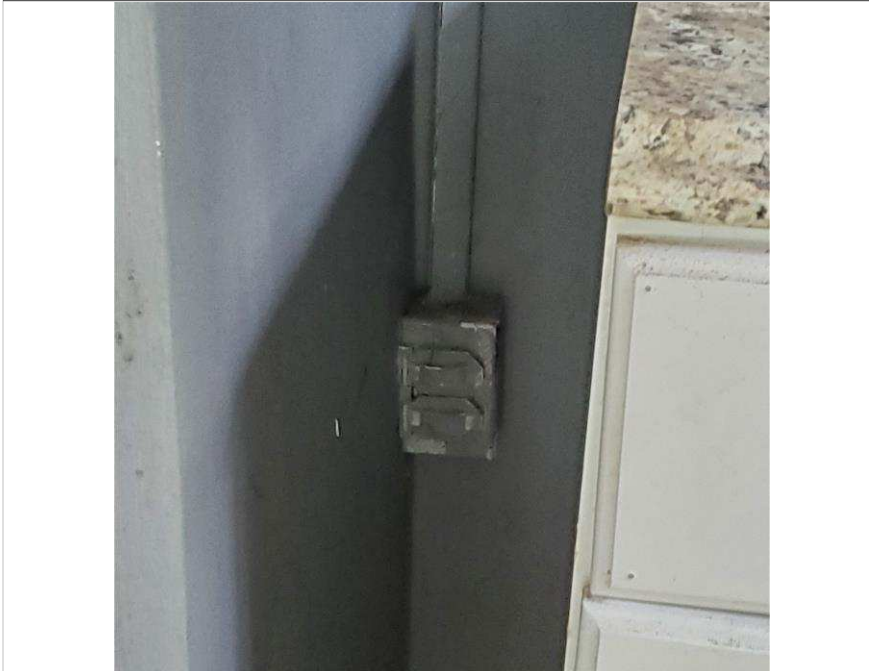
Photo 21 – Village of Dadeland Condominium Association

Apartments - Balcony/Patio
outlets not GFCI type.

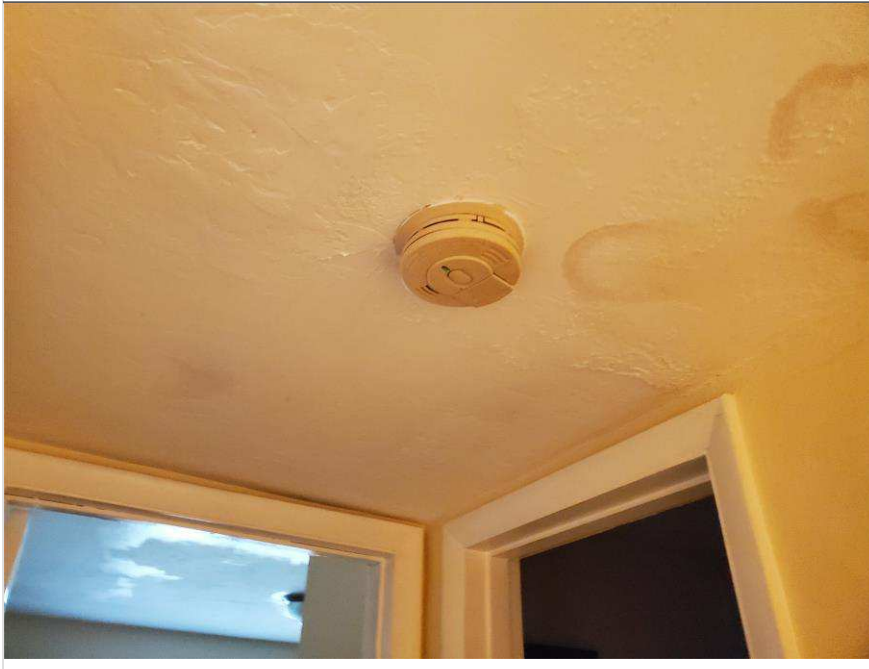
Photo 22 – Village of Dadeland Condominium Association

Apartments - Old Smoke
Detectors

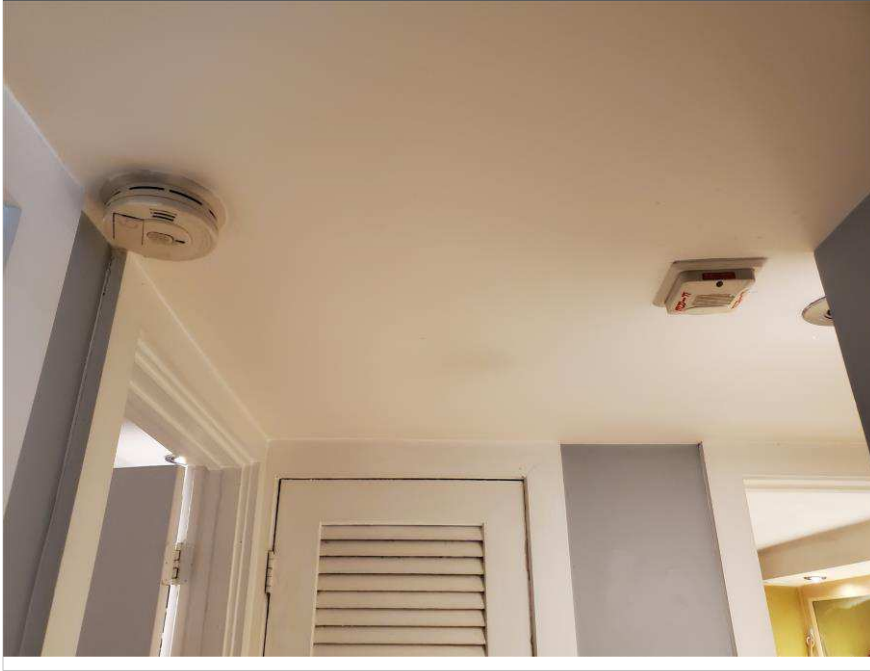
Photo 23 – Village of Dadeland Condominium Association

Apartments - Old Smoke or CO₂
detectors to be replaced.

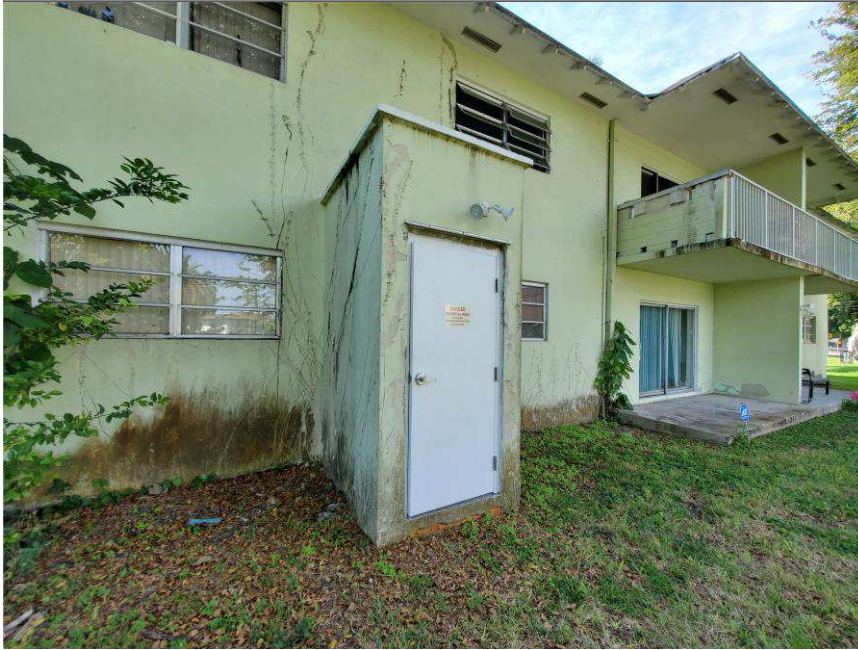
Photo 1 – Village of Dadeland Condominium Association

Existing Electrical Room - 1st FL
No Storage Permitted

Missing sign with room name
and building number.

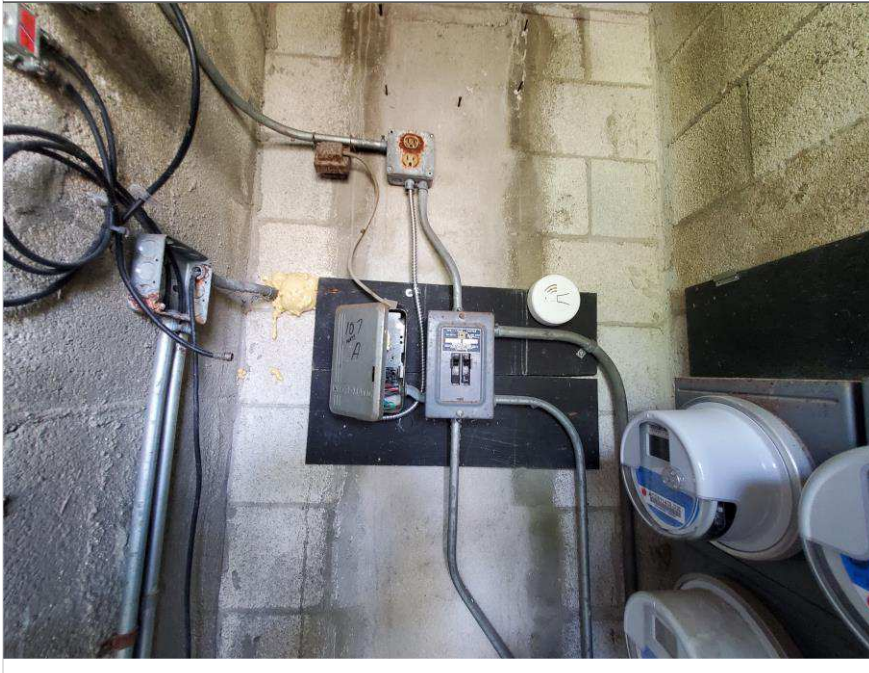
Photo 5 – Village of Dadeland Condominium Association

Existing Electrical Room - 1st FL
House Meter and Panel Board

Corroded electrical outlet.
Open junction boxes to be
closed.

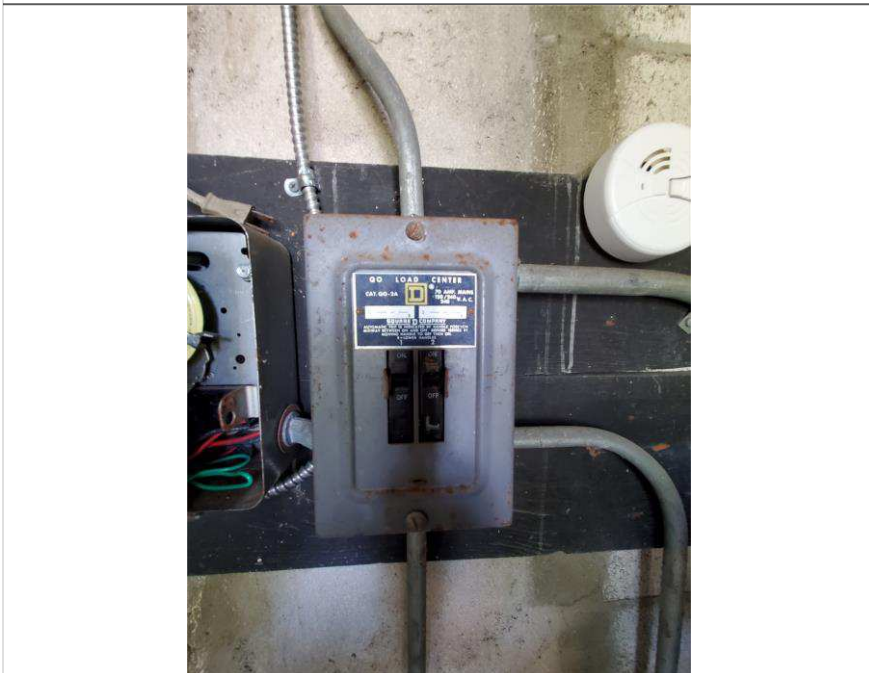
Photo 6 – Village of Dadeland Condominium Association

Existing Electrical Room - 1st FL
House Panel Board and breakers

Branch circuits are not
identified.

Corroded panel and old circuit
breakers.

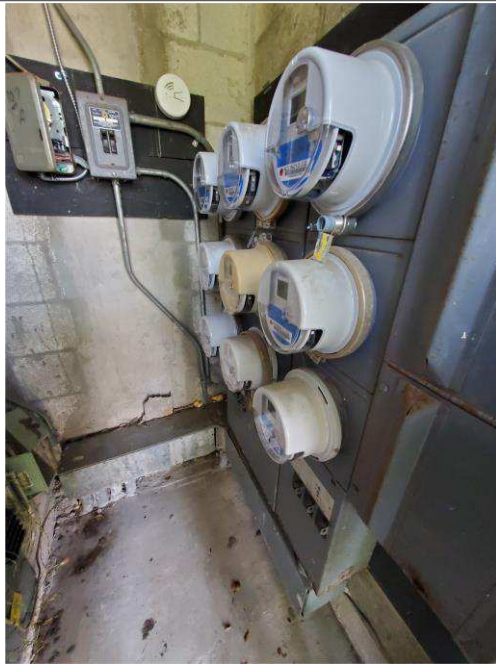
Photo 7 – Village of Dadeland Condominium Association

Existing Electrical Room - 1st FL
Apartment Meters, Main
Switches and Gutter

Old and oxidized meter stacks.

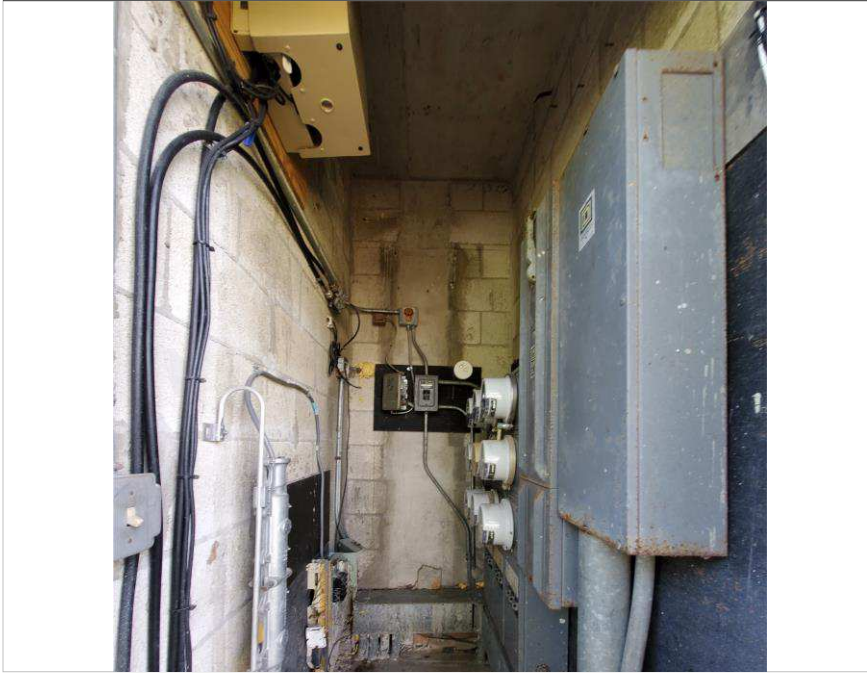
Photo 9 – Village of Dadeland Condominium Association

Existing Electrical Room - 1st FL
Apartment Meters, Gutter and
Main Disconnect Switch.

Insufficient clearance at
electrical components.

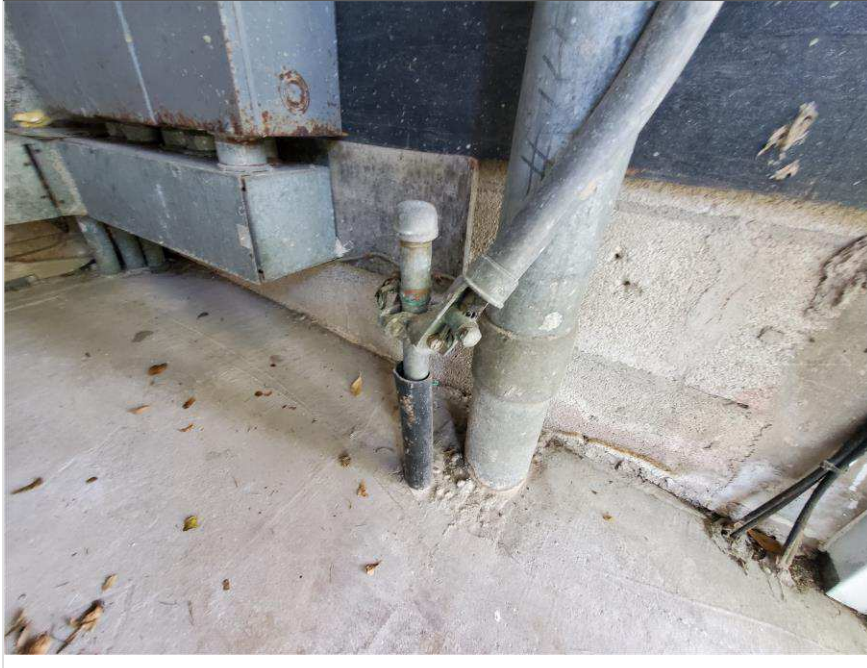
Photo 10 – Village of Dadeland Condominium Association

Existing Electrical Room - 1st FL
Main Service - Grounding

Grounding resistance to be
tested to determine if repairs
and/or maintenance are
required.

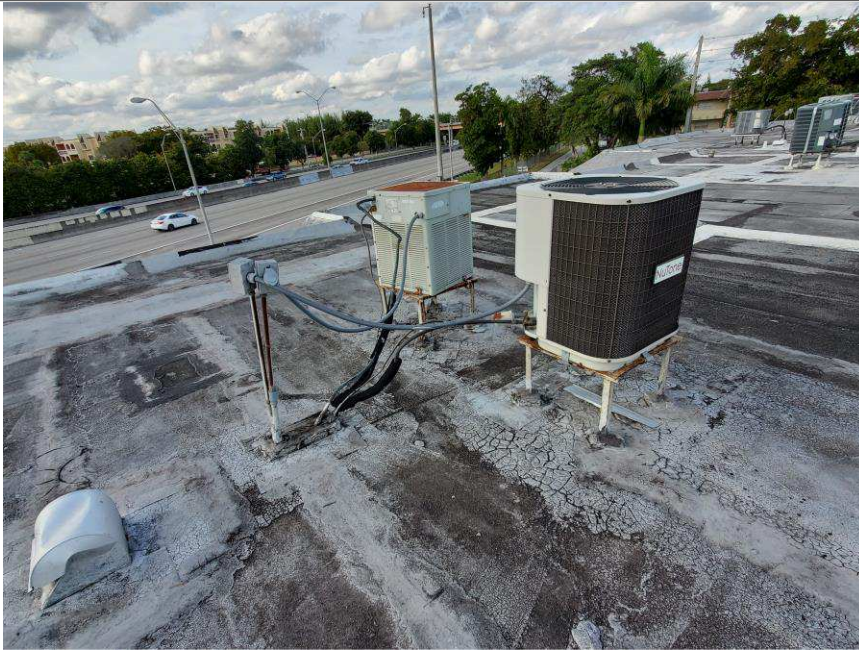
Photo 11 – Village of Dadeland Condominium Association

Rooftop Condenser Units

Improperly supported switches.

Corroded conduits and boxes.

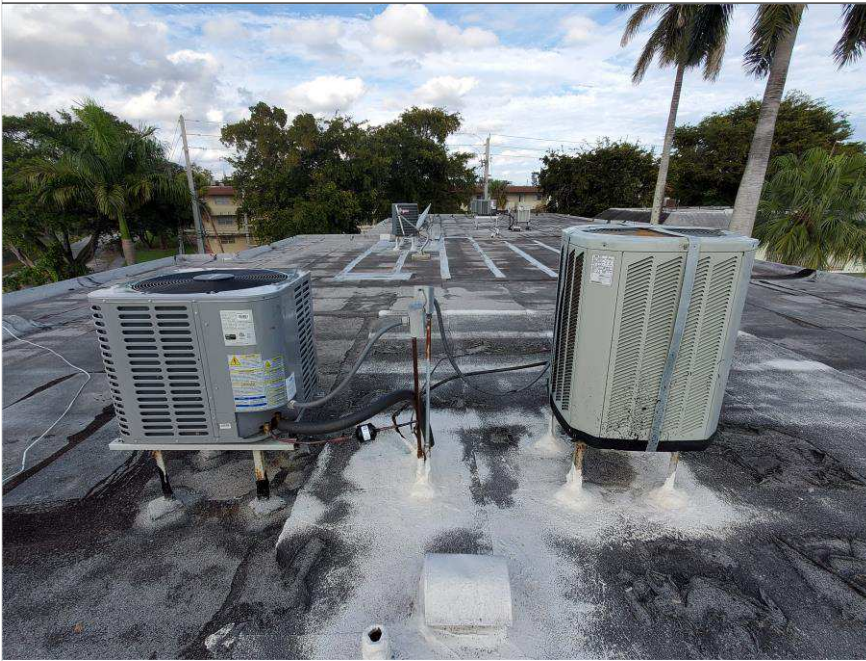
Photo 12 – Village of Dadeland Condominium Association

Rooftop Condenser Units

Corroded junction boxes and conduits.

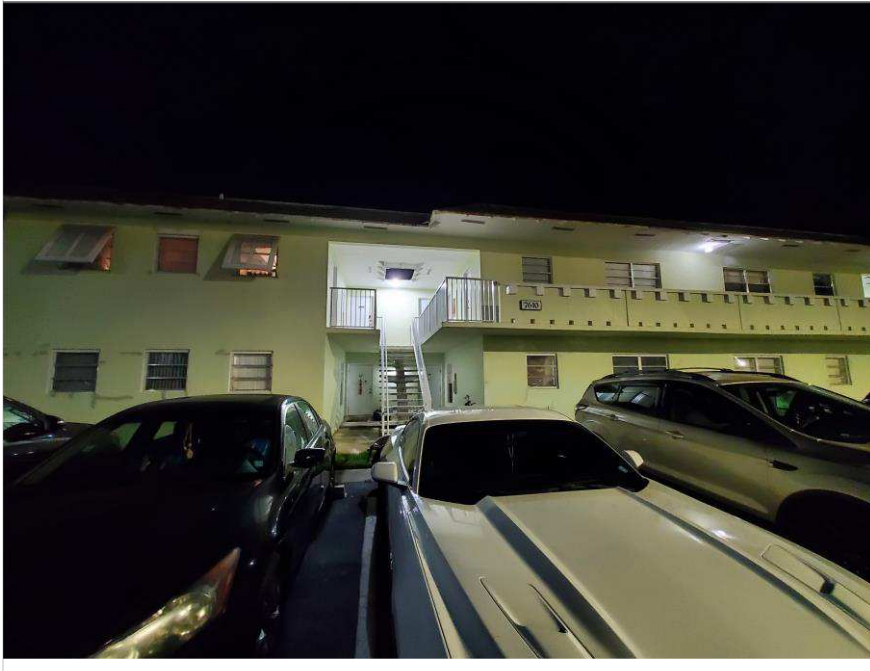
Photo 13 – Village of Dadeland Condominium Association

Points of Egress -
Insufficient illumination at
catwalks, stairs, and sidewalks.
Exterior lights not functional

Parking
Insufficient illumination at
sidewalks and parking spaces.

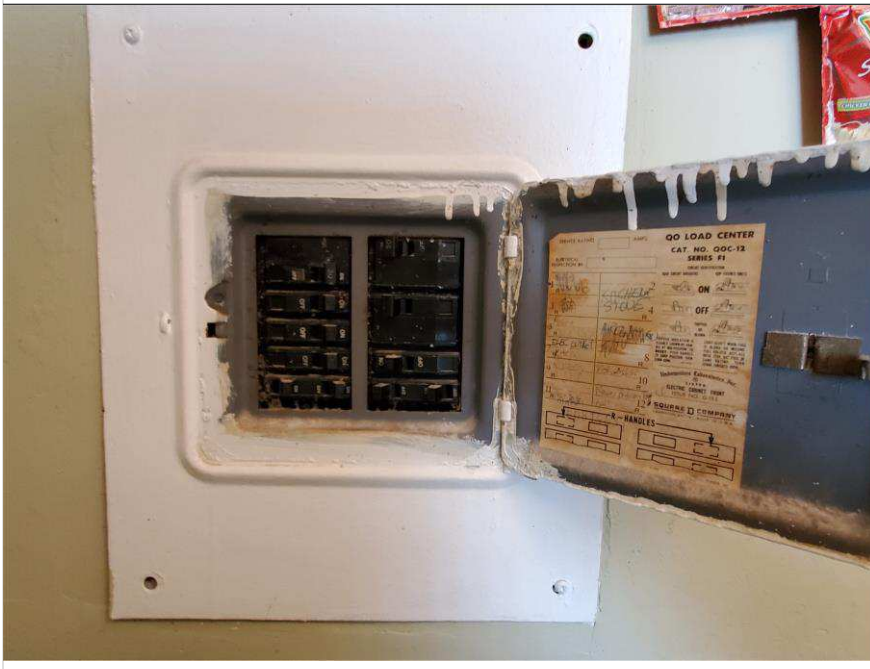
Photo 14 – Village of Dadeland Condominium Association

Apartments - Old Electrical
Panels

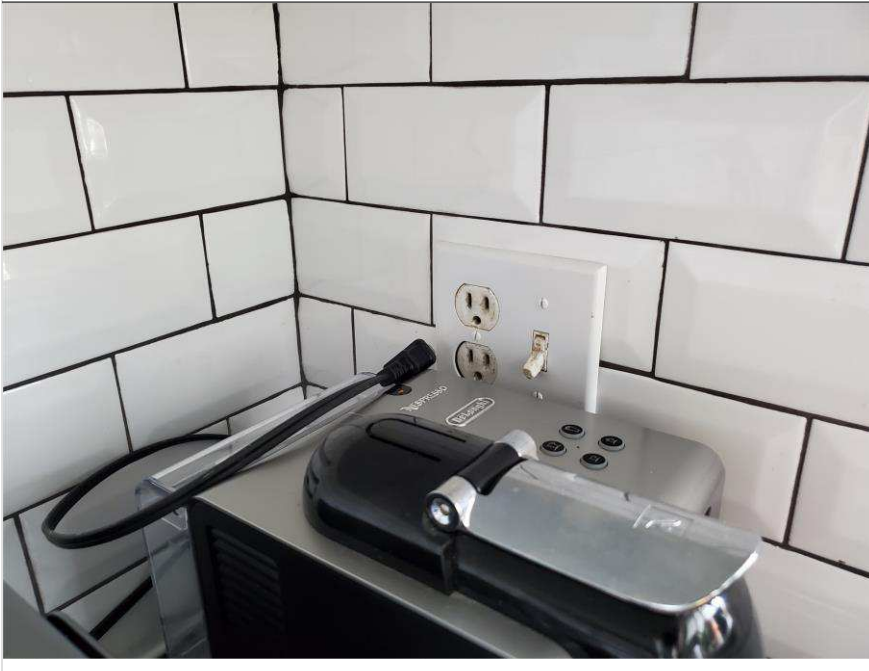
Photo 15 – Village of Dadeland Condominium Association

Apartments - Kitchen outlets are not GFCI type.

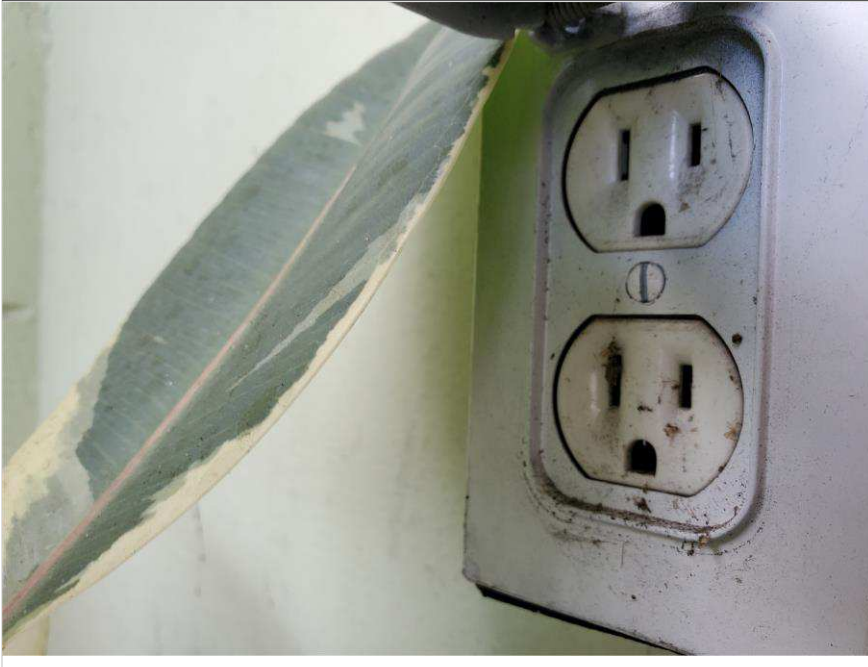
Photo 17 – Village of Dadeland Condominium Association

Apartments - Balcony/Patio outlets are not GFCI type.

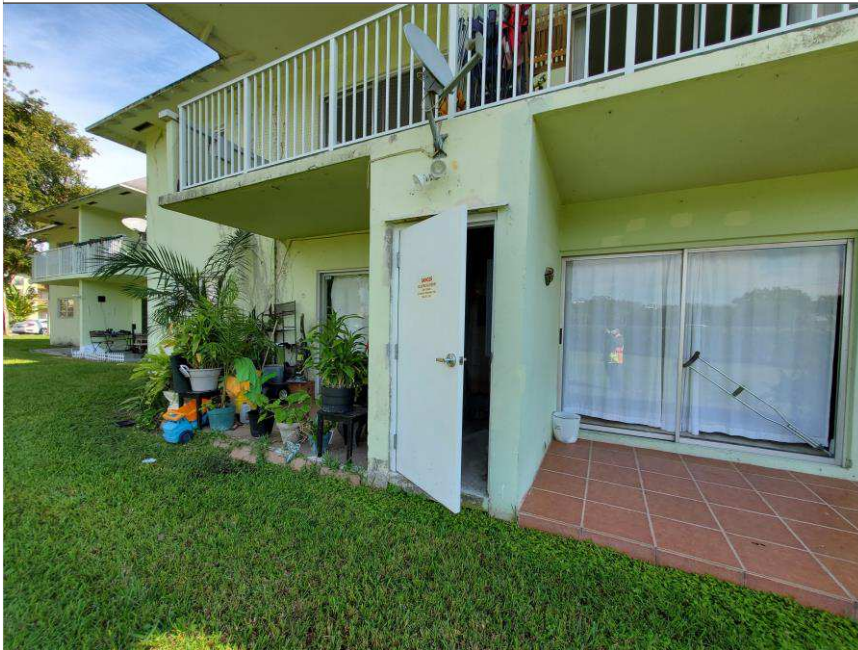
Photo 1 – Village of Dadeland Condominium Association

Existing Electrical Room - 1st FL
No Storage Permitted

Building Number sign is missing.

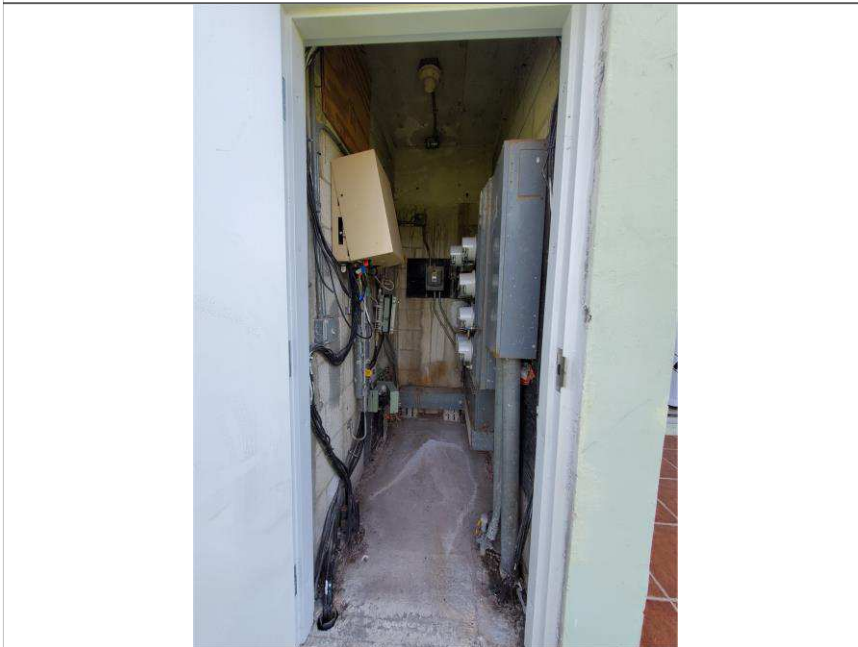
Photo 2 – Village of Dadeland Condominium Association

Existing Electrical Room -1st FL
Main Switches for Apartments,
Meters, and Gutter.

Insufficient clearance in front of
electrical components.

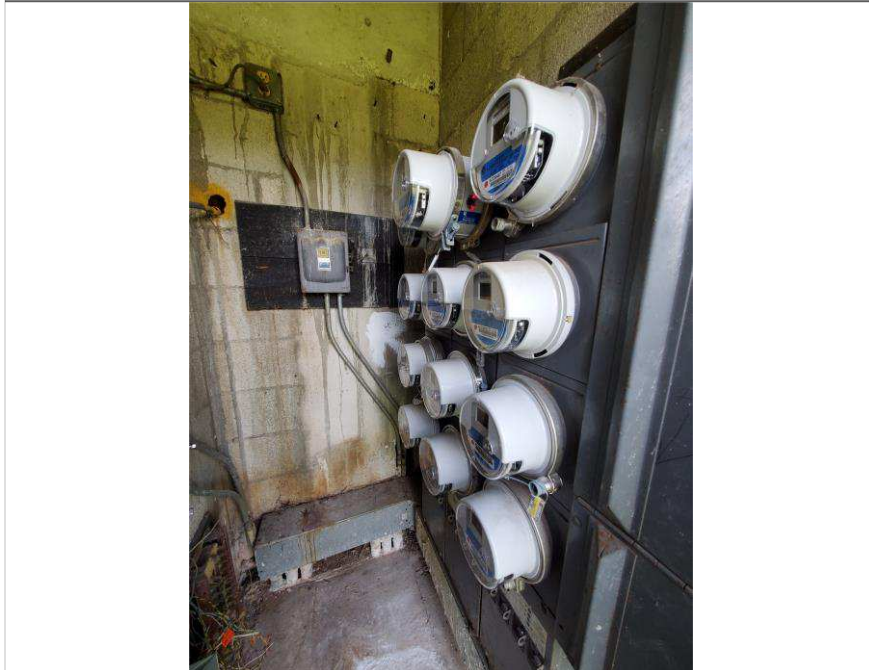
Photo 8 – Village of Dadeland Condominium Association

Existing Electrical Room - 1st FL
Main Switches for Apartments,
Meters, and Gutter.

Old and oxidized meter stacks.

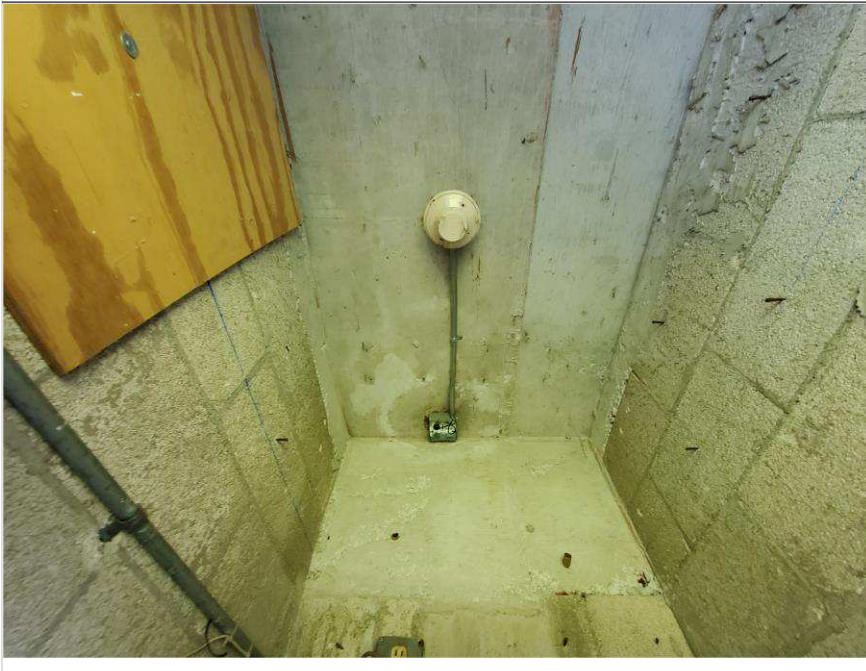
Photo 11 – Village of Dadeland Condominium Association

Existing Electrical Room - 1st FL

Old smoke detector.

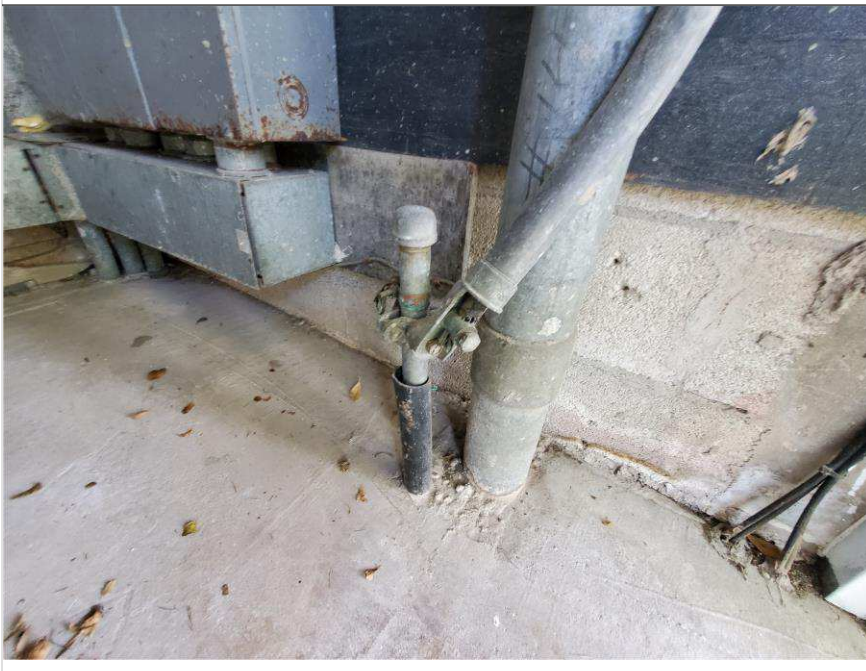
Photo 12 – Village of Dadeland Condominium Association

Existing Electrical Room - 1st FL
Main Service - Grounding

Grounding resistance to be tested to determine if repairs and/or maintenance are required.

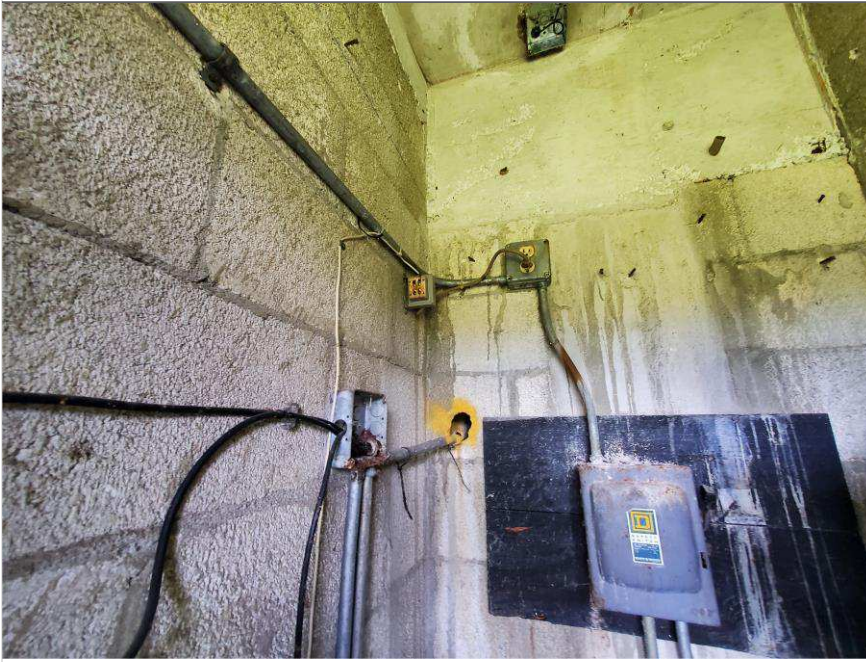
Photo 13 – Village of Dadeland Condominium Association

Existing Electrical Room - 1st FL

All wall penetrations to be fire caulked.

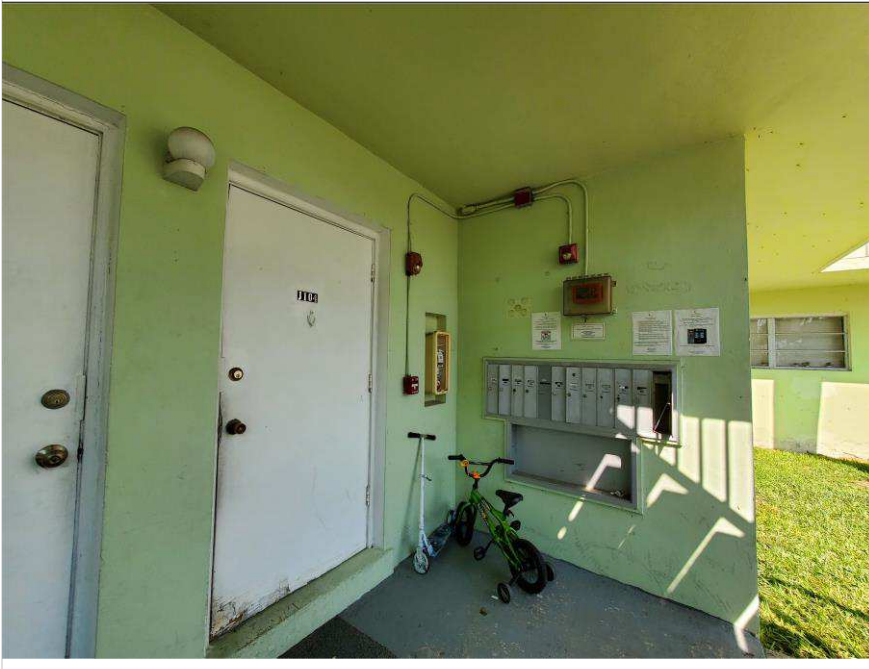
Photo 16 – Village of Dadeland Condominium Association

Level 1

Fire Alarm - Old and Weathered
Fire Alarm Devices and Control
Center

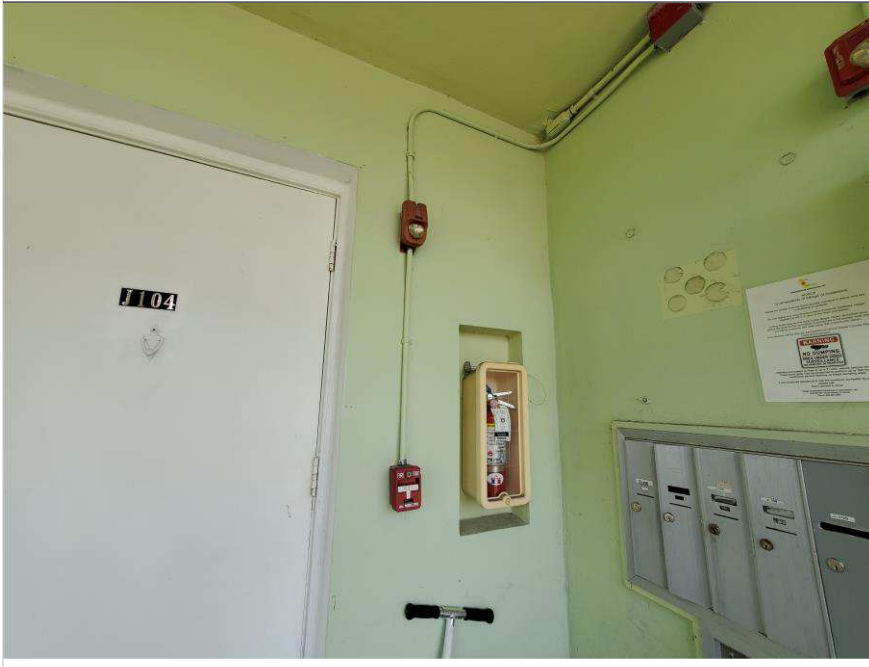
Photo 17 – Village of Dadeland Condominium Association

Level 1

Fire Alarm - Old and Weathered
Fire Alarm Devices and Control
Center

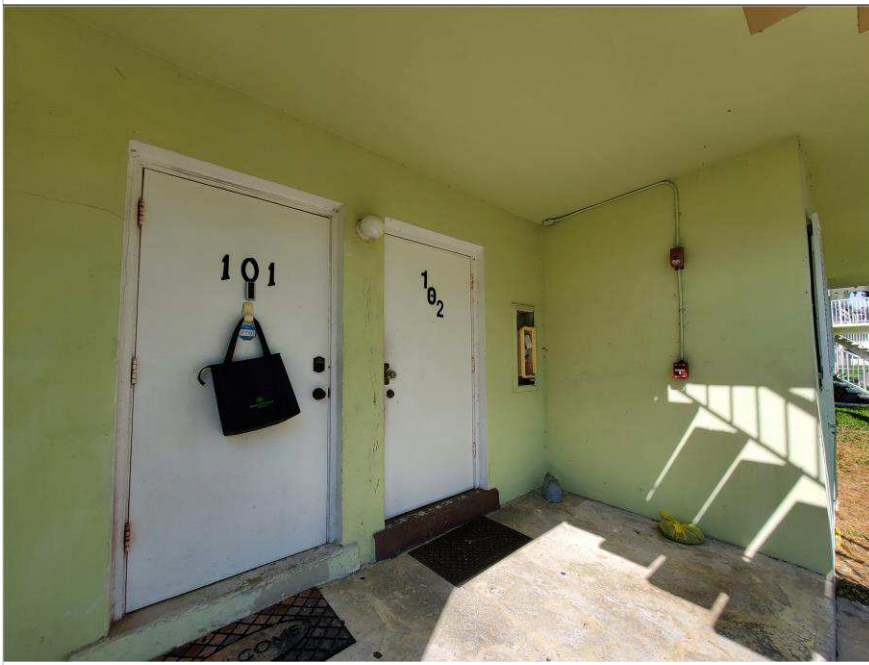
Photo 18 – Village of Dadeland Condominium Association

Level 1

Fire Alarm - Old and Weathered
Fire Alarm Devices and Control
Center

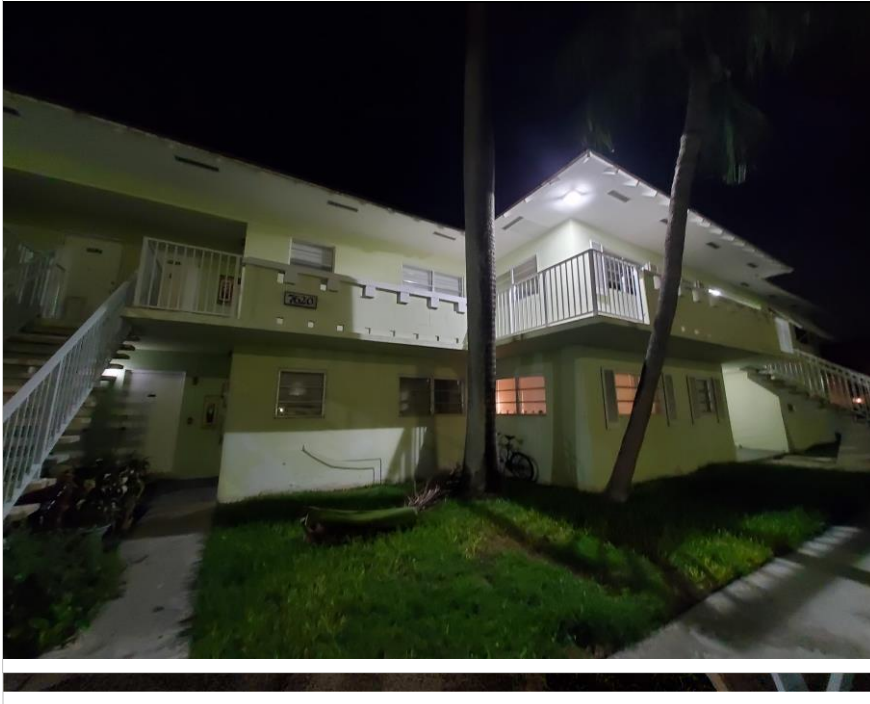
Photo 19 – Village of Dadeland Condominium Association

Egress Components - Poorly illuminated Catwalks and Points of Egress.

Exterior lights not functional.

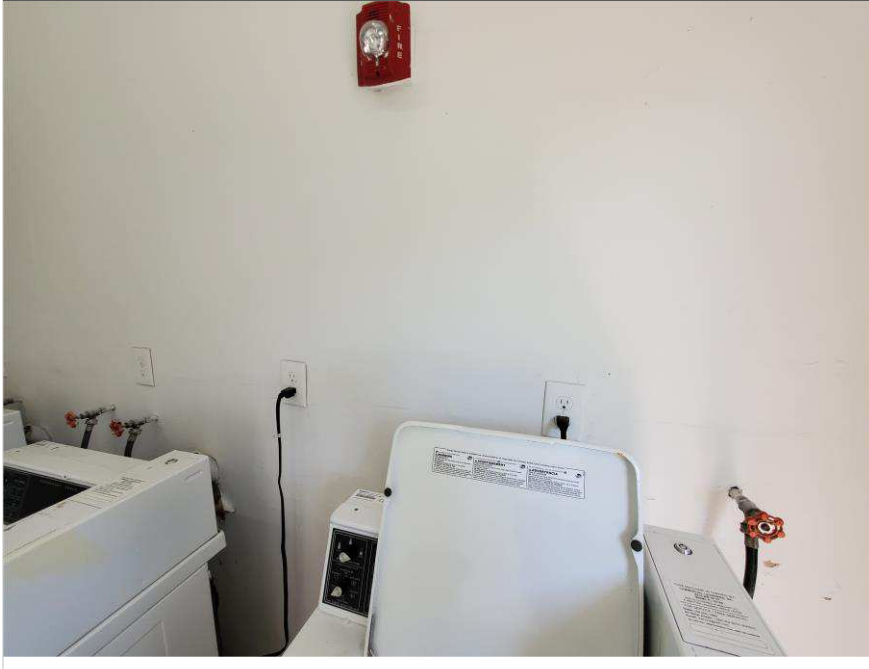
Photo 21 – Village of Dadeland Condominium Association

Laundry Room - Outlets are not GFCI type.
