MINIMUM INSPECTION PROCEDURAL GUIDELINES
FOR BUILDING ELECTRICAL RECERTIFICATION

INSPECTION MADE BY: FLORIN FLOREA P.E.

a. Name on Title: Village at Dadeland Condominiums (J)

b. Street Address: 7600 SW 82nd St. Miami, Florida 33143

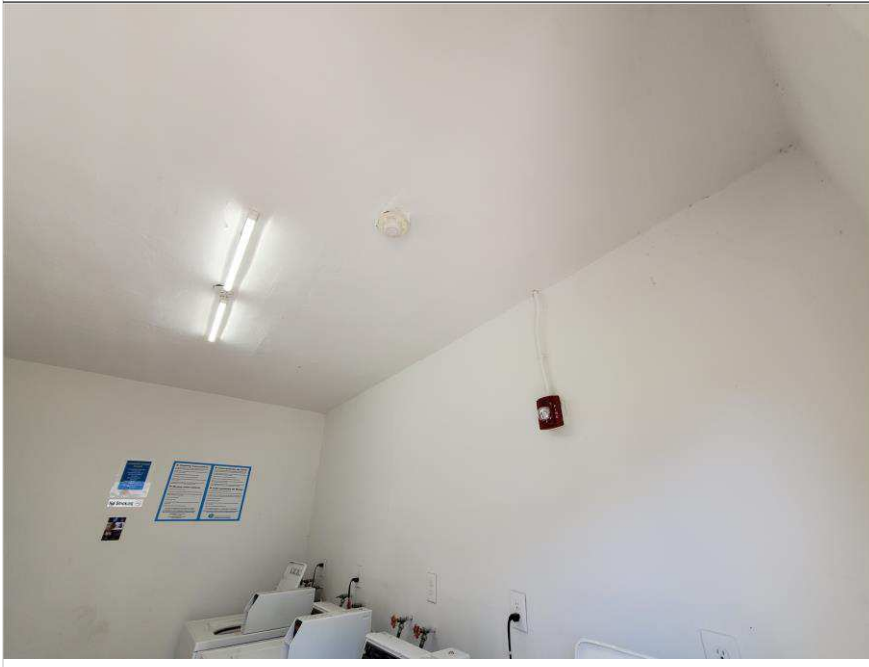
Photo 22 – Village of Dadeland Condominium Association

Laundry Room

Old smoke detector.

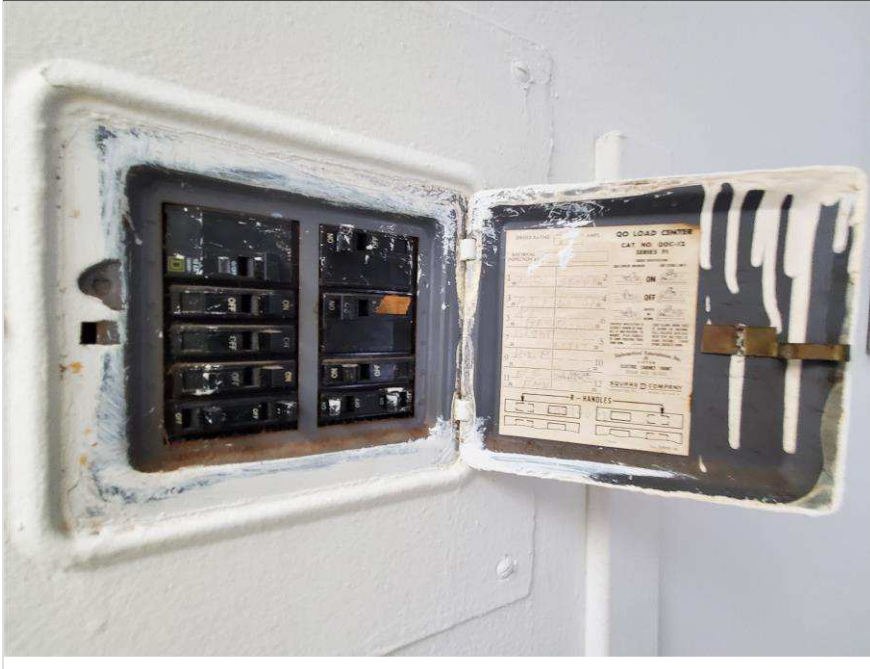
Photo 23 – Village of Dadeland Condominium Association

Apartments - Old Electrical
Panels

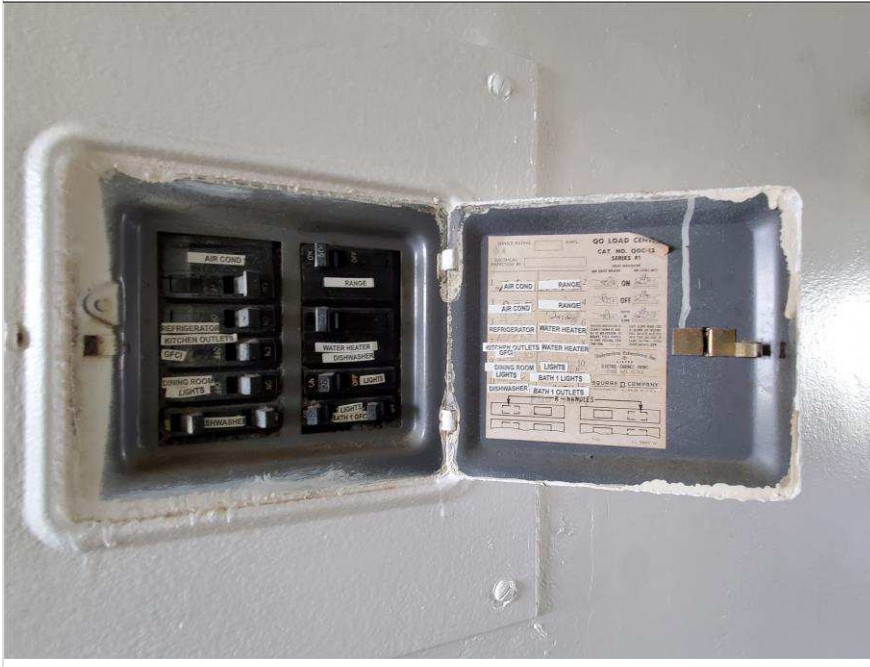
Photo 24 – Village of Dadeland Condominium Association

Apartments - Old Electrical
Panels

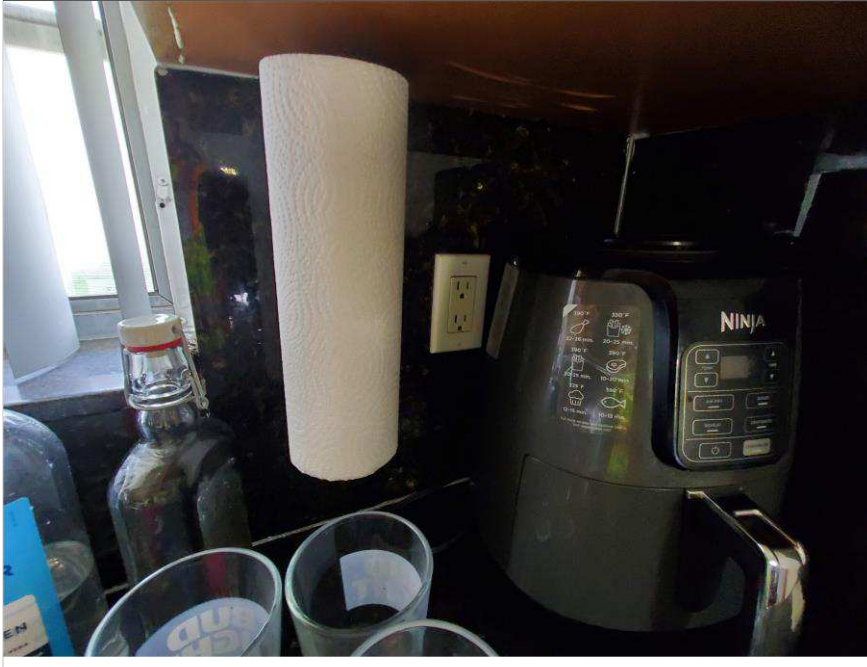
Photo 25 – Village of Dadeland Condominium Association

Apartments - Kitchen outlets
not GFCI Type

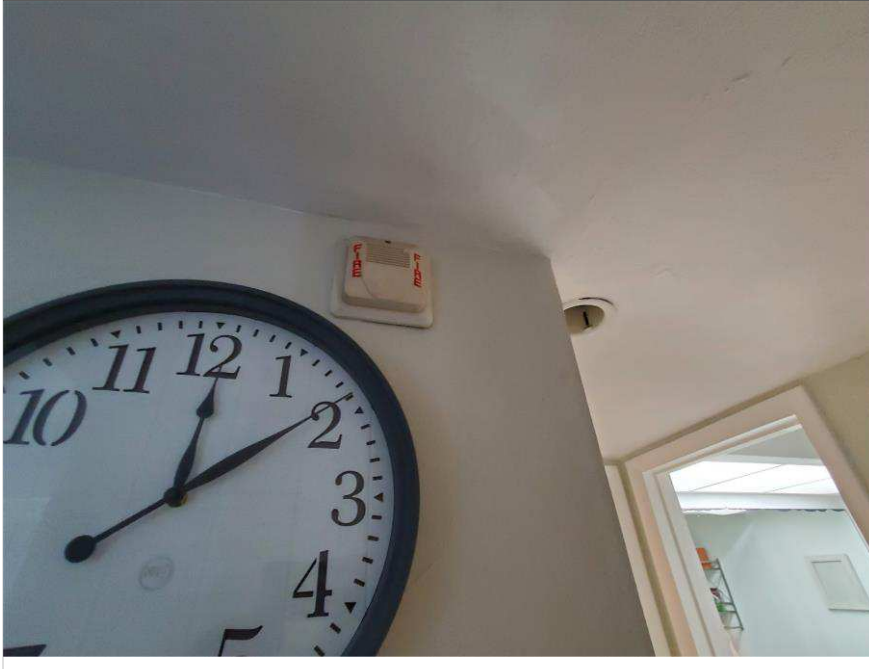
Photo 27 – Village of Dadeland Condominium Association

Apartments - Fire Alarm System

Old Devices exceeding useful life.

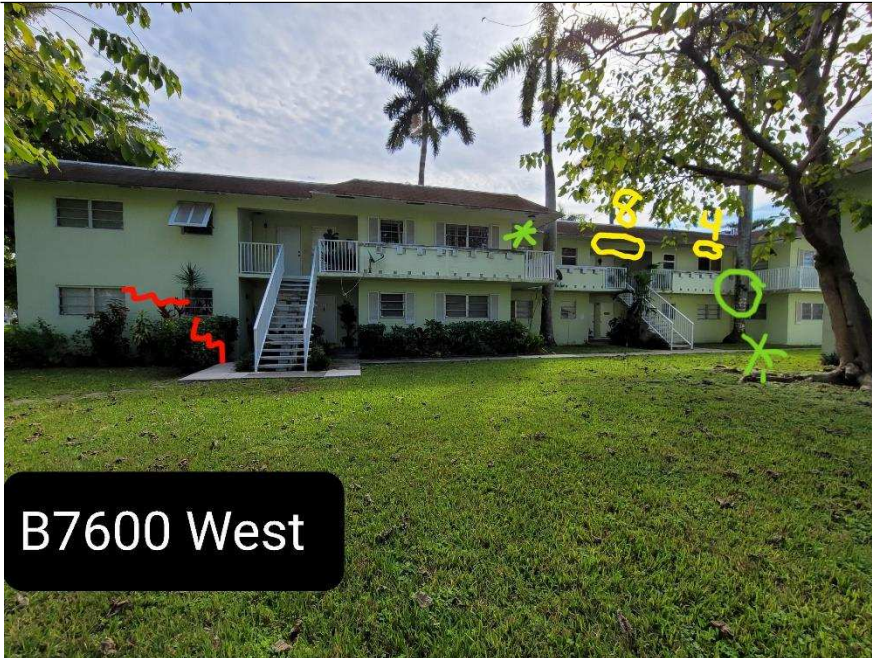
Photo #1:

Front elevation of building 7600 (Villa J)

The stuccoed envelope requires maintenance of the stucco exterior surfaces at many locations. Unsound stucco surfaces and surface cracks discovered at many areas of the exterior envelope.

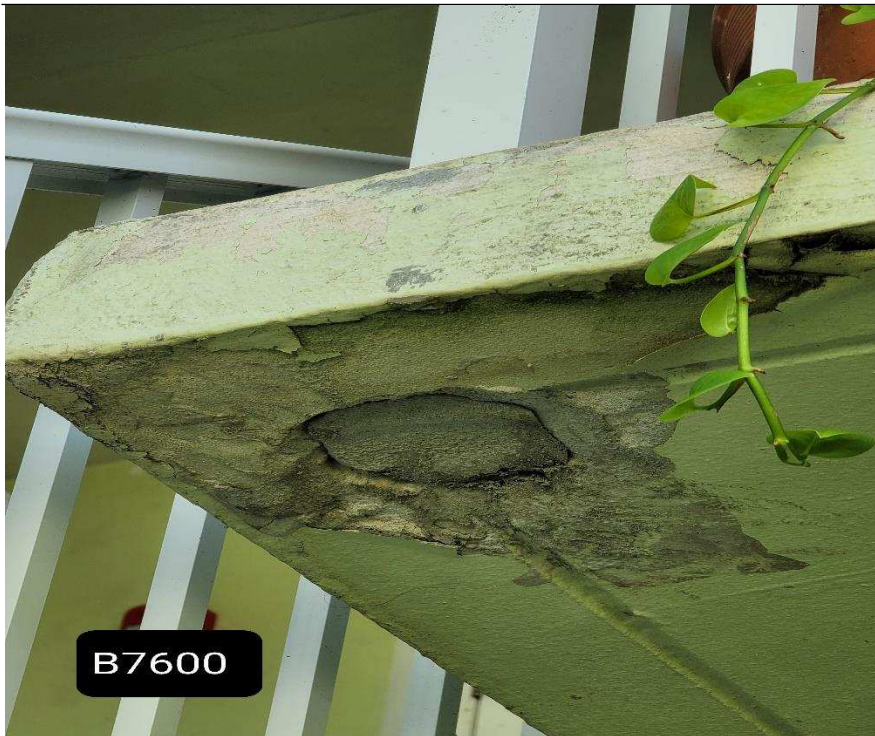
Photo #3:

Concrete pocket for the rail support is deteriorated and cracked. Surrounding concrete also unsound.

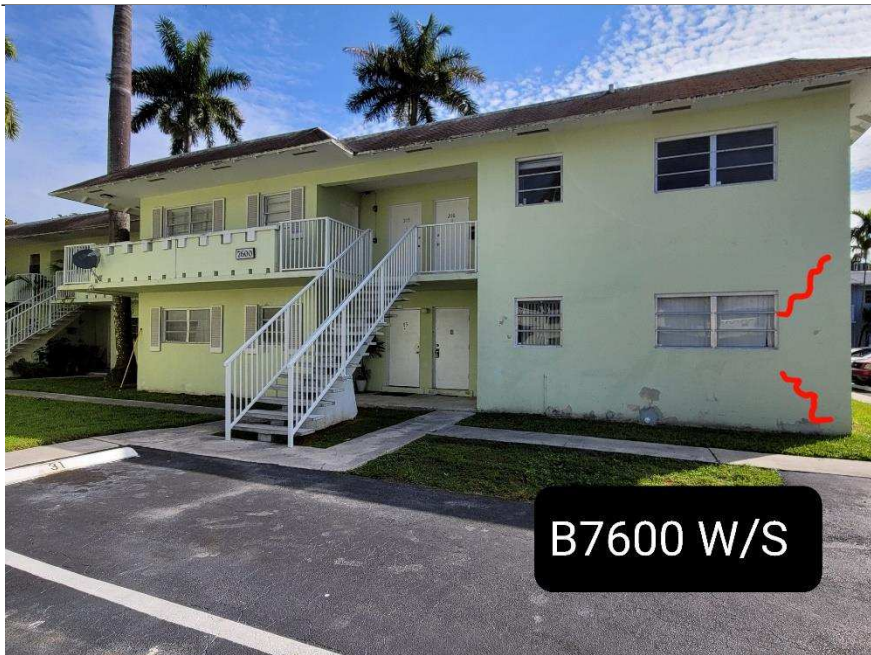
Photo #4:

The stuccoed envelope requires maintenance of the stucco exterior surfaces throughout the building. Fine horizontal and steps cracks observed sporadically.

Most cracks located near the corners of the buildings or at the top/bottom corners of the wall openings.

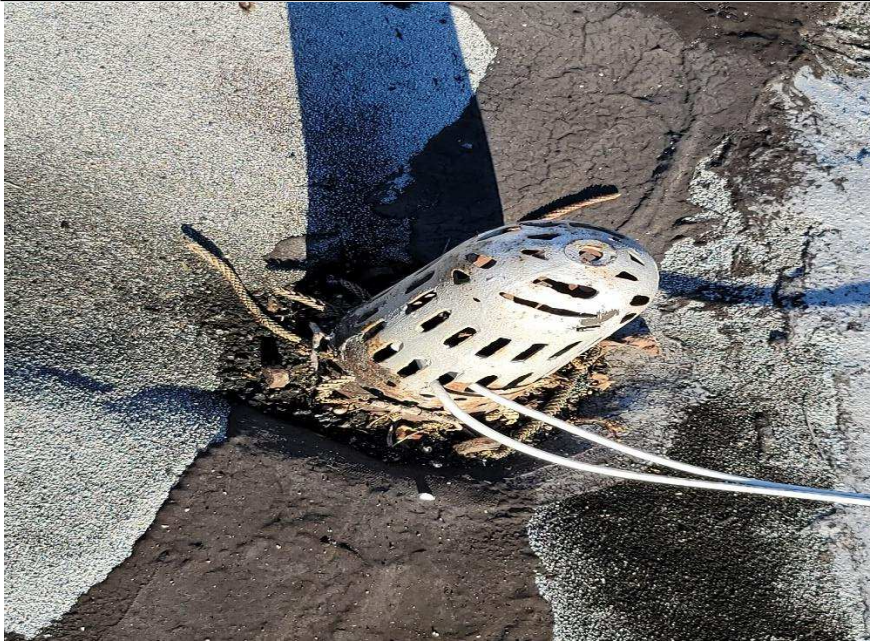
Photo #5:

The strainers for the interior drain lines were found to be rusted or non-functional since many of them are missing or not in their proper position. Others need maintenance to remove debris.

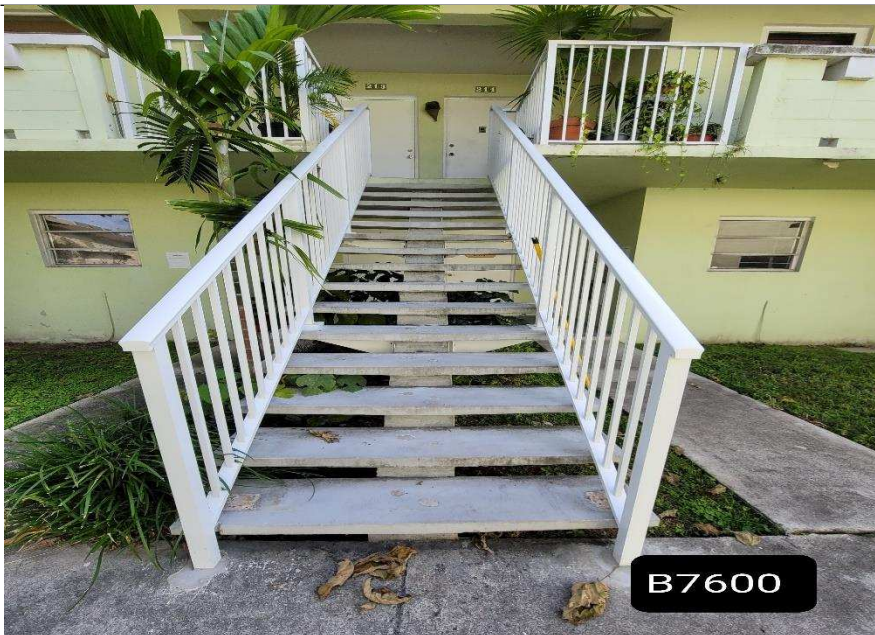
Photo #6:

The railings were deemed to be in fair/good condition.

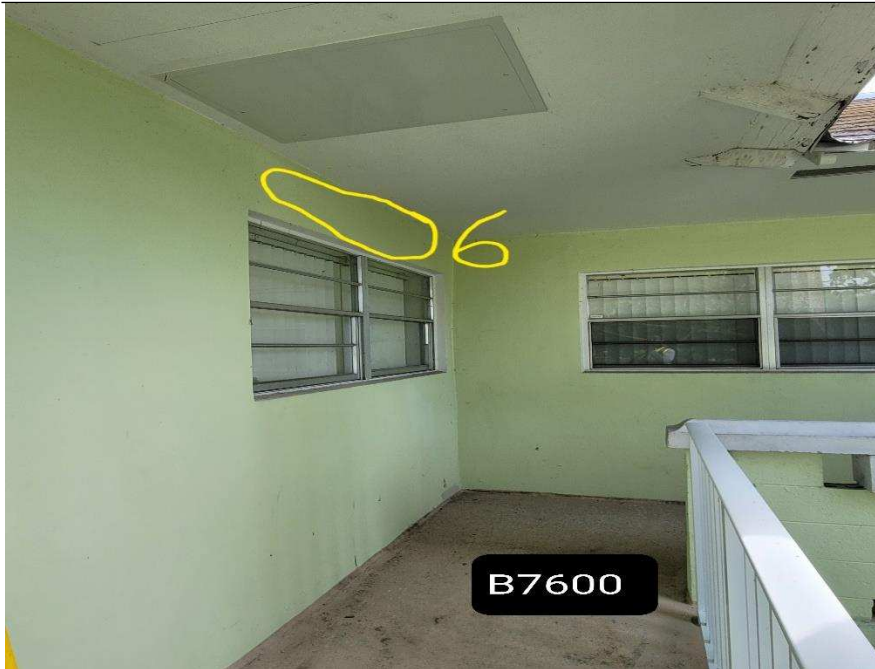
Photo #7:

The top wearing surface of the catwalks are stained or weathered and require maintenance.

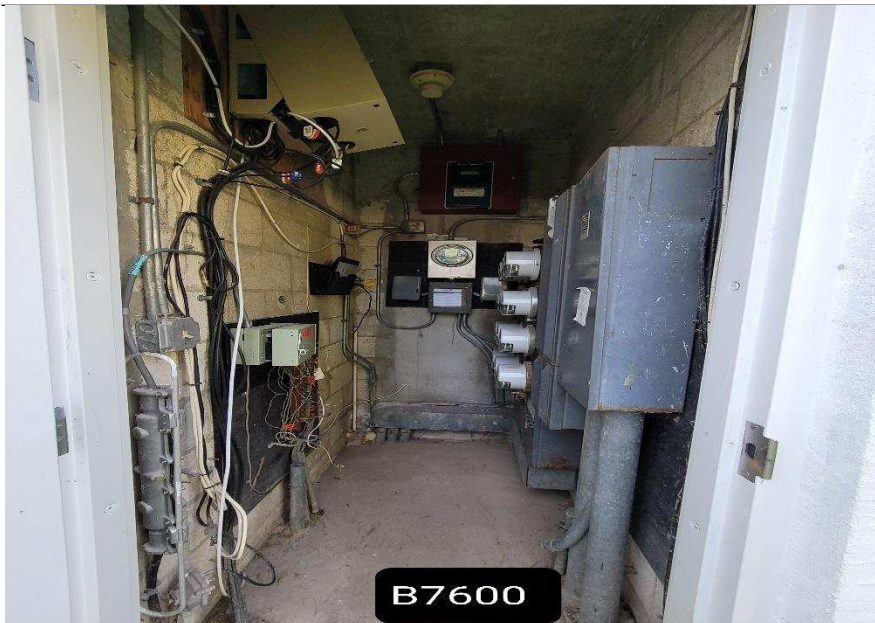
Photo #8:

The mechanical room was observed to be in good condition. Wall/ceiling penetration should be sealed.

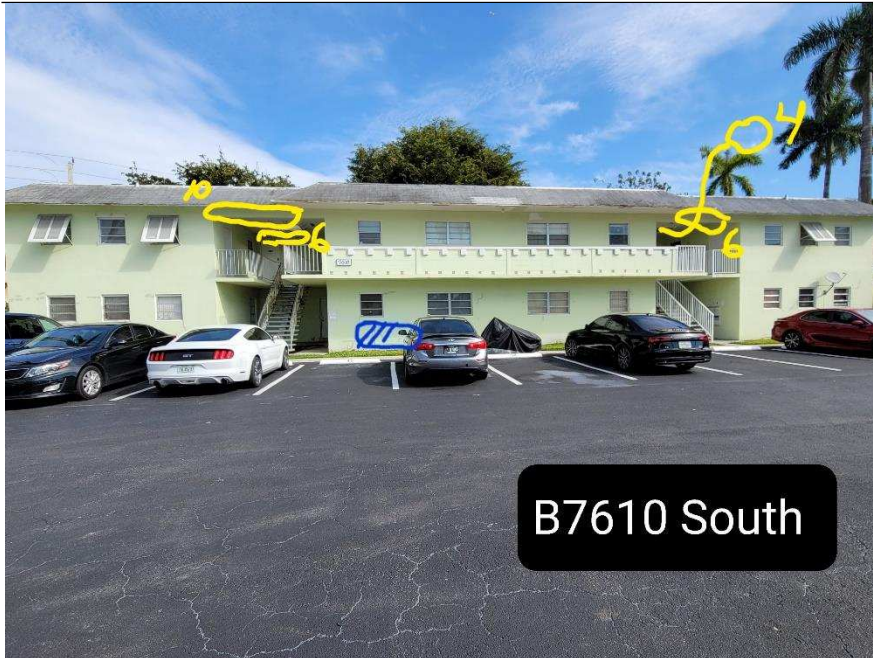
Photo #1:

Front elevation of building 7610 (Villa J)

The stuccoed envelope requires maintenance of the stucco exterior surfaces at many locations. Unsound stucco surfaces and surface cracks discovered at many areas of the exterior envelope.

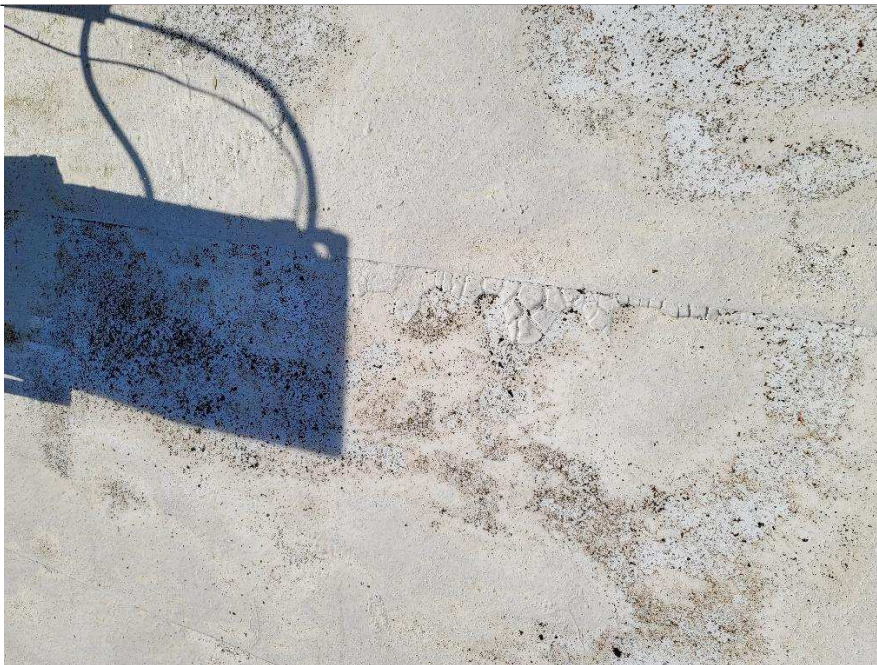
Photo #2:

Water ponding stains observed on the roof.

The bituminous roof membrane was deemed to be in fair condition with signs of weathering/distress at various locations.

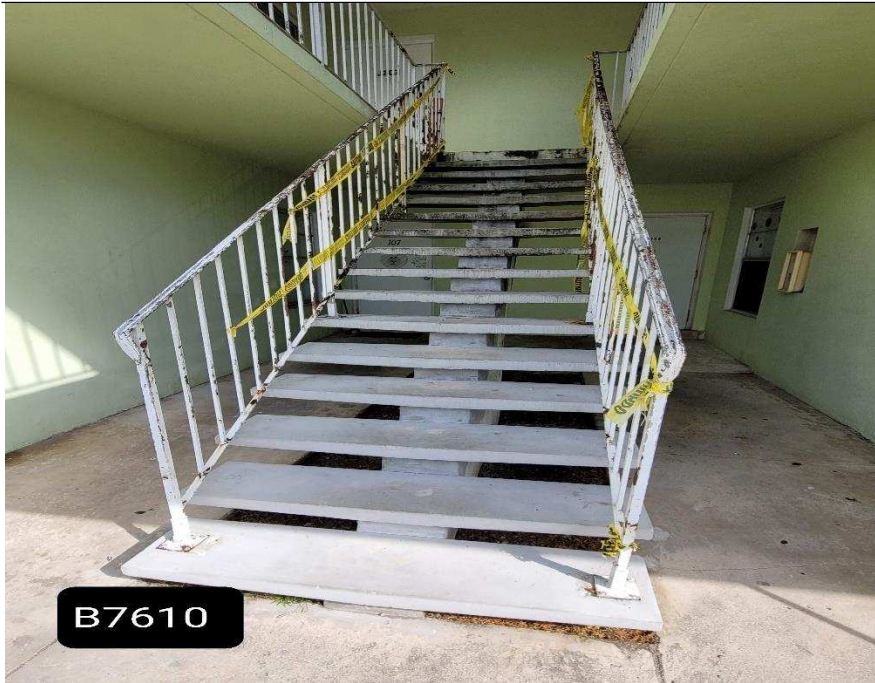
Photo #3:

Replacement of the steel picket rails is necessary due to the extent of corrosion at the base of the rail posts.

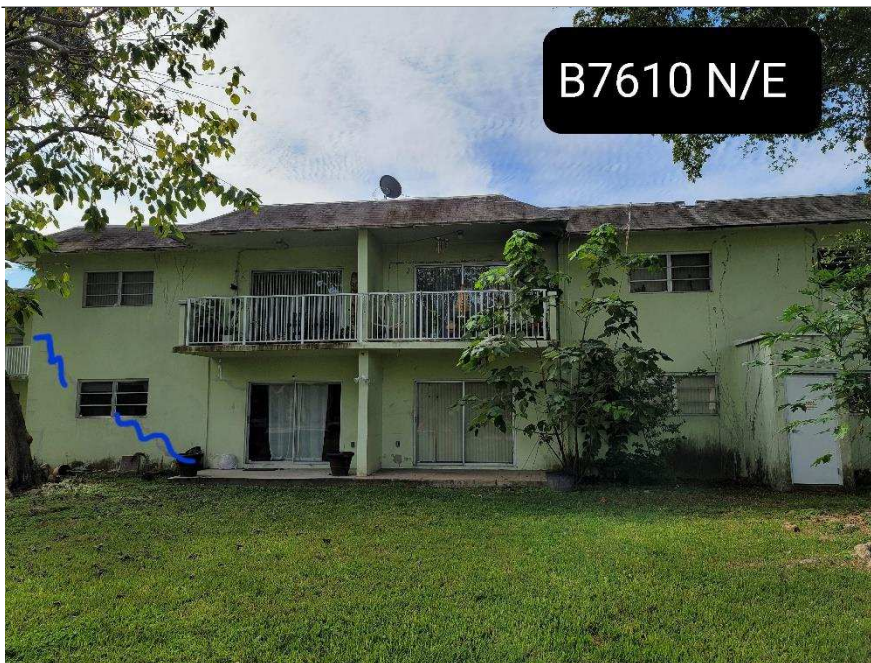
Photo #4:

The stuccoed envelope requires maintenance of the stucco exterior surfaces throughout the building. Fine horizontal and steps cracks observed sporadically.

Most cracks located near the corners of the buildings or at the top/bottom corners of the wall openings.

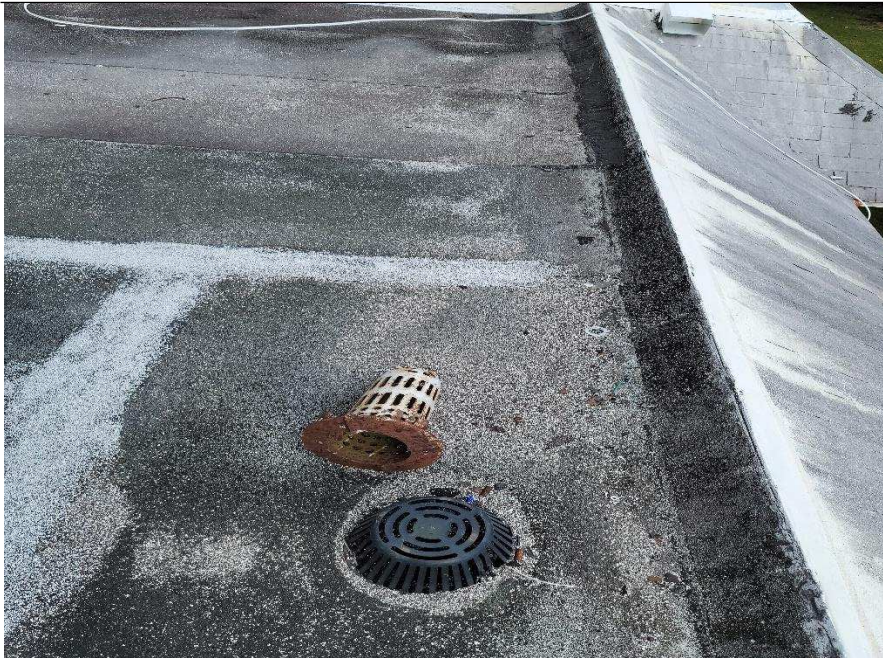
Photo #5:

The strainers for the interior drain lines were found to be rusted or non-functional since many of them are missing or not in their proper position. Others need maintenance to remove debris.

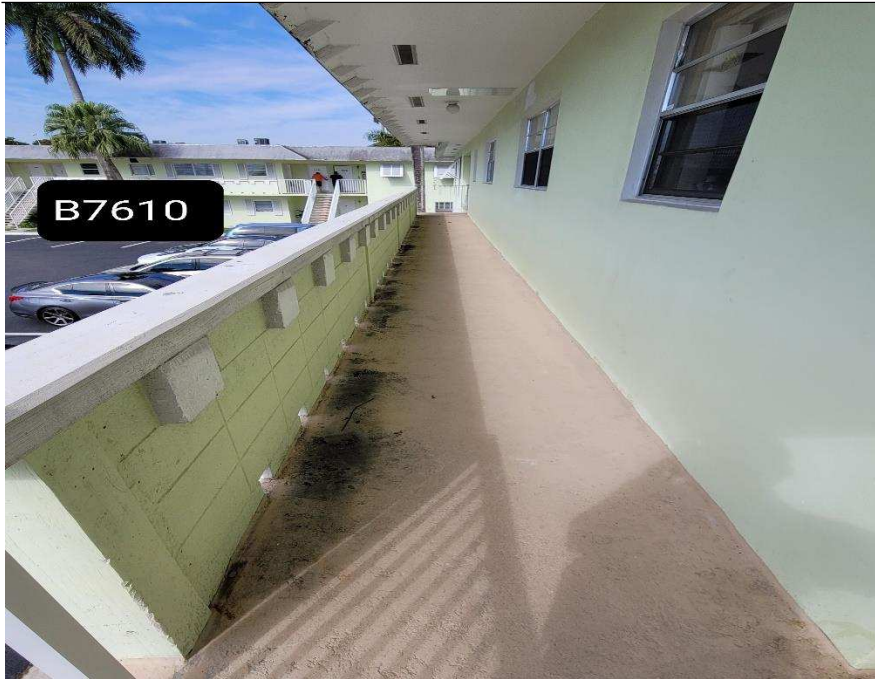
Photo #6:

The top wearing surface of the catwalks are stained or weathered and require maintenance.

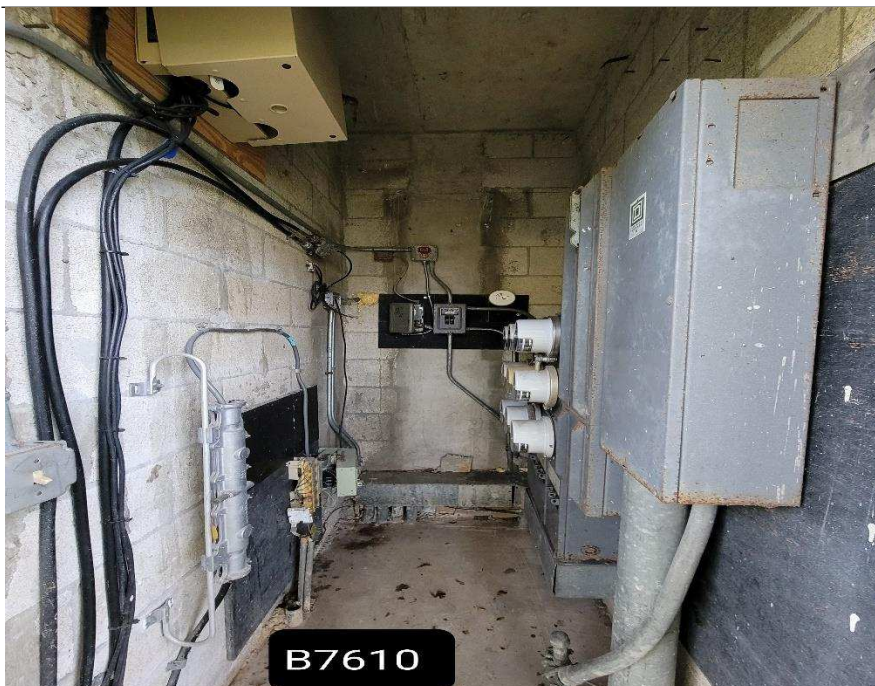
Photo #7:

The mechanical room was observed to be in good condition. Wall/ceiling penetration should be sealed.

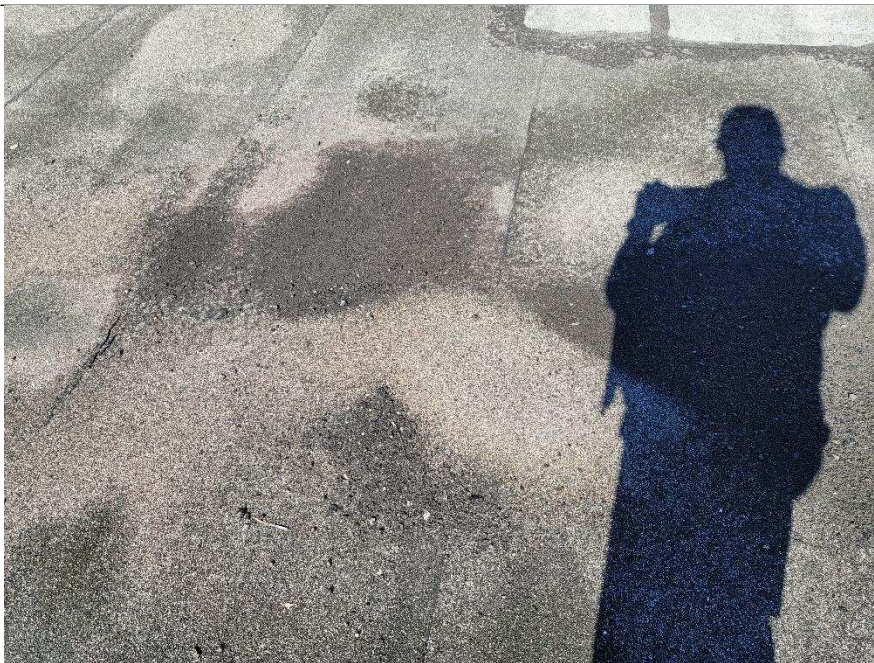
Photo #2:

Water ponding stains observed on the roof.

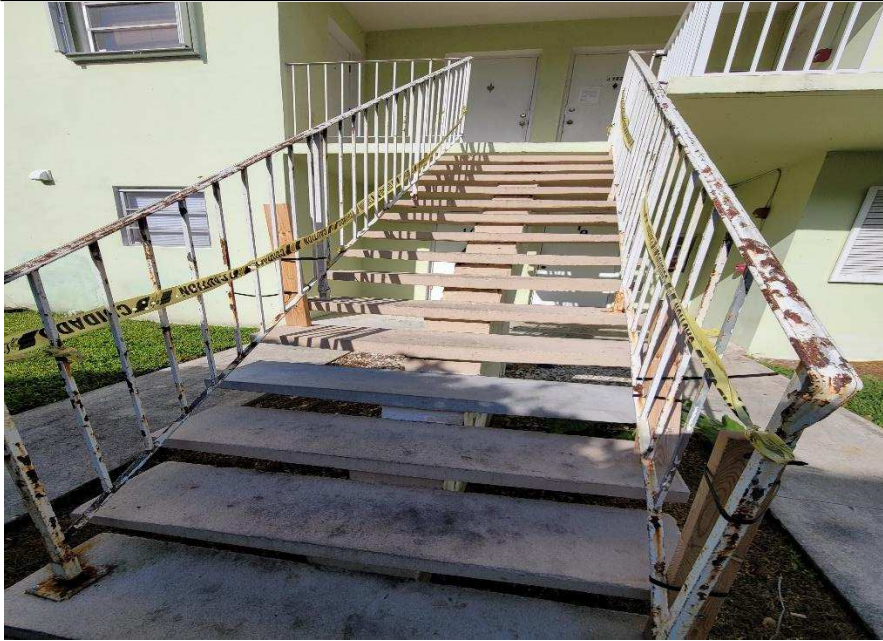
Photo #3:

Replacement of the steel picket rails is necessary due to the extent of corrosion at the base of the rail posts.

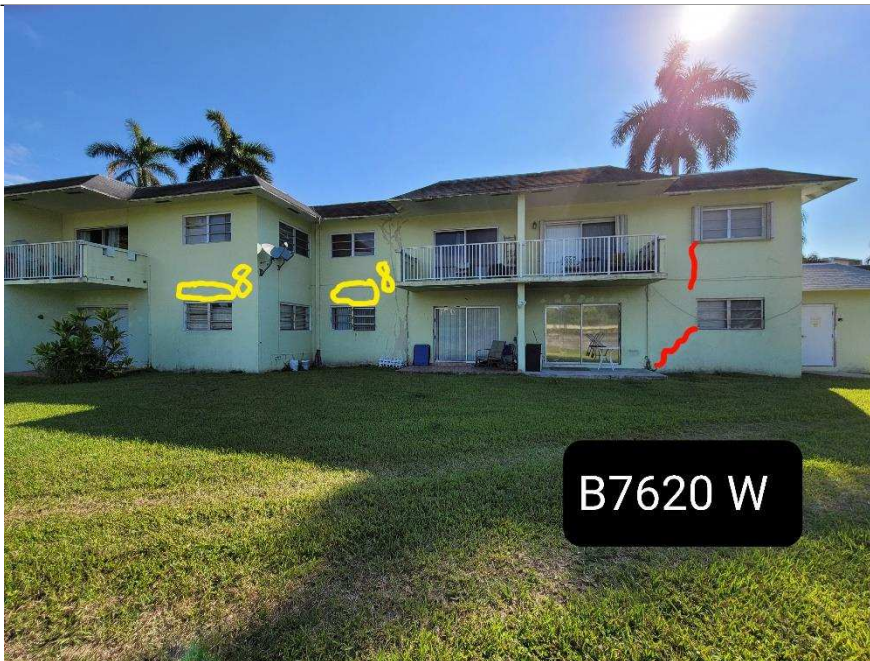
Photo #4:

The stuccoed envelope requires maintenance of the stucco exterior surfaces throughout the building. Fine horizontal and steps cracks observed sporadically.

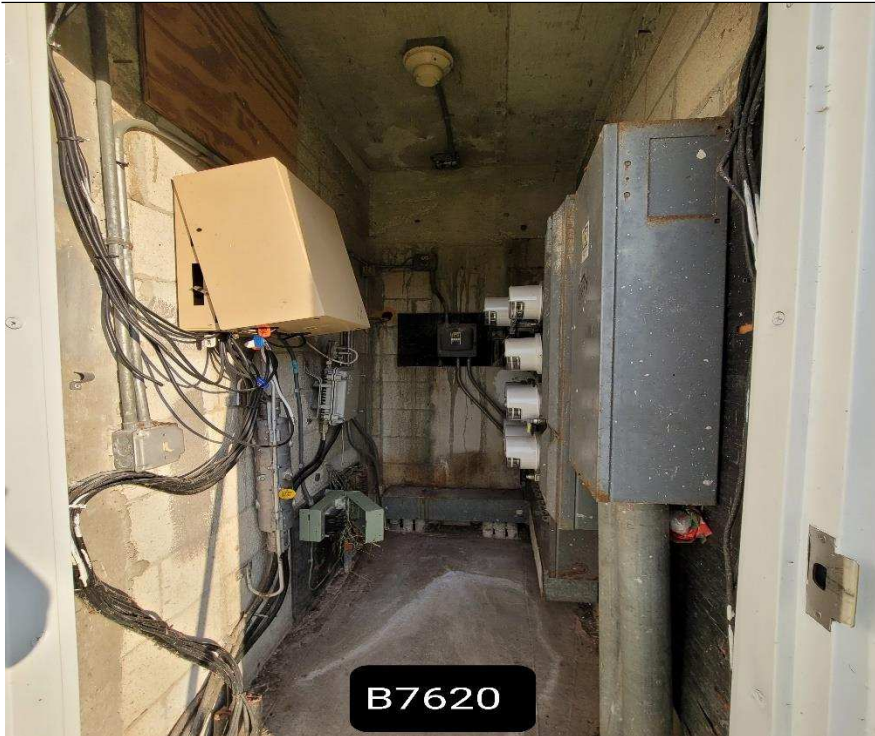
Photo #5:

The mechanical room was observed to be in good condition. Wall/ceiling penetration should be sealed.
